Doyle Creek/Tates Hell Wetlands Restoration Annual Monitoring Report (2008)
Nationwide Permit – SAJ-2004-706 (NW-TLZ) issued 4/26/2004

Impact: SR 65 in Franklin County, 2.27 acres of low quality wet flatwoods

Mitigation: Doyle Creek/Tates Hell

Monitoring date: 11/11/08

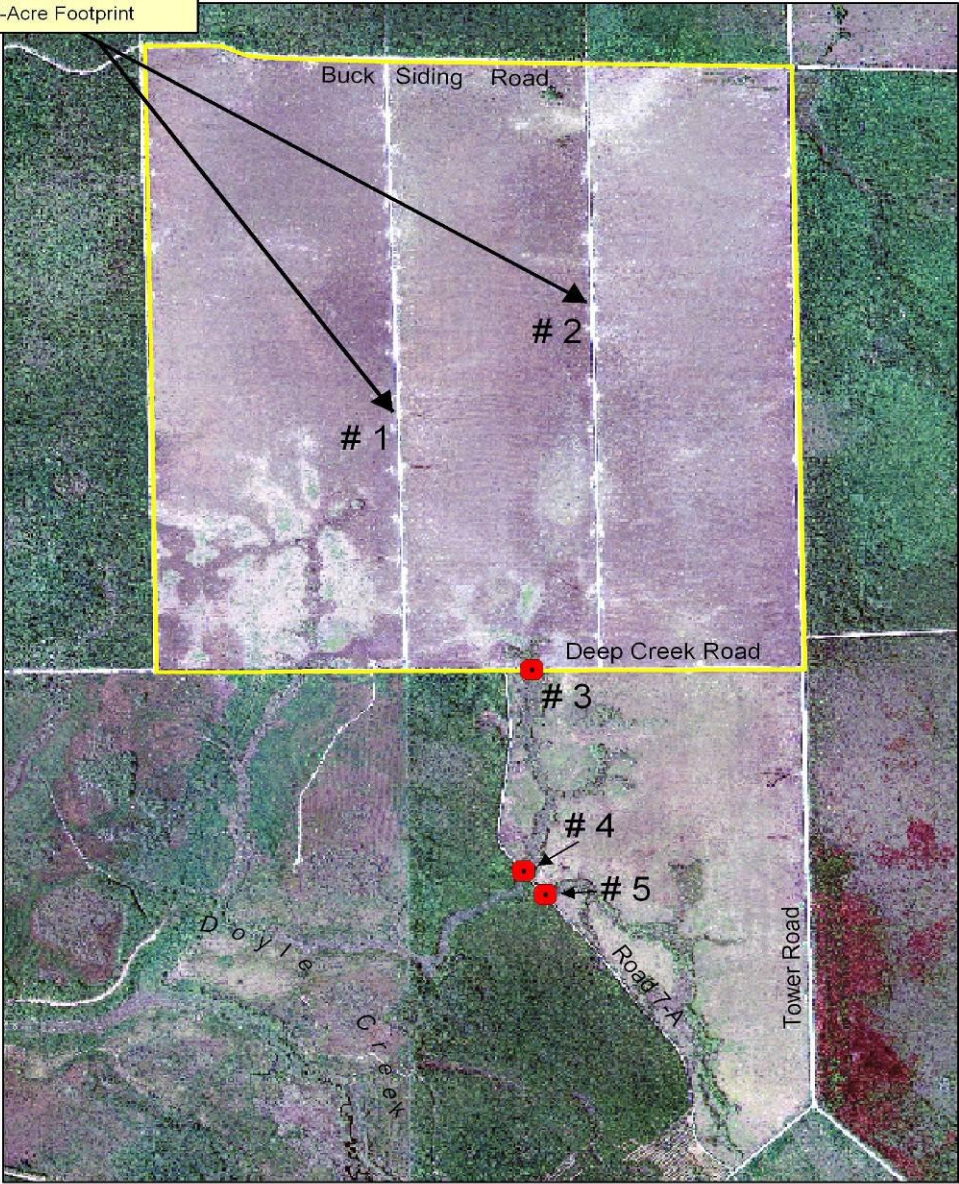
Removal of Road Fill / Ditches
and Revegetation of Footprint
~18,000 Linear Feet
~25-Acre Footprint

Low Water Crossing

Figure 2. Doyle Creek mitigation site with location of each construction activity. Sites #1-2 are road removals; sites #3-5 are hardened low-water crossings.

The project was divided into two phases with all construction activities (road removal and construction of HLWCs) included in phase one and vegetation planting in phase two. Construction began on February 10, 2006 and was completed by July 11, 2006. Nearly 18,000 feet of roadbed was pushed into the adjacent ditches (Figure 2). The roadbed footprint was contoured and graded to approximate adjacent land elevations and seeded with brown topped millet as an erosion control measure. Comparative photographs of the road removals are shown for site #1 (Figures 3 and 4) as an example; the set of photos shows the sites immediately after construction and again after about 16 months. Hardened low water crossings were installed at sites #3 - #5. Stream reconnection was observed with water flowing over the structures during and after several recent rain events. Best management practices were implemented during both road removal and construction of low water crossings. No turbid runoff was observed at either road removal or low water crossing sites during or after construction. Guard rails and water elevation staff gages were installed at each of the crossings as a safety precaution.

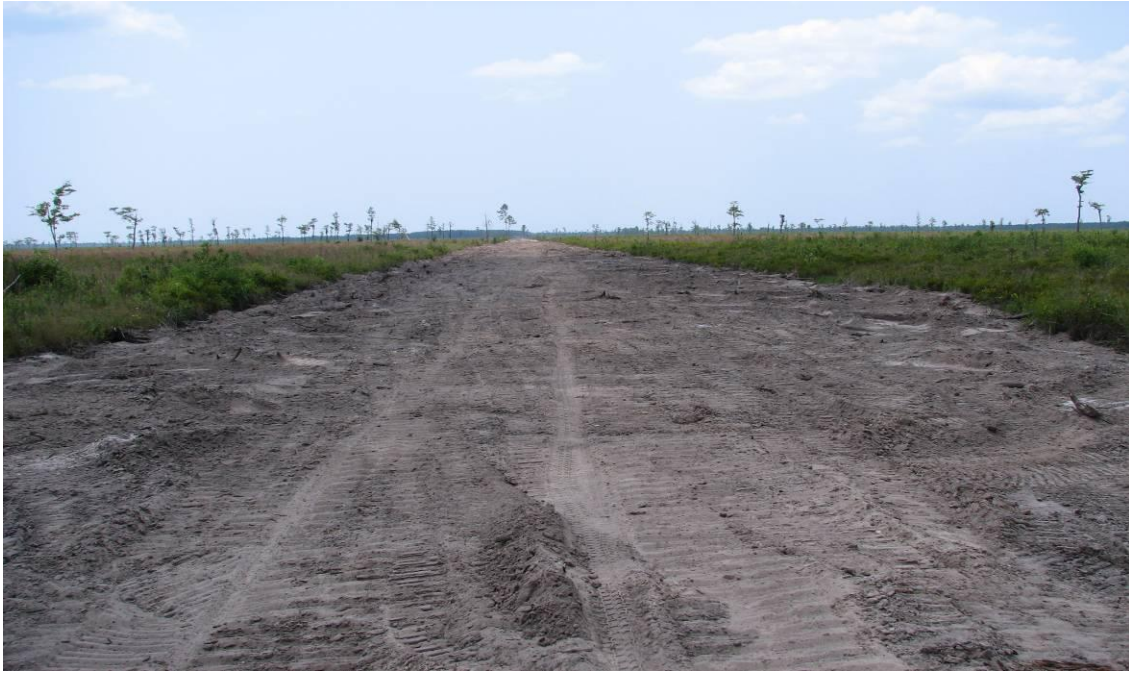
Figure 3. Road removal site #1 (westernmost road) after roadbed material was pushed into adjacent ditches and contoured to existing adjacent natural grade.

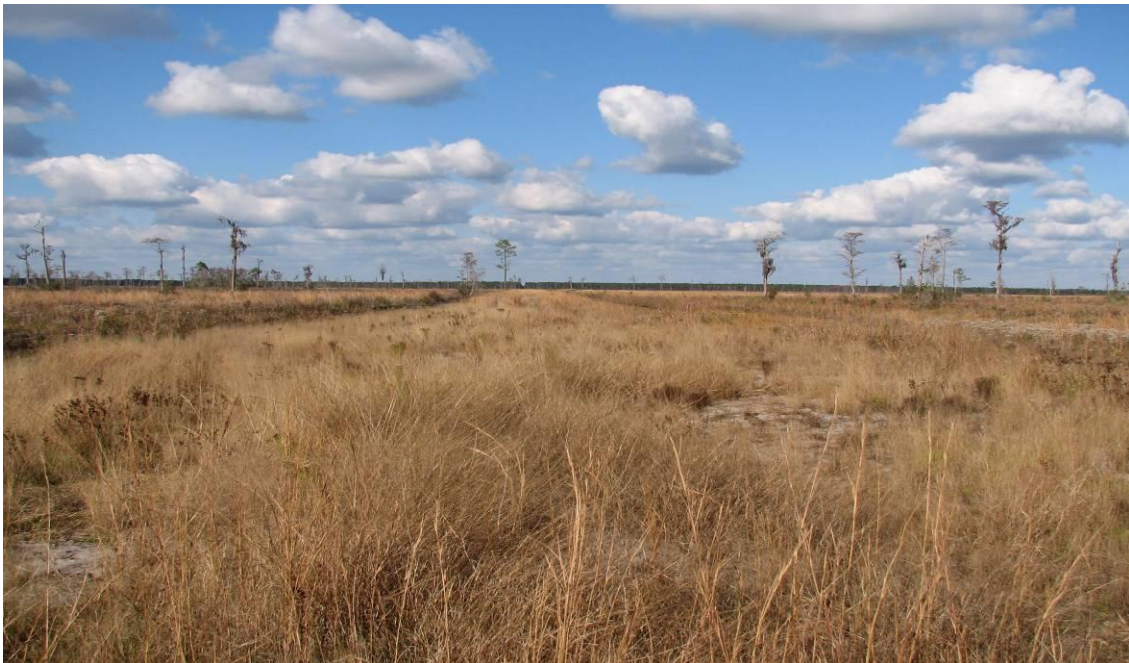
Figure 4. Road removal site #1 (westernmost road) after natural recolonization of vegetation. Photograph was taken about 16 months after completion of construction and can be compared with that in Figure 3.

Prior to planting the roadbed sites were surveyed for existing vegetation on December 10, 2007 (see Figure 4). A 15-minute pedestrian survey was taken at each site; thirty-seven plant species were observed. Native groundcover covered about 30-40% of both sites and no invasive or exotic species were observed.

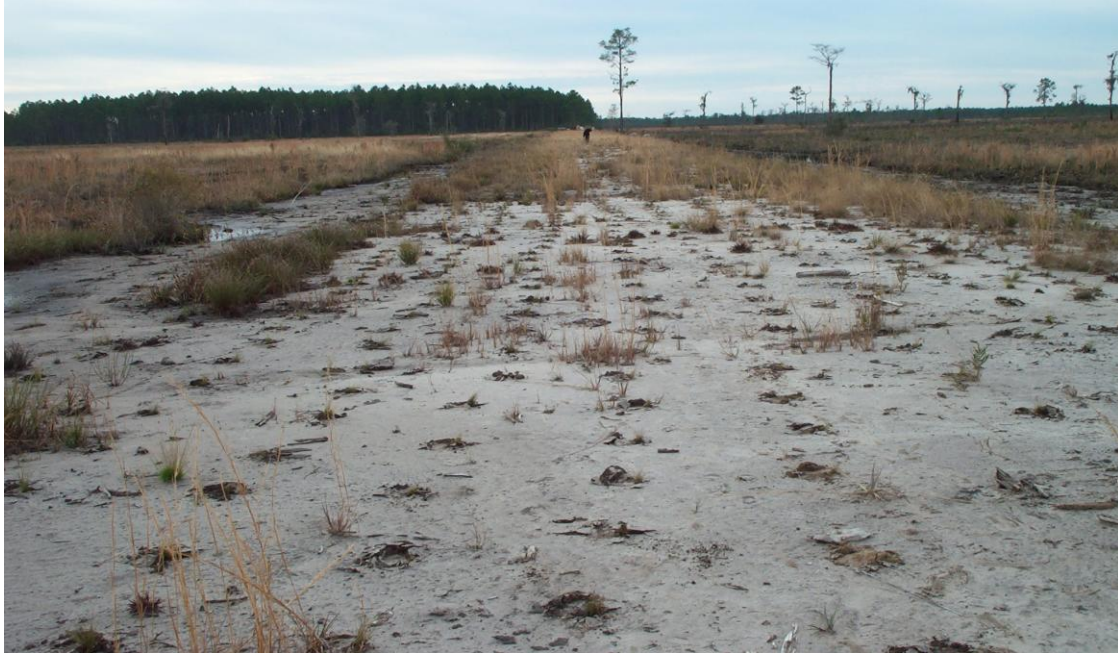
Figure 5. Planting of wiregrass plugs and cypress tubelings on road removal site. Planting was done on 14-15 January 2008.

On 14-15 January 2008, 68,075 wiregrass tubelings were planted on 4-foot centers throughout the roadbed footprint (Figure 5). In addition, 2,725 cypress seedlings were planted in appropriate areas of the footprint.

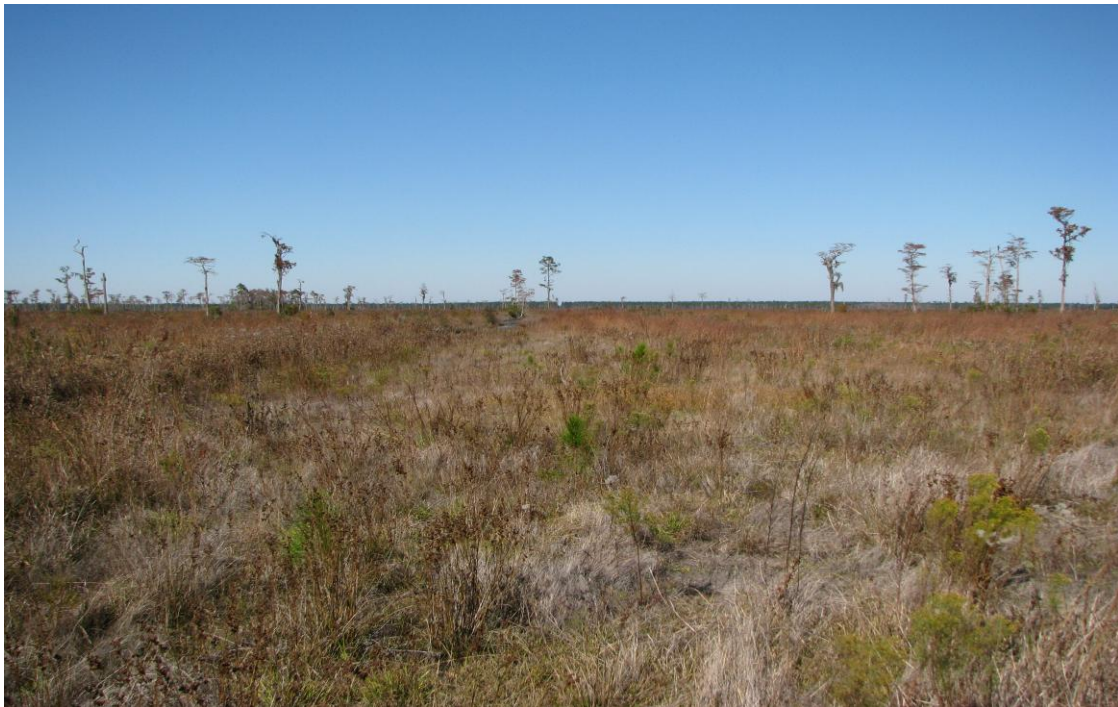
Annual monitoring of the restoration site was carried out on 11 November 2008. About 60-65% coverage of native groundcover has been established after two years (Figure 6); however, planted wiregrass survival was poor (<25%). Cypress survival was high with greater than 80% of the planted individuals present and growing well. Less than 1% coverage of exotic species was noted throughout the site. Wiregrass will be replanted in 2009 to meet the required dominance specifications. Fifteen-minute pedestrian surveys were taken at each site noting vegetation present. Forty-five species were observed (Table 1) with eight new species noted from the pre-

Figure 6. Vegetation coverage during annual monitoring on 11 November 2008. Cover is estimated to be 60-65% native groundcover with less than 25% wiregrass survival. Wiregrass replanting is scheduled for Fall 2009.

- Minimum 80% native groundcover dominated by wiregrass within five years of restoration: only about 60-65% native groundcover has been established after two years with poor survival of planted wiregrass (<25%). Replanting of wiregrass is scheduled for Fall 2009.
