DOYLE CREEK/TATES HELL WETLANDS RESTORATION ANNUAL MONITORING REPORT (2010)
Franklin County

Impact: SR 65 in Franklin County, 2.27 acres of low quality wet flatwoods; **Nationwide Permit – SAJ-2004-706 (NW-TLZ) issued 4/26/2004**

Mitigation: Doyle Creek/Tates Hell Swamp

Monitoring date: October 30, 2010

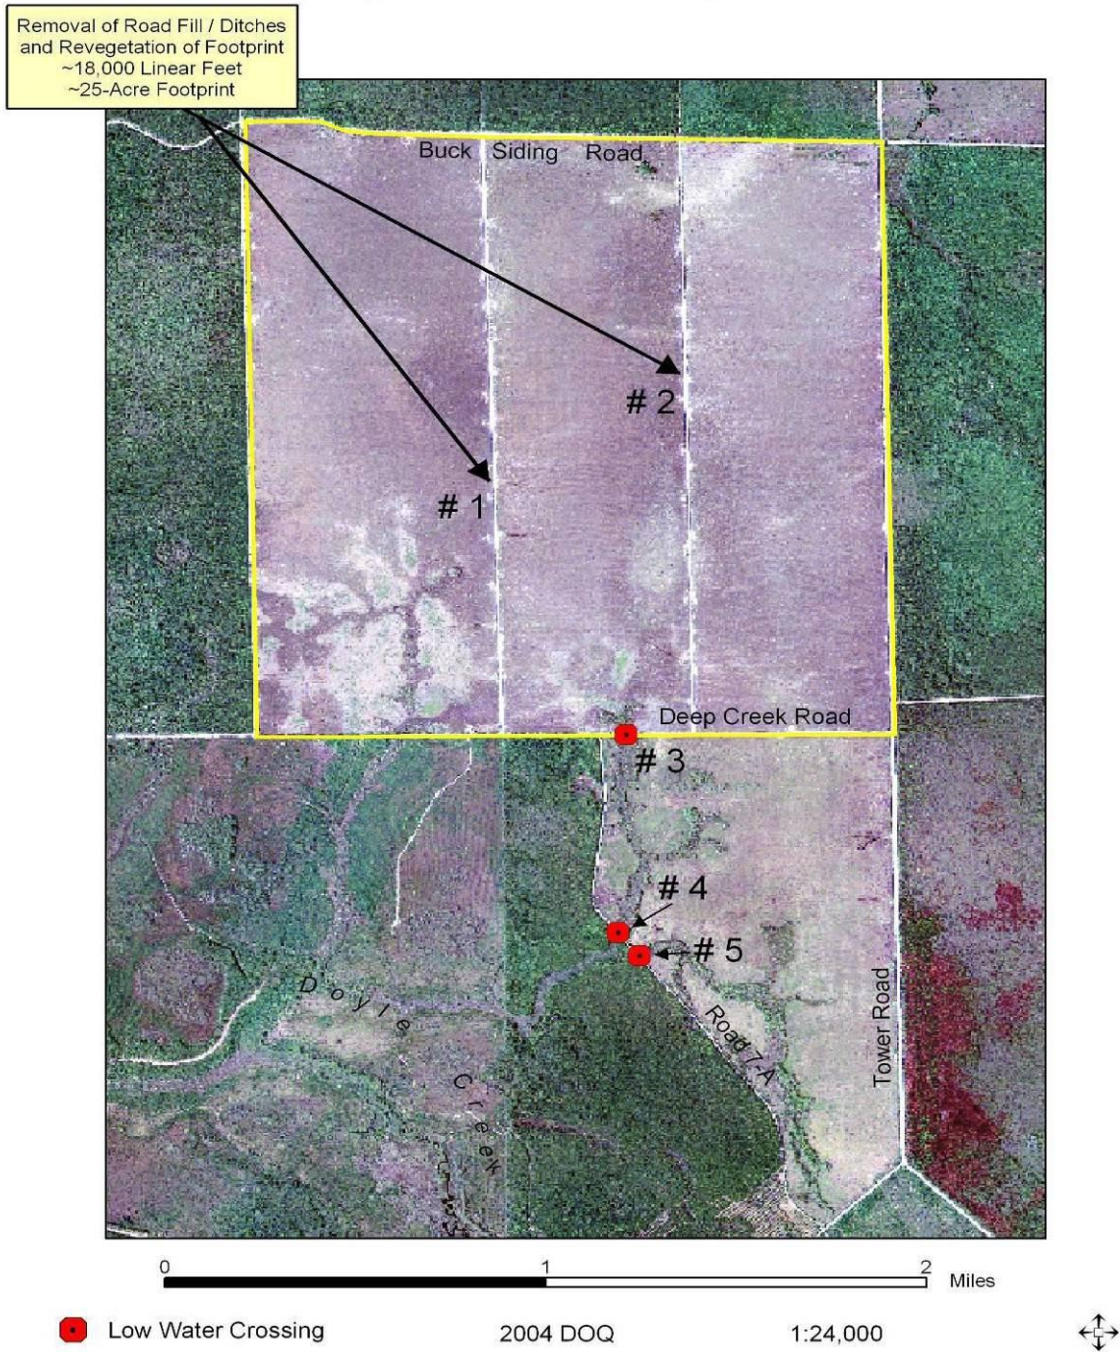
Figure 2. Doyle Creek mitigation site with location of each construction activity. Sites #1-2 are road removals; sites #3-5 are hardened low-water crossings.

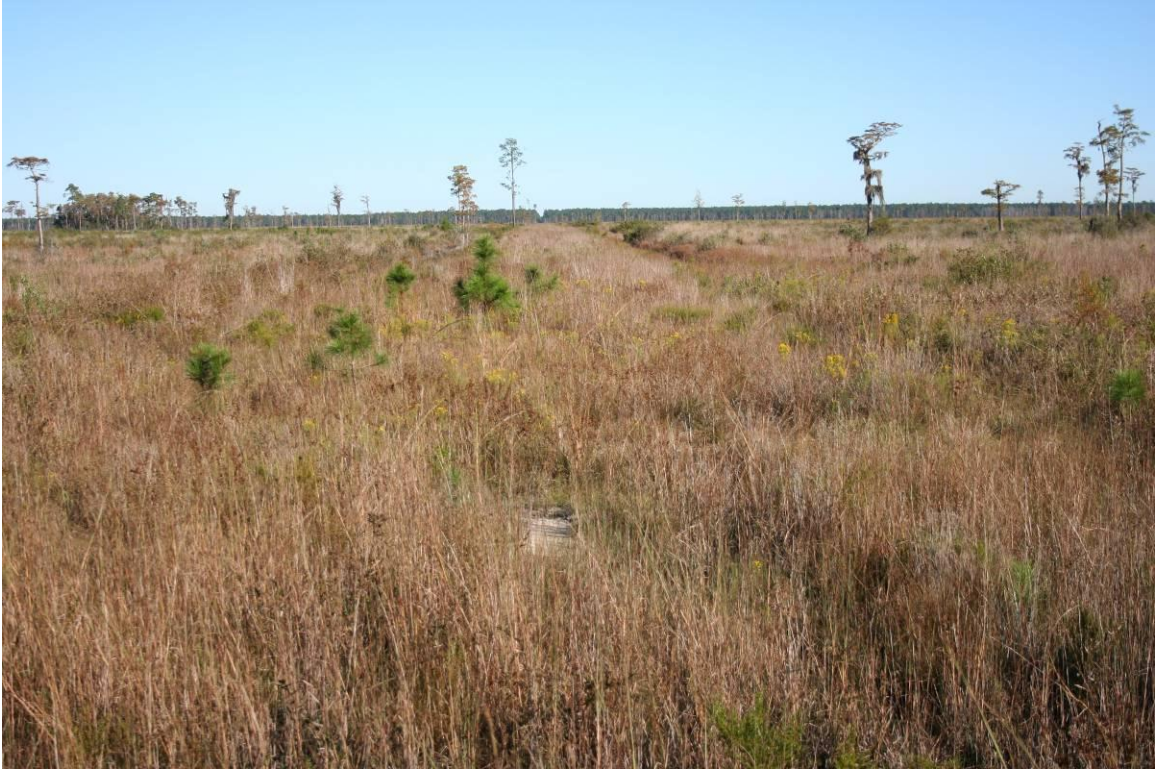
Figure 3. Road removal Site #1 (West); photo facing north.

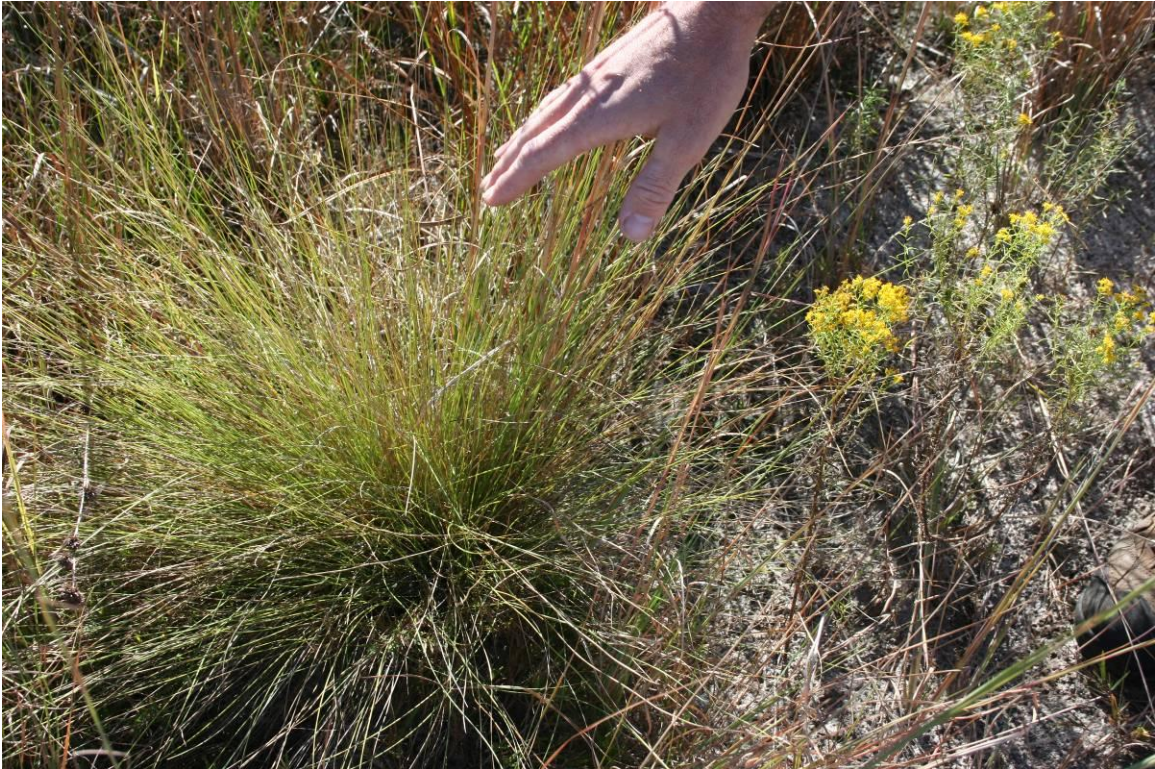
- Minimum 80% native groundcover dominated by wiregrass within five years of restoration: only about 60-65% native groundcover has been established after two years with poor survival of planted wiregrass (<25%). **Survival of wiregrass in the west road appears to meet the success criteria, survival of wiregrass in the east road is minimal and does not meet the success criteria. However, there is excellent native species recruitment in the ground cover, meeting the intent of this success criterion.**

Figure 4. Wiregrass survival in road #1.

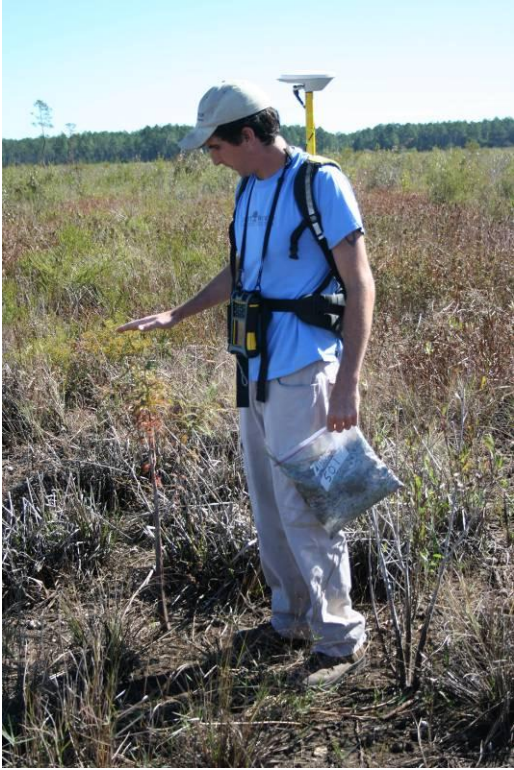
- No more than 1% coverage of invasive or exotic plant species. **A moderate *Panicum repens* infestation was seen in the eastern roadbed.**
- 80% survival of planted cypress within five years of restoration. **Met.**

Figure 5. Cypress survival in road removal site #2 (East).

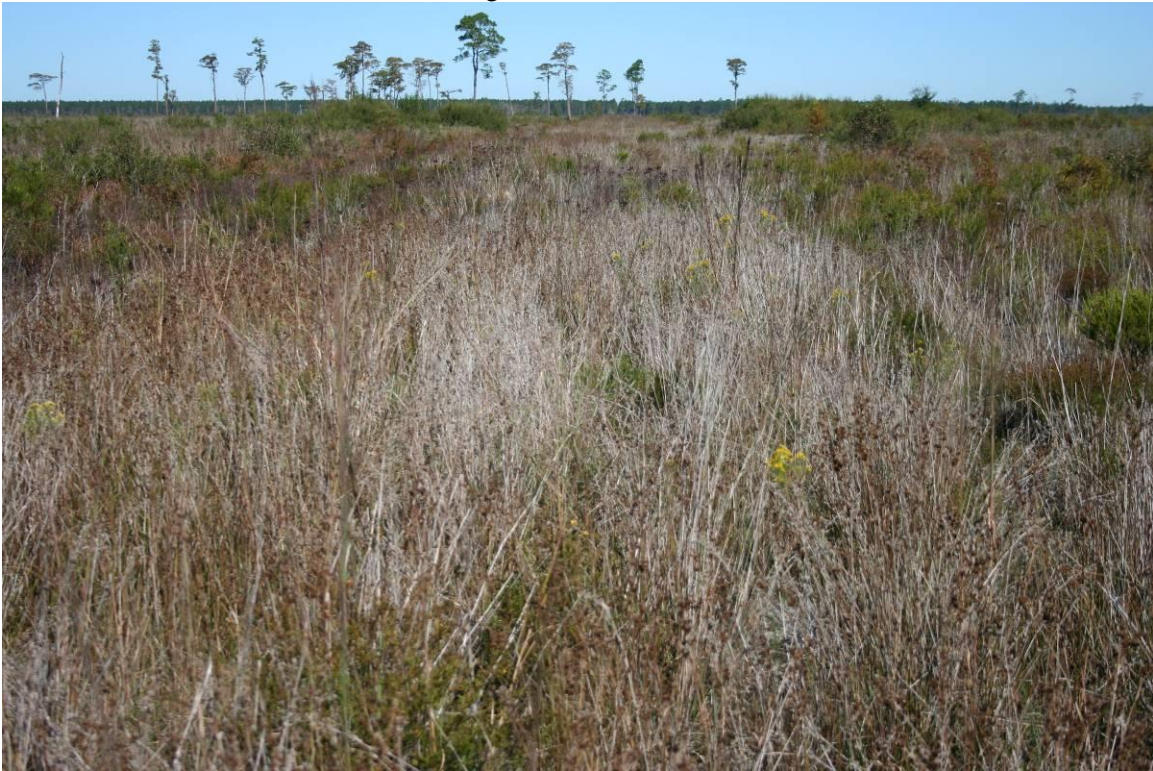
Figure 6. Road removal site #2 (East), facing north.
