Sand Hill Lakes Mitigation Bank  
First Annual Report  
December 2006

## Executive Summary

## Introduction

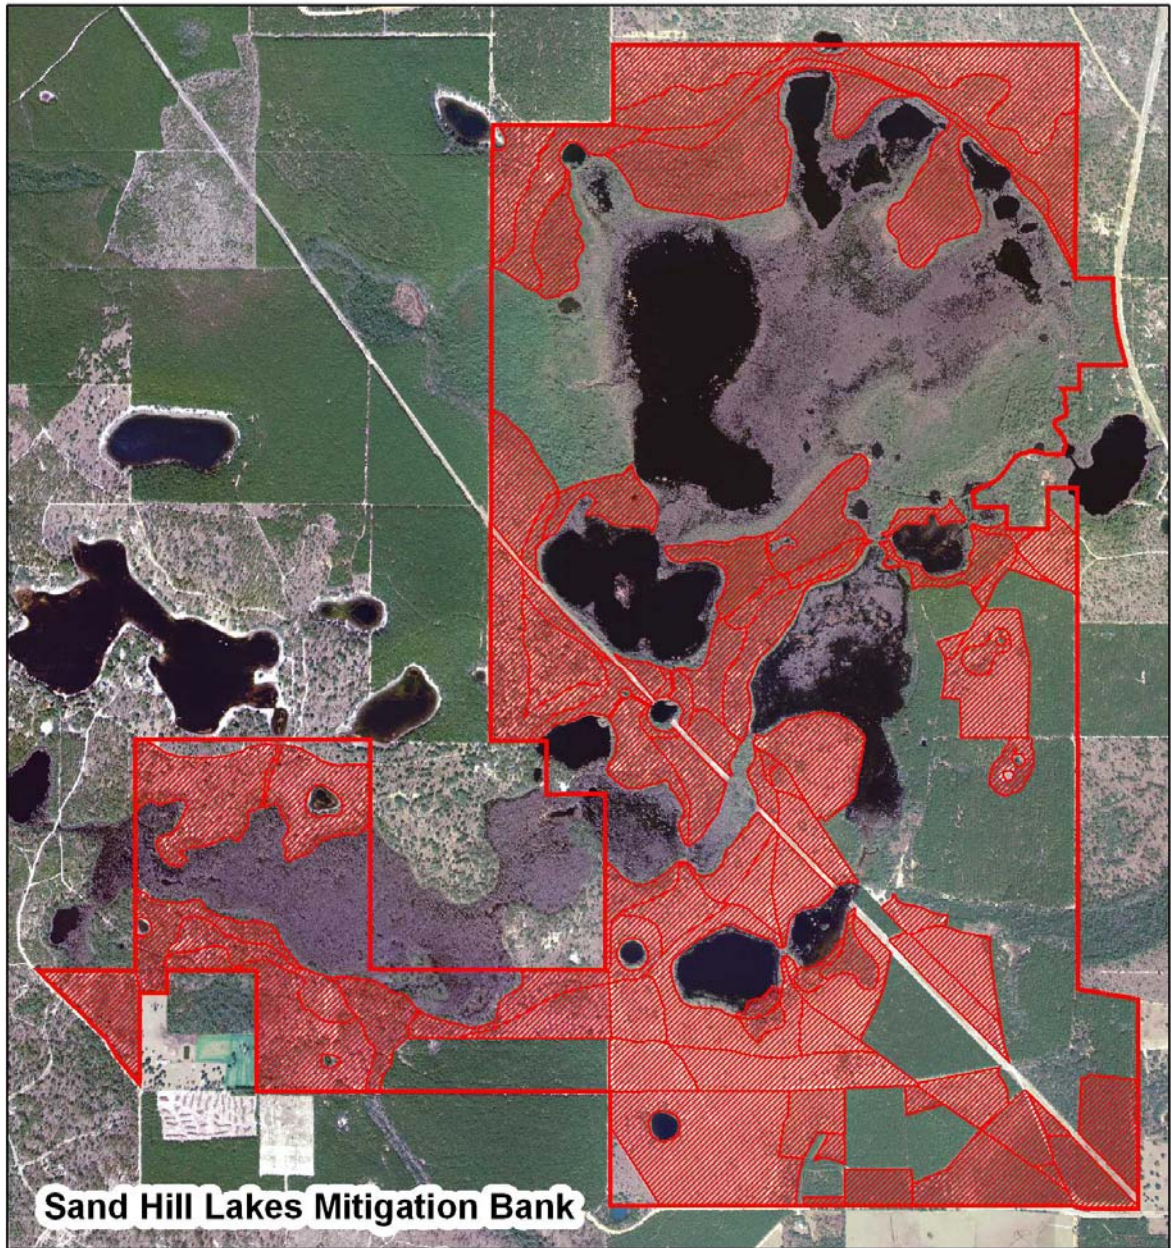
Figure 6 - Areas Burned Since Inception of Bank Through 2006

Fire was re-introduced to the SHLMB during the winter of 2004 to portions of Management Unit 11 and 12. Subsequently portions of the sand hills and hydric pine flatwoods were burned during the summer of 2005 with the remaining initial burns completed by December of 2005 in accordance with the Fire Management Plan (Figure 6). In areas with a high fuel loads such as Management Unit 2, 3, 8 and some portions of Management Unit 10 adjacent to Black pond dormant season fuel reduction fires were utilized. However in portions of Management Unit 11 and 12 that already had initial burns, warm season burns were conducted. Wire grass flowered in these areas following the fire and plants appeared healthy. The burns at the SHLMB have also been successful in reducing woody vegetation coverage as well as stimulating a seed bank of fire adapted species. Dramatic shifts in dominant species composition have been observed in the sand hills. Prior to the initiation of fire, woody golden rod (*Chrysoma pauciflosculosa*) was the dominant species, however, the initial fires greatly reduced the woody goldenrod cover and stimulated the wire grass coverage. In addition, Sand Hill species such sky blue lupine (*Lupinus diffuses*) and blue star (*Amsonia ciliata*) had not been observed at the SHLMB, prior to the re-introduction of fire, however, the year after the initial burns were conducted they were observed in the uplands near Boat Pond and Deep Edge Pond. Dormant season burns have been scheduled for 287 acres for 2006/2007 (Figure 7). The burn will include seventeen acres of Management Unit 11 along the western portion of the property (Carter SW), 183 of Management Units, 10, 11 and 12 adjacent to Boat Pond and Big and Little Deep Edge Pond, and 22 acres will be burned in Management Unit 12 adjacent to Dykes Mill Pond (Figure 7). These areas had previously had the live and turkey oaks thinned to less than 150 trees per acre and the burns should aid in the removal of downed oaks and also kill any stump sprouts.

Area Burned Through 2006 (963 Acres)

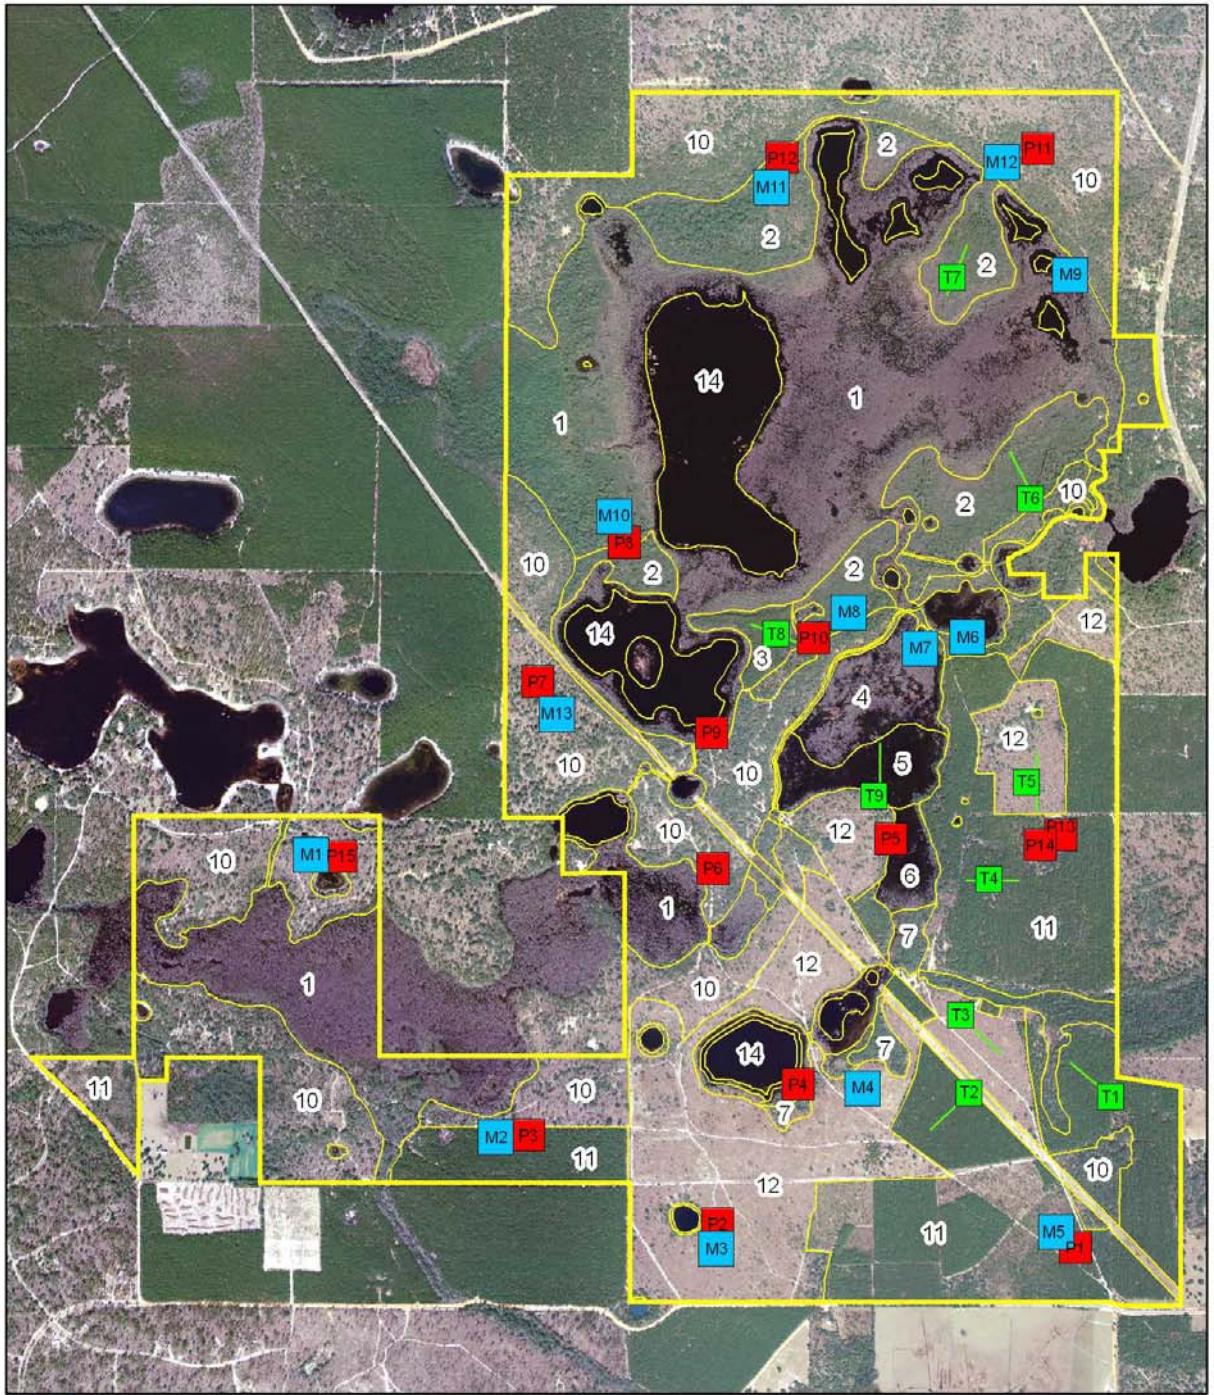
Figure 13 - Monitoring Locations

In accordance with the permit all sampling locations have been identified (Figure 13). Fall monitoring methods as well as data analysis are described below. Sampling for the annual report was conducted on October 11, 13, 16, 25, 28, 29, 30 2006. Sample data sheets, raw data sheet as well as computations and analysis and transect photographic documentation are included in Appendix 2, 3 and 4 in accordance with the Monitoring Plan, oblique aeriels were taken for the SHLMB on October 23, 2006 and have been included in Appendix 5.

- = Permanent Transect / Photopoint (e.g., T1)
- = Pedestrian Meander Transect (e.g., M1)
- = Photopoint (e.g., P1)
- 1 = Management Unit No. (Only Selected Units Labeled)

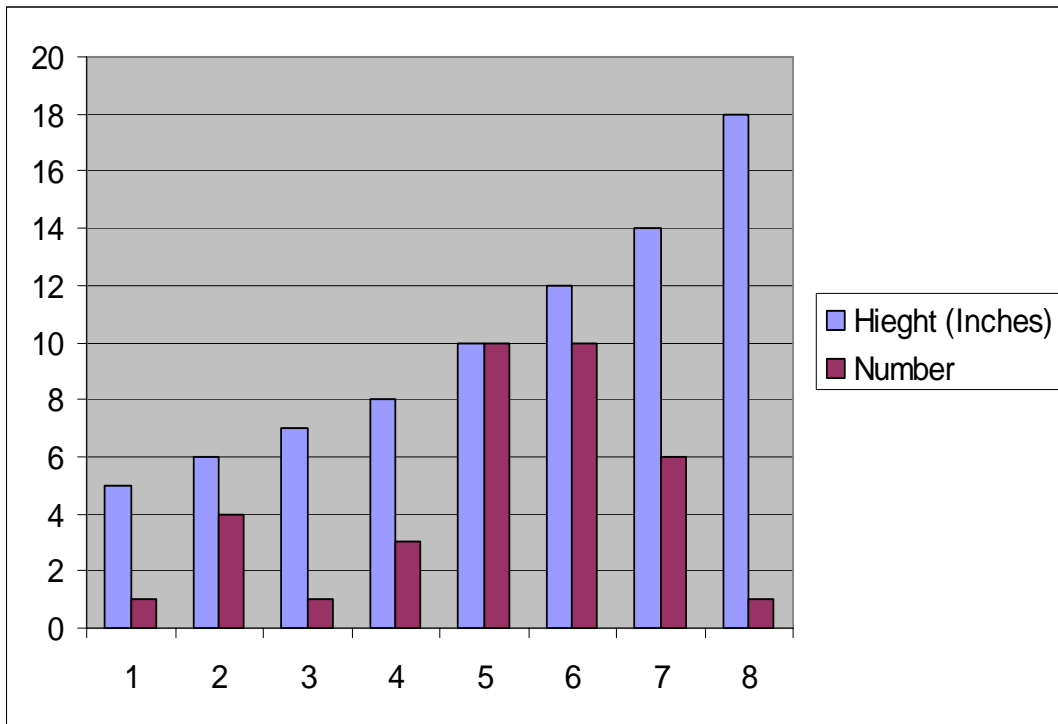
Figure 19. Height Distribution and Number for Longleaf Pine Transect 3

Longleaf pines were planted for the majority of UMAM polygon I, Management Unit 12 in the winter of 2004. However, planted longleaf pines were only observed in Transect 3. A belt transects 600' feet in length and 30' feet in width was co-located with the vegetation transect. The number, height and condition of each planted tree were recorded. A total of 36 trees were observed or an average of 871 trees per acre. The majority of the trees were in excellent health. The longleaf pine seedlings are all within

the grass stage and ranged in height from 5” to 18”. A comparison of height distribution to number of trees per acre can be found in Figure 18.

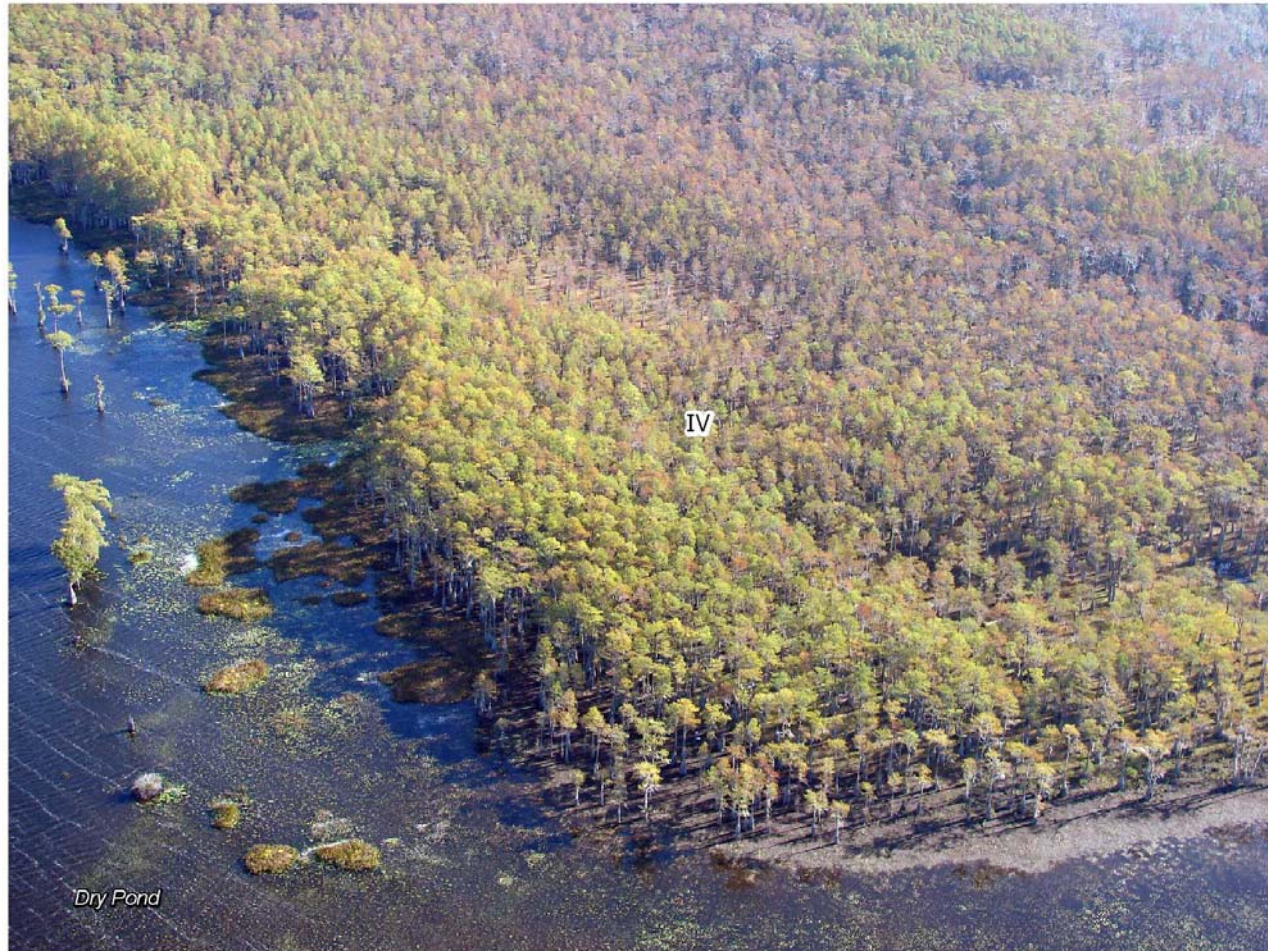
Oblique Aerial (10/23/06) Looking Northeast Across Cypress Swamp

Notes: Roman numerals represent Florida UMAM polygons. IV = Wetlands/Pond Preservation (Notice Wave Crests on Dry Pond).

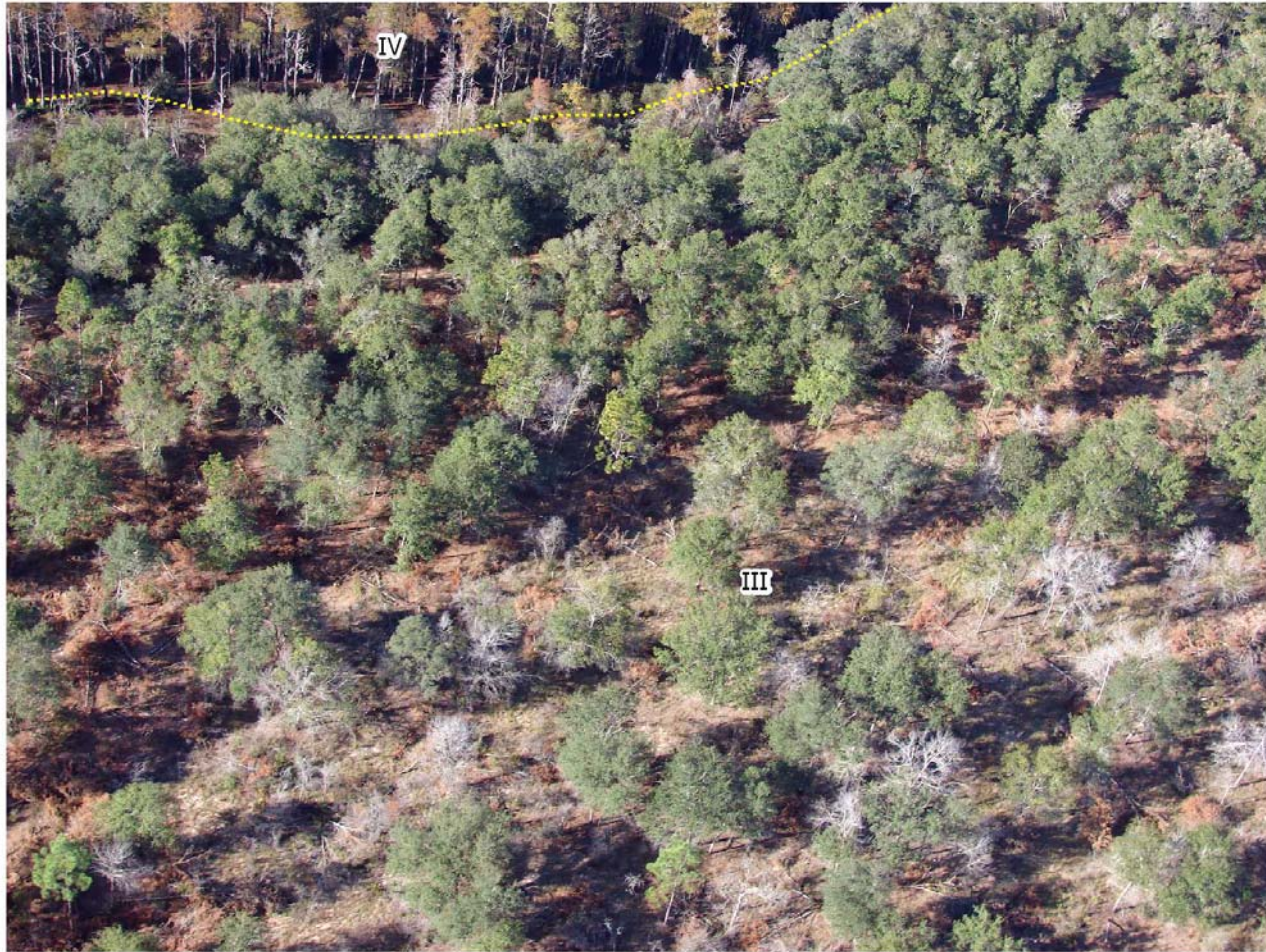
Oblique Aerial (10/23/06) Looking South Across Managed Uplands

Notes: Roman numerals represent Florida UMAM polygons. III = Uplands Preservation and Management (Oaks have been thinned in this area based on decision by QMS); IV = Wetlands/Pond Preservation.

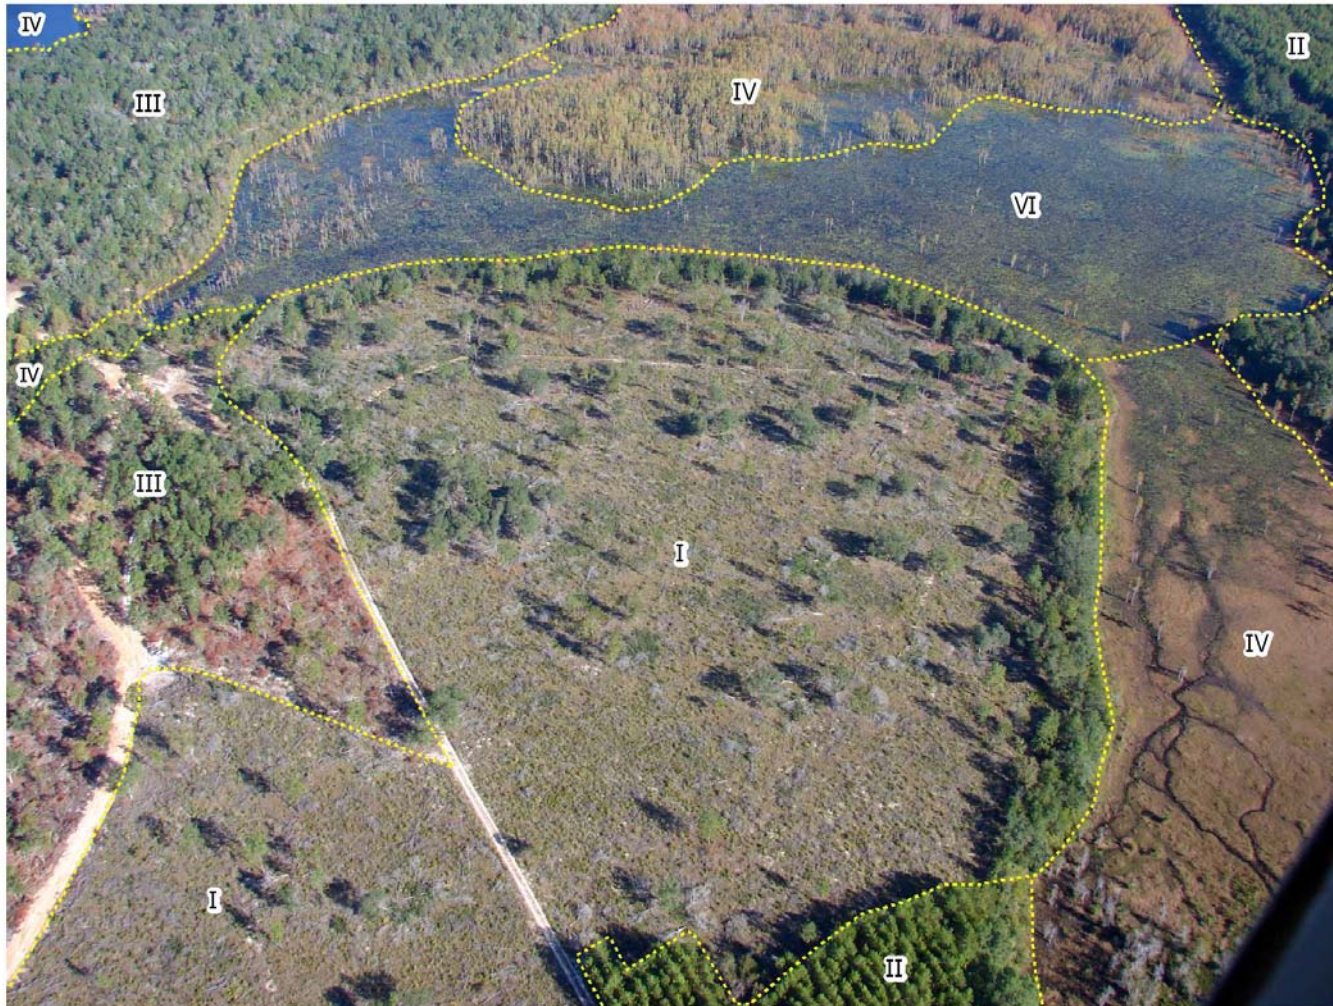
Oblique Aerial (10/23/06) Looking North to Dykes Mill Pond

Notes: Roman numerals represent Florida UMAM polygons. I = Longleaf/Wiregrass Restoration from Cutover Sandhills; II = Longleaf/Wiregrass Restoration from Sand Pine Plantation; III = Uplands Preservation and Management; IV = Wetlands/Pond Preservation; VI = Cypress/Gum Restoration from Impoundment. Oaks removed from Polygon I in April, 2006.

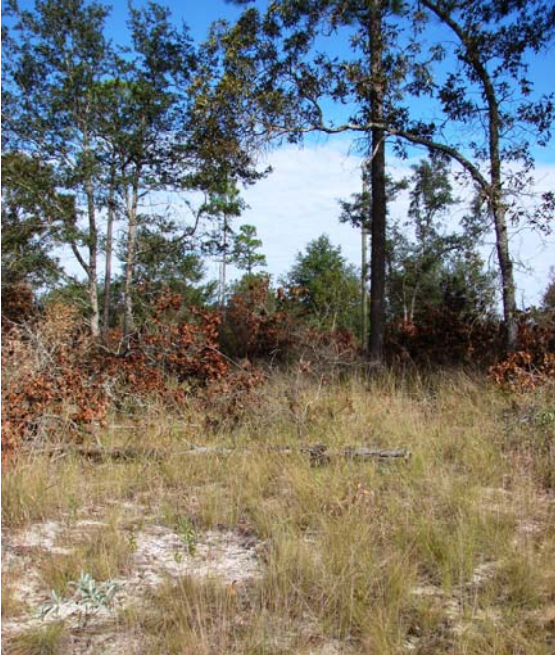
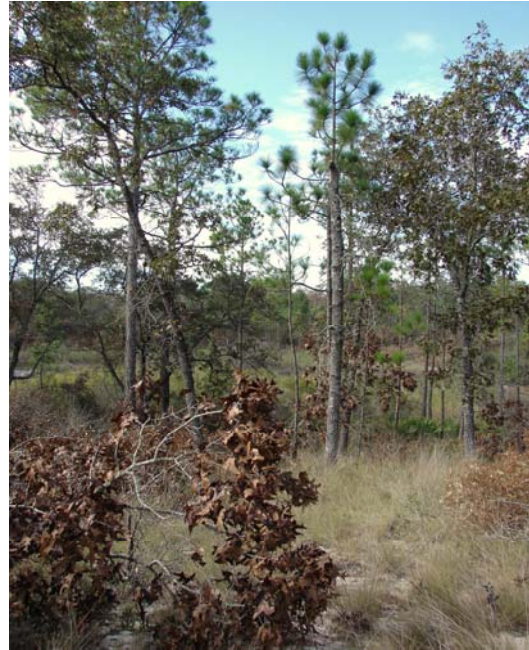
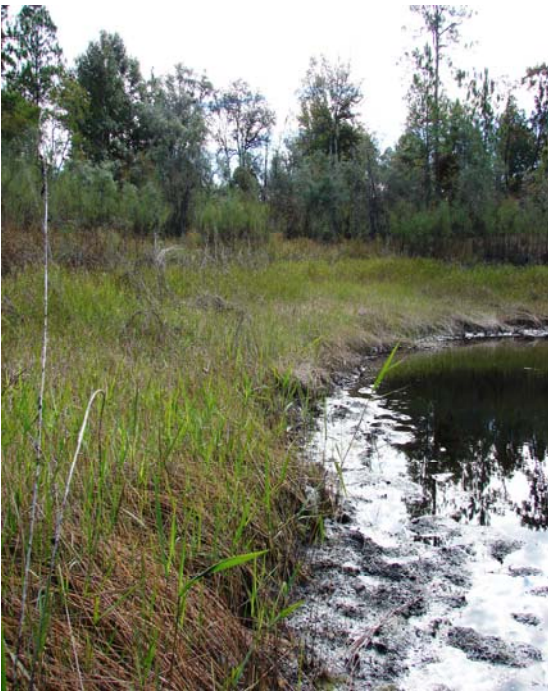
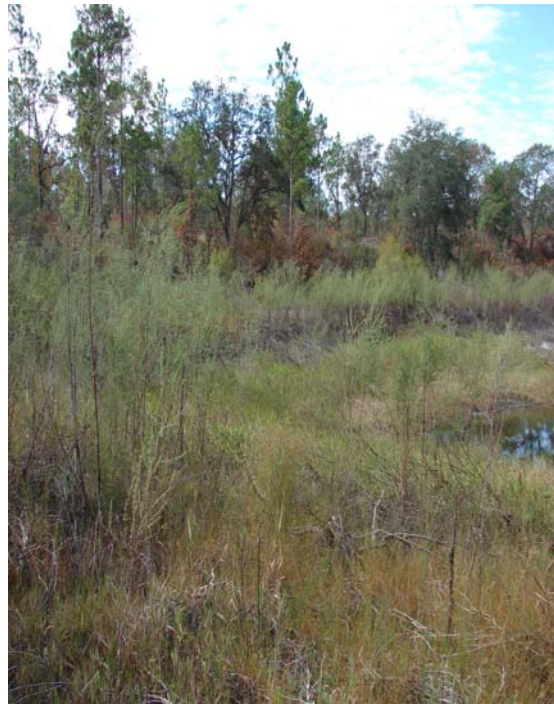
Pedestrian Transect: Upland Sand Hill with oak eradication: Note: Gulf Coast Lupine in upper left photo

<b>Date:</b> 10/25/2006 <b>Time:</b> 9:30 am <b>Data Collector:</b> David Clayton					
<b>Location:</b> Pedestrian Transect # M1 near photo point 15					
<b>Management Unit:</b> 10					
<b>Nuisance Species:</b> Bahia grass at gate entrance					
<b>Fuel Load:</b> Oak Trees have been thinned, area due to be burned this winter 2008/2009, fuel load high					
<b>Wildlife Observations:</b> Blue jay, tufted titmouse, deer and raccoon tracks					
<b>T &amp; E Species:</b> Large population of Gulf Coast Lupine in sand hill and Smooth Barked St. John's Wort around pond					
<b>Community Description:</b> Sandhill upland adjacent to a solution pond. Sandhill with good diversity and excellent groundcover. Marsh with excellent zonation consisting of an outer ring of myrtle leaved holly, and some black, then a dense zone of smooth barked St. John's wort, followed by maidencane, then open water and submerged aquatics.

Marsh showing zonation and T & E species Smooth Barked St. John's Wort on right

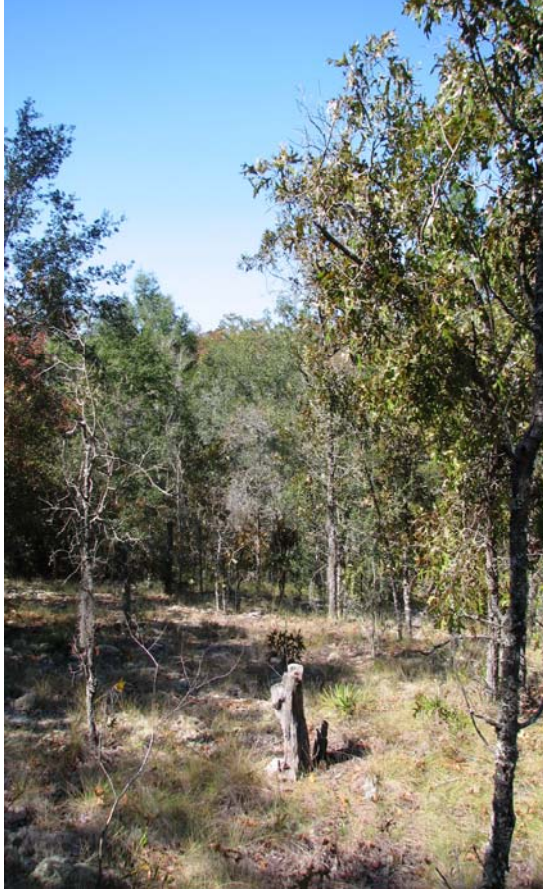
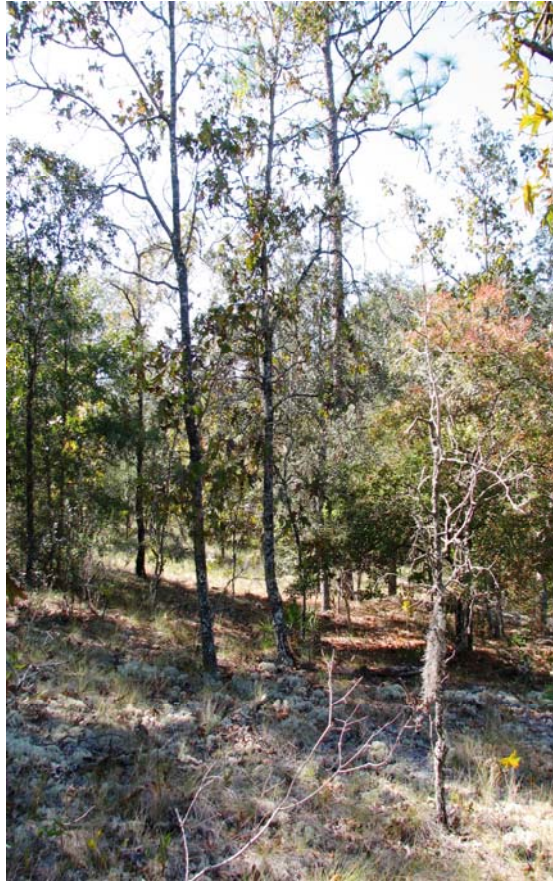
M2: Oaks with good wiregrass cover

<b>Date:</b> 10/28/2006		<b>Time:</b> 2:00 pm		<b>Data Collector:</b> David Clayton	
<b>Location:</b> Pedestrian Transect # M2 near photo point 3					
<b>Management Unit:</b> 10					
<b>Nuisance Species:</b> None					
<b>Fuel Load:</b> Fuel load moderate					
Wildlife Observations: Chickadee, red bellied woodpecker					
<b>T &amp; E Species:</b> None					
<b>Community Description:</b> Sandhill upland overgrown with live and turkey oaks...good wiregrass cover, but allot of shade, recommend that oaks be thinned. Lots of deer moss on ground, a very dry site that grades down towards Pine Log Creek.					
<u>Scientific Name</u>	<u>Common Name</u>	<u>Tree</u>	<u>Shrub</u>	<u>Vine</u>	<u>Herb</u>
<i>Aristida stricta</i> var. <i>beyrichiana</i>	Wiregrass				X
<i>Baptisia lanceolata</i>	Gopher weed				X
<i>Chrysoma pauciflosculosa</i>	Woody Goldenrod				X
<i>Dichanthelium</i> sp.	Witch grass				X
<i>Diospyros virginiana</i>	Persimmon	X

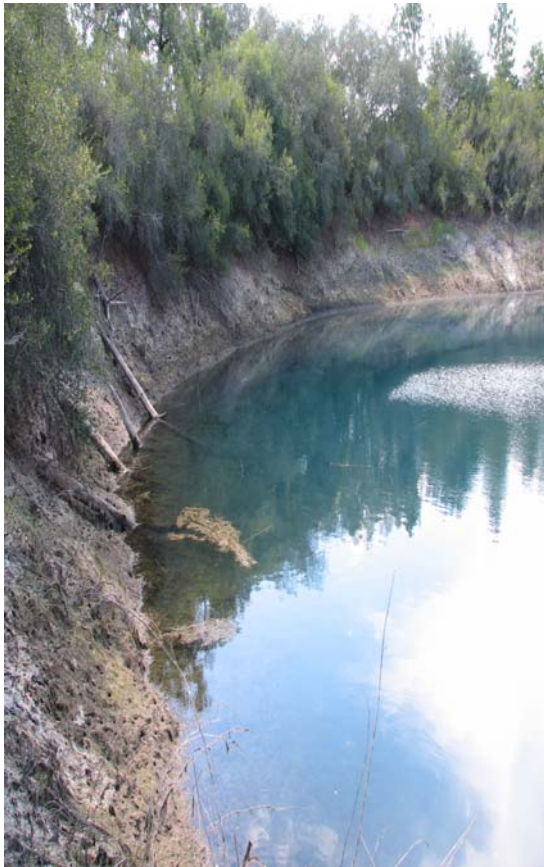
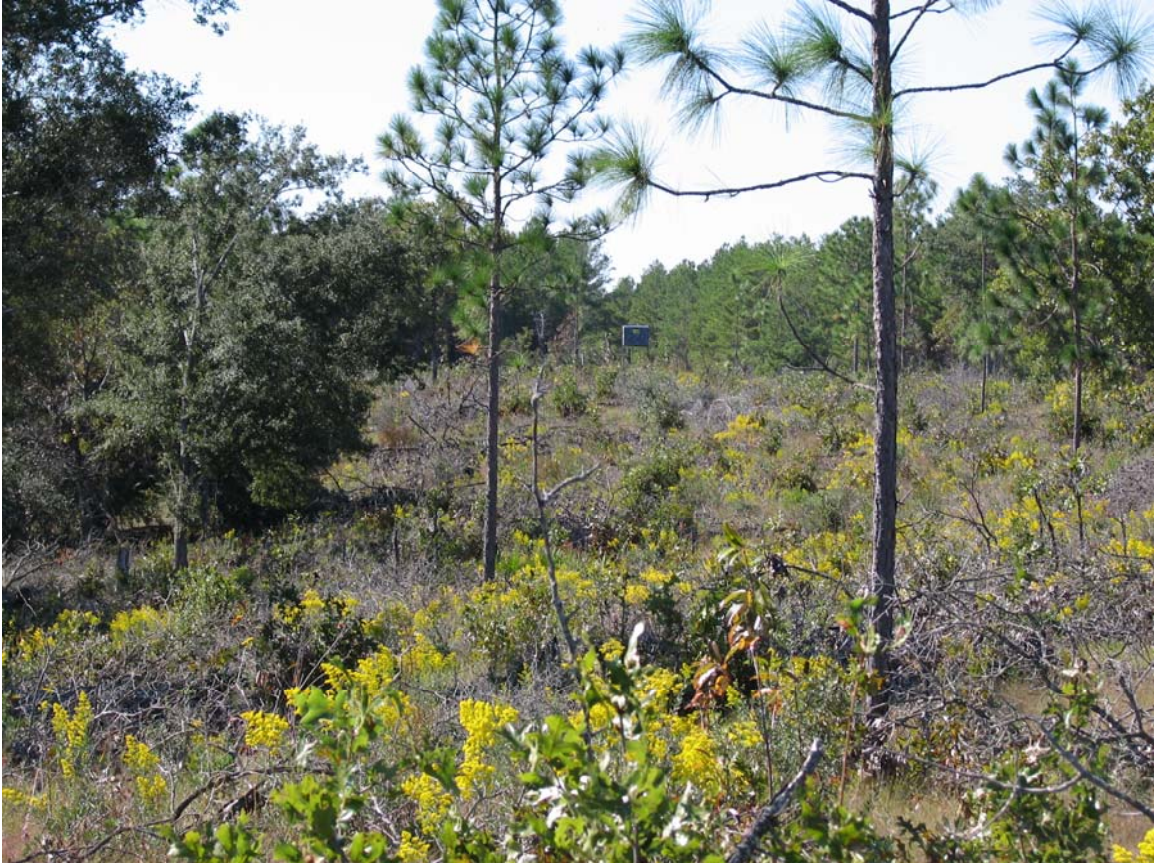
Pedestrian Transect M3: Cat pond and surrounding uplands

<b>Date:</b> 10/16/2006 <b>Time:</b> 11:00 am <b>Data Collector:</b> David Clayton					
<b>Location:</b> Pedestrian Transect # M3 near photo point 2					
<b>Management Unit:</b> 12					
<b>Nuisance Species:</b> None					
<b>Fuel Load:</b> Fuel load high due to thinned oaks... will be burned in the winter of 2006/2007					
Wildlife Observations: none					
<b>T &amp; E Species:</b> Southern crab apple					
<b>Community Description:</b> Sandhill upland sloping down into the seepage area associated with Cat pond. Excellent diversity and groundcover. Wire grass bloomed this summer...area planted with long leaf pine					
<u>Scientific Name</u>	<u>Common Name</u>	<u>Tree</u>	<u>Shrub</u>	<u>Vine</u>	<u>Herb</u>
<i>Agalinis setacea</i>	Threadleaf false foxgloves				X
<i>Andropogon glomeratus</i>	Busy blue stem				X
<i>Andropogon gyrans</i>	Elliot's blue stem				X
<i>Aristida stricta</i> var. <i>beyrichiana</i>	Wiregrass				X

M3: Upland with good wiregrass cover

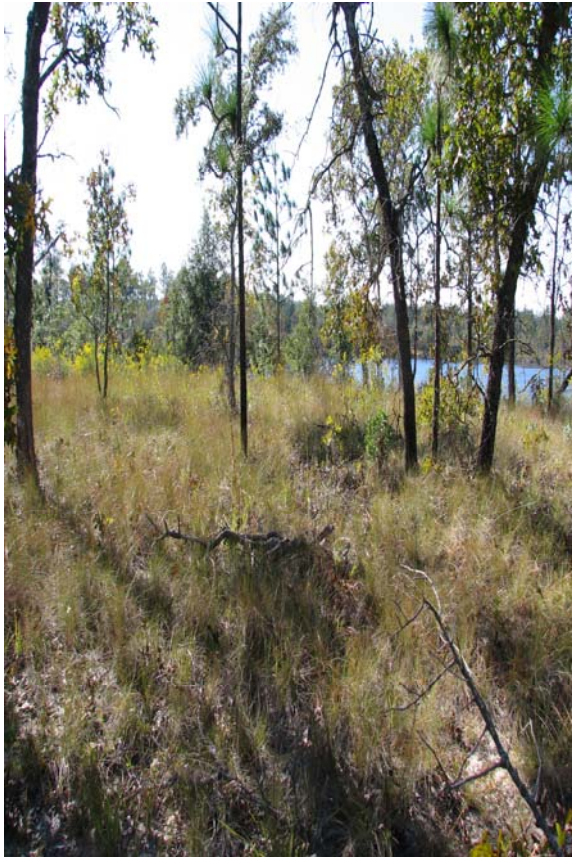
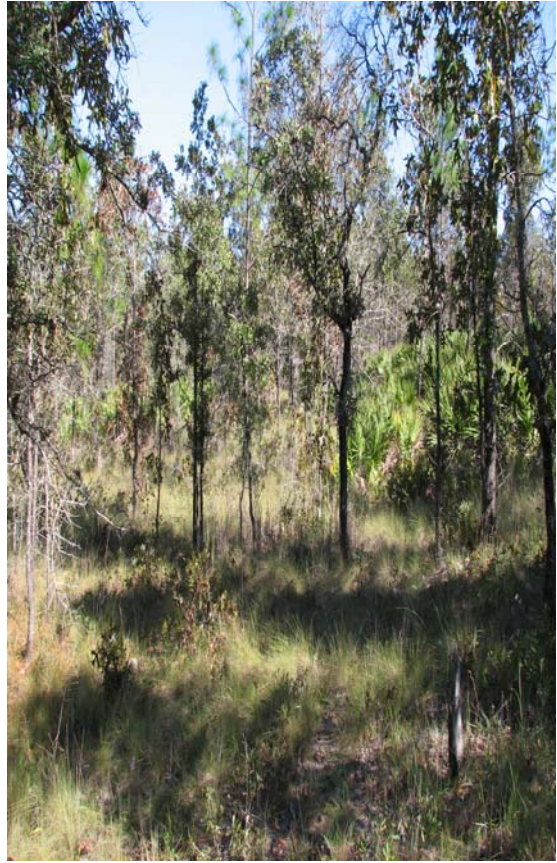
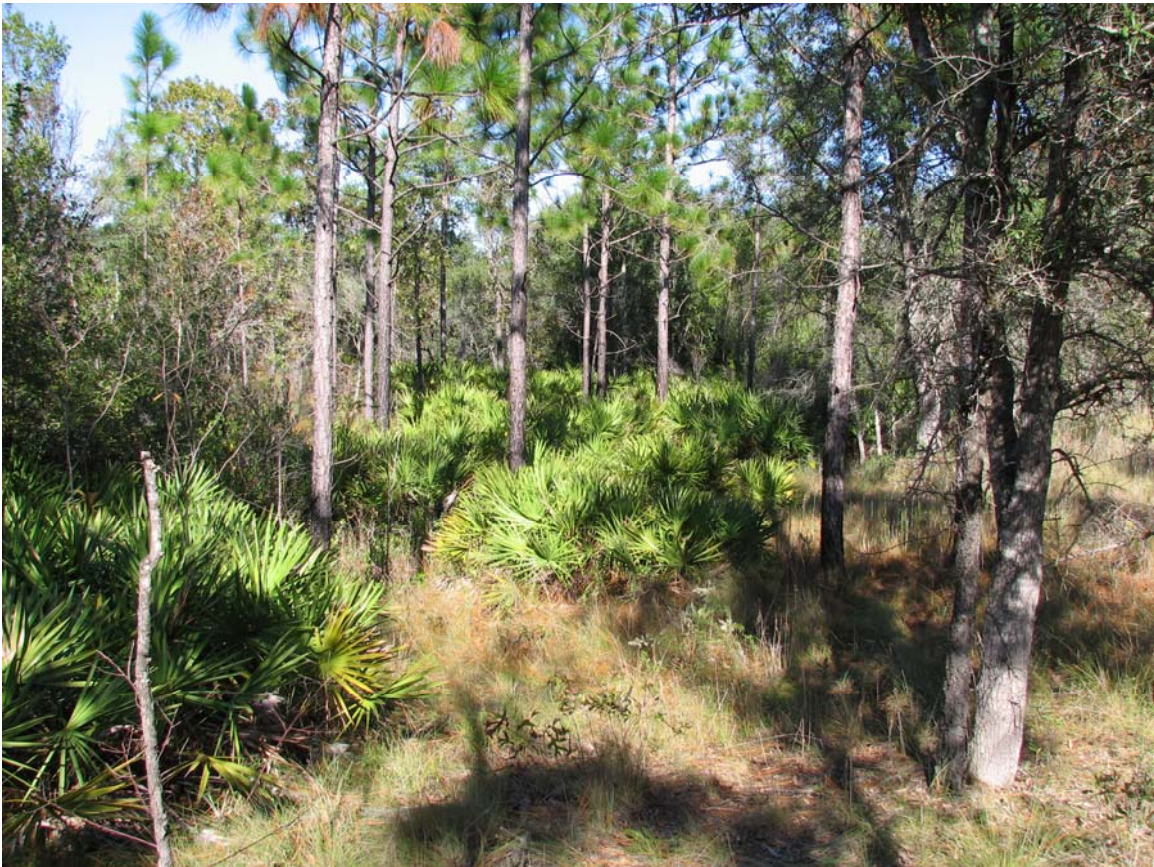
Pedestrian Transect M4: Upland Sand Hill: Note: Wiregrass

<b>Date:</b> 10/28/2006 <b>Time:</b> 4:00 pm <b>Data Collector:</b> David Clayton <b>Location:</b> Pedestrian Transect # M4 near photo point 4 <b>Management Unit:</b> 12					
<b>Nuisance Species:</b> None <b>Fuel Load:</b> Fuel load low to moderate, area was burned but shrubs are returning...some kill off of oaks from previous burns...should be burned in the next year					
<b>Wildlife Observations:</b> Blue jay, titmouse, red bellied woodpecker, active gopher tortoise burrow near pond <b>T &amp; E Species:</b> None observed					
<b>Community Description:</b> Sandhill upland sloping down into the seepage area associated with Little Deep Edge pond. Excellent diversity and groundcover. Wire grass bloomed this summer...					
<u>Scientific Name</u>	<u>Common Name</u>	<u>Tree</u>	<u>Shrub</u>	<u>Vine</u>	<u>Herb</u>
<i>Agalinis setacea</i>	Threadleaf false foxgloves				X
<i>Andropogon glomeratus</i>	Busy blue stem				X

M4: Upland with good wiregrass cover grading down towards seepage slope

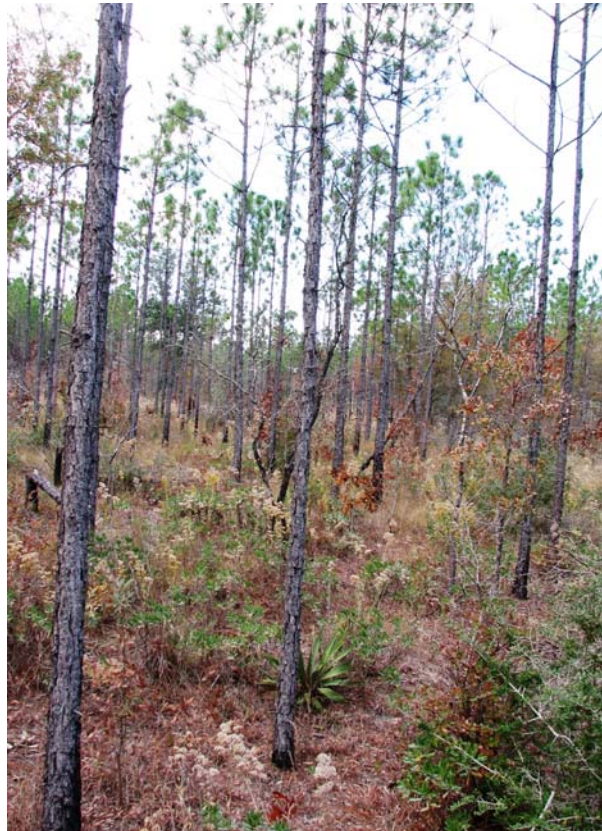
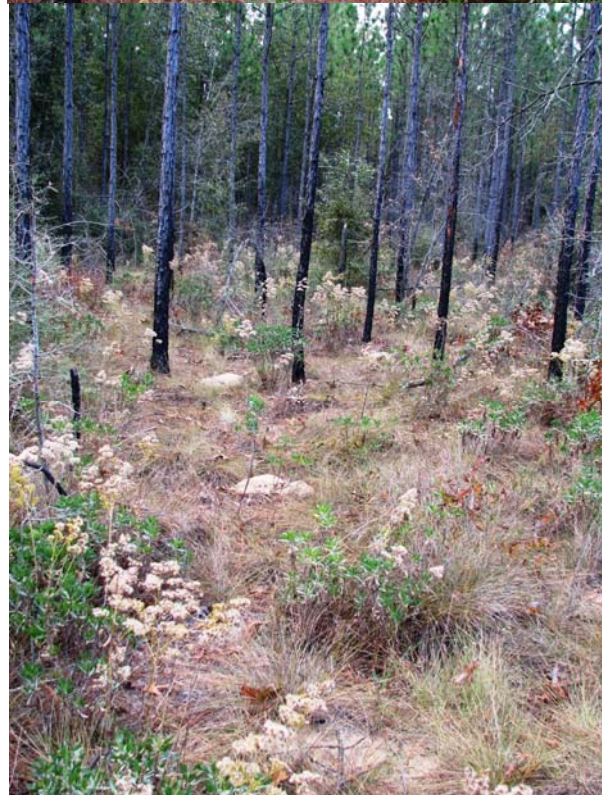
Pedestrian Transect M5: Planted slash pine stand

<b>Date:</b> 10/28/2006 <b>Time:</b> 4:50 pm <b>Data Collector:</b> David Clayton					
<b>Location:</b> Pedestrian Transect # M5 near photo point 1					
<b>Management Unit:</b> 11					
<b>Nuisance Species:</b> None					
<b>Fuel Load:</b> Planted pine, fuel load moderate, area was burned but shrubs are returning...should be burned in the next year					
Wildlife Observations: squirrel nest					
<b>T &amp; E Species:</b> None observed					
<b>Community Description:</b> Sandhill upland upslope of black pond. Sandhill with good diversity and excellent groundcover. Wire grass bloomed this summer...area planted with long leaf pine.					
<u>Scientific Name</u>	<u>Common Name</u>	<u>Tree</u>	<u>Shrub</u>	<u>Vine</u>	<u>Herb</u>
<i>Agalinis setacea</i>	Threadleaf false foxgloves				X
<i>Andropogon glomeratus</i>	Busy blue stem				X
<i>Andropogon gyrans</i>	Elliot's blue stem				X
<i>Aristida stricta var. beyrichiana</i>	Wiregrass				X

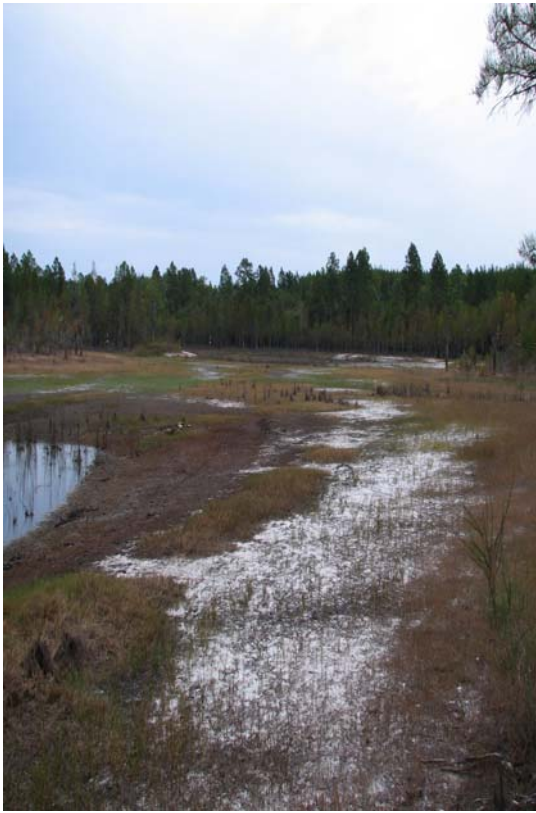
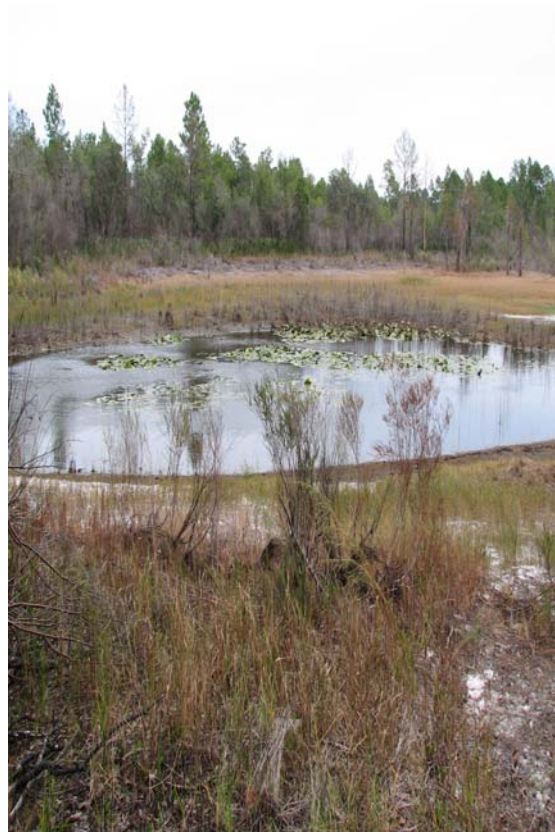
Pedestrian Transect M6: Note: Garret Pond dry down

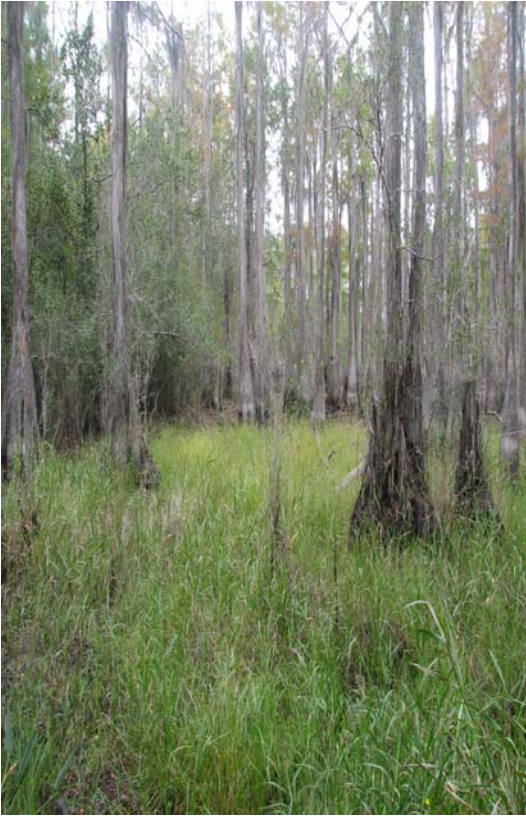
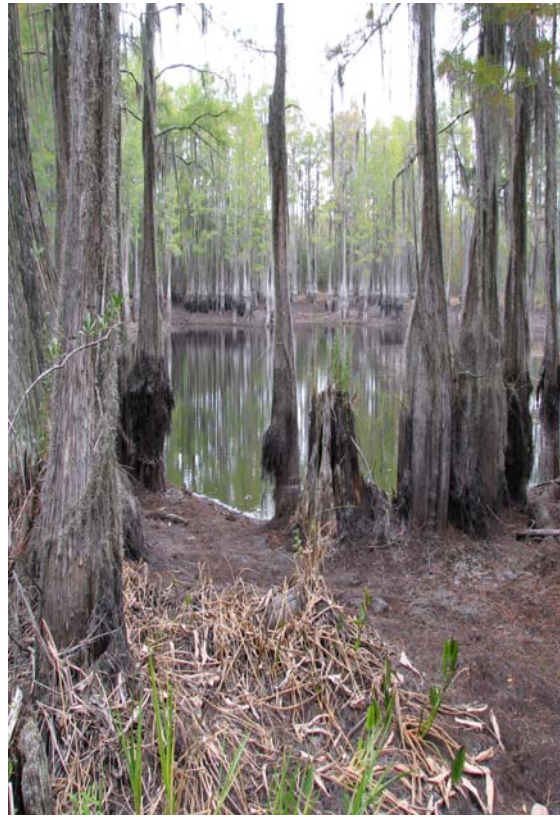
Pedestrian Transect M8: Note: pond mostly dry

<b>Date:</b> 10/16/2006 <b>Time:</b> 12:15 pm <b>Data Collector:</b> David Clayton					
<b>Location:</b> Pedestrian Transect # M8					
<b>Management Unit:</b> 1 and parts of two...moved point into dry pond and adjacent wetland					
<b>Nuisance Species:</b> None					
<b>Fuel Load:</b> Low					
<b>Wildlife Observations:</b> cardinal, white ibis, phoebe, towhee, red bellied wood pecker, deer and raccoon tracks					
<b>T &amp; E Species:</b> One-toed amphiuma...listed by FNAI but not the state or feds					
<b>Community Description:</b> Swamp dominated by pond cypress with a fringe of black gum...little water present due to drought. Trees healthy, numerous cypress seedlings. Some herbaceous plants have died from lack of water. Most species appear healthy					
<u>Scientific Name</u>	<u>Common Name</u>	<u>Tree</u>	<u>Shrub</u>	<u>Vine</u>	<u>Herb</u>
<i>Bidens mitis</i>	Bur marsh marigold				X
<i>Brasenia schreberi</i>	Water shield				X

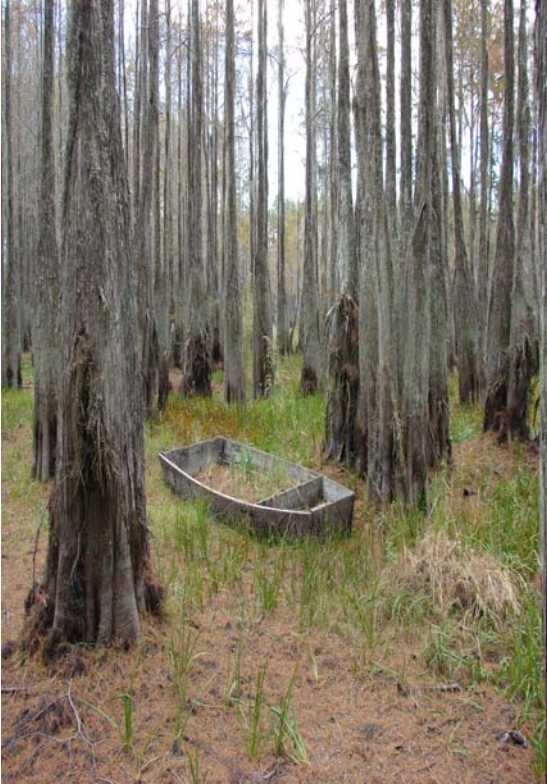
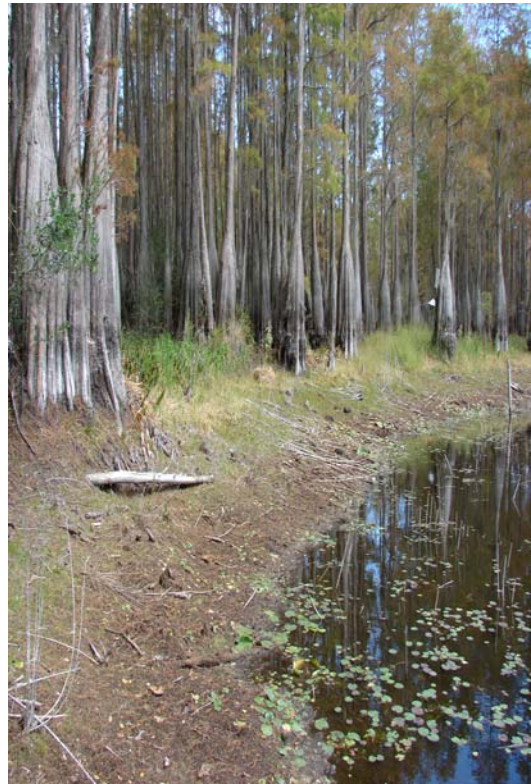
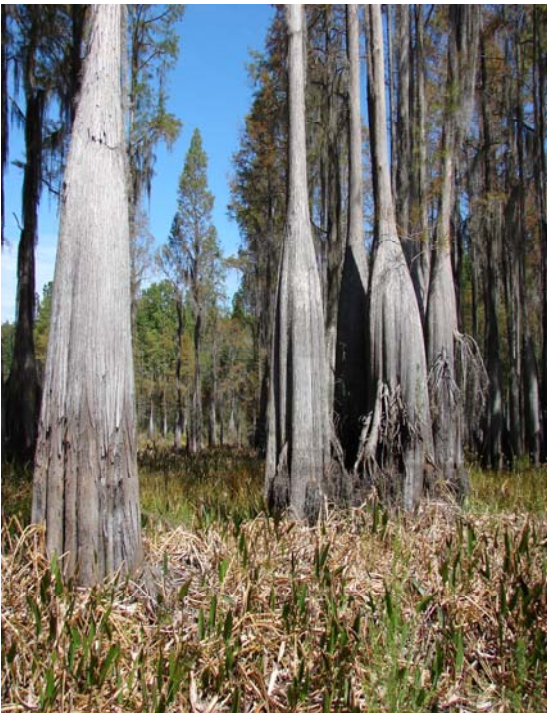
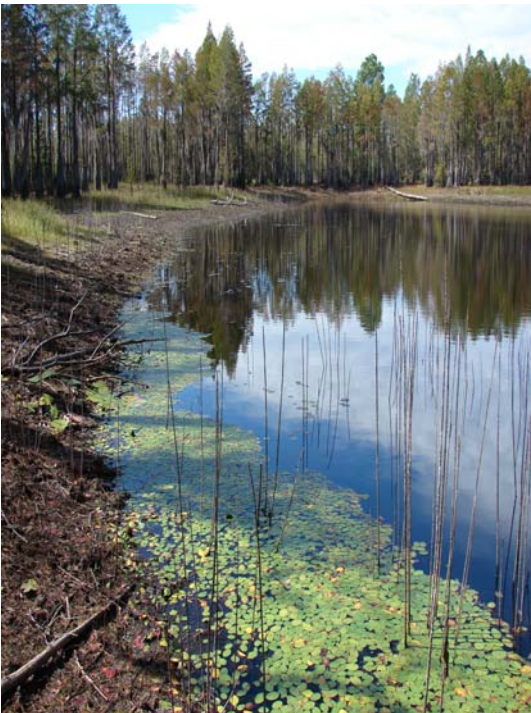
Pedestrian Transect: Green Ponds: Note: sunken wooden boat

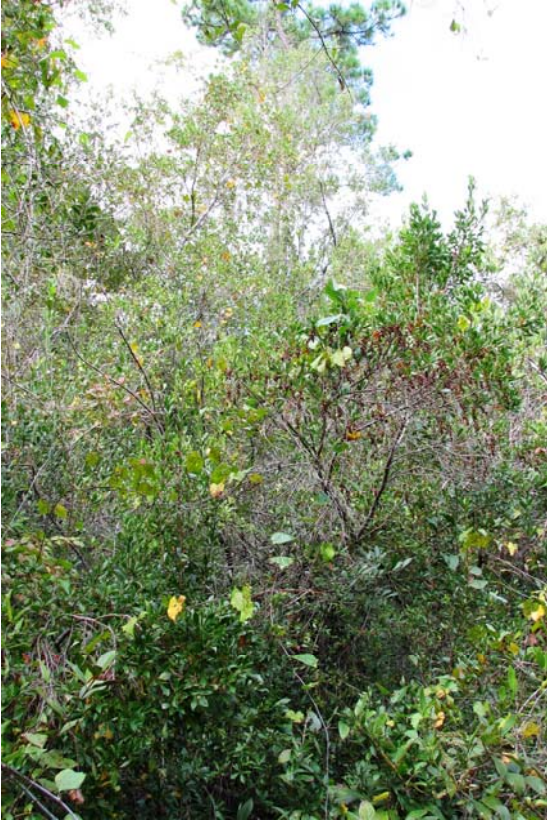
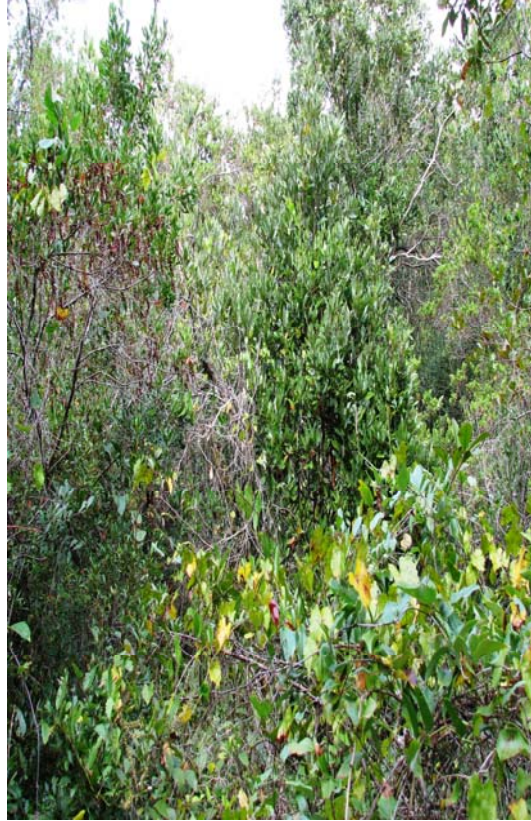
Pedestrian Transect M10: Note: red bay and pine overstory and understory dominated by shrubs
