Sand Hill Lakes Mitigation Bank  
First Annual Report  
December 2006

## Executive Summary

## Introduction

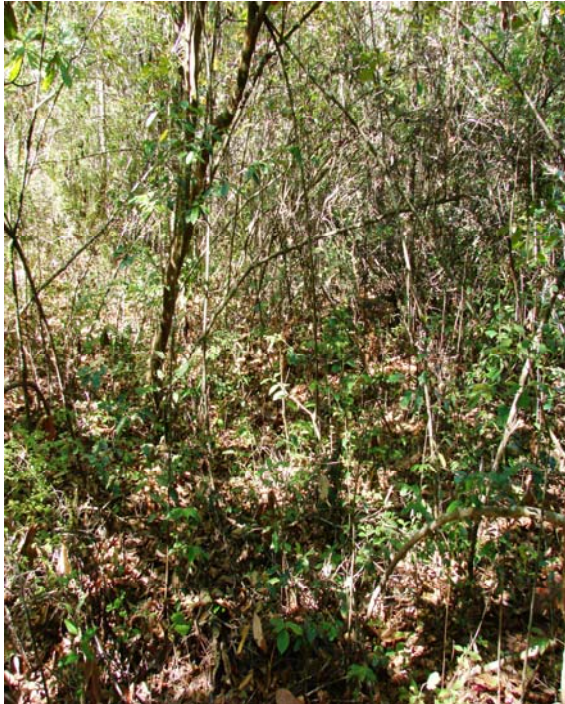
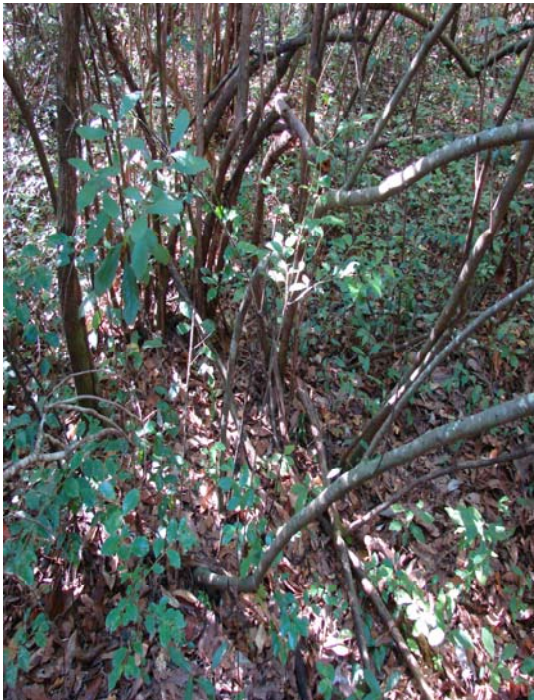
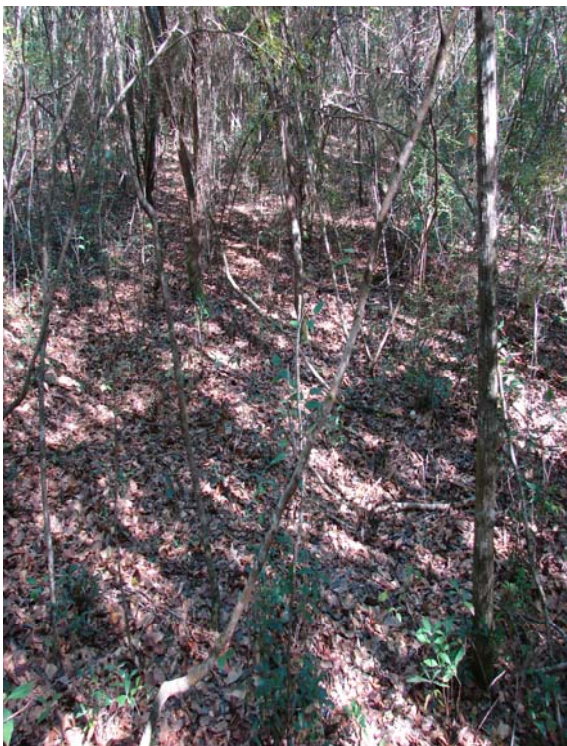
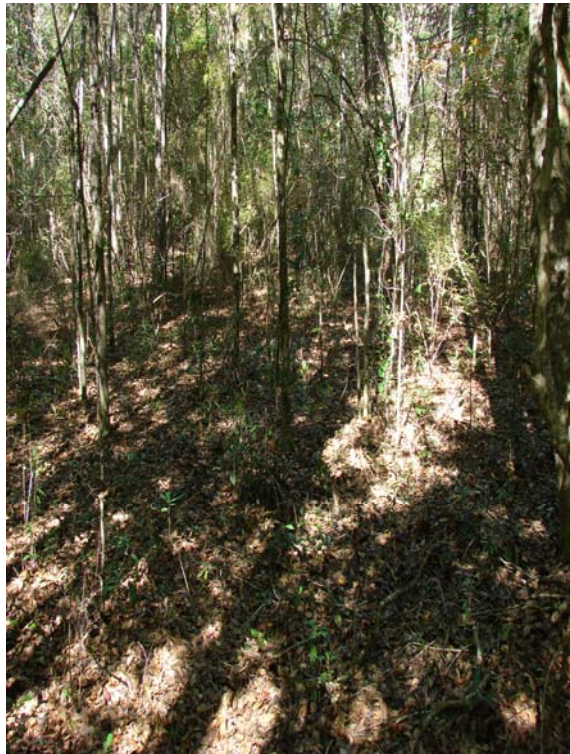
<b>Date:</b> 10/25/2006 <b>Time:</b> 11:30 am <b>Data Collector:</b> David Clayton					
<b>Location:</b> Pedestrian Transect # M11 near photo point 12					
<b>Management Unit:</b> 2					
<b>Nuisance Species:</b> None observed					
<b>Fuel Load:</b> medium, very hot fire last year, fair amount of deadfall due to fire, many oaks have died or are sprouting, wire grass in flower					
<b>Wildlife Observations:</b> Blue jay, squirrel, red bellied woodpecker					
<b>T &amp; E Species:</b> Southern Crab Apple (Florida Threatened)					
<b>Community Description:</b> Degraded wet flatwoods overgrown by hardwoods grading into a hardwood swamp. Many oaks killed by fire, some reprotuing. Remnant sandhill and flatwood species					
<u>Scientific Name</u>	<u>Common Name</u>	<u>Tree</u>	<u>Shrub</u>	<u>Vine</u>	<u>Herb</u>
<i>Andropogon glomeratus</i>	Busy blue stem				X
<i>Andropogon gyrans</i>	Giant blue stem				X

Pedestrian Transect: Wet flatwoods overgrown with shrubs

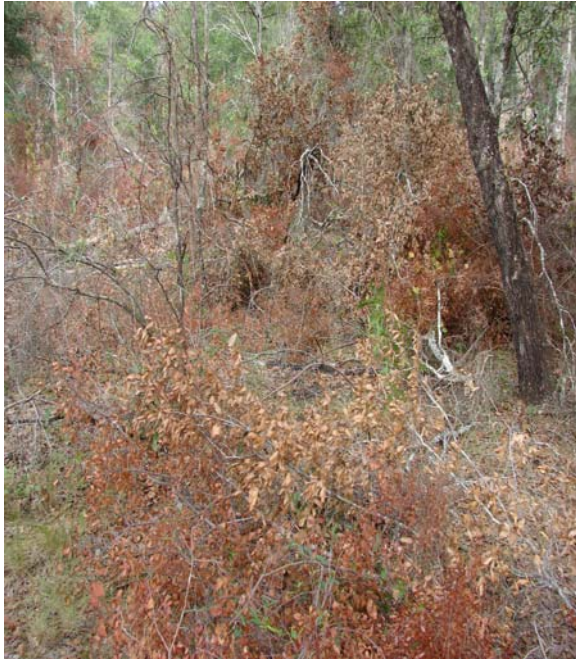
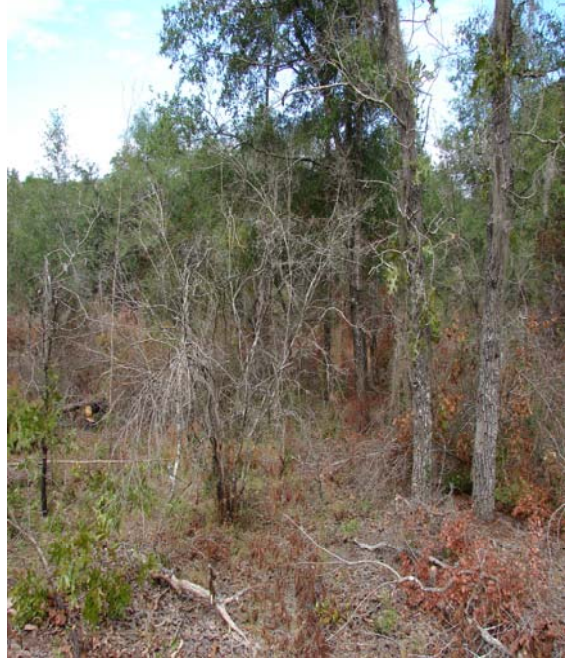
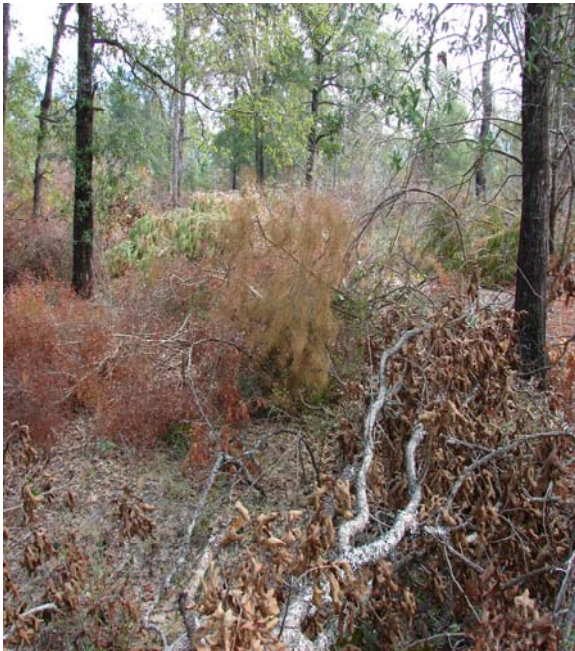
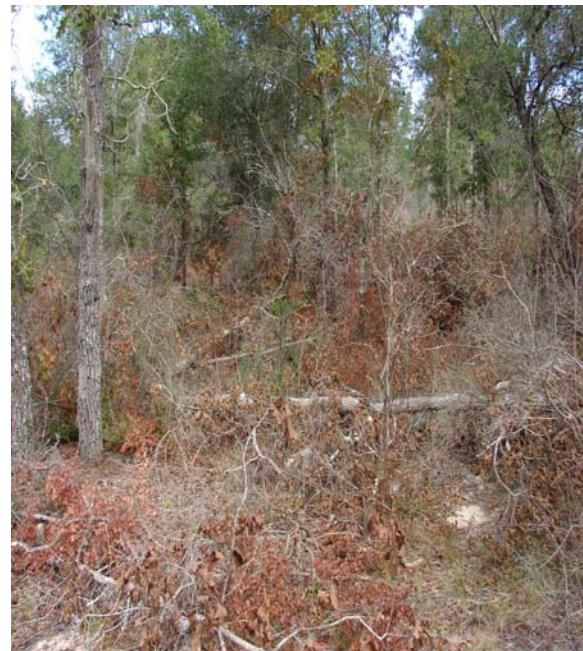
**Date:** 10/25/2006      **Time:** 10:30 am      **Data Collector:** David Clayton  
**Location:** Pedestrian Transect # M12 near photo point 11  
**Management Unit:** 10

**Nuisance Species:** None observed  
**Fuel Load:** Oak Trees have been thinned, area due to be burned winter 2007/2008, fuel load high  
**Wildlife Observations:** Blue jay, red bellied wood pecker, deer tracks, active gopher tortoise burrow

Pedestrian Transect: Upland Sand Hill with oak eradication

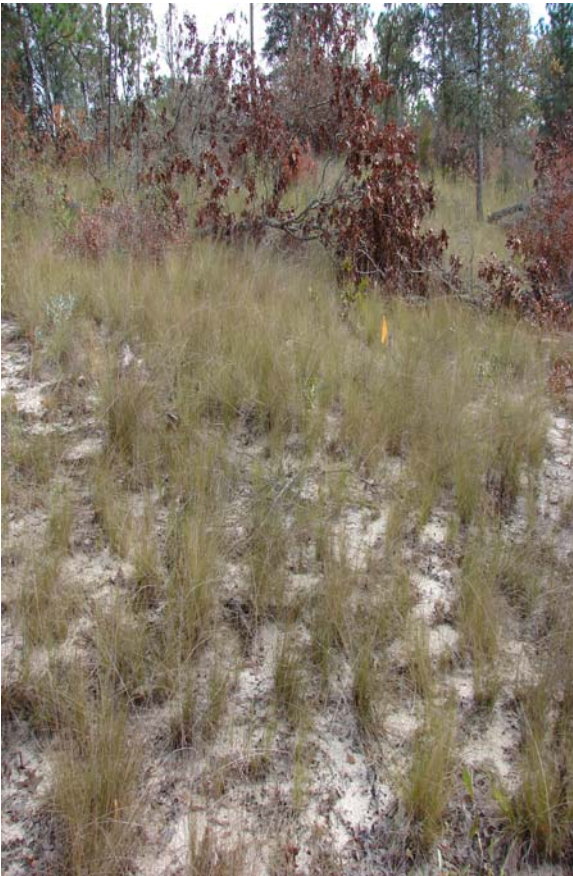
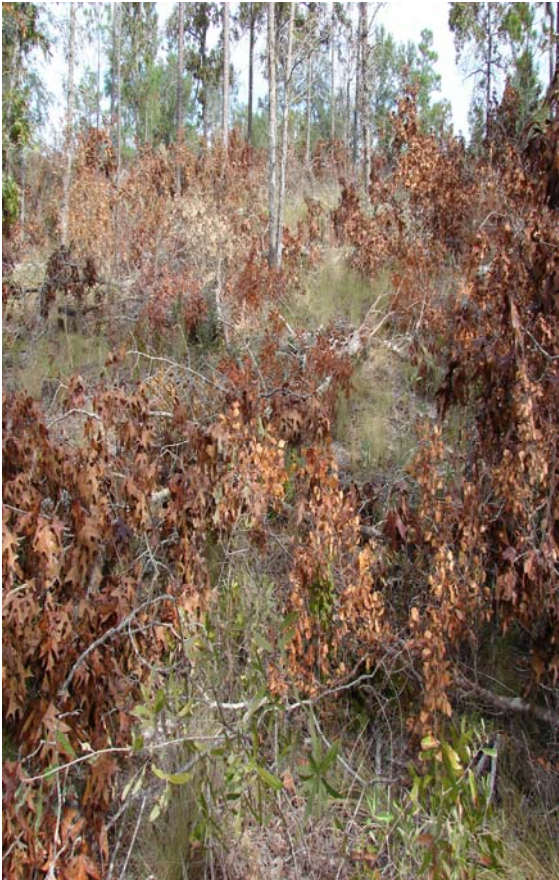
Pedestrian Transect: Upland Sand Hill with oak eradication: Note: Wiregrass and felled oaks
