JUNIPER CREEK HEADWATERS PRESERVE MITIGATION SITE
Annual Monitoring Report, Year 5 of 5
February 10, 2012

Impact: SR 73 (from SR 71 to north of SR 20)
USACE Permit No.: SAJ-2005-3585 IP-DEB, issued 5/5/06
Mitigation: Juniper Creek Headwaters Preserve, Bay County
Permittee/Consultant: FDOT
Responsible Party for Monitoring: Northwest Florida Water Management District (NFWFMD)
81 Water Management Dr.
Havana, FL 32333
Date of Inspection: January 20, 2012
Inspectors: Leigh Brooks, Robert Lide

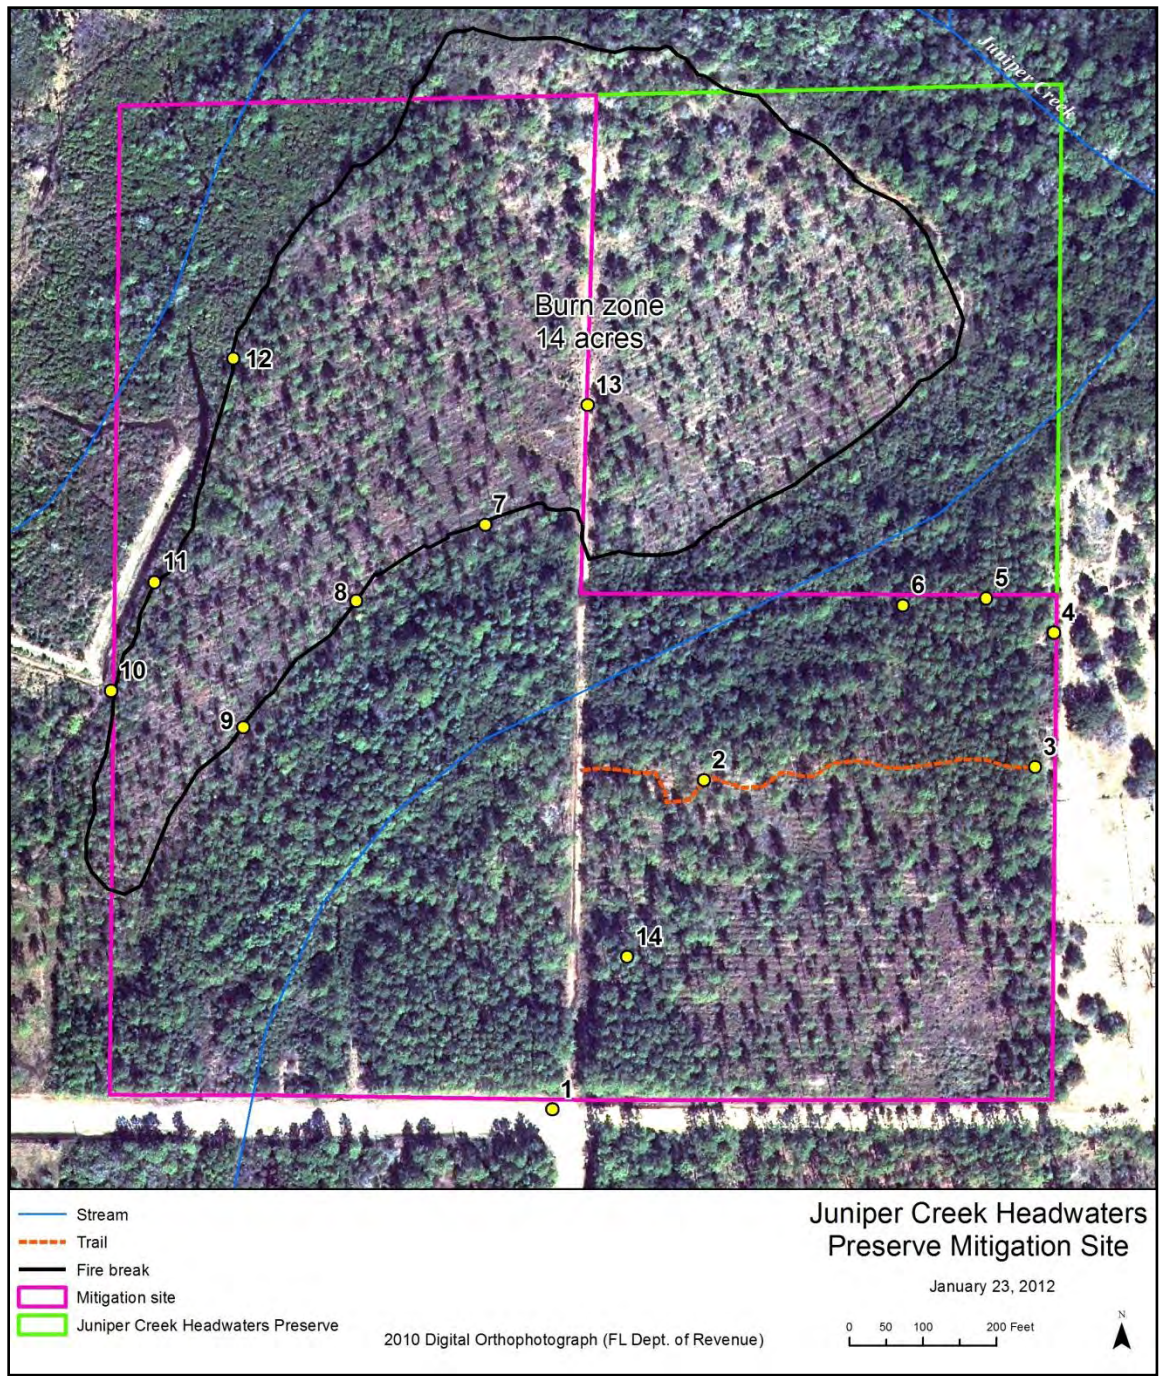
Figure 3. Aerial photograph of mitigation site with survey photo points indicated.

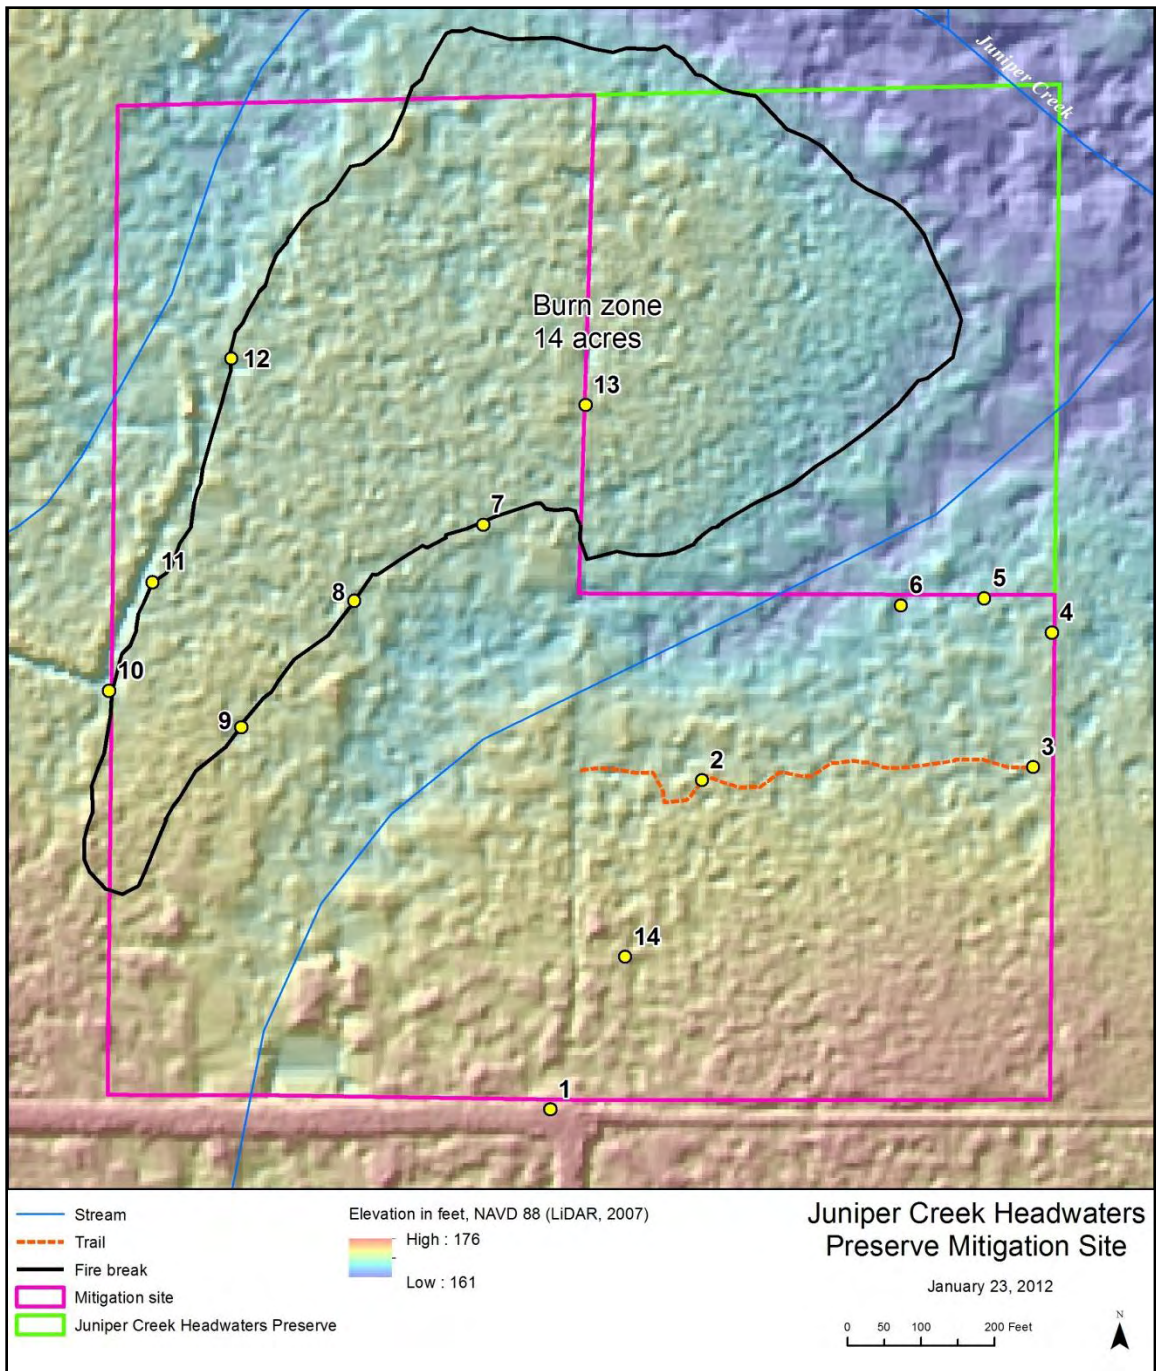
Figure 4. Topography of mitigation site with survey photo points indicated.

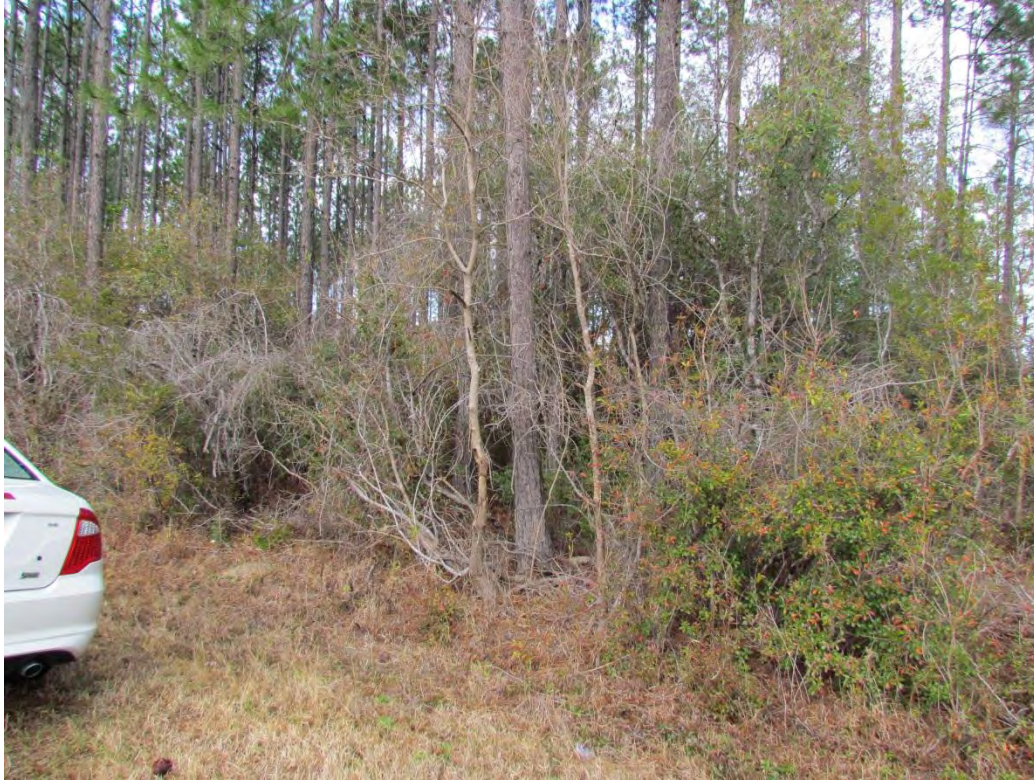
Preserve boundaries generally appeared intact and undisturbed. No perimeter fencing (except adjacent property fencing) and no boundary signage were visible. The south boundary on Silver Lake Road had some minor trash and trash had collected at all three culverts on the road. On Silver Lake Road, immediately west of the Preserve sign and abandoned road, several dead Chinese tallow trees ([Photo 1](#)) were noted. No non-native species were seen inside the Preserve.

Photo 1. Treated Chinese tallow trees at Preserve entrance. Photo point 1, facing northwest. 1/20/2012. [RTN](#)

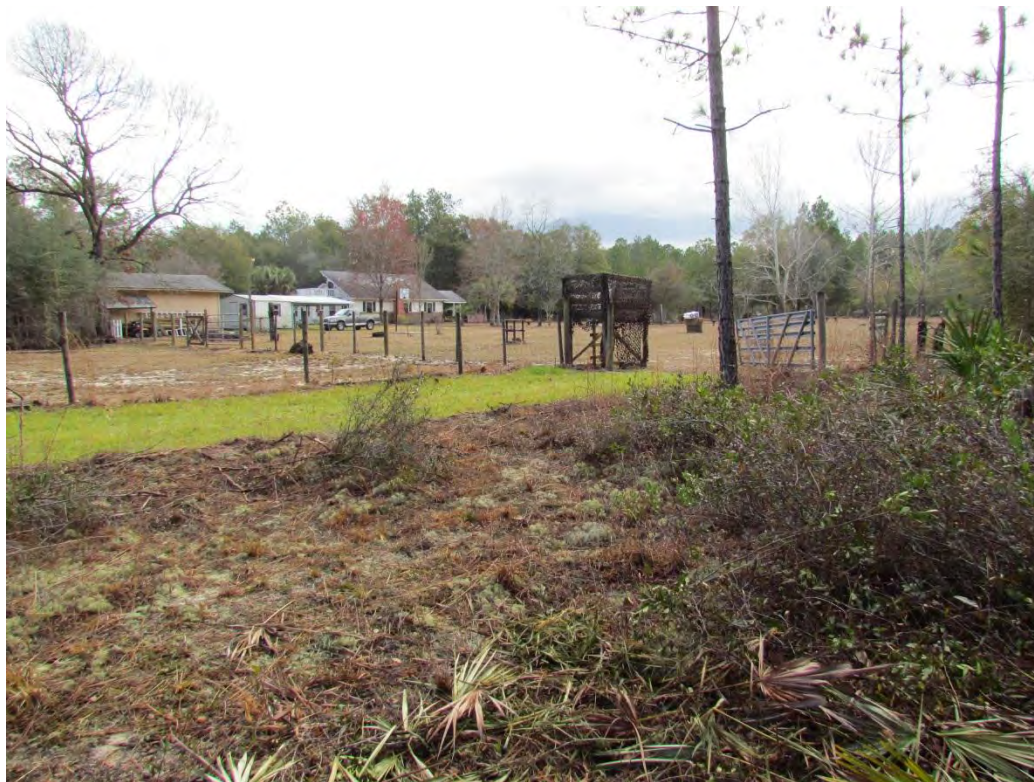
At the east boundary, the adjoining property owner has created a wildlife food plot ([Photos 2 and 3](#)). Brush from clearing was piled up onto the Preserve.

Photo 2. Flagged trail opens to neighboring property, hunt stand to south. Photo point 3, facing southeast. 1/20/2012. [RTN](#)

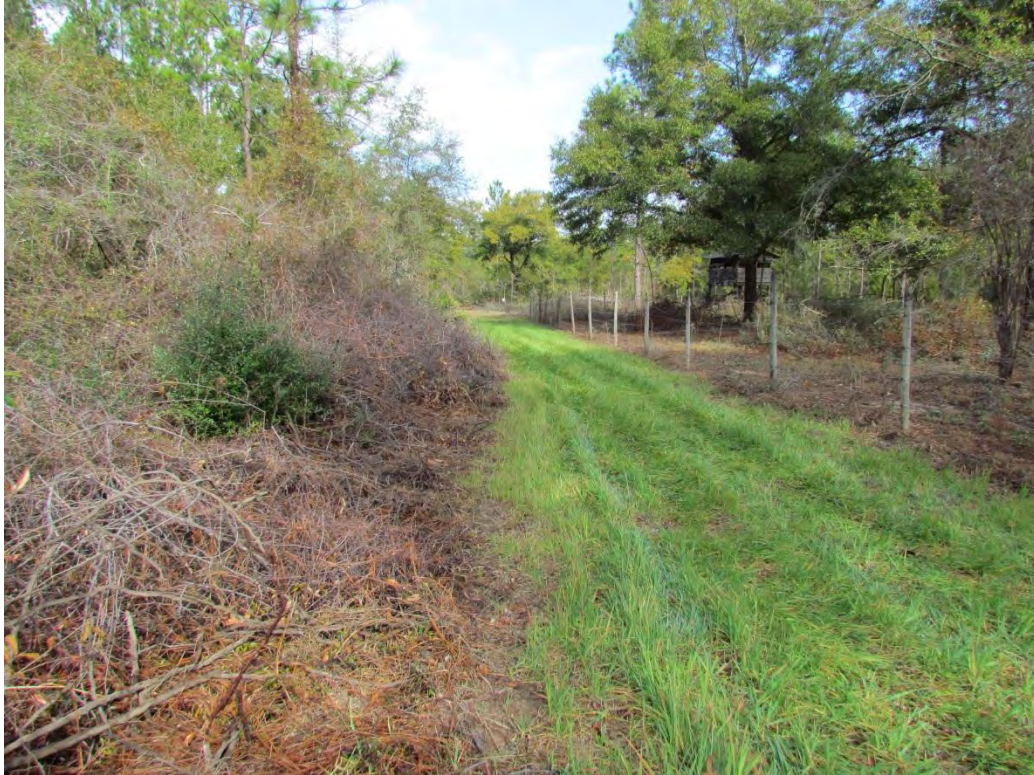
Photo 3. Hunt stand to north beyond oak tree. Property boundary unclear. Brush cleared and piled onto Preserve, new road/deer field planted in Bahia grass. Photo point 4, facing north. 1/20/2012. [RTN](#)

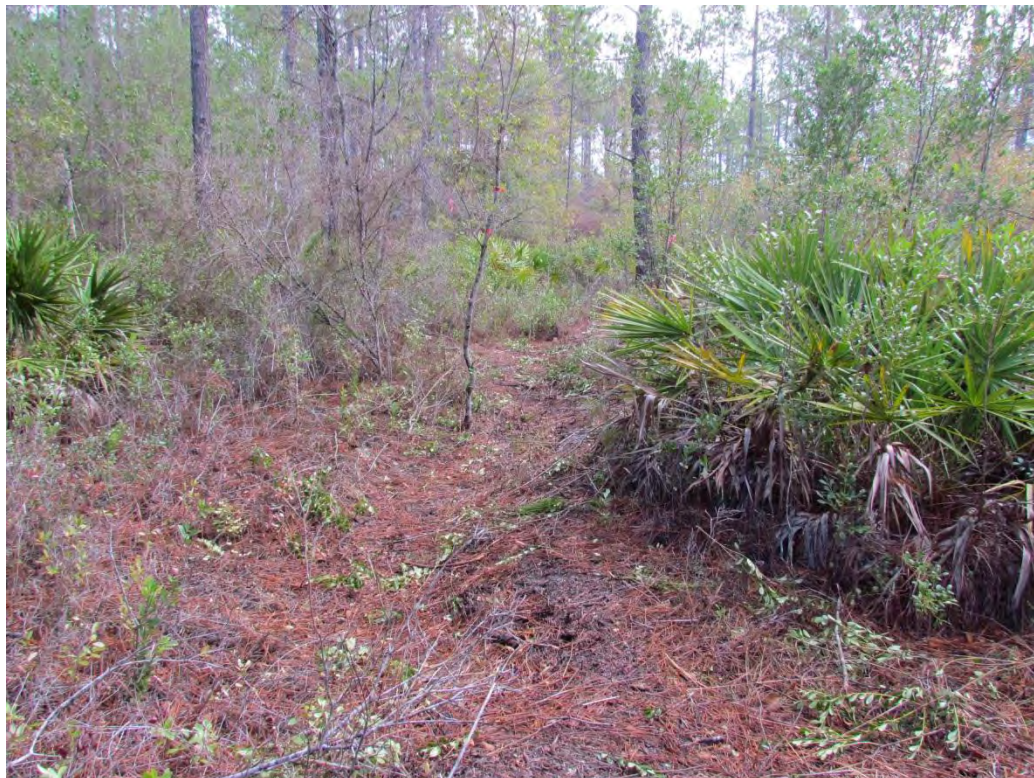
A newly flagged and roughly cleared single-track trail running east/west was found in the southeastern quadrant between the drain and the flatwoods as shown in [Figures 3 and 4](#) and [Photo 4](#). The east end opened to the aforementioned neighboring property. It is not clear if this is an authorized trail. There was also a short flagged trail on the north end of the property, leading off the Preserve to the fire line. BCC indicated a loop trail had been developed; however, these observers could not distinguish it.

Photo 4. Flagged trail on south portion of Preserve. Photo point 2, facing east. 1/20/2012. [RTN](#)

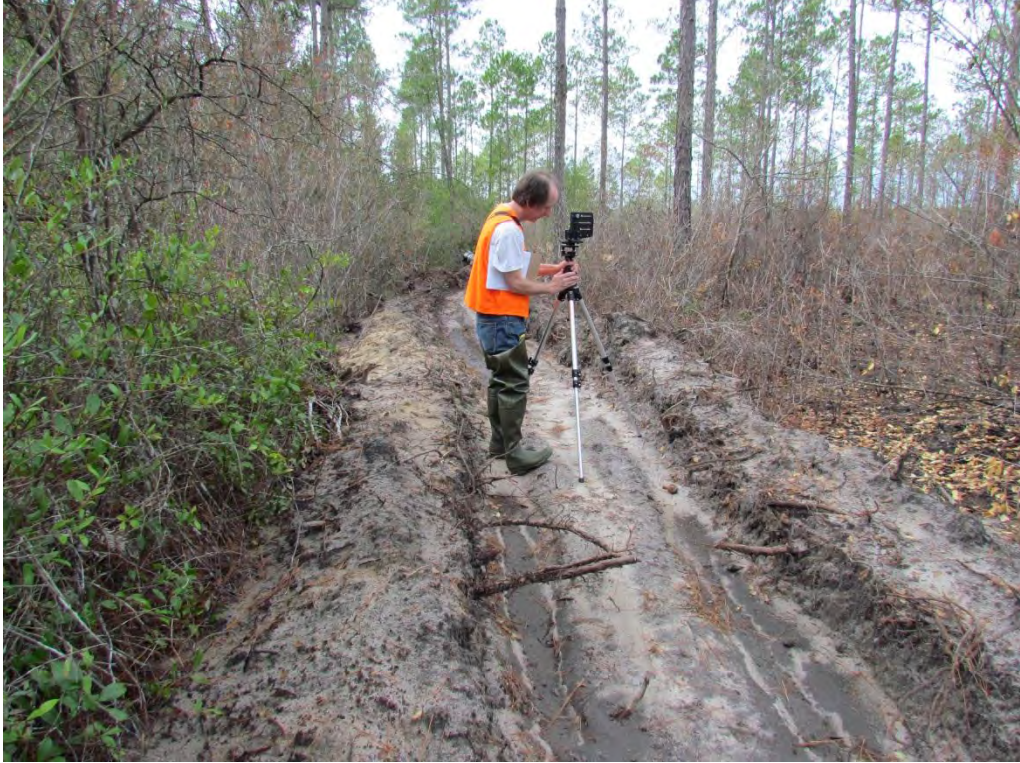
Of concern is the fire break plowed around the perimeter of the burn zone, a distance of 0.7 miles. The fire break is deeper than necessary (1-2 feet deep and holding water in places) and does not incorporate the existing road and ditch ([Photos 5-11](#)). A fire break of this magnitude could affect hydrology of the site by draining adjacent areas, conveying surface water off site during rain events instead of retaining it on site for recharging groundwater, and promoting

Photo 5. Unburned shrubs on left, burned flatwoods on right, separated by plowed fire break. Photo point 7, facing west. 1/20/2012. [RTN](#)

Performance standards have not been fully met due to continued dominance of titi and fire not having been applied everywhere it is needed. The fire break will need to be remediated to restore natural hydrologic function. As part of this process, it would be a good time to consider means of restoring natural hydrology on the western side of the Preserve by blocking or filling in the pre-existing ditch and restoring the adjacent road footprint if it is determined that offsite flooding of adjacent property or housing will not occur.

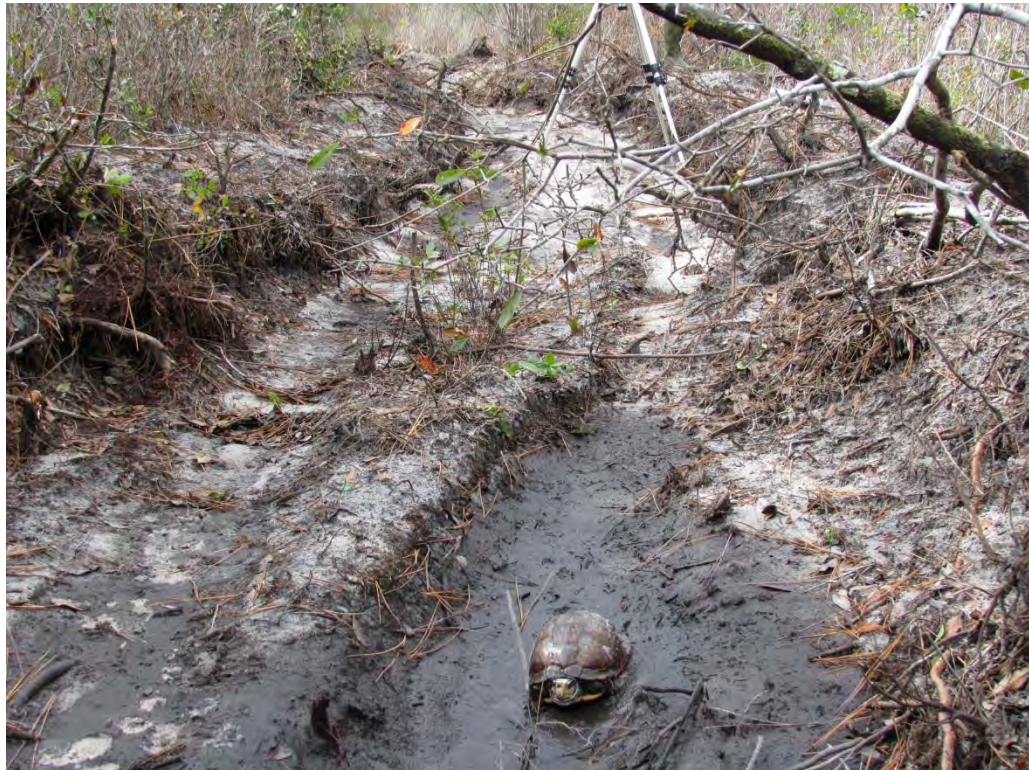
Photo 6. Box turtle in wet spot of plowed fire break. Photo point 8, facing southwest. 1/20/2012.

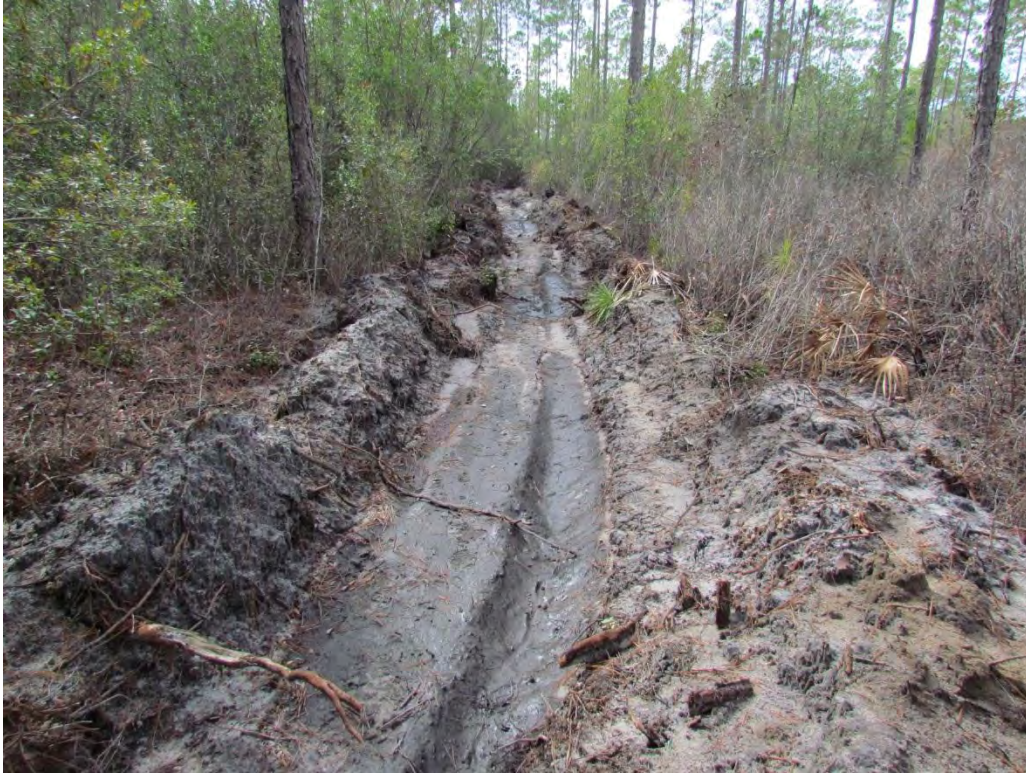
Photo 7. Plowed fire break with mucky bottom. Unburned titi in background of burn zone. Photo point 9, facing southwest. 1/20/2012. [RTN](#)

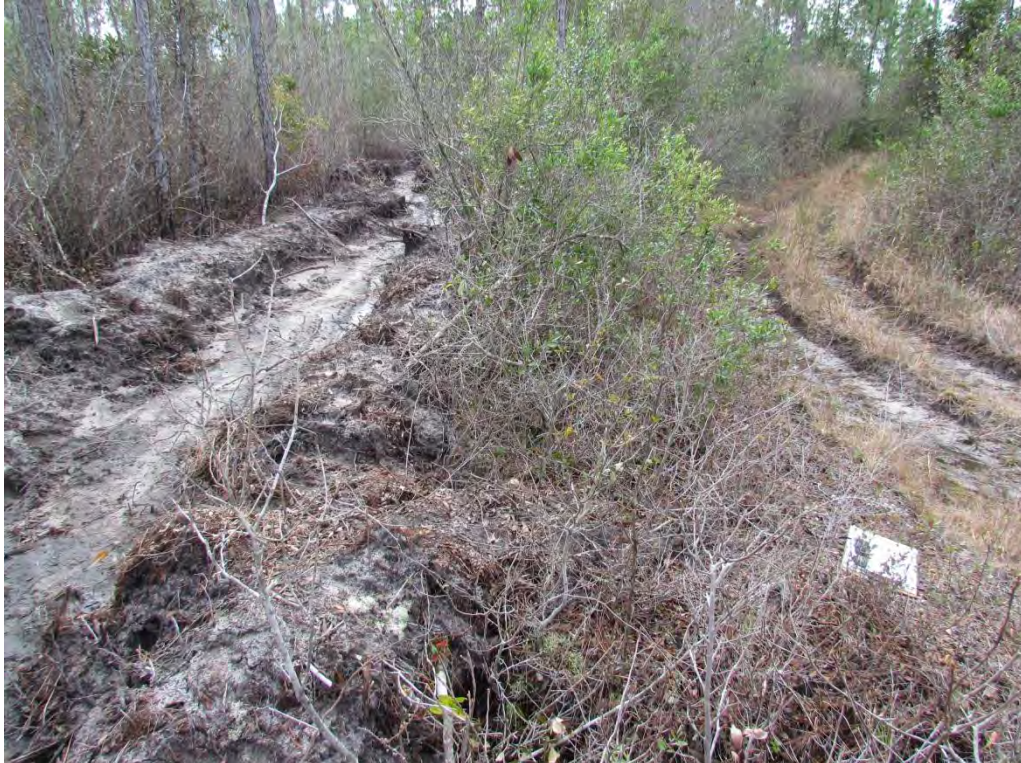
Photo 8. Newly plowed fire break on left, existing road on right. Photo point 10, facing south. 1/20/2012. [RTN](#)

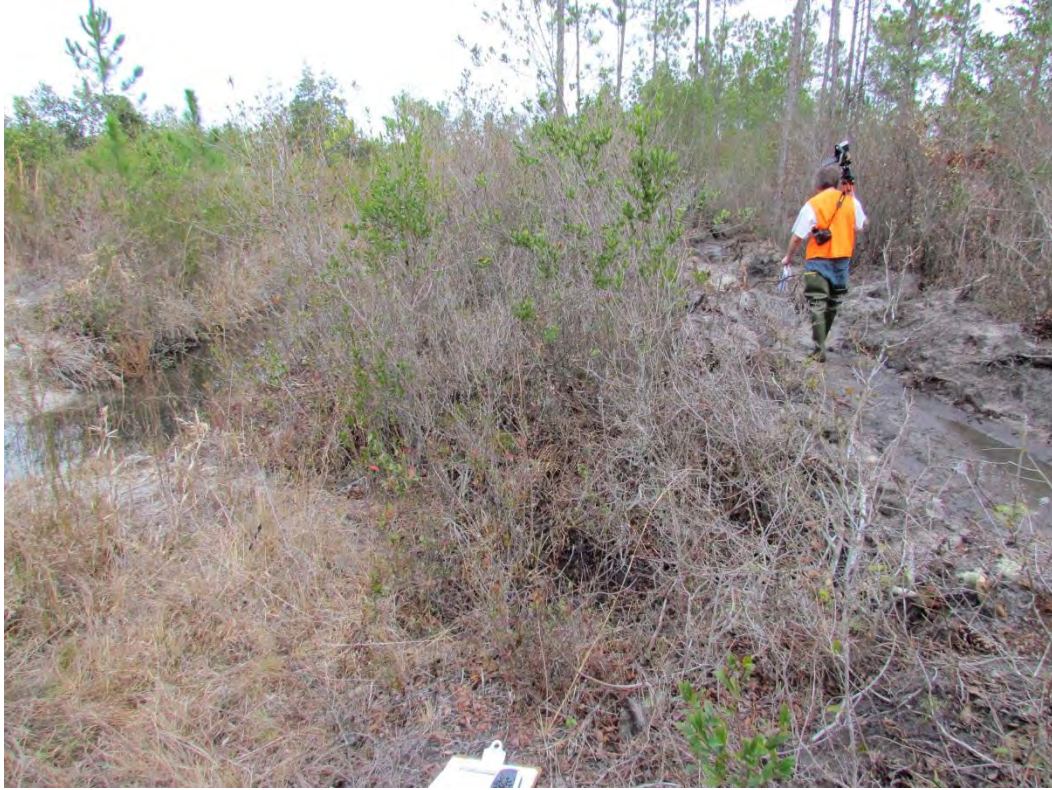
Photo 9. Newly plowed fire break on right parallels existing, lower ditch on left. Photo point 10, facing north. 1/20/2012. [RTN](#)

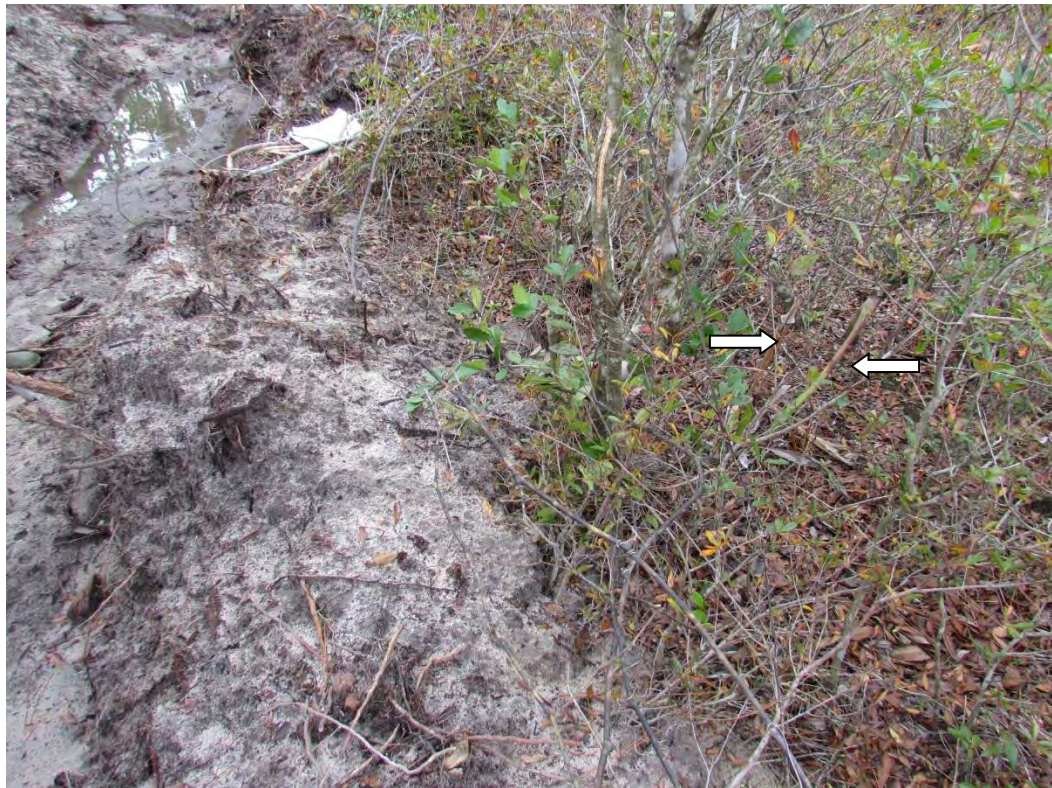
erosion of loose pushed up soil. Also of concern is an area of remnant wet prairie on the west side of the burn zone with state-endangered whitetop pitcher plants (*Sarracenia leucophylla*) as well as club moss and pipewort, which was bisected by the fire break ([Photo 10](#)). Some plants were plowed up and others smothered; some desirable large trees (*Persea* sp. and *Pinus* sp.) were knocked down or injured.

Photo 10. Plow fire break bisected a remnant wet prairie with whitetop pitcherplants (white arrows). Photo point 11, facing south. 1/20/2012. [RTN](#)

It is recommended that mechanical shrub reduction be employed to deal with titi that has encroached into wet flatwoods and the wet prairie, as fire alone will not be sufficient to return to healthy natural communities. In the wet prairie, it is recommended work be conducted with hand tools and no heavy equipment to prevent further disturbance to the ground. Mechanical techniques could also be considered to reduce fuel loads prior to burning in unburned flatwoods. Thinning of plantation pines in drains and unburned flatwoods should also be considered to help manage fuel loads and may provide supplemental revenue to implement additional restoration activities.

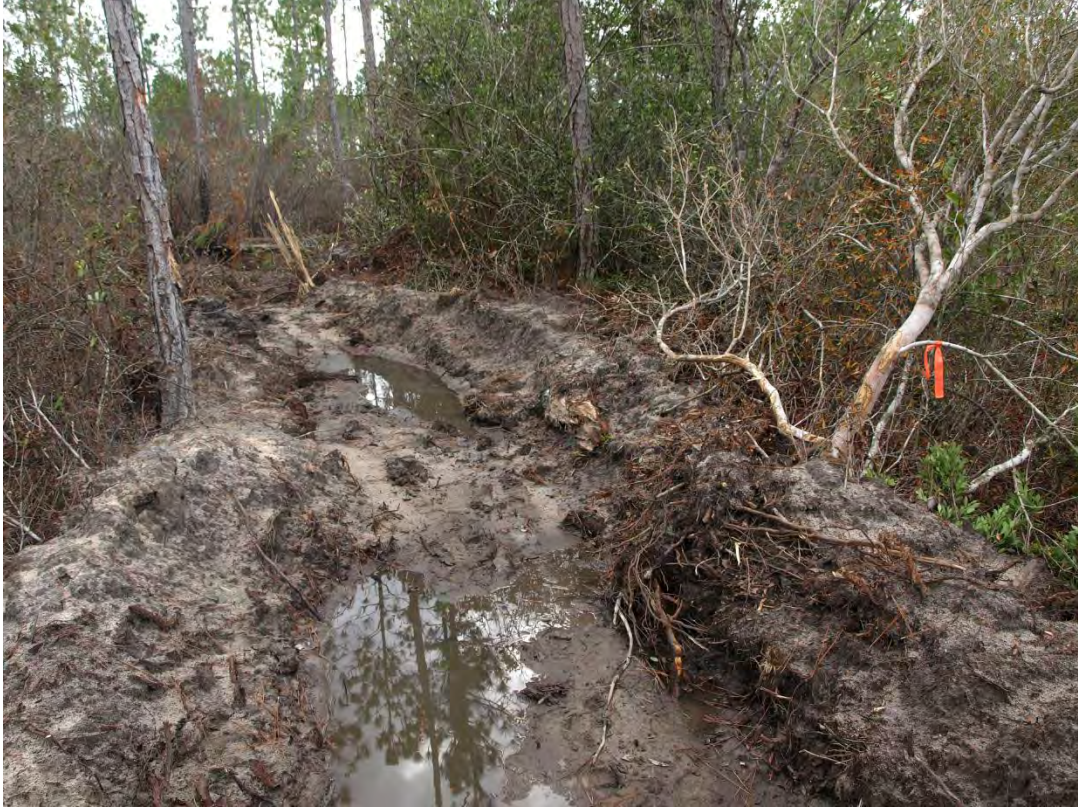
Photo 11. Plowed fire break. Photo point 12, facing north. 1/20/2012.

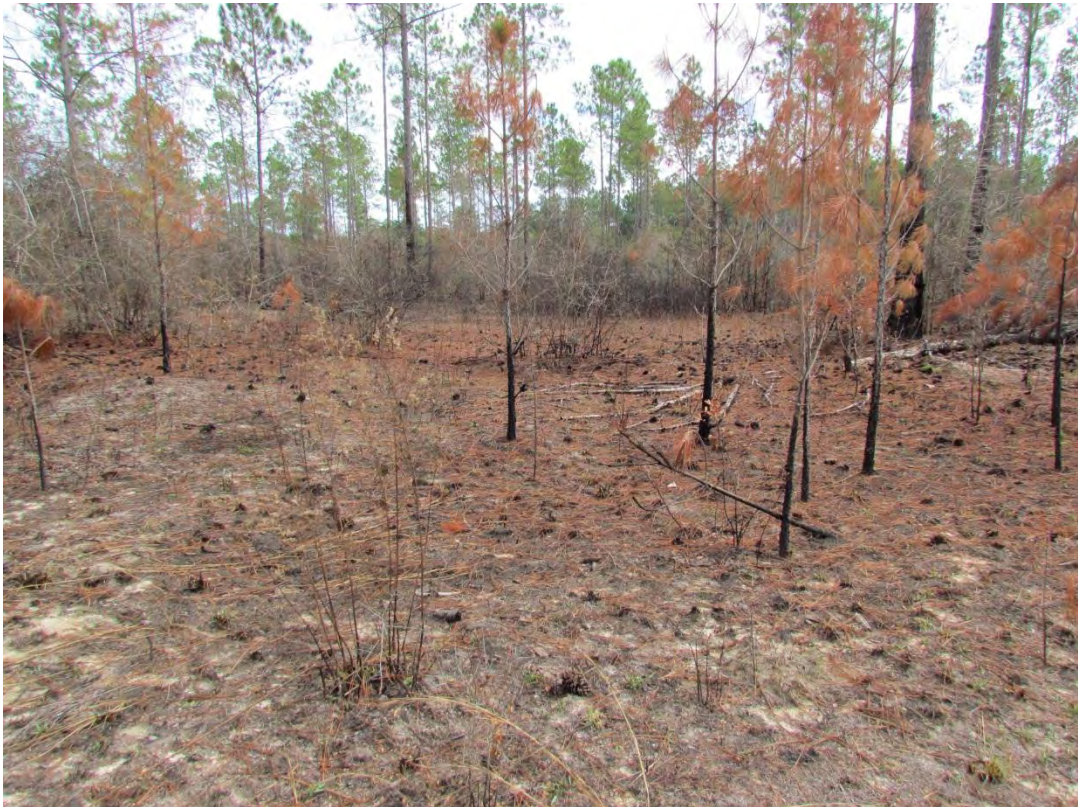
A prescribed fire had been conducted recently in the flatwoods north of the main drain ([Figures 3 and 4](#); [Photo 12](#)). Approximately 14 acres were burned. Results in the interior of the burn area looked good, with the understory opened up and grasses (wiregrass and bluestem) starting to re-sprout. There appeared to be some mortality of young slash pines which will help prevent a dense canopy from developing. In some areas titi was still green and clearly did not burn well ([Photos 5 and 7](#)), and in areas with denser hardwoods, fire failed to carry to the fire line. The burning off of vegetation exposed some small historic trash piles.

Photo 12. Burned flatwoods on north side of Preserve. Photo point 13, facing east. 1/20/2012. [RTN](#)

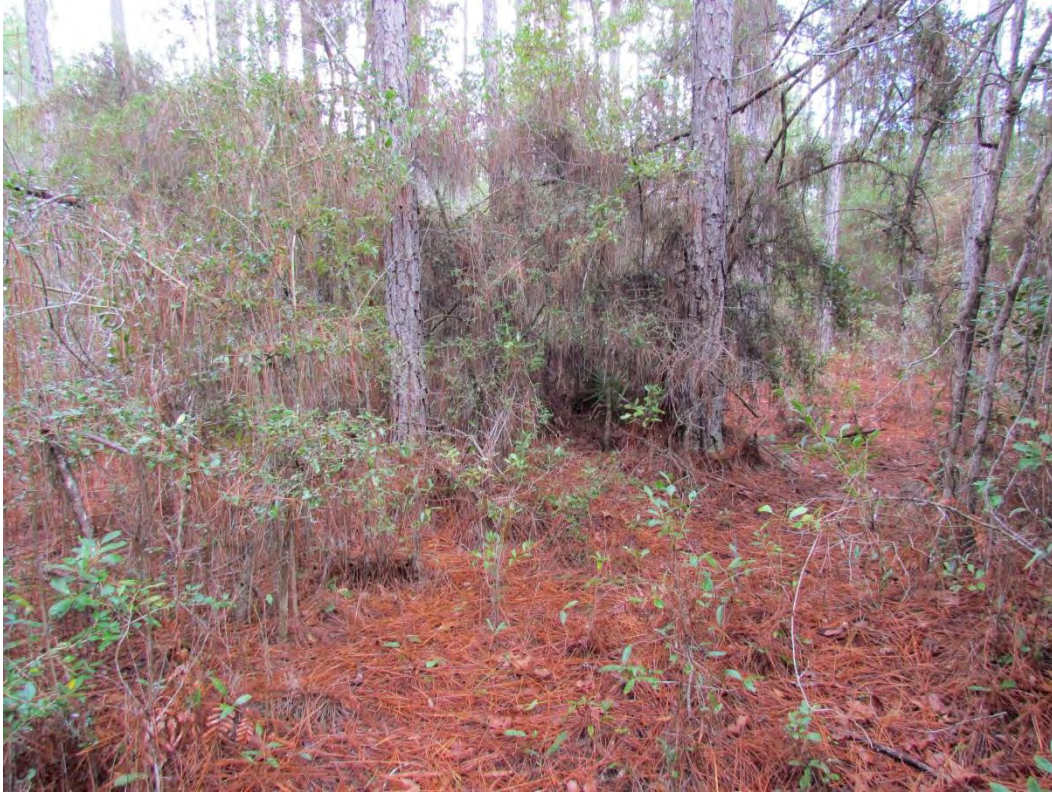
Titi continues to dominate in the unburned hydric pine flatwoods, covering ≥ 5 percent of the mitigation site. These areas would benefit from mechanical shrub reduction prior to burning. Unburned areas of flatwoods and drains had excessive buildup of pine needles and other fuels in the sub-canopy, shrub layer, and on the ground ([Photos 13-15](#)) from the density of pines remaining in the pine plantation. Fire is needed but care in burn strategy will be required to prevent the fire from getting too hot and killing desired vegetation, and from risking spot overs off the property.

Photo 13. Heavy fuel accumulation in unburned flatwoods. Photo point 5, facing north. 1/20/2012. [RTN](#)

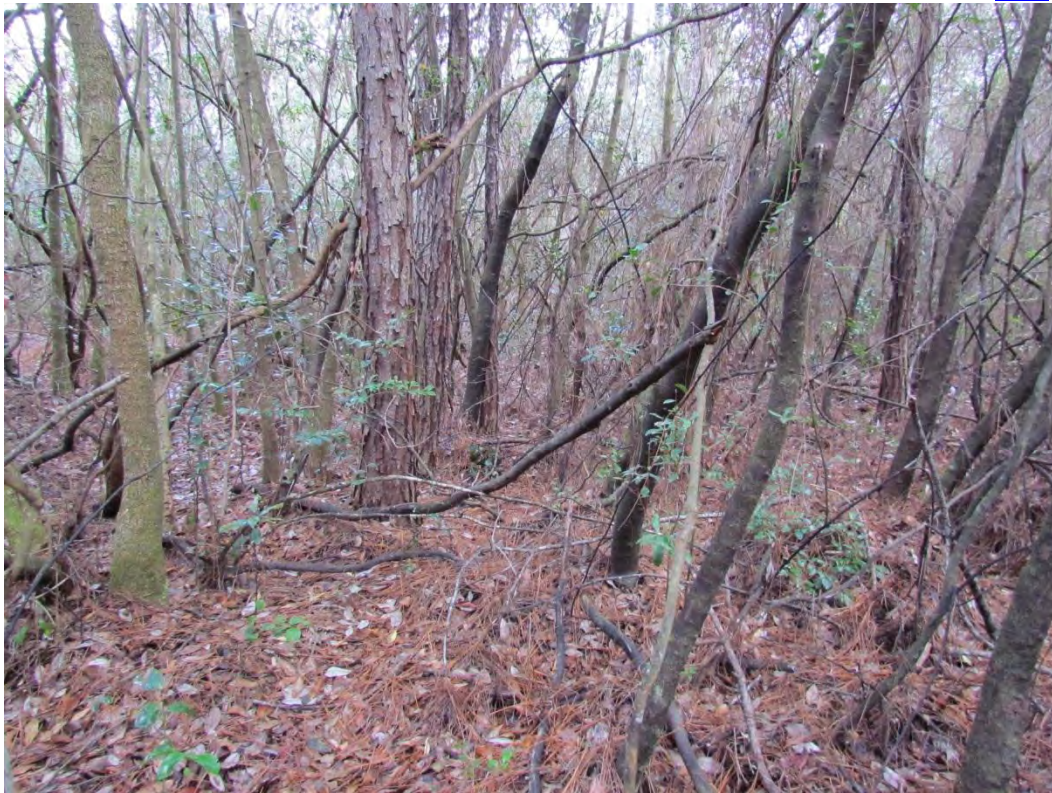
Photo 14. Heavy fuel accumulation in forested wetland drain. Photo point 6, facing northwest. 1/20/2012. [RTN](#)

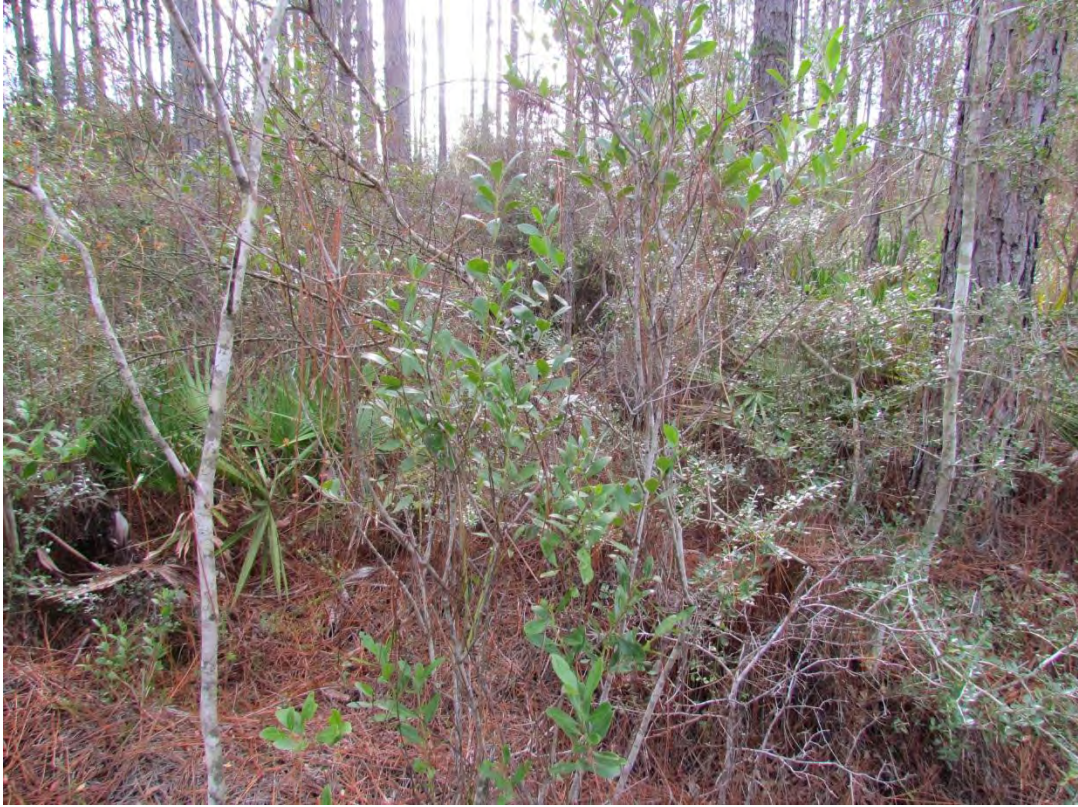
Photo 15. Condition of south side of Preserve, in need of fire. Photo point 14, facing west. 1/20/2012. [RTN](#)
