# Northwest Florida Water Management District

Re: Progress Report 17

Please accept this submittal as the 17th semi-annual progress report for the SHLMB. This report was written in accordance with Specific Condition 27.

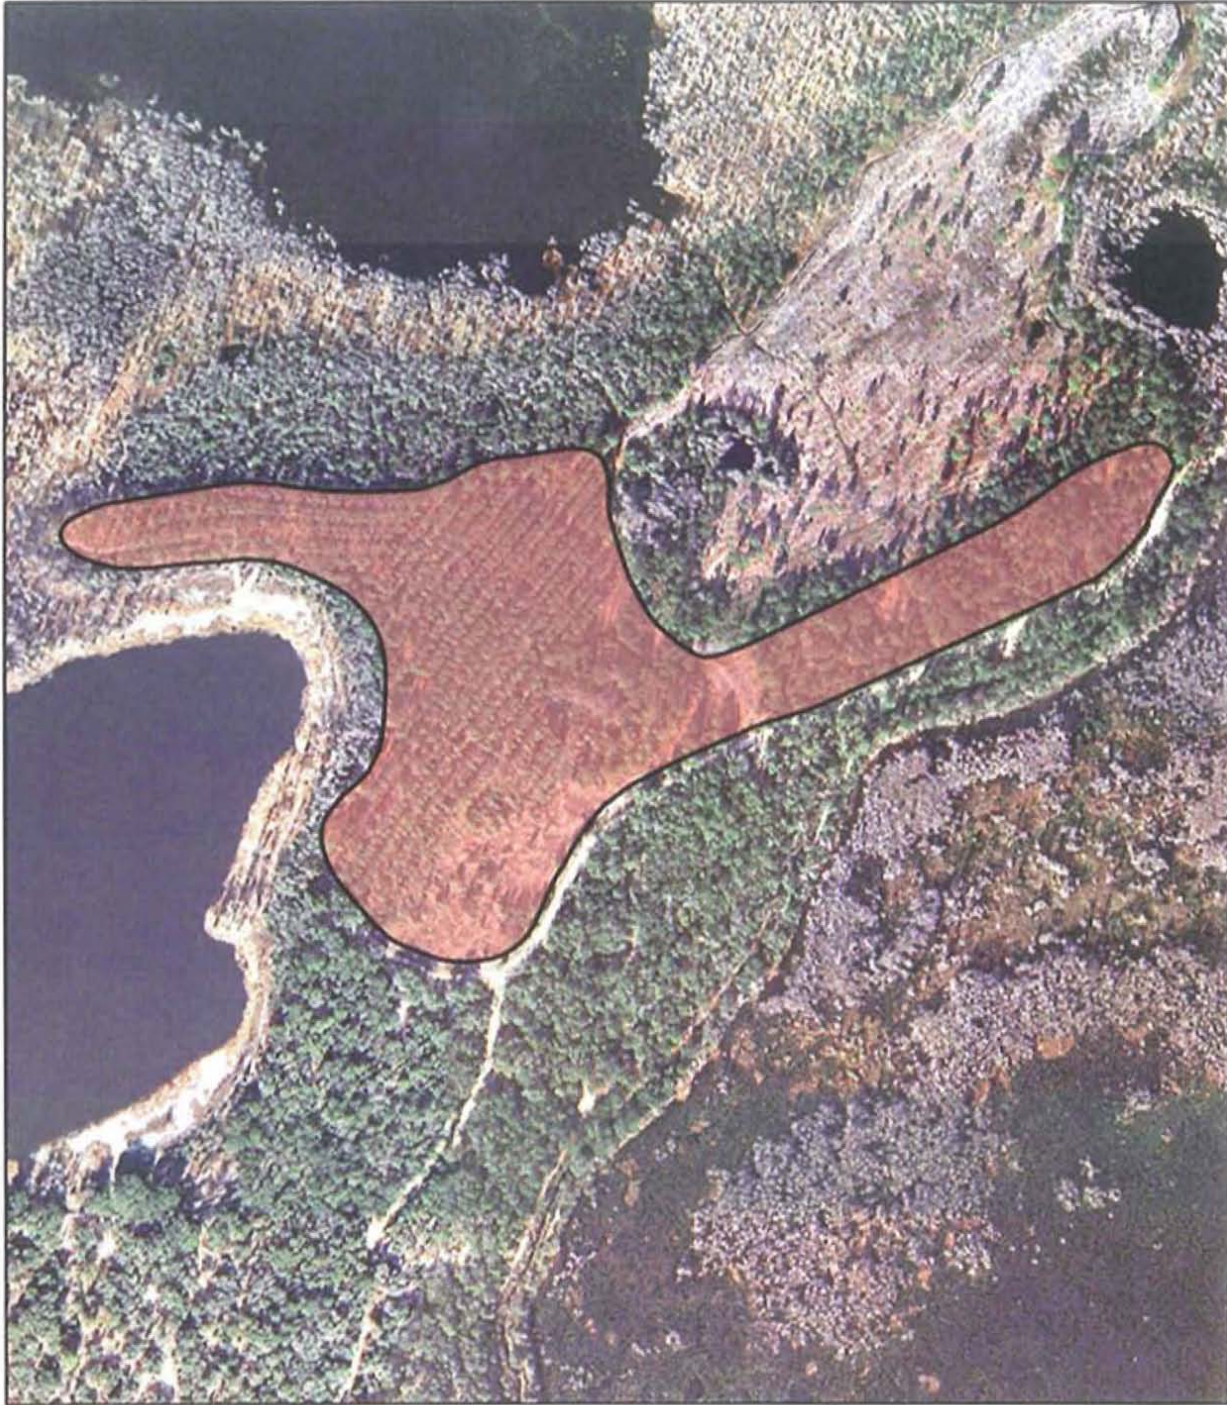
Figure 4. Slash Pine Thinning/Wire grass/toothache grass planting areas (16 acres) (Winter 2012/2013).

### Slash Pine Thinning, Toothache & Wiregrass Planting - 2012

Northwest Florida Water Management District  
Sand Hill Lakes Mitigation Bank (SHLMB)  
Slash Pine Thinning,  
Toothache & Wiregrass Planting Areas (~16 Acres)  
Section 6, Township 1 North, Range 14 West  
Washington Co., Florida

7. In accordance with Specific Condition 10a, slash pine thinning to reduce tree densities to 200 trees per acre or less occurred within Management Unit 3, slash pine wet flatwoods restoration area in late August/September 2012 (Figure 4).
8. The annual monitoring was conducted between September 24-28 and October 24-31 2012 in accordance with Specific Conditions 26 and 28.
9. Oblique aerals were flown October 23, 2012 in accordance with Specific Condition 28 and have been posted at NFWFMD.wetlands.com

4. A total of 16 acres of wet wire grass and tooth ache grass will be planted in early January in Management Unit 3 and adjacent hydric flatwoods (154,880 tubelings) in accordance with Specific Condition 10c and Attachment D (Figure 4).

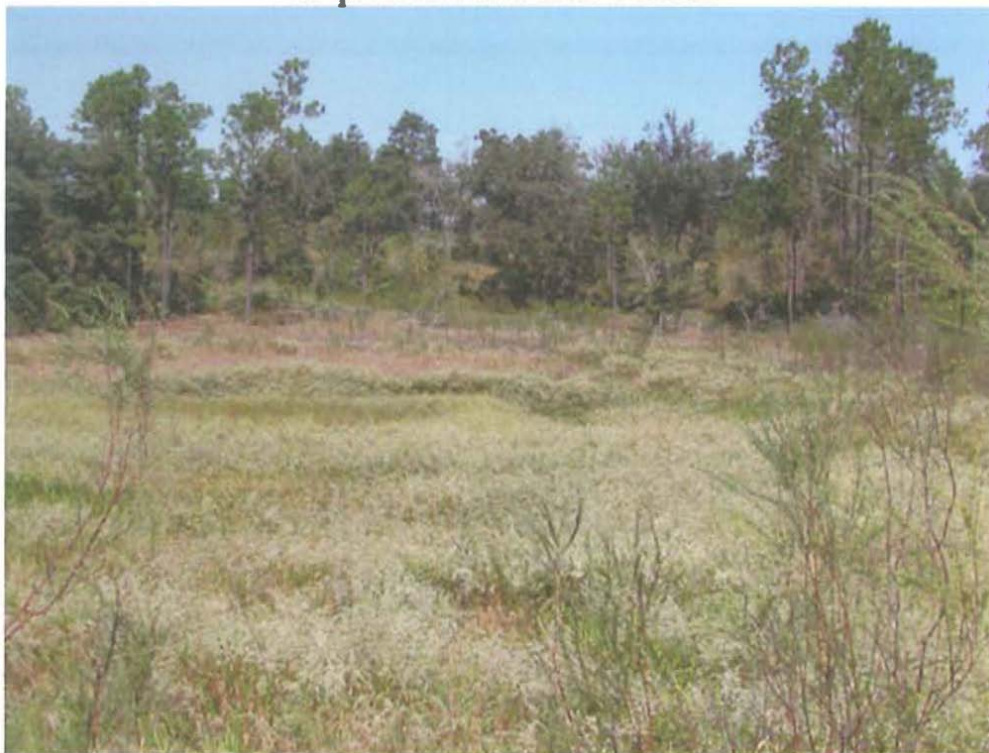
M1: (09-24-2012) facing West, pond mostly dry, note smooth barked St. John's wort at edge.  
(Preservation)

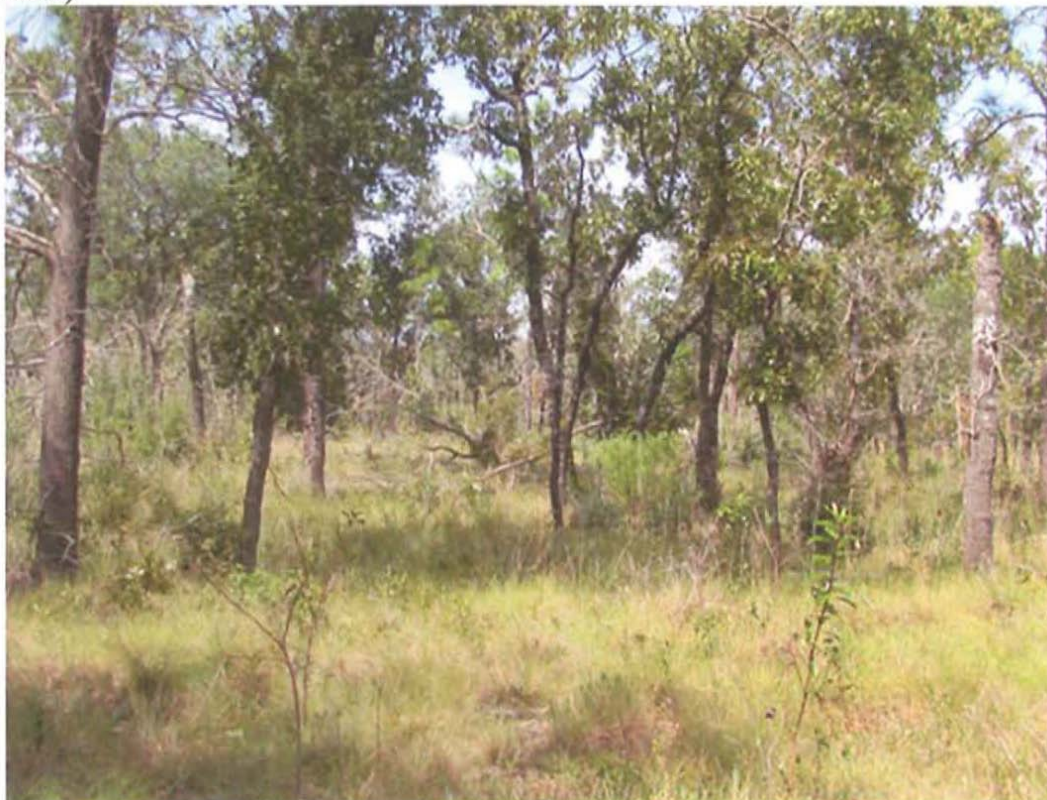
M2: 09-26-2012 M2: Turkey Oak dominated sandhill, management Unit 10, facing North  
(Enhancement)

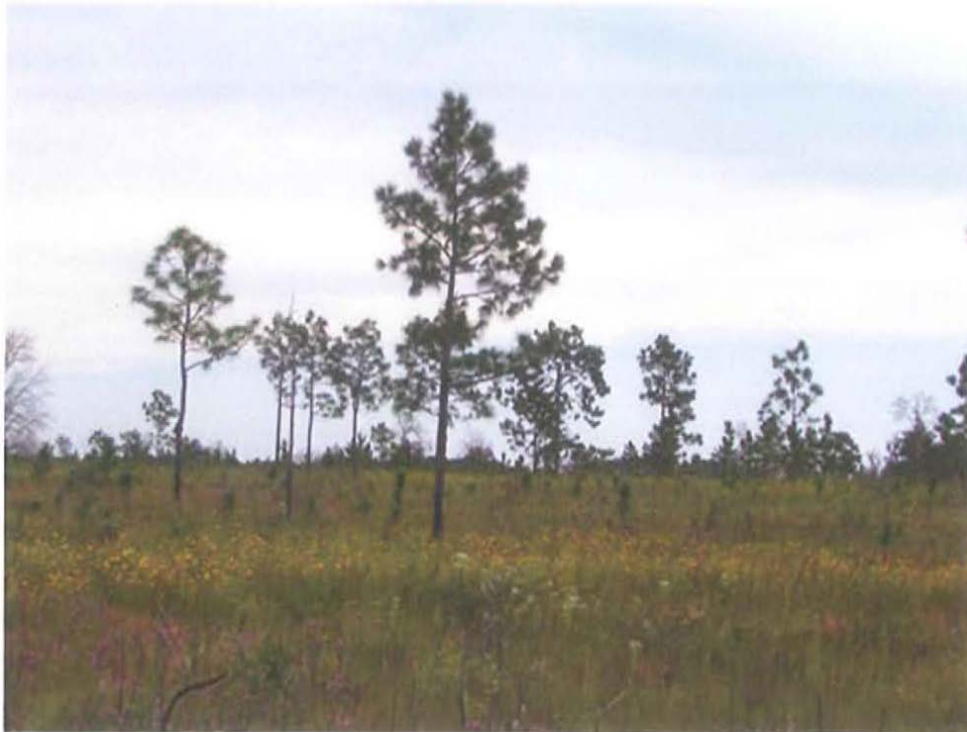
M3: 09-26-2012- Sandhill above Cat Pond facing North. Reduced LLP seedling density since fire in 2011 (Enhancement)

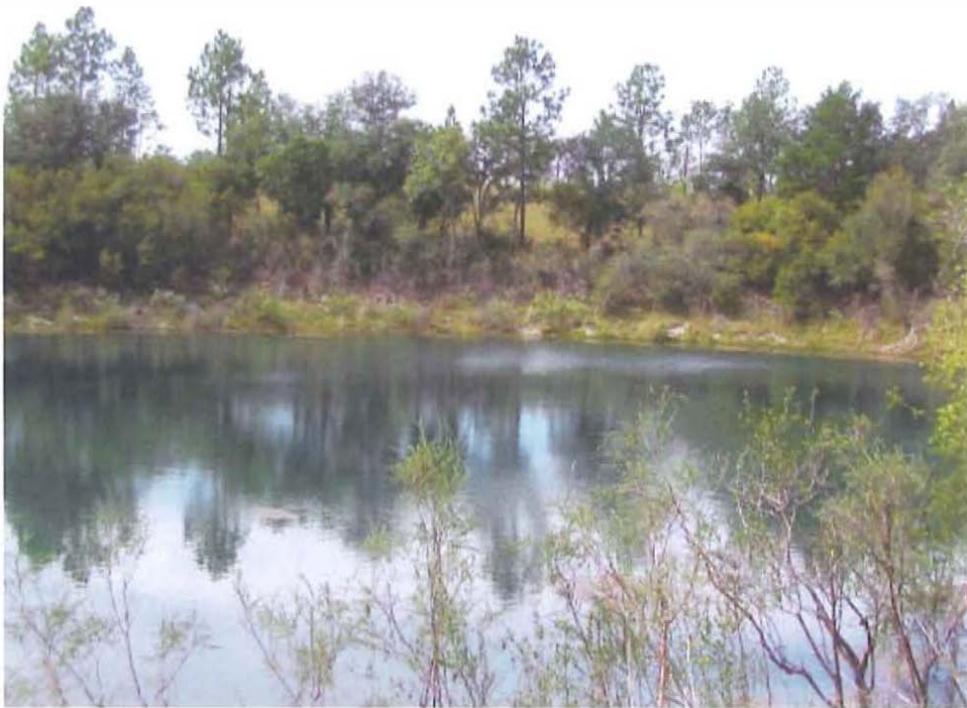
M3: 09-26-2012- Cat Pond facing West. Endangered Smooth-barked St. John's Wort in foreground (Preservation)

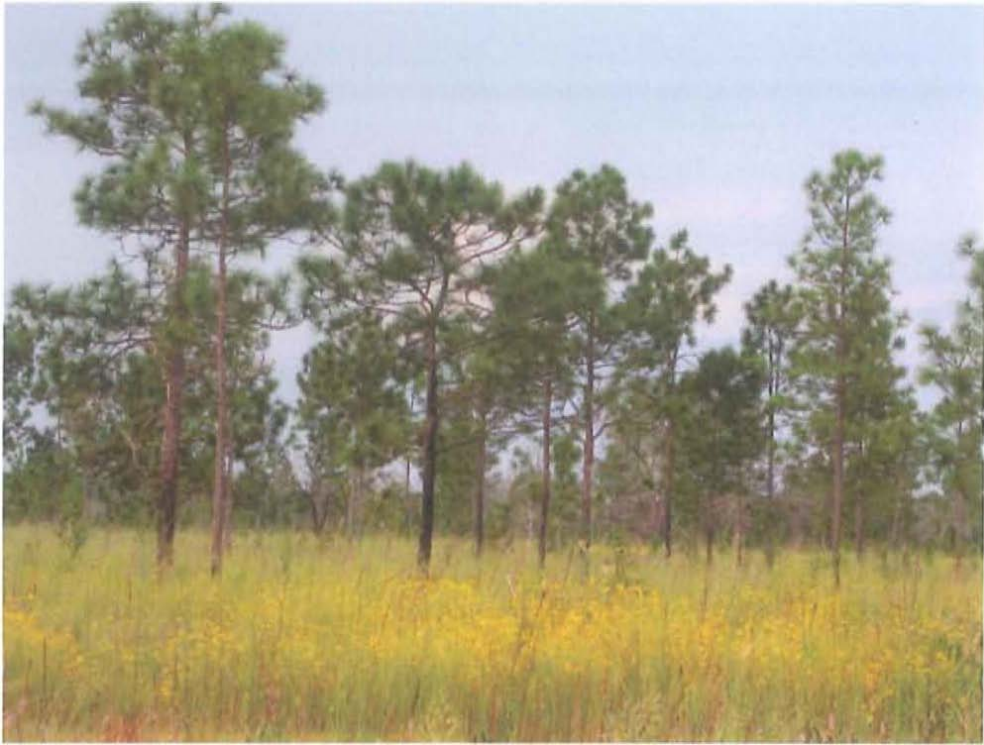
M4: 09-26-2012 facing Southwest. Sandhill Wiregrass and wildflowers, upland next to Little Deep Edge. (Restoration)

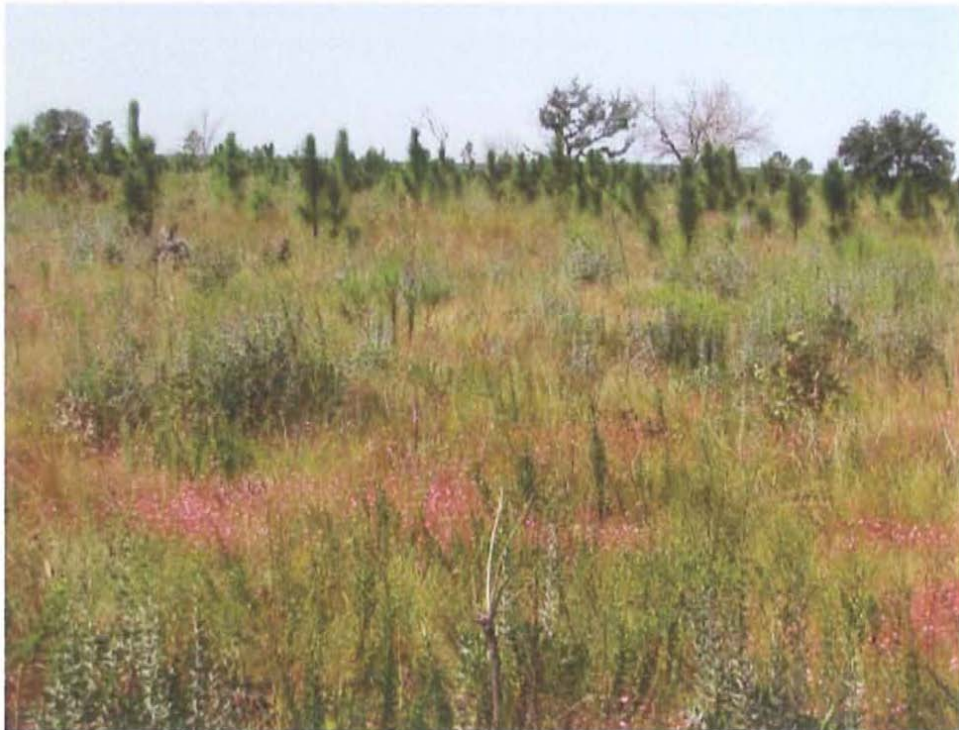
M5: 09-24-2012: facing South. Sandhill restored from slash pine plantation. Note dense wiregrass regeneration along with planted long leaf pine. (Enhancement)

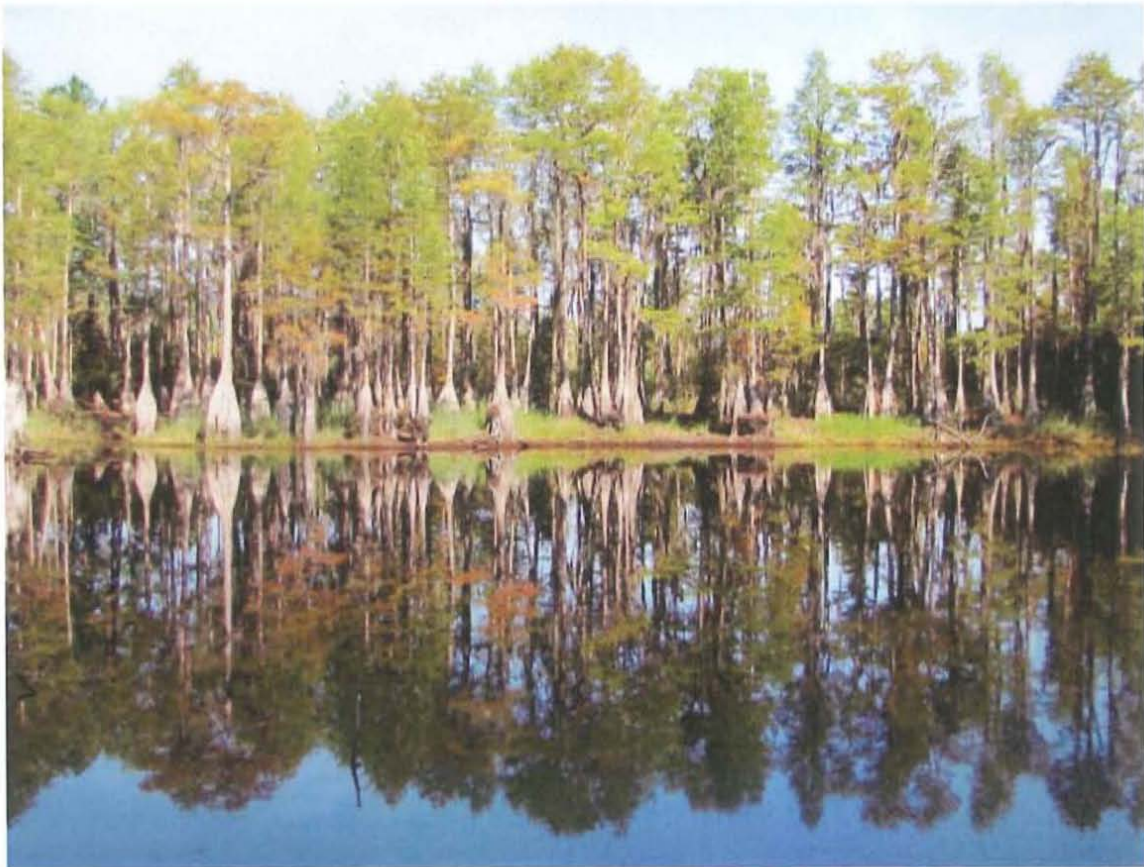
M8: 09-28-2012. facing North, Water in pond, cypress appear healthy. Recruitment of cypress found in dry down areas surrounding pond. (Preservation).

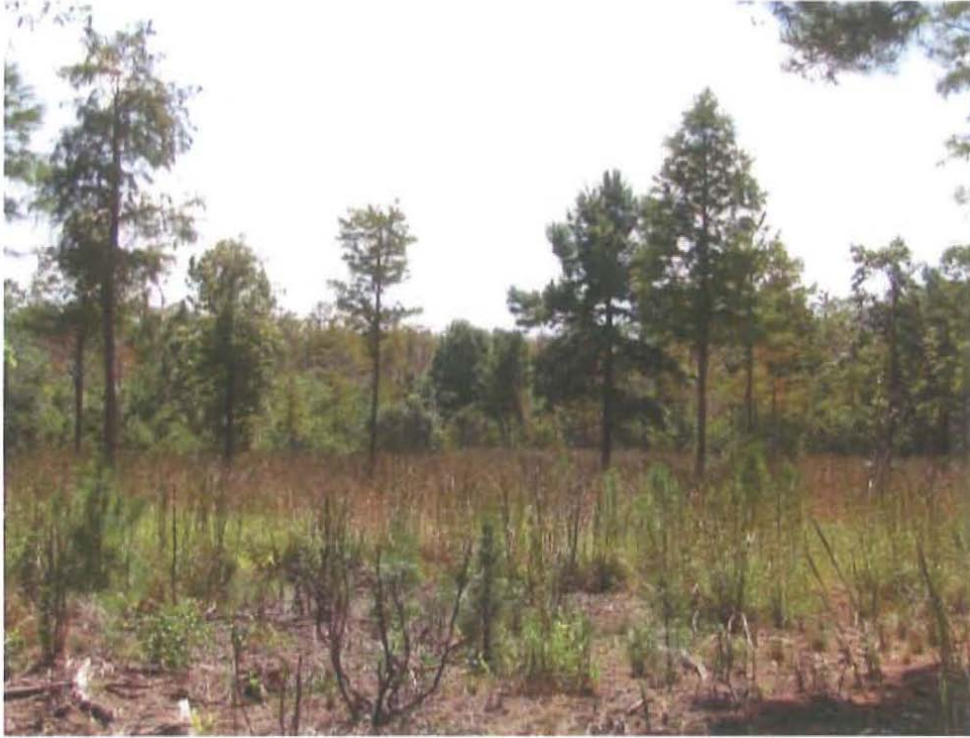
M11: 09-27-2012 facing Southwest: Hydric Pine Flatwoods (Restoration), planted wire grass.

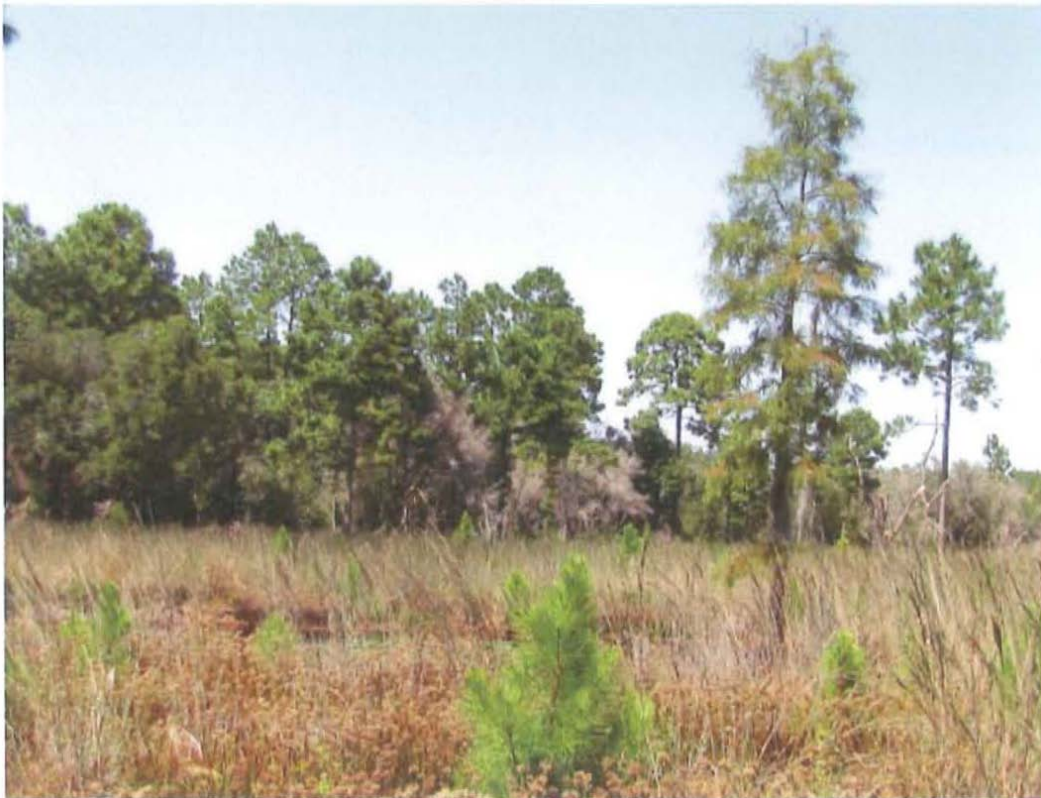
M10: facing West, 09-24-2012. Hydric Pine Flatwoods restored from Titi swamp. Gyro-Trac followed by intense shrub reduction. Planted wire and tooth ache grass and hydric pine flatwood wildflowers (Restoration)
