**DOYLE CREEK/TATES HELL WETLANDS RESTORATION ANNUAL MONITORING REPORT
(2009)**

Franklin County

Monitoring date: October 30, 2009

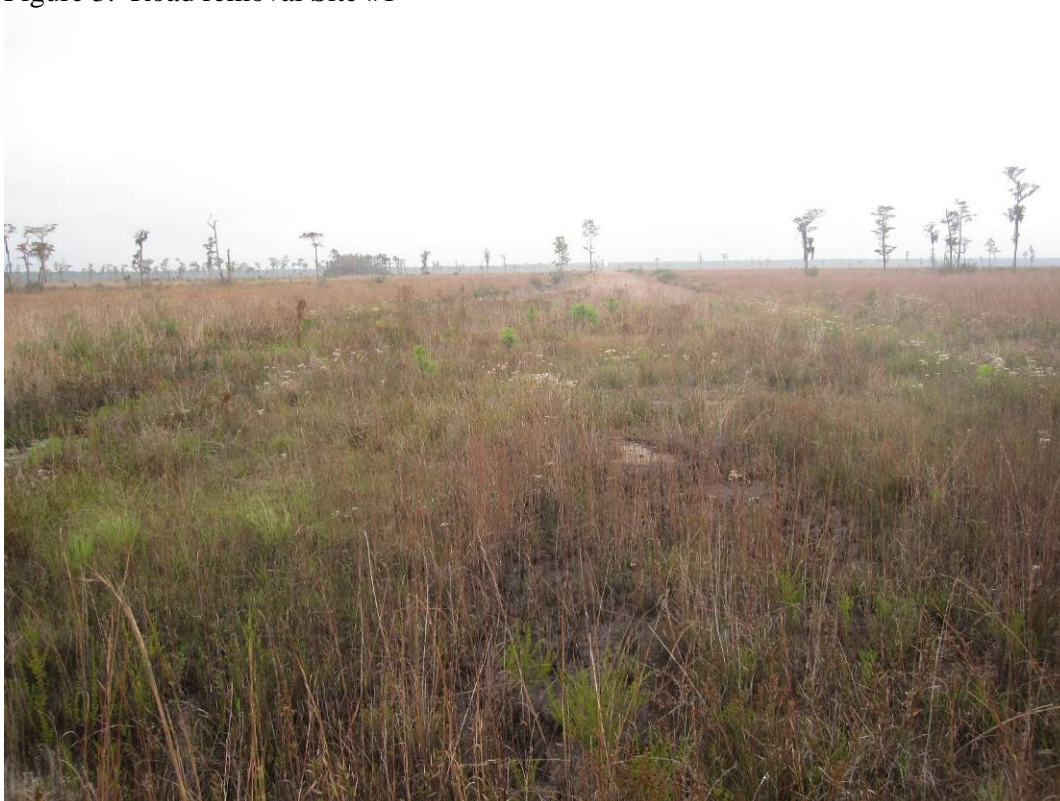
Figure 3. Road removal Site #1

Annual monitoring of the restoration site was carried out on 30 October 2009. Coverage of native groundcover ranges from 50-100%, with an average of 65-70% since project completion. The initial wiregrass plantings had poor survival (<25%), so it was replanted in Fall 2009. Cypress survival was high with greater than 80% of the planted individuals present and growing well. Less than 1% coverage of exotic species was noted throughout the site. The road bed sites were walked in their entirety noting species that were present. Number of plant species observed has increased from 51 in 2008 to 81 in 2009. Evidence of wildlife usage (e.g., tracks, scat) at the sites is provided at the end of the plant species observed table. Representative photos are appended to this report.

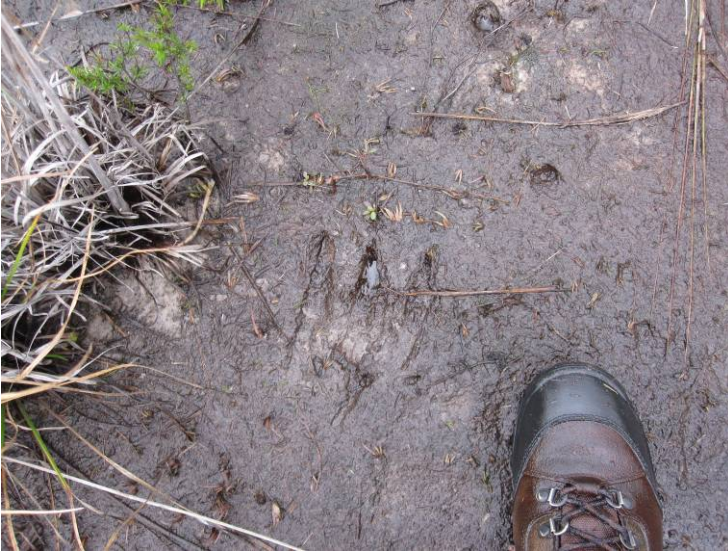
Figure 4. Gator track in road removal area #1.

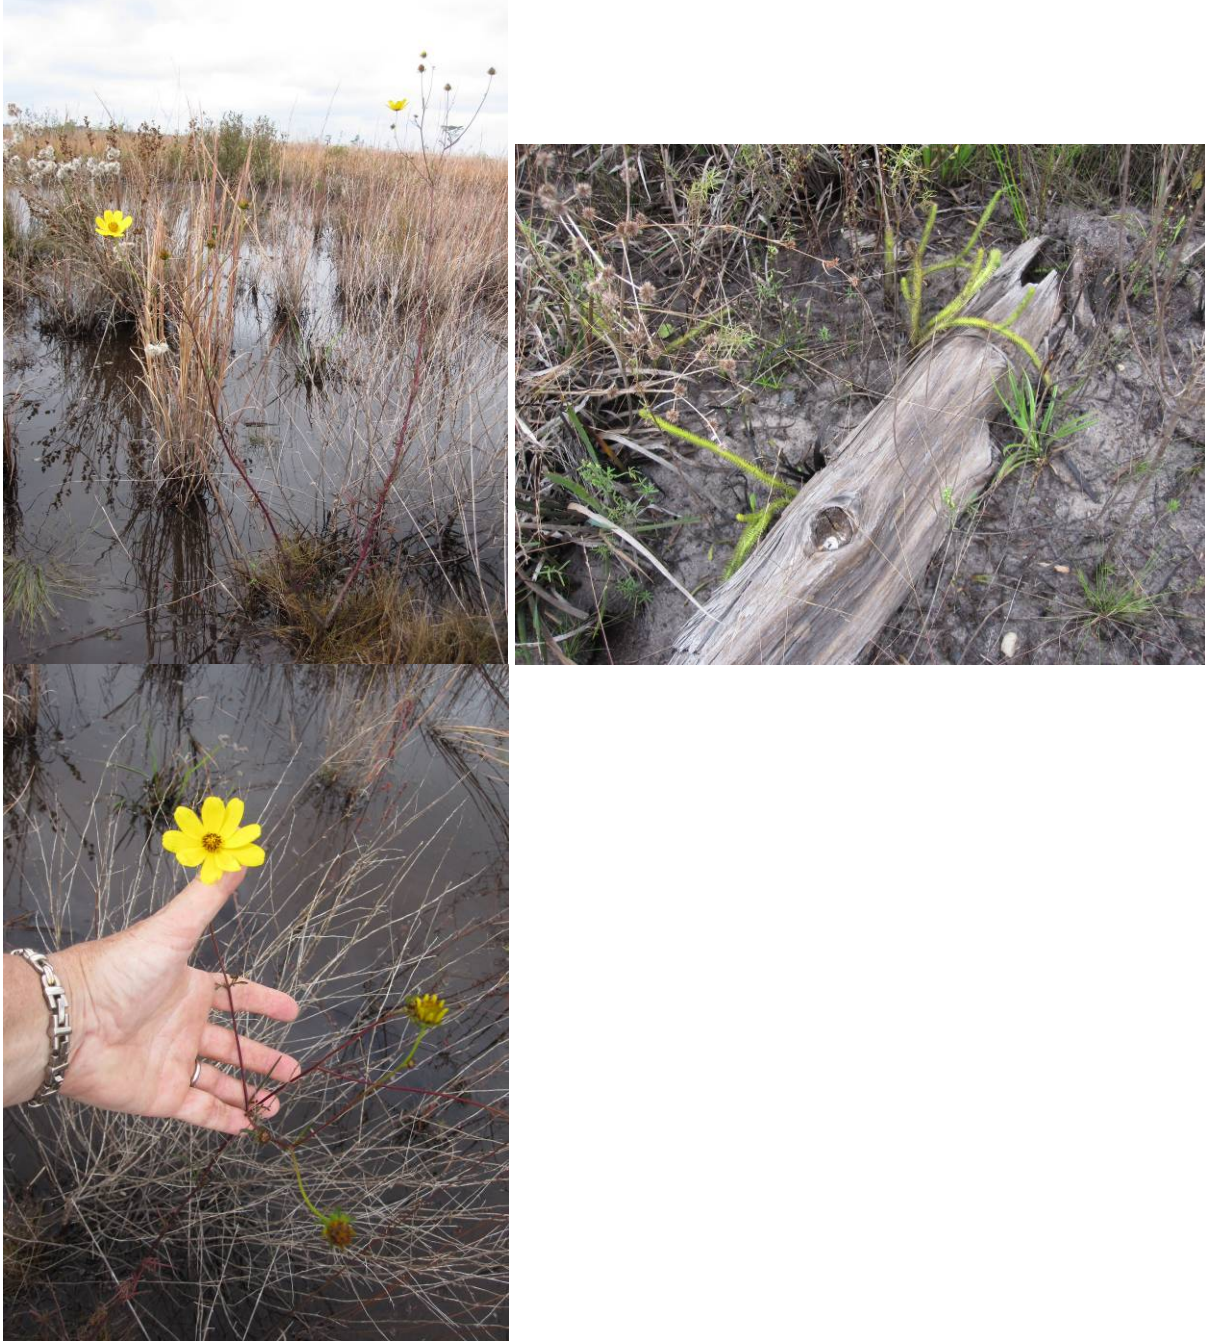
Figure 4. Road removal site #2, representative photos. Unfortunately the photos of the overall road aspect did not turn out, but the photo of site #1 is highly similar.
