TATE’S HELL - WOMACK CREEK MITIGATION SITE
Annual Monitoring Report, Year 4
January 12, 2012

PROJECT OVERVIEW

Mitigation: Tate’s Hell – Womack Creek, Liberty County

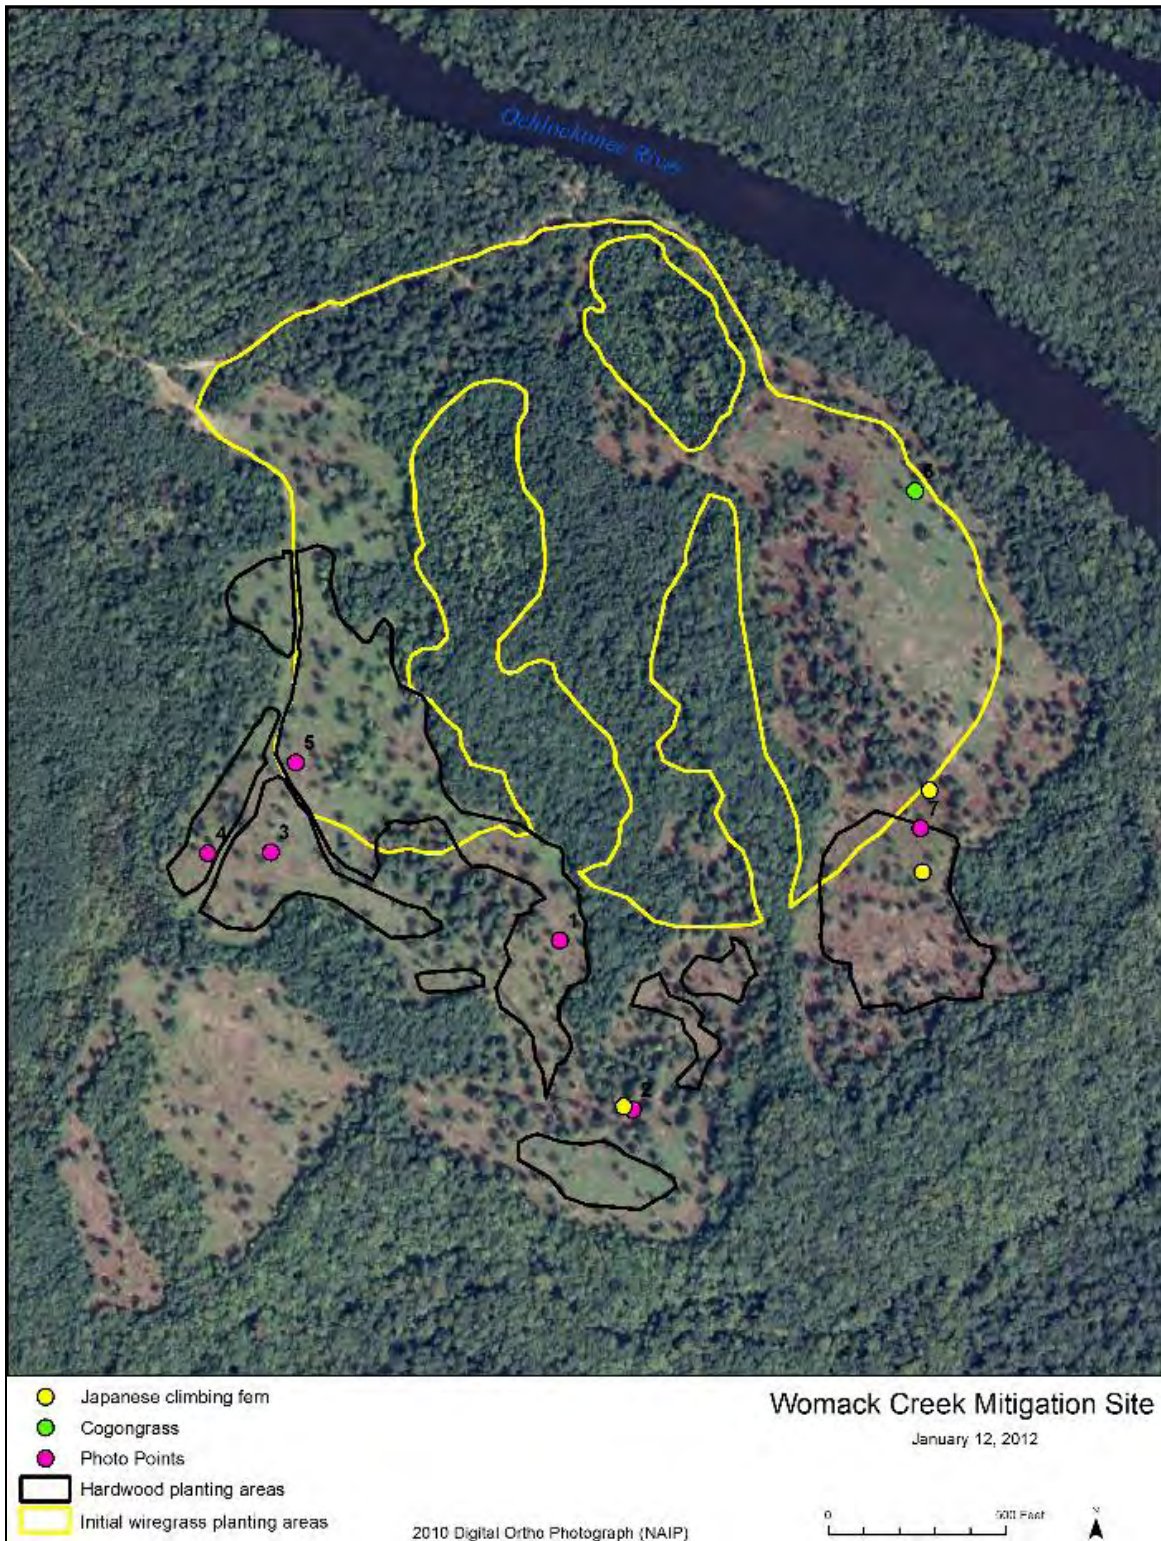
A new but partially overlapping area of 20 acres immediately south of the initial site was mapped for bottomland hardwood restoration ([Figures 3 and 4](#)). Planting of three tree species – swamp chesnut oak (*Quercus michauxii*), black gum (*Nyssa biflora*), and spruce pine (*Pinus glabra*) – was conducted on 16 December 2010. Bare-root seedlings were planted on 12 foot centers over 20 acres. Two thousand trees of each species (6,000 trees total) were planted, yielding a density of about 300 trees per acre.

One large patch of cogongrass ([Photo 6](#)) was found (see location in Figure 3). There were numerous occurrences of Japanese climbing fern yet none covered more than a very small area. Overall cover of nuisance exotic species was less than five percent. The cogongrass patch was noted in previous monitoring and was treated unsuccessfully in both 2010 and 2011; further treatment is necessary.

Numerous wildlife and wildlife signs were observed during the monitoring. A site that appeared to be frequented by black bear was found under a tree (east of photo point 3, Figure 3) where vegetation was matted down and there were several large scats.

Figure 3. 2010 aerial image of mitigation site with original and current project boundaries shown. Also indicated are locations of the new hardwood planting areas and recent photo points. [RTN](#)

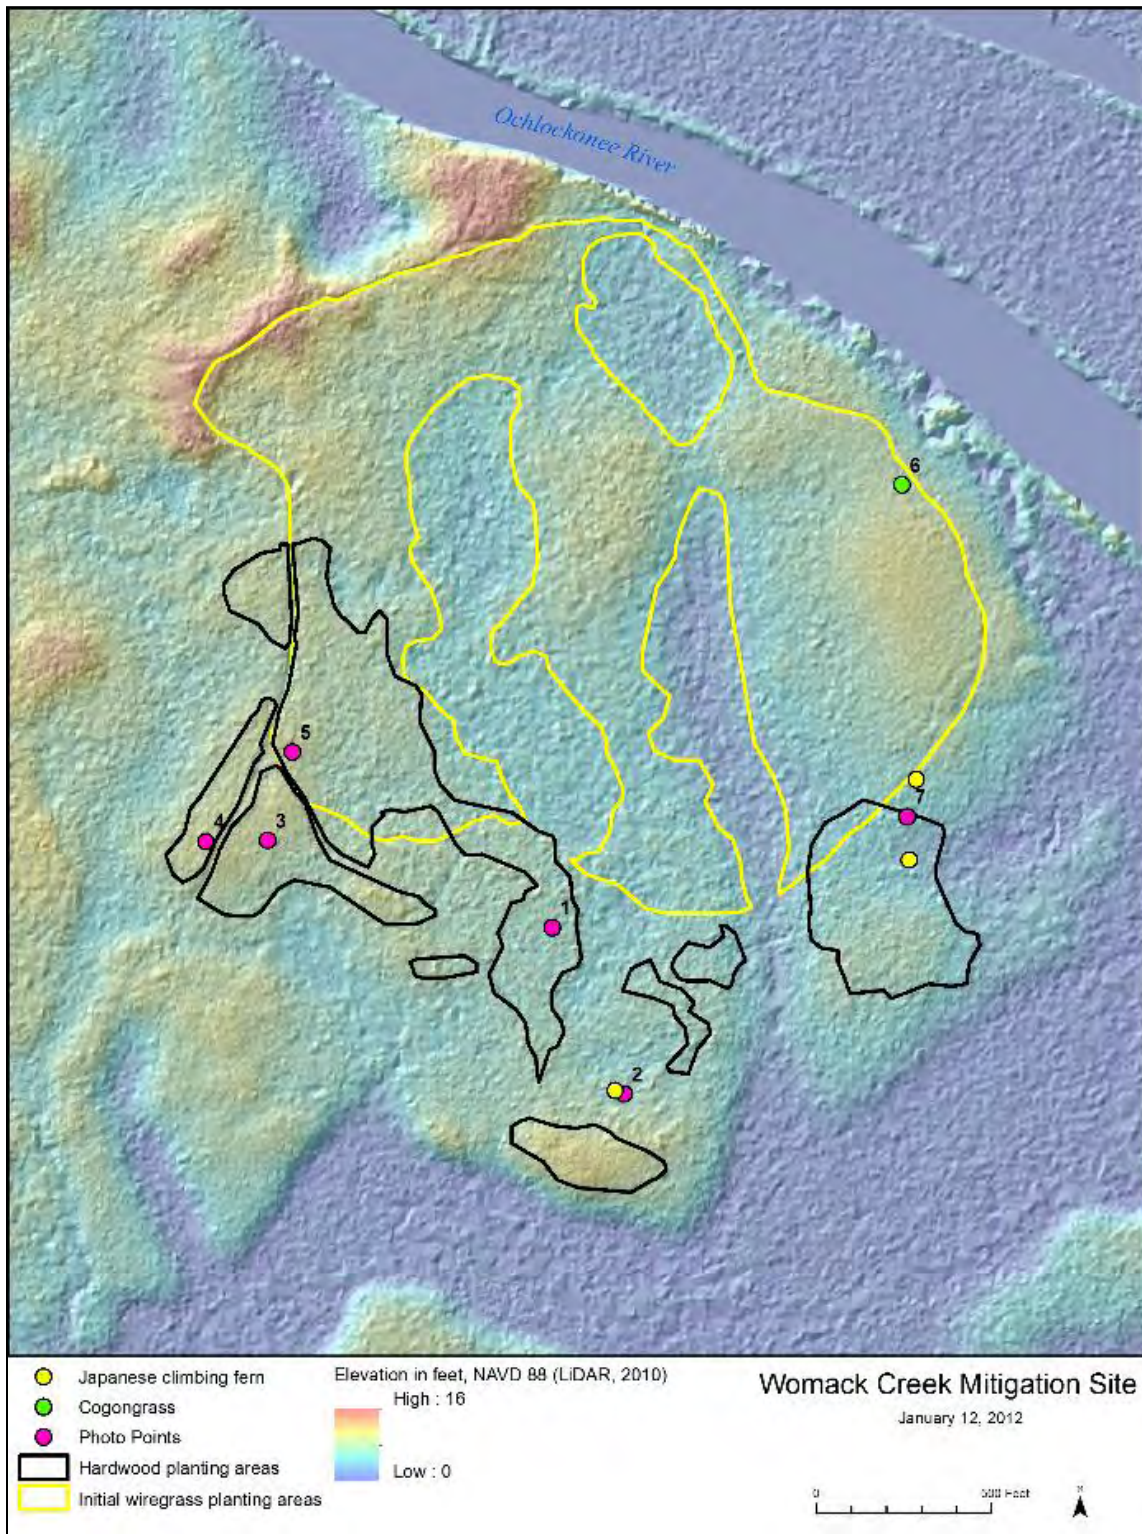
Figure 4. Topography of the mitigation site taken from LiDAR imagery (2006).

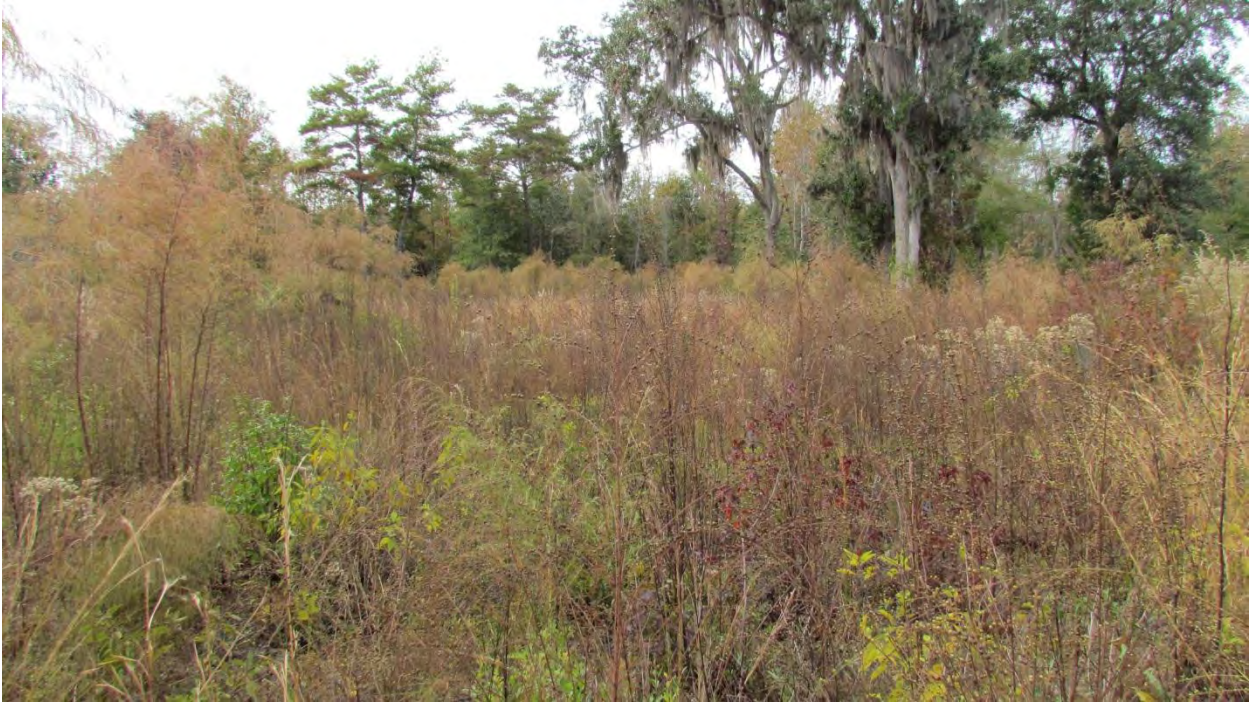
The mitigation area ground surface was dry on the day of this site visit due to extended drought conditions. The open areas that had previously been subject to mechanical shrub reduction and fire displayed diverse and dense native groundcover ([Photos 1-3](#)), with many plants in seed. Density of the herbs and shrubs was evidenced by difficulty walking, having to push down vegetation that was often thick and overhead. Several species were early successional and abundant including dog fennel (*Eupatorium capillifolium*), beautyberry (*Callicarpa americana*), and sweetgum (*Liquidambar styraciflua*). There were also more persistent wetland species such as netted chain fern (*Woodwardia areolata*), arrowwood (*Viburnum dentatum*), and numerous overcup oak (*Quercus lyrata*) saplings ([Photo 4](#)). Spruce pine saplings were also common; it could not be determined if they were planted or natural as there were many mature trees on site that could be parent trees. Red maple (*Acer rubrum*) saplings were common. Very few of the planted swamp chestnut oaks ([Photo 5](#)) were found and no planted black gums were observed.

Photo 1. Representative photograph of natural diversity amidst abundant dog fennel. Photo Point 4, looking southwest. 11/09/2011. [RTN](#)

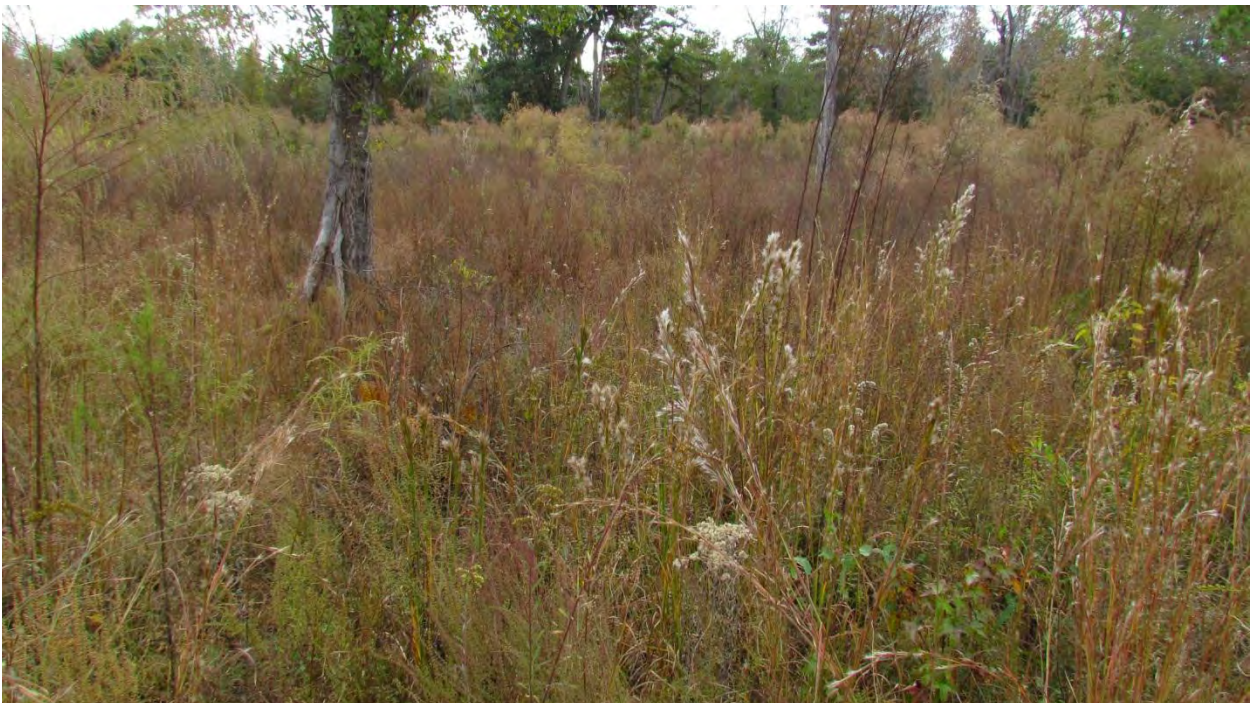
Photo 2. Representative photograph of natural diversity amidst abundant dog fennel. Photo point 5, looking northeast. 11/09/2011. [RTN](#)

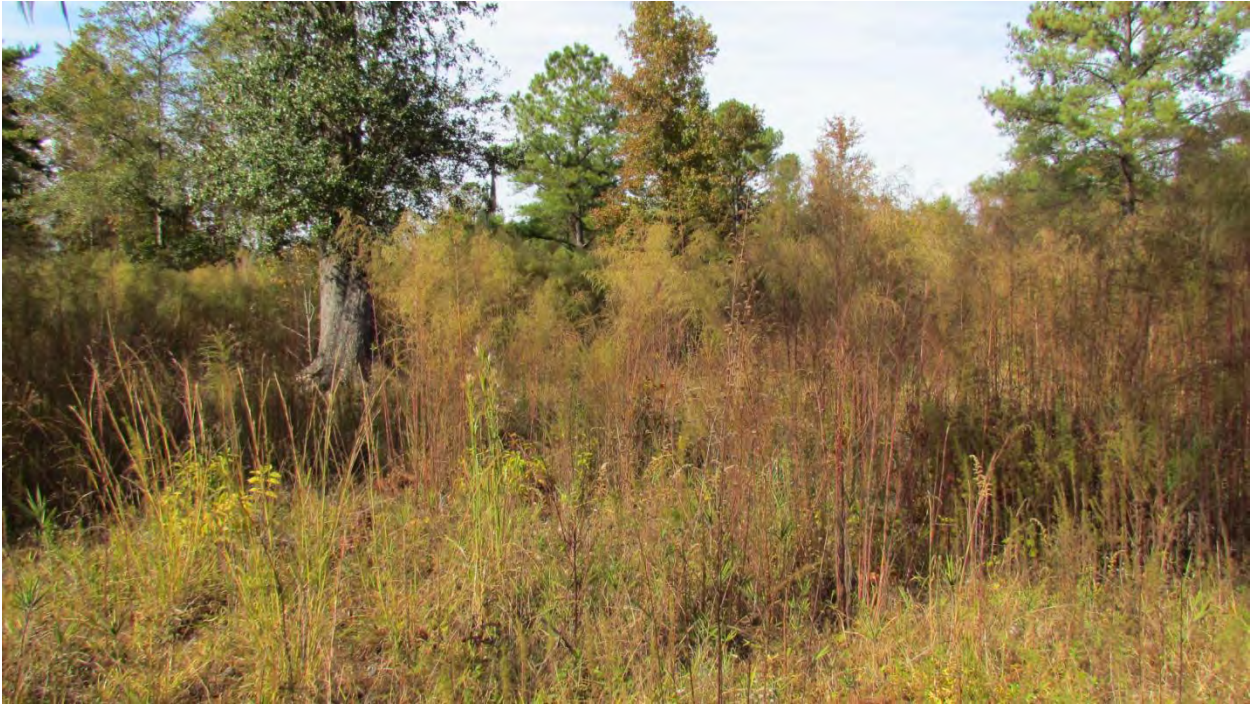
Photo 3. Representative photograph of natural diversity amidst abundant dog fennel. Photo point 5, looking northeast. 11/09/2011. [RTN](#)

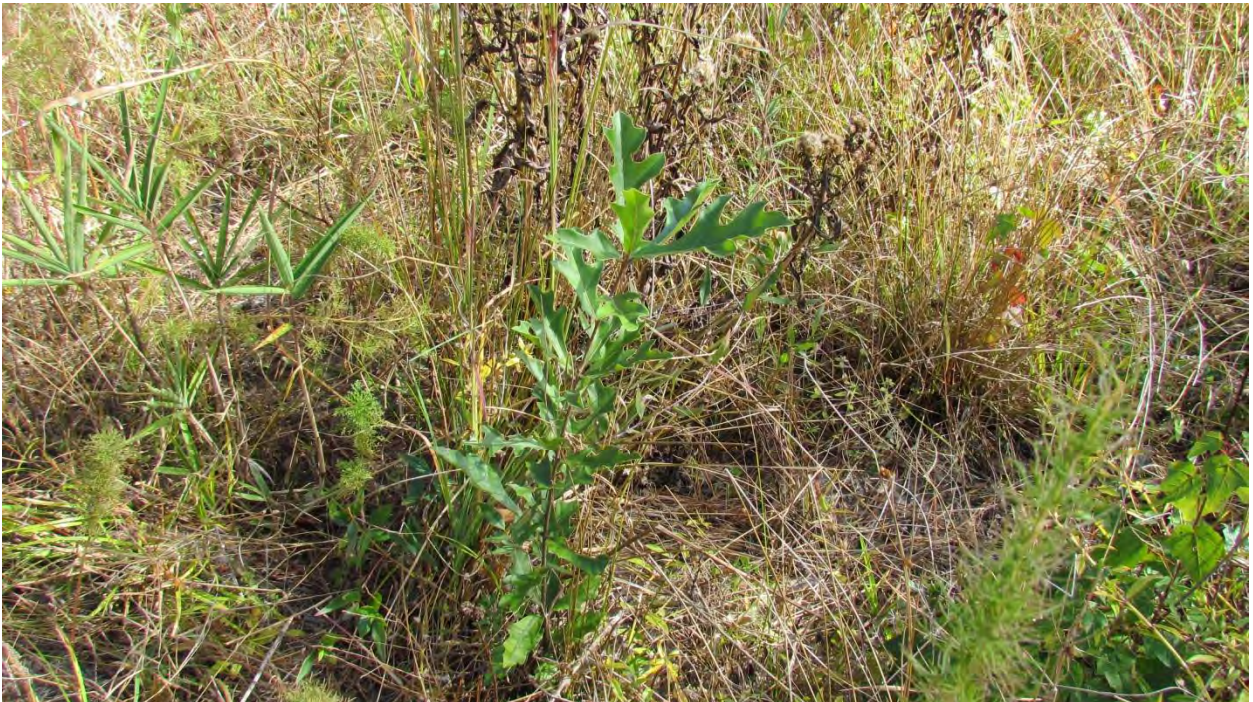
Photo 4. Overcup oak (*Quercus lyrata*) natural regeneration. 11/09/2011. [RTN](#)

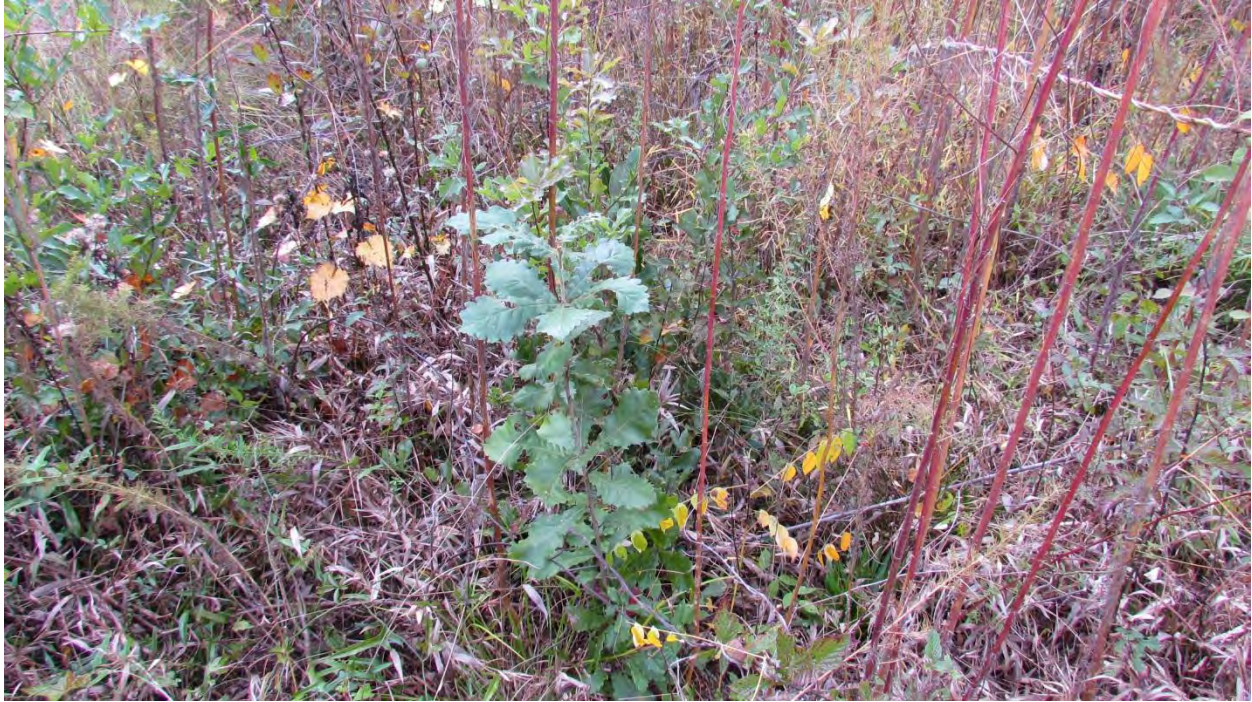
Photo 5. Swamp chestnut oak (*Quercus michauxii*) planted seedling. 11/09/2011.

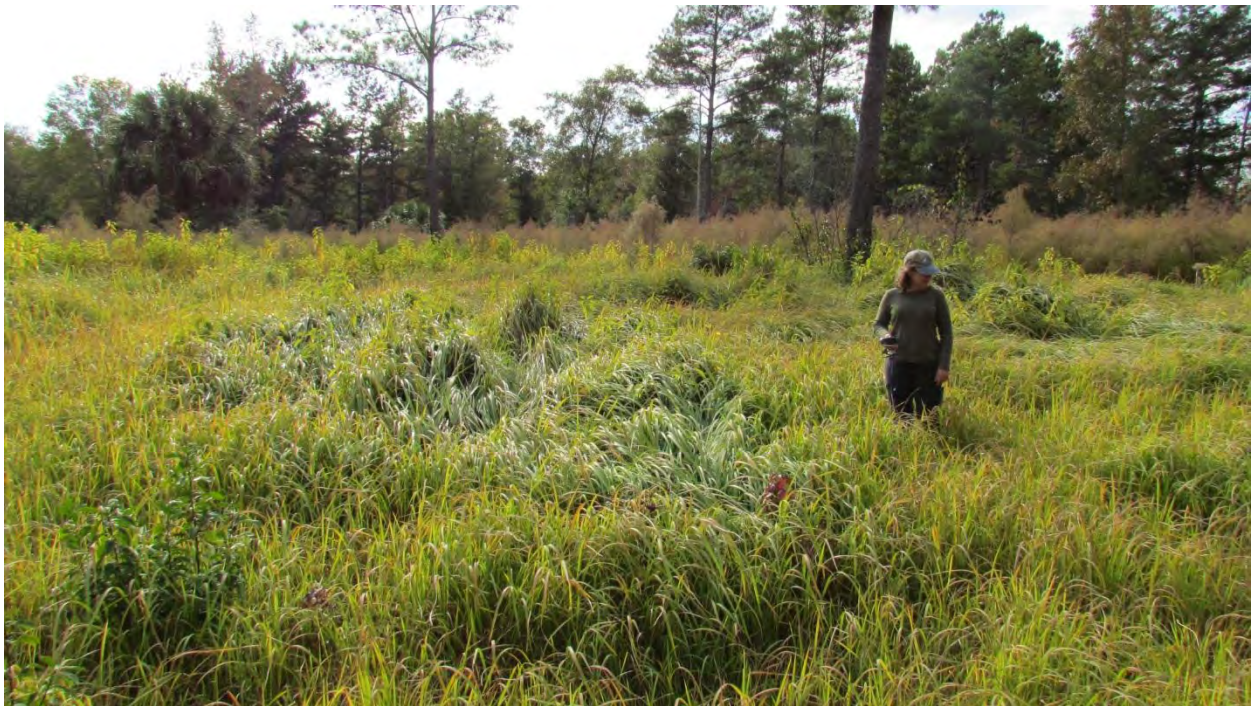
Photo 6. Cogongrass (*Imperata cylindrica*) patch on east side of site. Photo point 6. 11/09/2011.

- Herbicide treatment of cogongrass and climbing fern
- Continued annual site inspection with photo-documentation
- No replanting necessary at this time

Given the recent observations, there is a strong likelihood of progress toward project goals if tree species are allowed to regenerate and re-establish the closed canopy that is natural for a bottomland forest community. Further augmentation of hardwood species, despite the low survival of recent planting, is not warranted at this time but will be evaluated during future monitoring. It should be noted that fire is not a significant factor in the maintenance and development of a bottomland forest community. Continued spot treatments of cogongrass and Japanese climbing fern will prevent further infestation and displacement of native, desirable species.
