2012 Monitoring Report

DUTEX RESTORATION SITE

Escambia County, Florida

December 2012

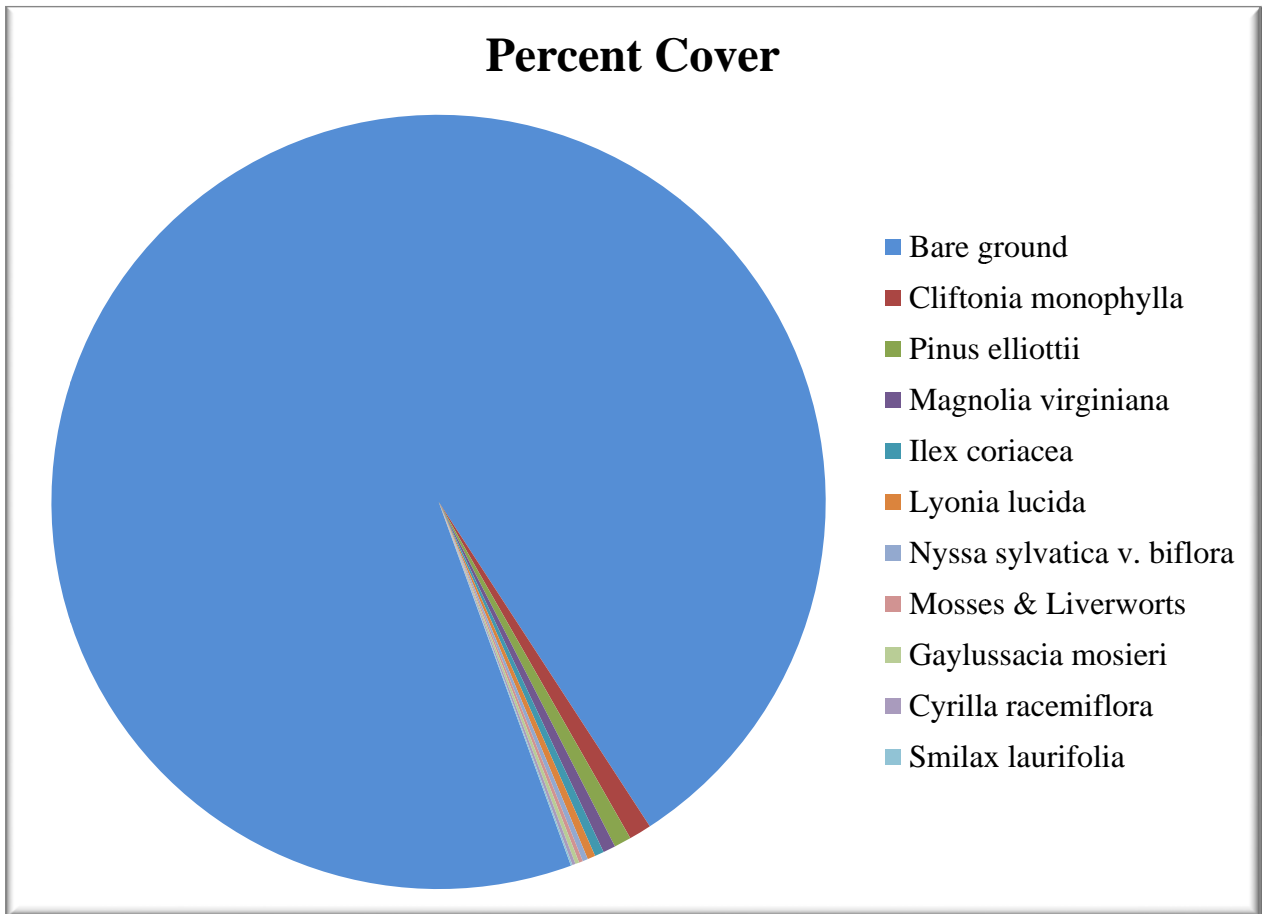
Transect DEQT1-626 Hydric Pine Savanna

Groundcover Vegetation Relative Cover (%)			Average Cover (%)	Species Richness
Bryophytes	Forbs	Woody Plants	Bare ground/ Standing water	
4%	2%	94%	96%	10
Shrub Height (meters)				0.5

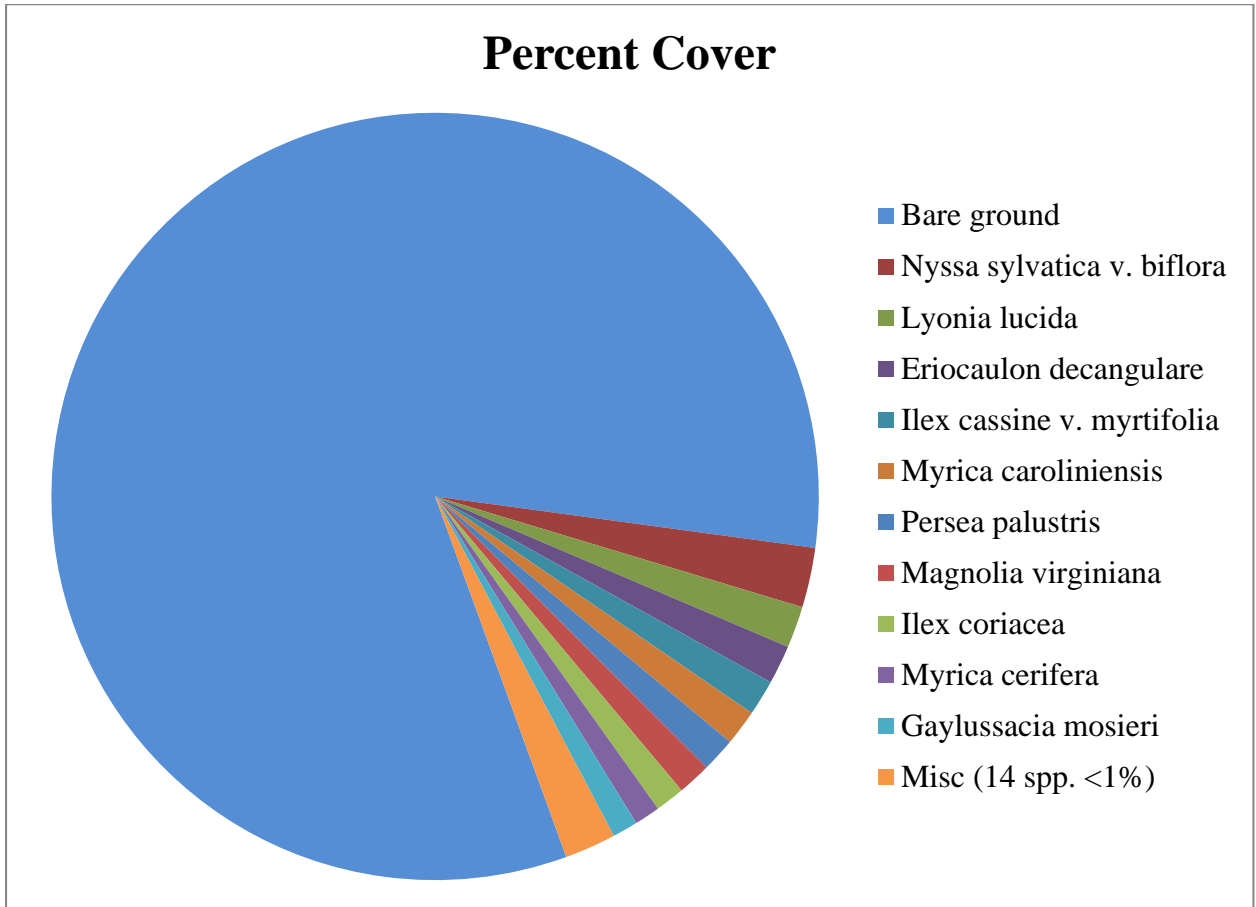
Transect DEQT2-625 Hydric Pine Flatwoods

Groundcover Vegetation Relative Cover (%)					Average Cover (%)	Species Richness
Bryophytes	Forbs	Graminoids	Vines	Woody Plants	Bare ground/ Standing water	
4%	12%	1%	4%	79%	83%	25
Shrub Height (meters)						1.5

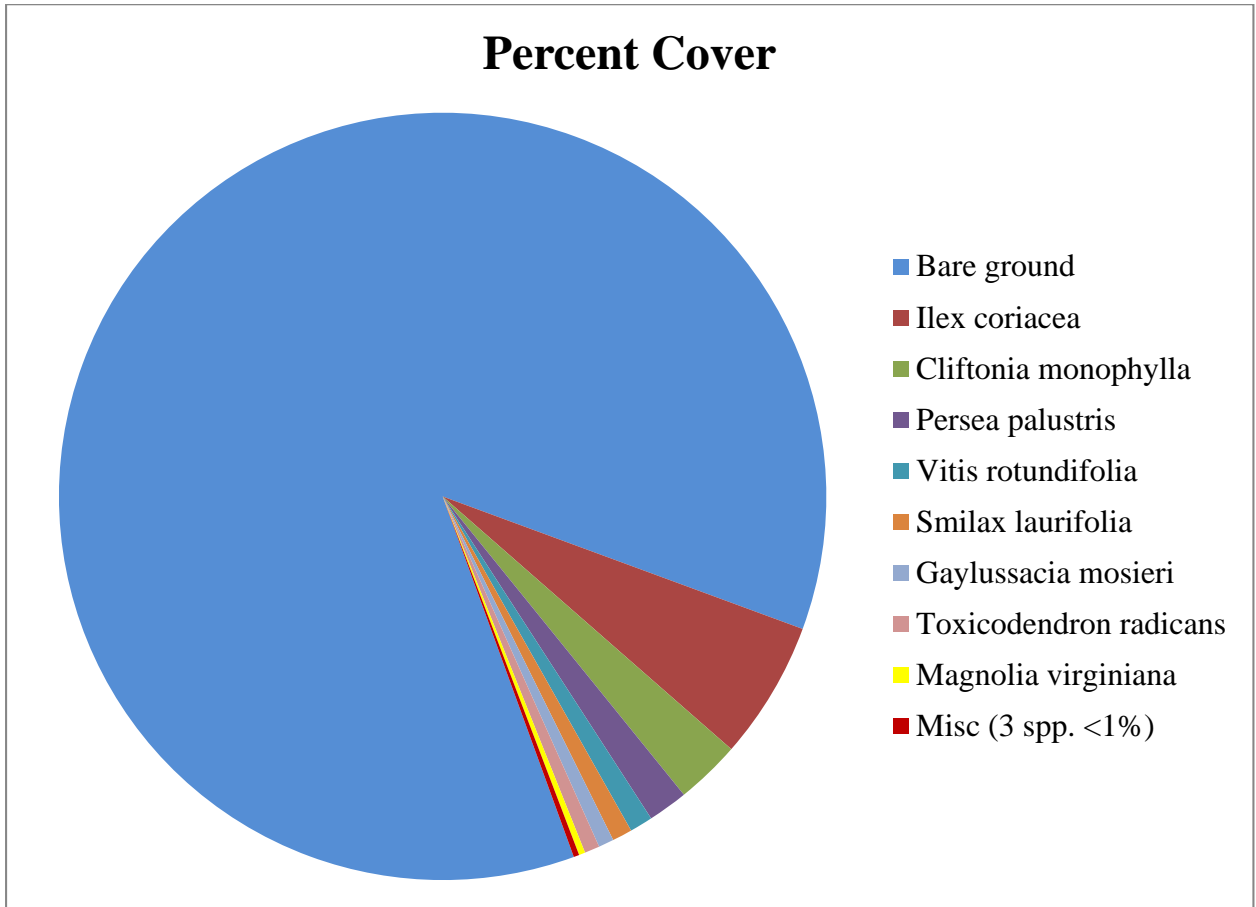
Transect DEQT3-625 Hydric Pine Flatwoods

Groundcover Vegetation Relative Cover (%)			Average Cover (%)	Species Richness
Forbs	Vines	Woody Plants	Bare ground/ Standing water	
0.7%	17.7%	81.6%	86%	11
Shrub Height (meters)				2.0

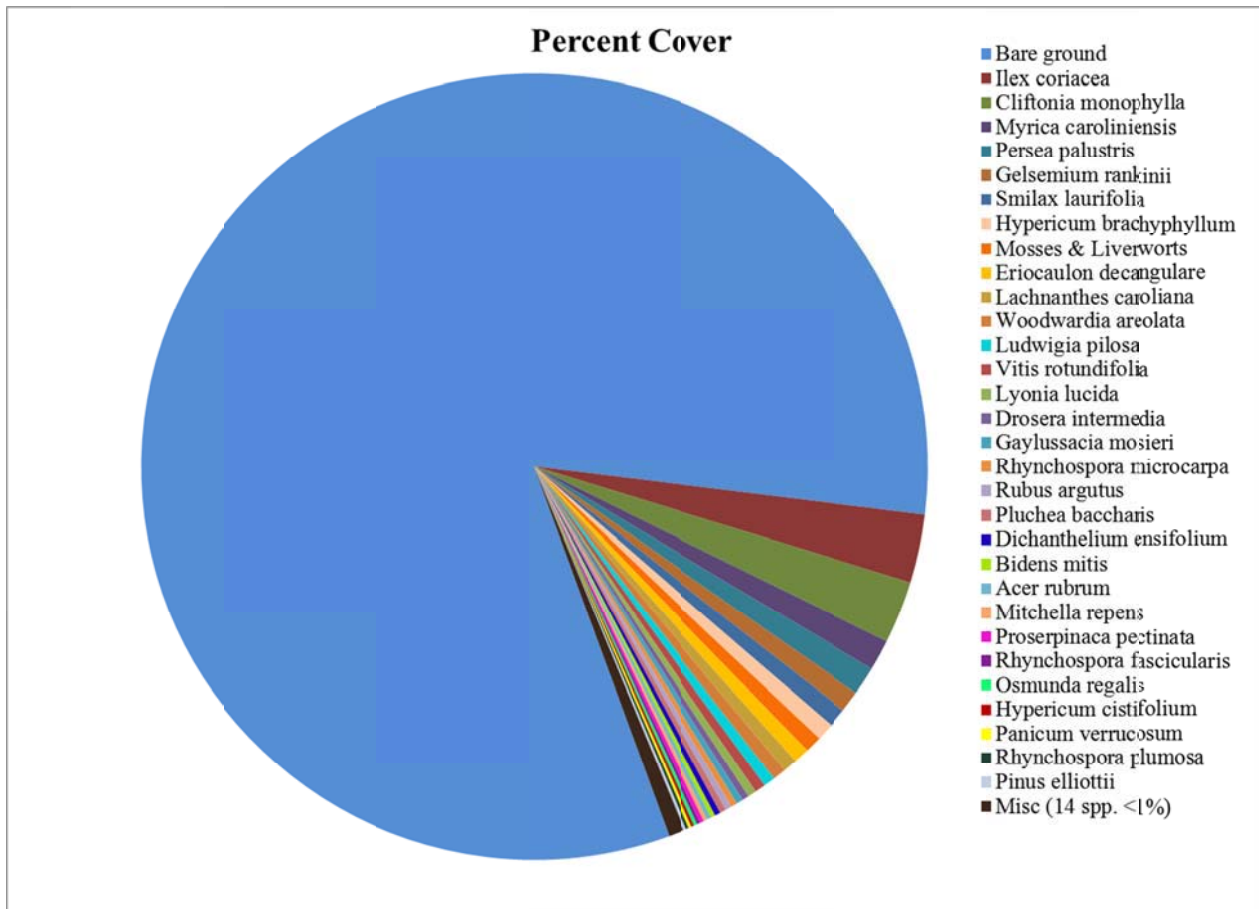
Transect DEQT4-626 Hydric Pine Savanna

Groundcover Vegetation Relative Cover (%)					Average Cover (%)	Species Richness
Bryophytes	Forbs	Graminoids	Vines	Woody Plants	Bare ground/ Standing water	
4%	27%	6%	12%	51%	82%	44
Shrub Height (meters)						1.75

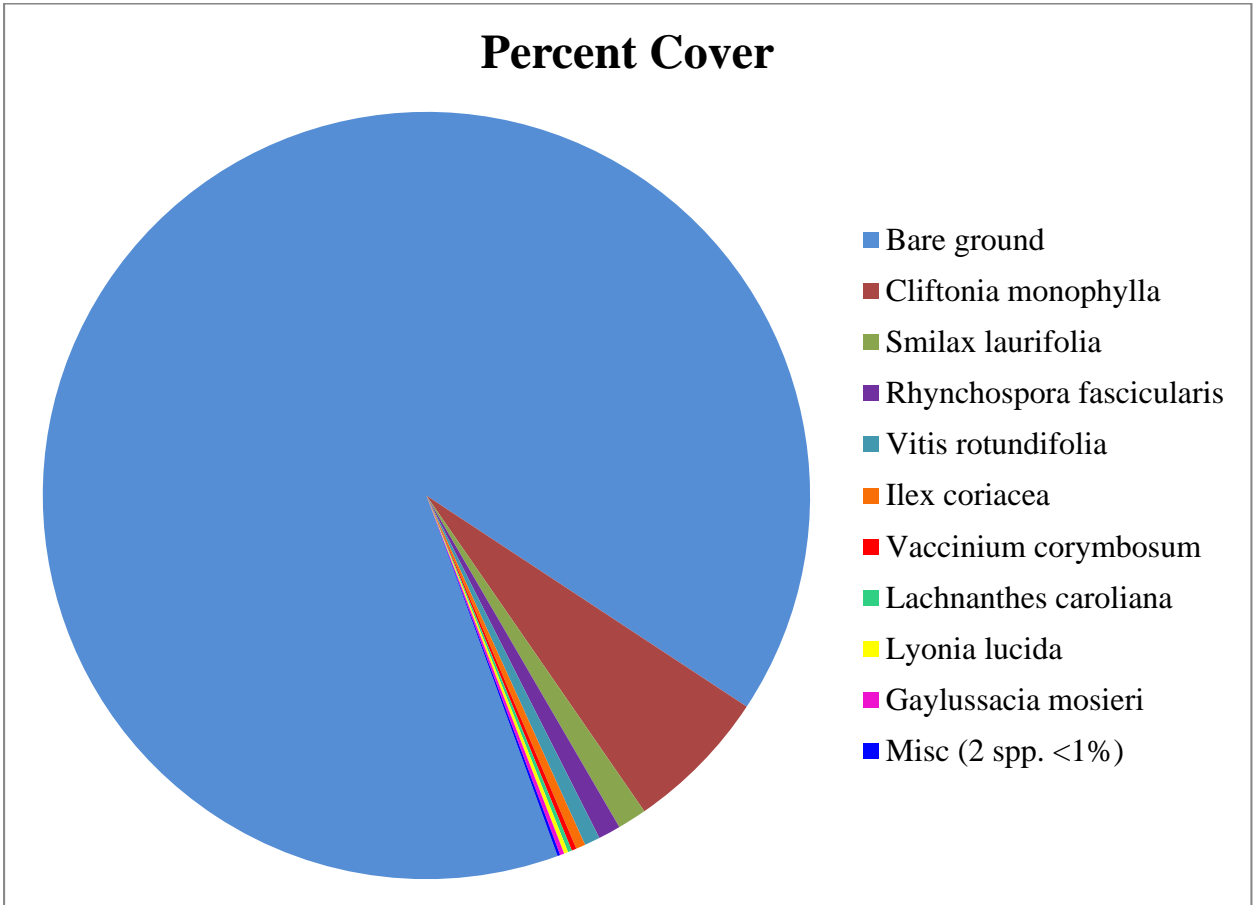
Transect DWQT1-625 Hydric Pine Flatwoods

Groundcover Vegetation Relative Cover (%)				Average Cover (%)	Species Richness
Forbs	Graminoids	Vines	Woody Plants	Bare ground/ Standing water	
2%	9%	19%	70%	90%	11
Shrub Height (meters)					0.5

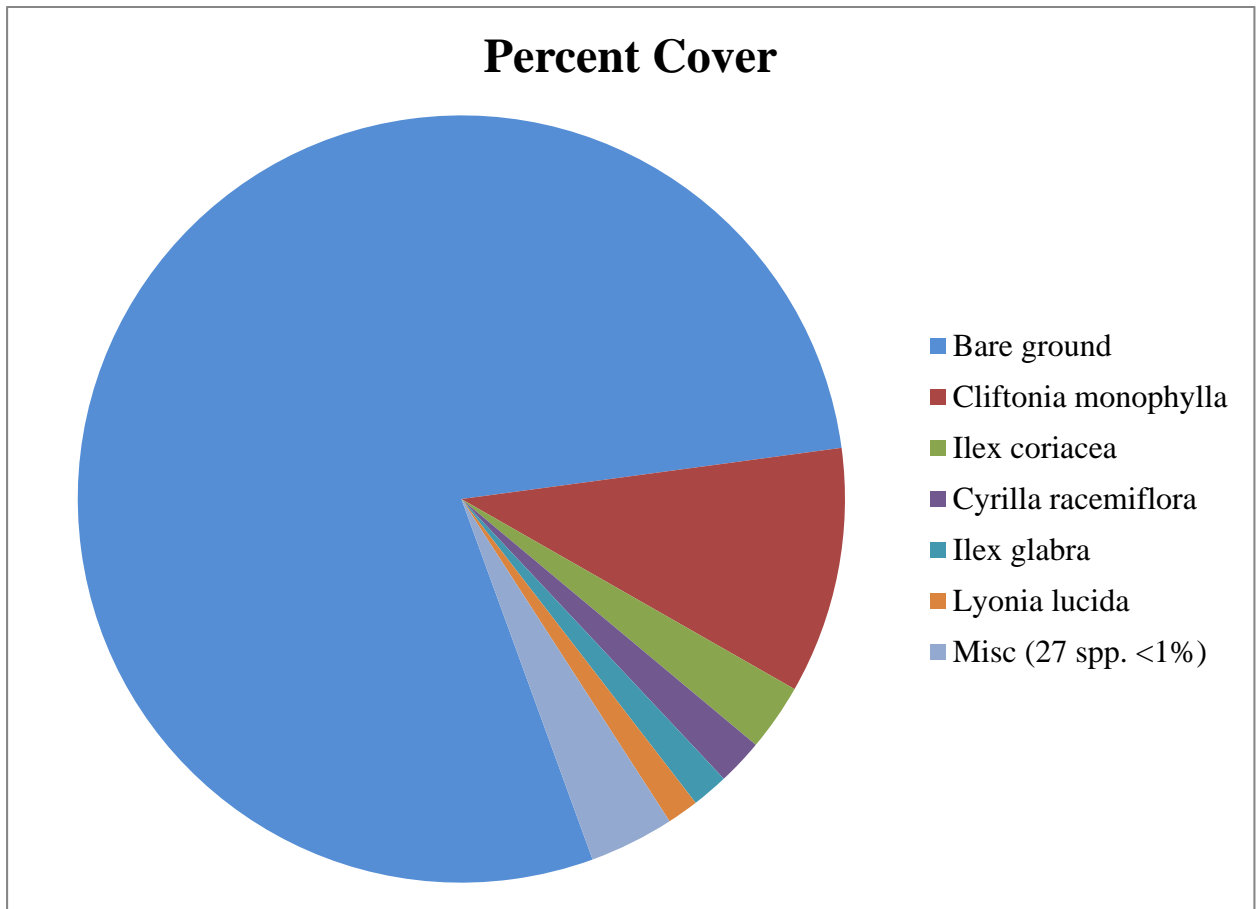
Transect DWQT2-626 Hydric Pine Savanna

Groundcover Vegetation Relative Cover (%)					Average Cover (%)	Species Richness
Bryophytes	Forbs	Graminoids	Vines	Woody Plants	Bare ground/ Standing water	
3%	3%	4%	0.6%	90%	78%	32
Shrub Height (meters)						1.0

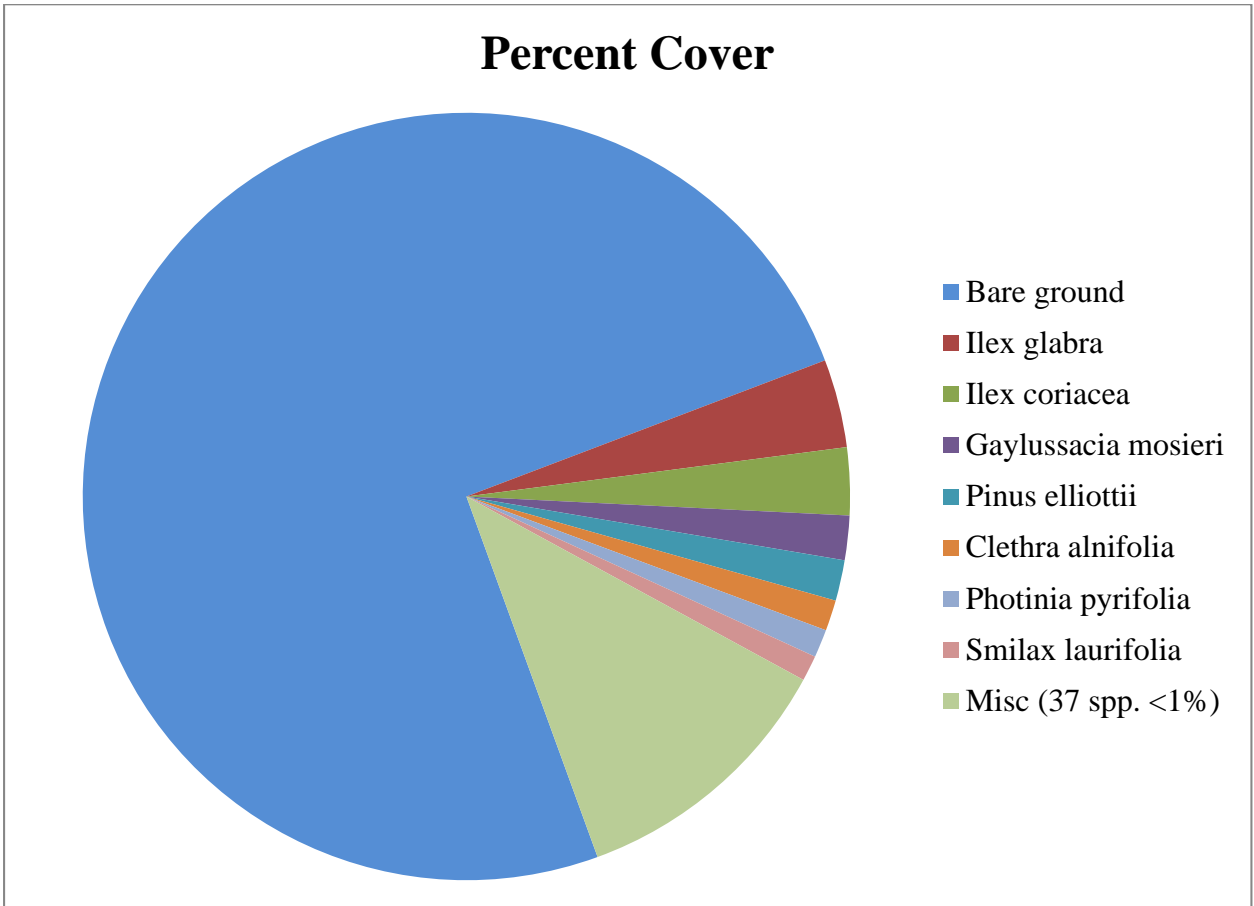
Transect DWQT3-626 Hydric Pine Savanna

Groundcover Vegetation Relative Cover (%)				Average Cover (%)	Species Richness
Forbs	Graminoids	Vines	Woody Plants	Bare ground/ Standing water	
4%	18.5%	4%	73.5%	72.5%	44
Shrub Height (meters)					0.5

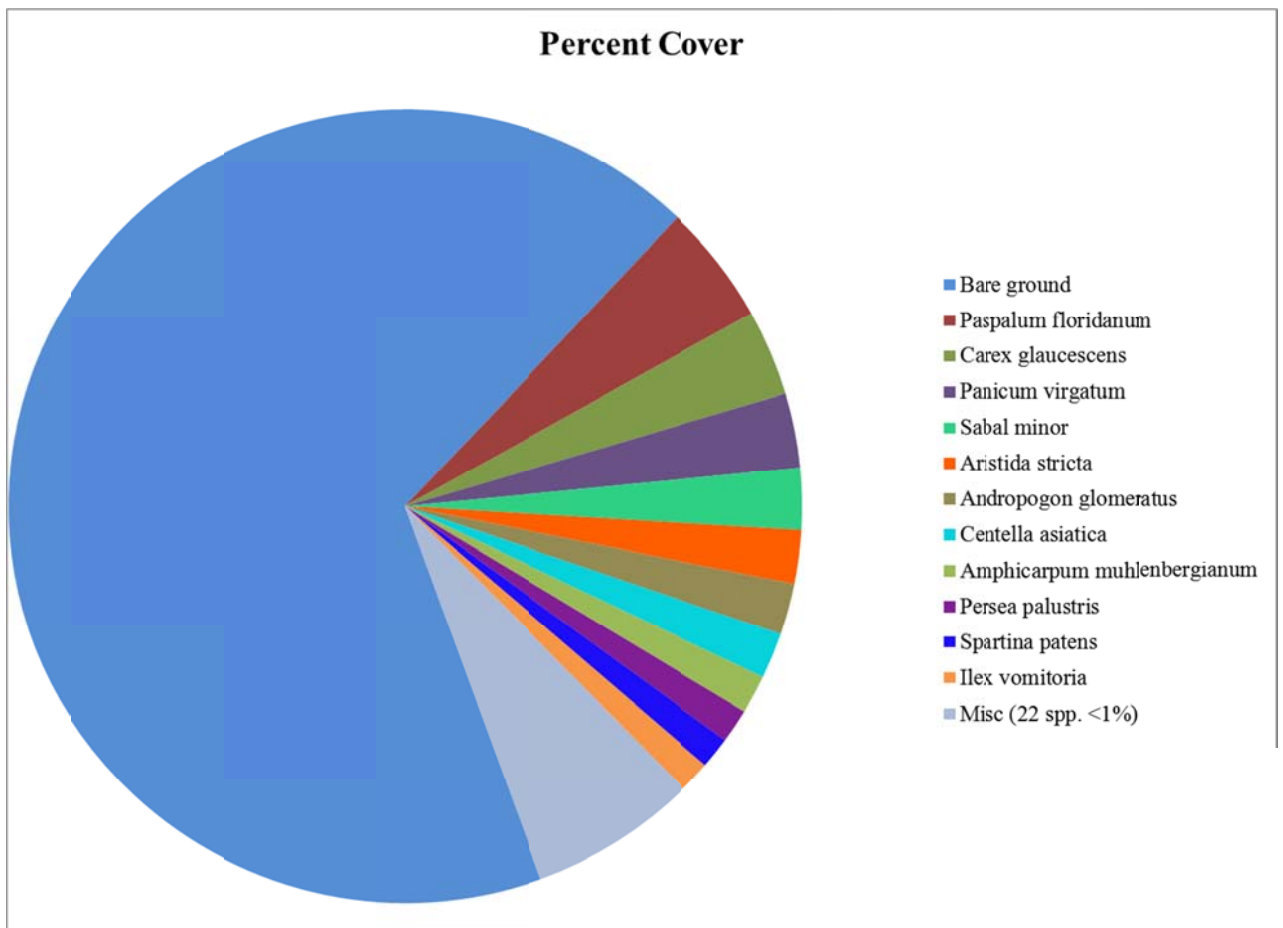
Transect DWQT4-625 Hydric Pine Flatwoods

Groundcover Vegetation Relative Cover (%)				Average Cover (%)	Species Richness
Forbs	Graminoids	Vines	Woody Plants	Bare ground/ Standing water	
18%	66%	2.6%	13.5%	67.5%	36
Shrub Height (meters)					1.0
