Sand Hill Lakes Mitigation Bank  
Third Annual Report  
December 2008

## **Executive Summary**

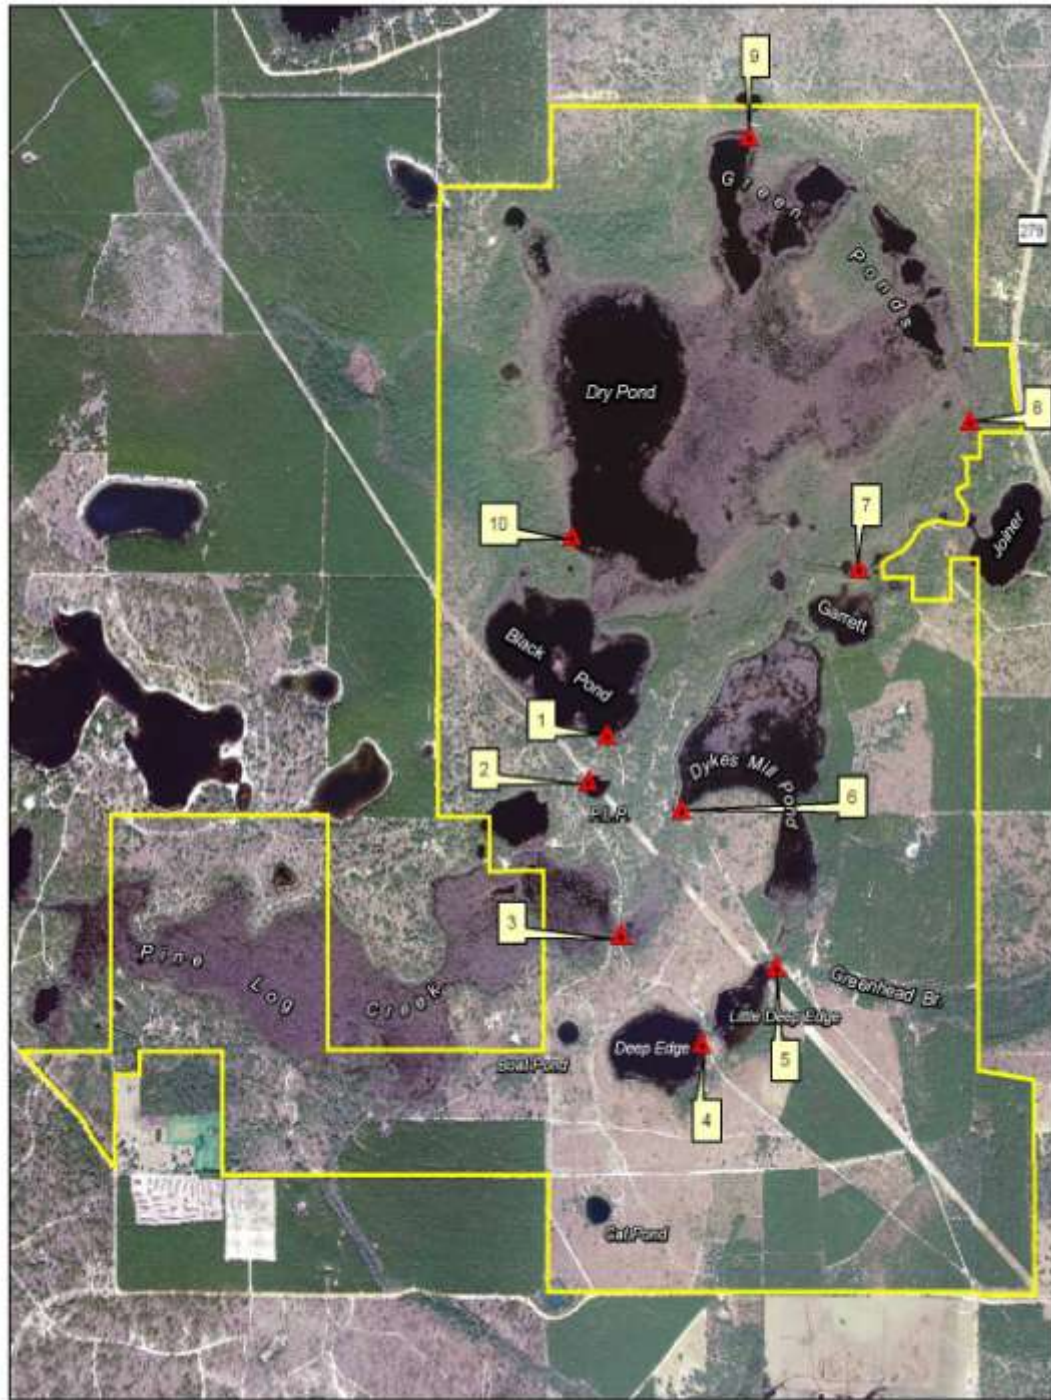
Figure 9 - Water Level Staff Gage Locations

▲ = Staff Gage (Installed 2005)

Water levels gauges were installed and surveyed in on December of 2005 for 10 locations throughout the bank. These locations include Black Pond, Power Line Pond, Pine Log Creek, Deep Edge Pond, Little Deep Edge Pond, Dykes Mill Pond, Ditch connecting to Pine Log Creek #7, natural channel from Joiner Lake to the Green Pond, Green Ponds, and Dry Lake (Table 2, Figure 9). The gauges were read monthly by the

Florida Wildlife Conservation Commission staff and the results submitted to the NFWFMD (Table 2, Figure 9). In 2006, the water levels were above the gages until April, then from May to December then water levels were below the staff gages for all but Little Deep Edge and Dykes Mill Pond. The drought continued in 2007 and 2008. Water levels were below the staff gages for most of the year for all locations except Little Deep Edge Pond and Dykes Mill Pond, and Dry Pond.

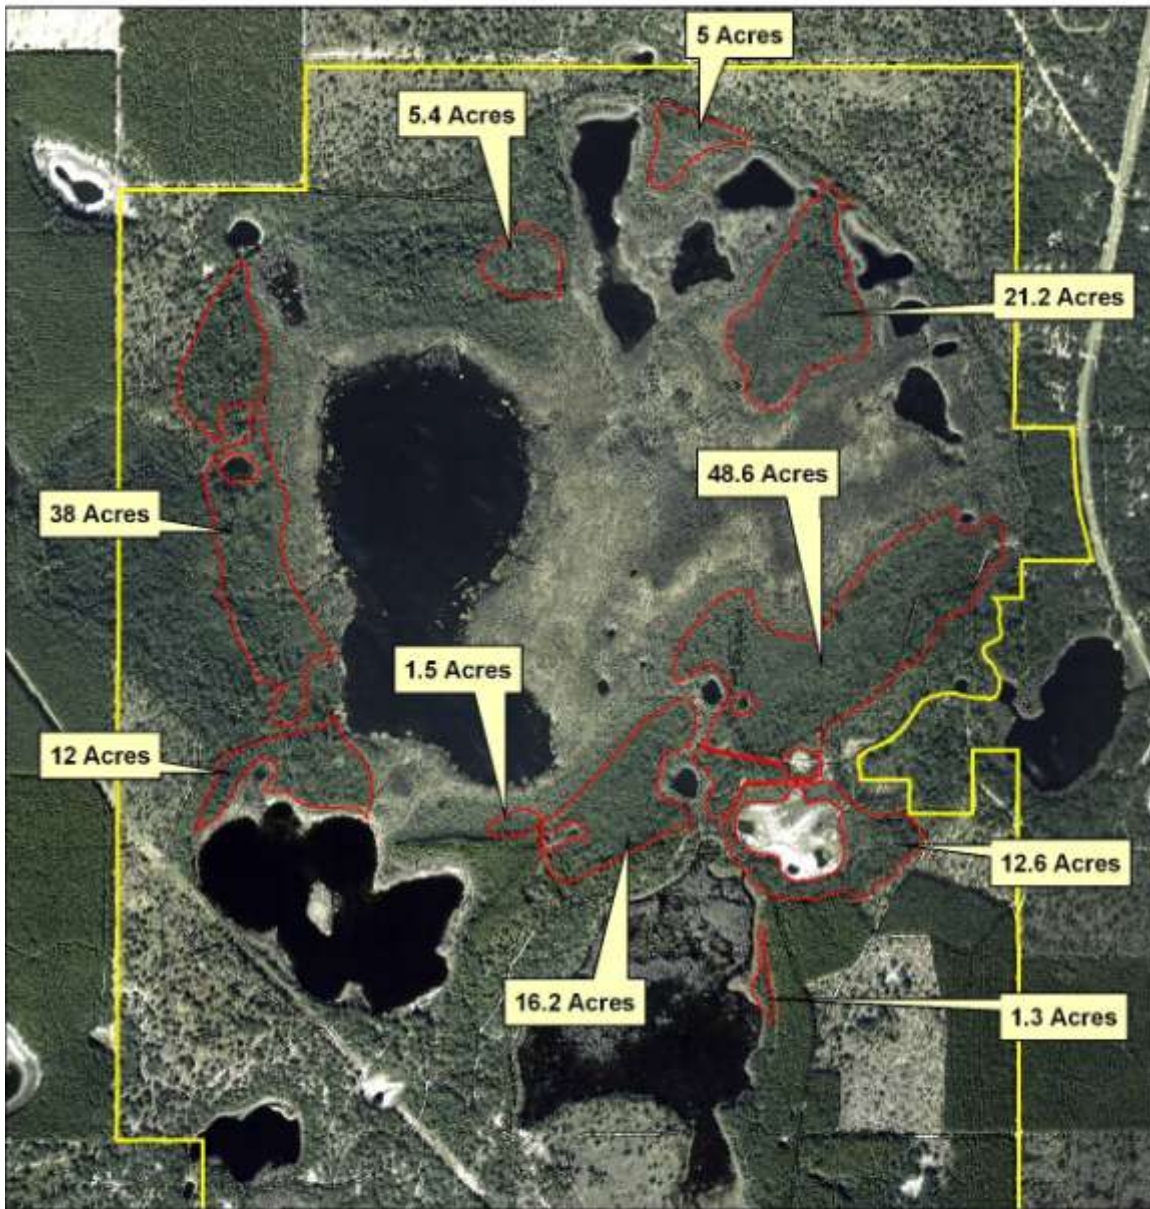
Figure 12. Pine Flatwood Restoration Areas  
**Brush Reduction**

According to the permit requirements, 147 acres of wet flatwood restoration was to occur at the SHLMB., Management Unit 2. However, District staff identified and additional 18 acres that historically was wet flatwoods and added this acreage to Management Unit two for a total acreage of 165 acres of wet , flatwoods restoration (Figure 12). Standing biomass of shrubs (primarily titi, gallberry and fetterbush) has been reduced to ground level with the use of a Gyro-Trac followed by winter burns. The gyrotack work was initiated on March 13 and was completed by August 20, 2007. The black titi in these areas was extremely thick often with a dbh of 8-10" and 20 – 25' tall. Even with the large "tree" size black titi, the gyrotrack was excellent in reducing the thick dense shrub cover to ground level. There were no noticeable track marks or ruts left by the Gyro-Trac. The mulch within these areas was allowed to dry for several months prior to burning. Sites were burned in December of 2007.

By March 2008, it was apparent, that while the shrub cover was greatly reduced, re-sprouting of the shrubs had occurred in all Gyro-Trac areas. Average shrub densities were determined through randomly established transects and stems per meter squared were determined. In areas with a hot fire 50-80 stems per meter squared were observed while in areas with an incomplete burn, 100 to 135 stems per meter squared were common. Based on these observations, the shrub wetlands would return if the number of shrubs were not significantly reduced. In an effort to determine if selected herbicides could aid in reducing shrubs numbers to an acceptable level, two polygons, the Whale, a 12 acre polygon adjacent to the Dry Pond parking, and a 16.2 acre polygon adjacent to Dry Pond and the slash pine restoration sites were chosen. These two areas were treated twice by Entrix with appropriate wetland approved herbicides, once in July and again in September. The 16.2 acre polygon was burned in the winter of 2008-2009 with a very hot fire. The 16.2 acre polygon was planted with wire grass plugs while the whale, had previously been direct seeded with wire grass seed. Preliminary results indicate that the shrub cover was greatly reduced from greater than 85% cover to less than 15% cover. Due to the success in the test treatments, similar treatments will be expanded to 84 acres in 2009.

Northwest Florida Water Management District  
Sand Hill Lakes Mitigation Bank (SHLMB)  
Brush Reduction (Gyro-Track Mulching) - ~165 Acres  
Section 6, Township 1 North, Range 14 West  
Washington Co., Florida

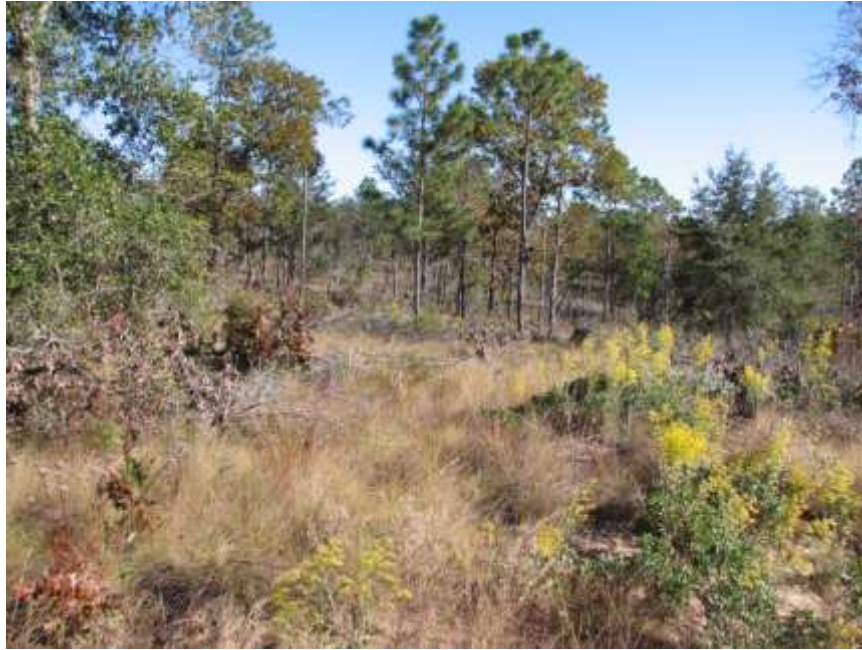
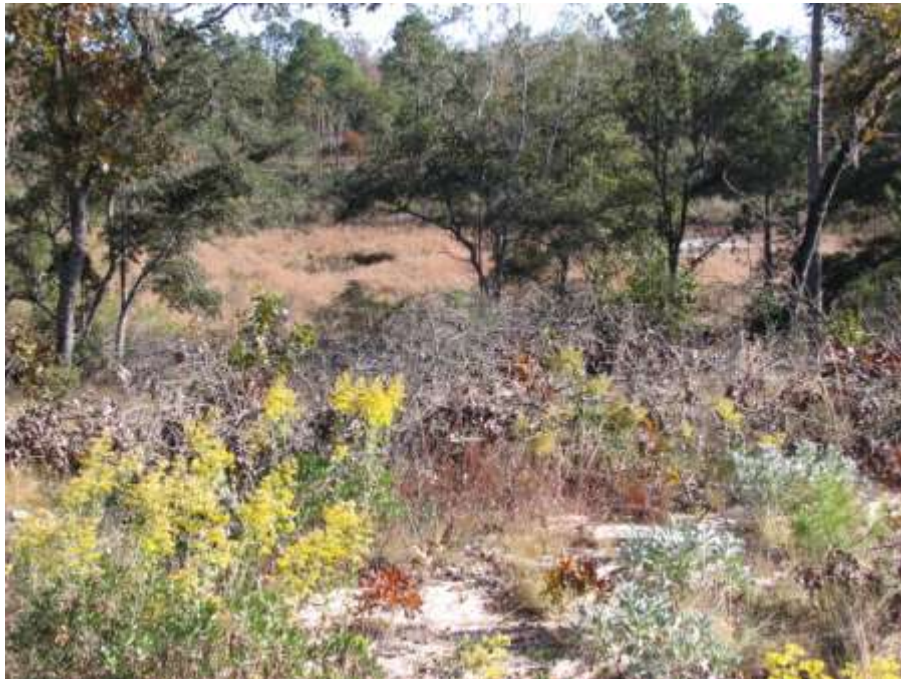
Pedestrian Transect: Upland Sand Hill with oak eradication: Note: Gulf Coast Lupine in upper left photo

Marsh showing in background and gulf coast lupine (threatened) in foreground

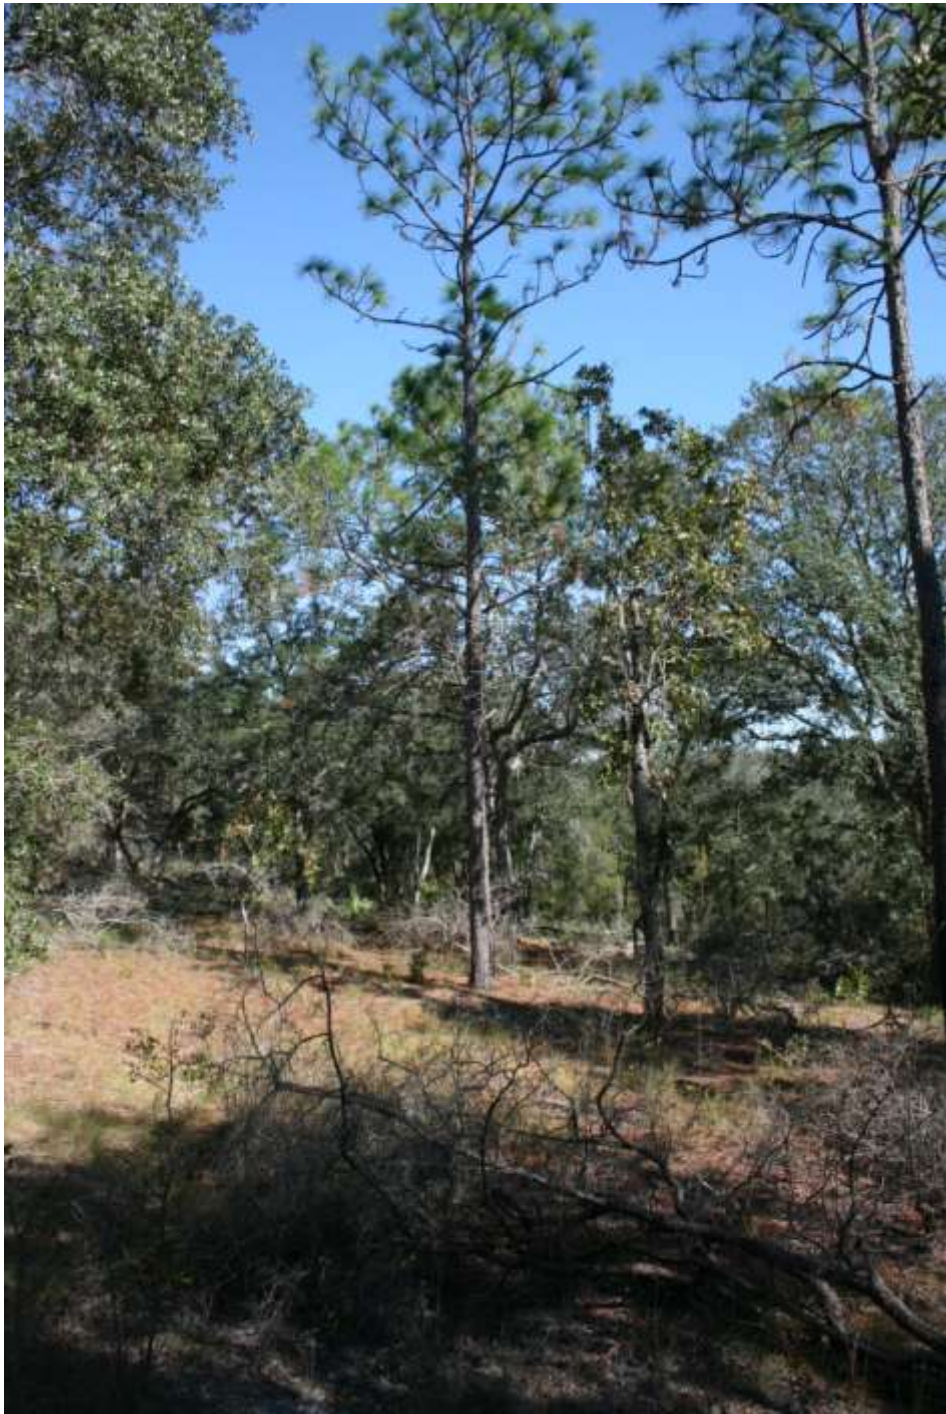
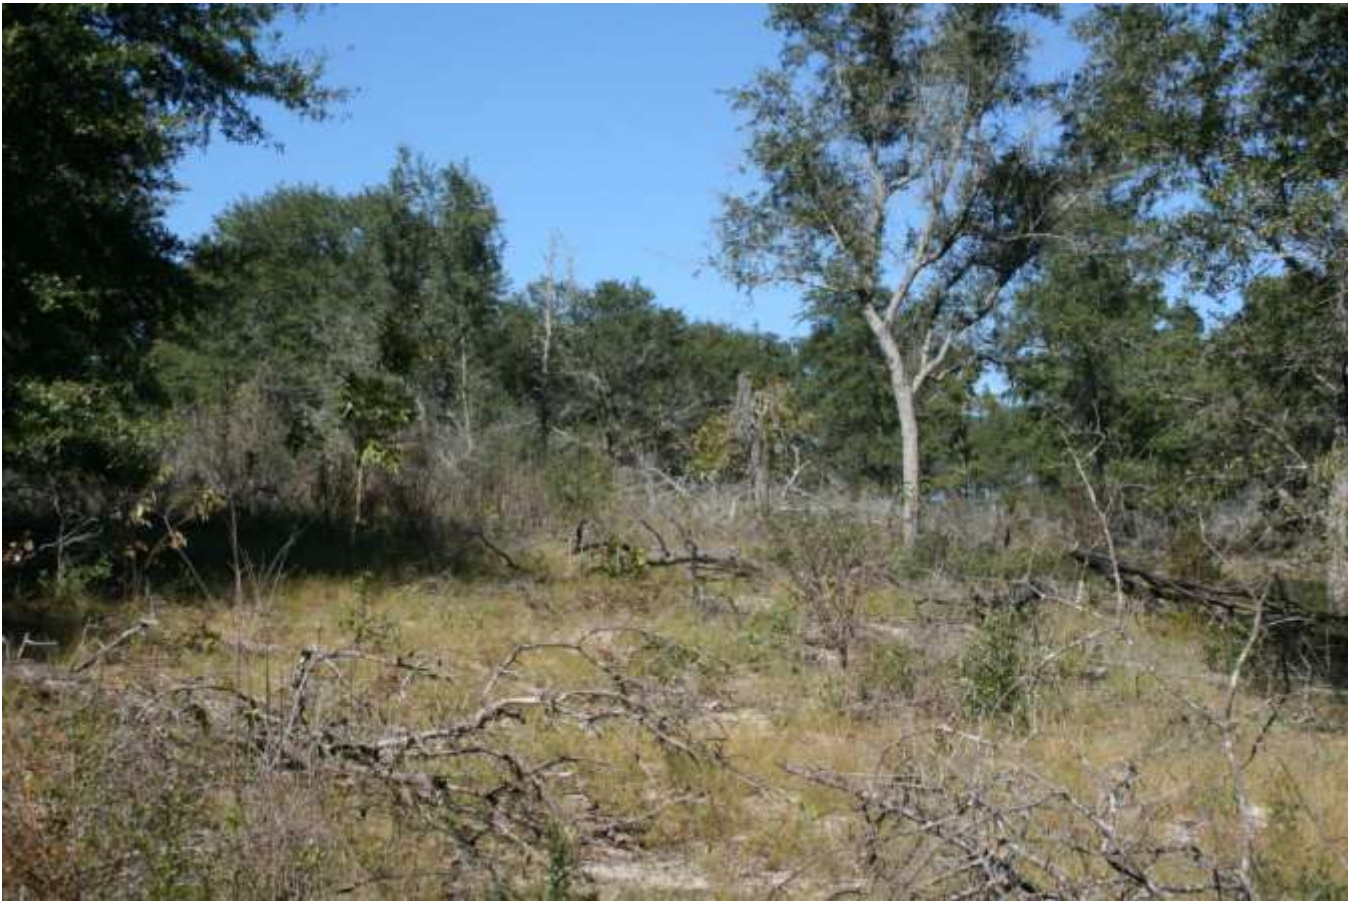
M2: Pines with good wiregrass cover

M2. Wiregrass in oak eradication area with felled trees

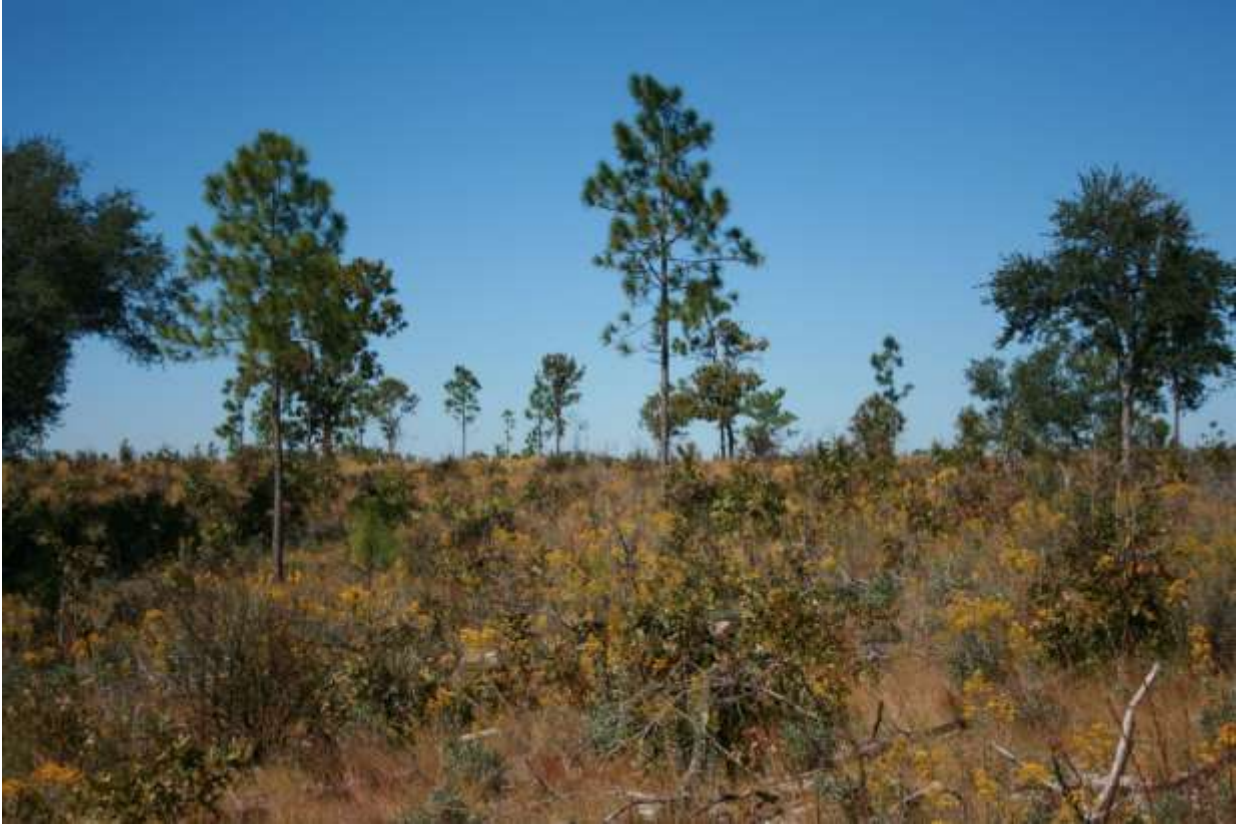
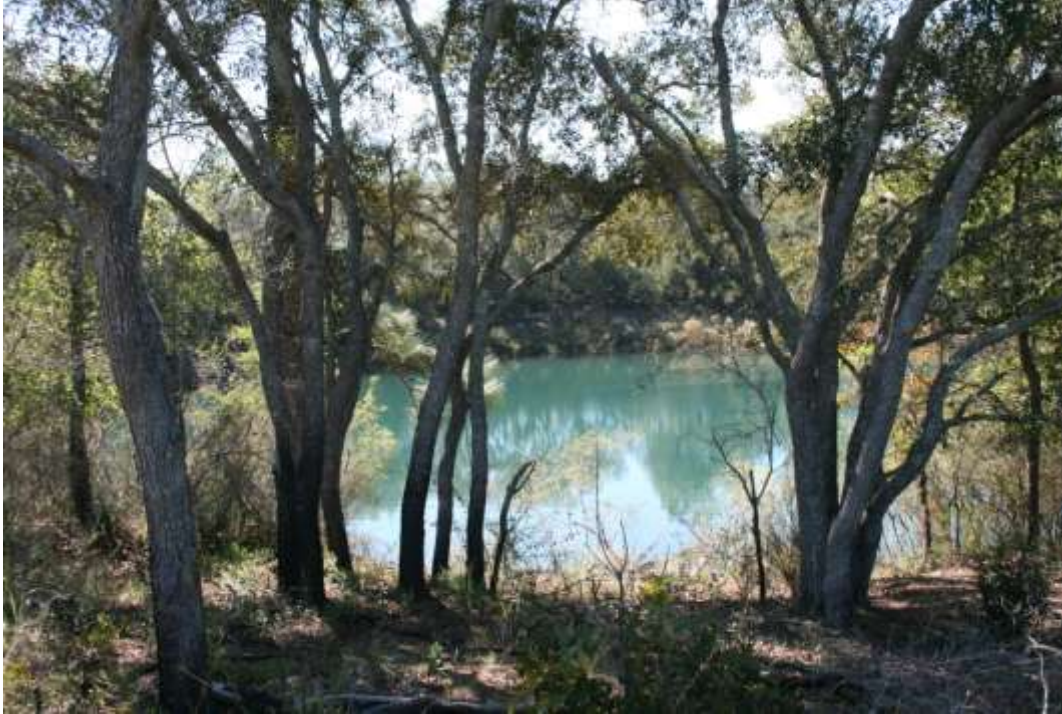
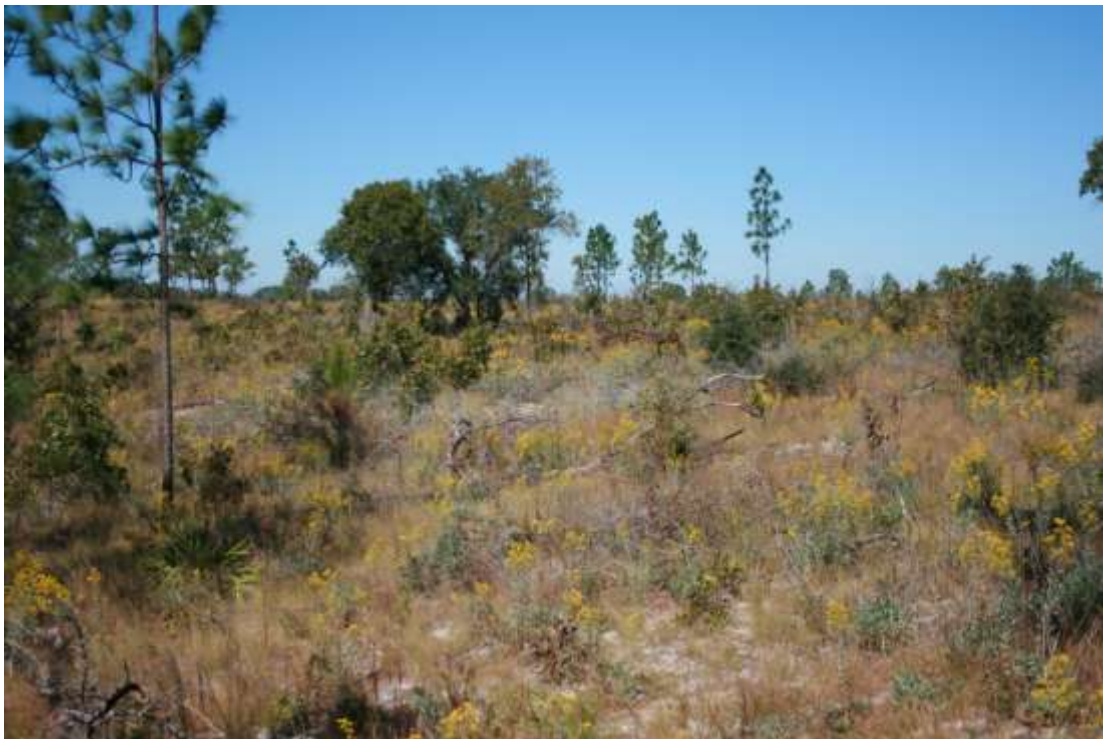
Pedestrian Transect M3: Cat pond and surrounding uplands

Cat Pond with Smooth barked St. John's in background

M3:Sandhill Upland facing east

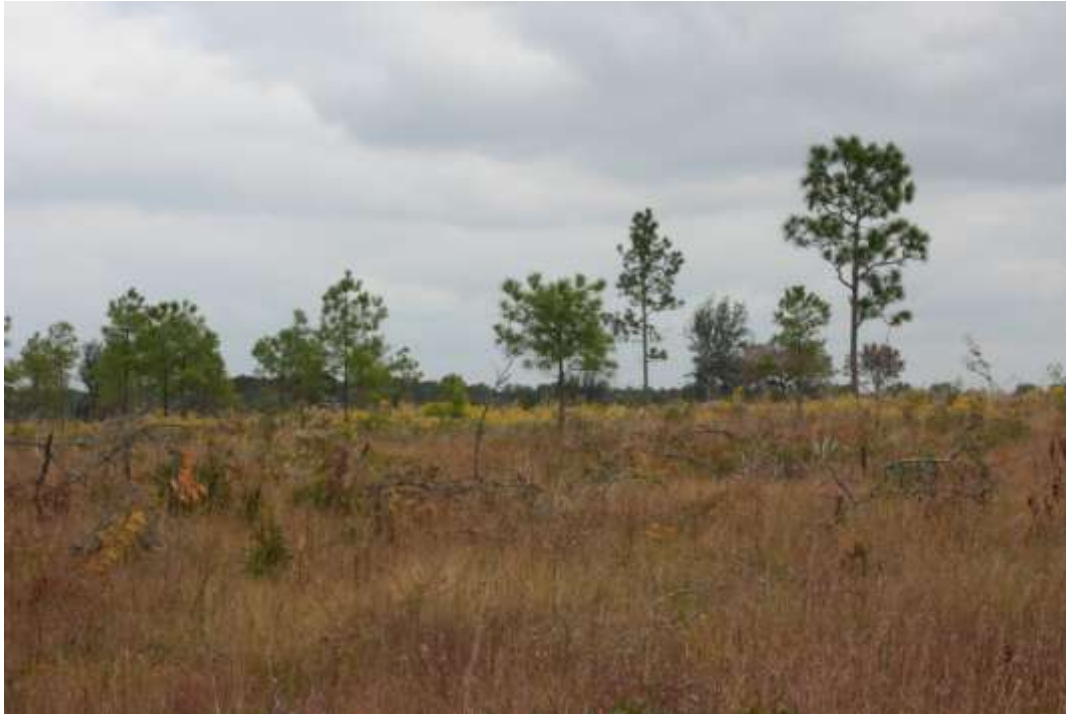
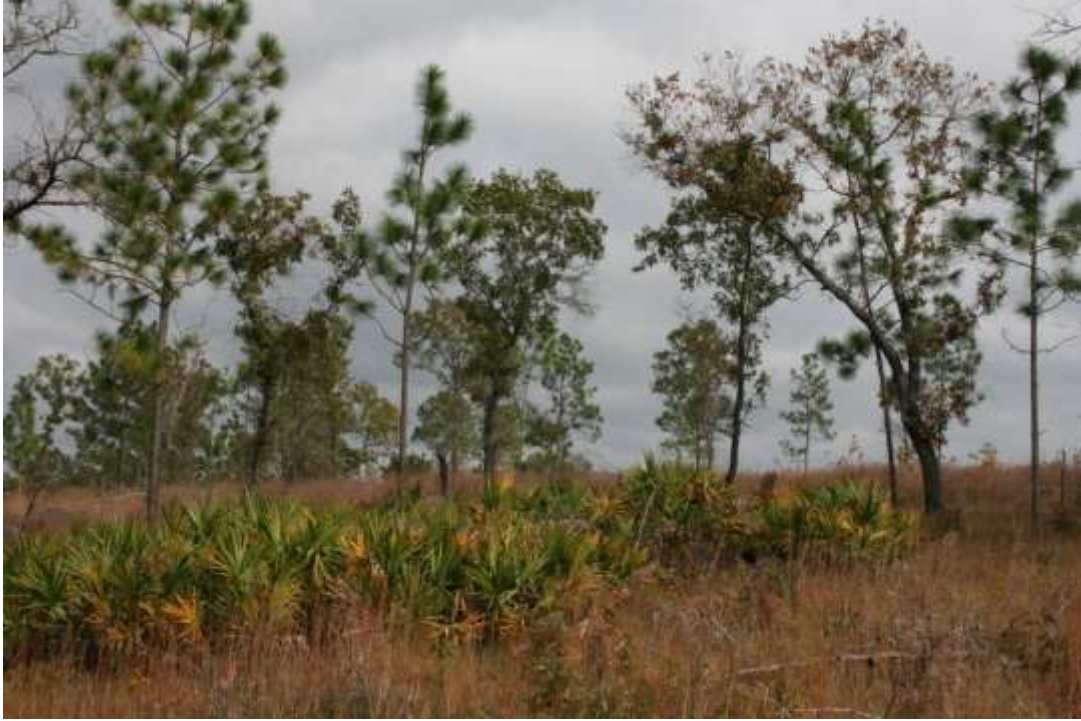
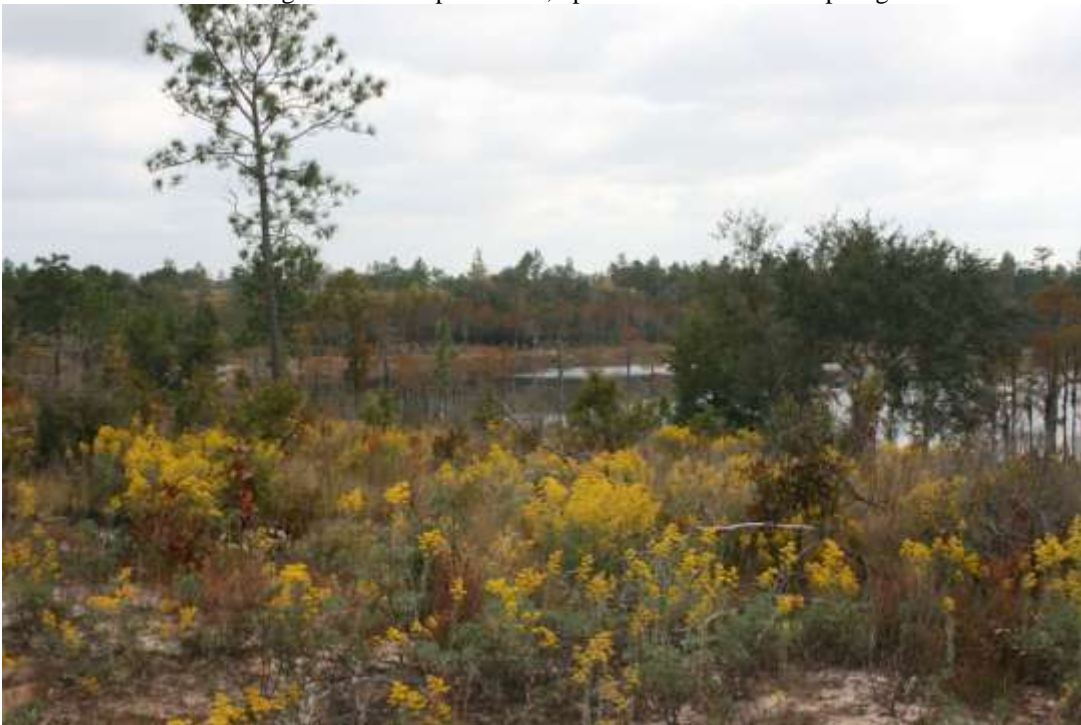
Pedestrian Transect M4: Upland Sand Hill: Note: Wiregrass

Upland near loop road and Little Deep Edge.

M4. Wiregrass and saw palmettos , upland next to Little Deep Edge.

M4. Adjacent to Deep Edge, area has had 1 less burn, burn in 2009.

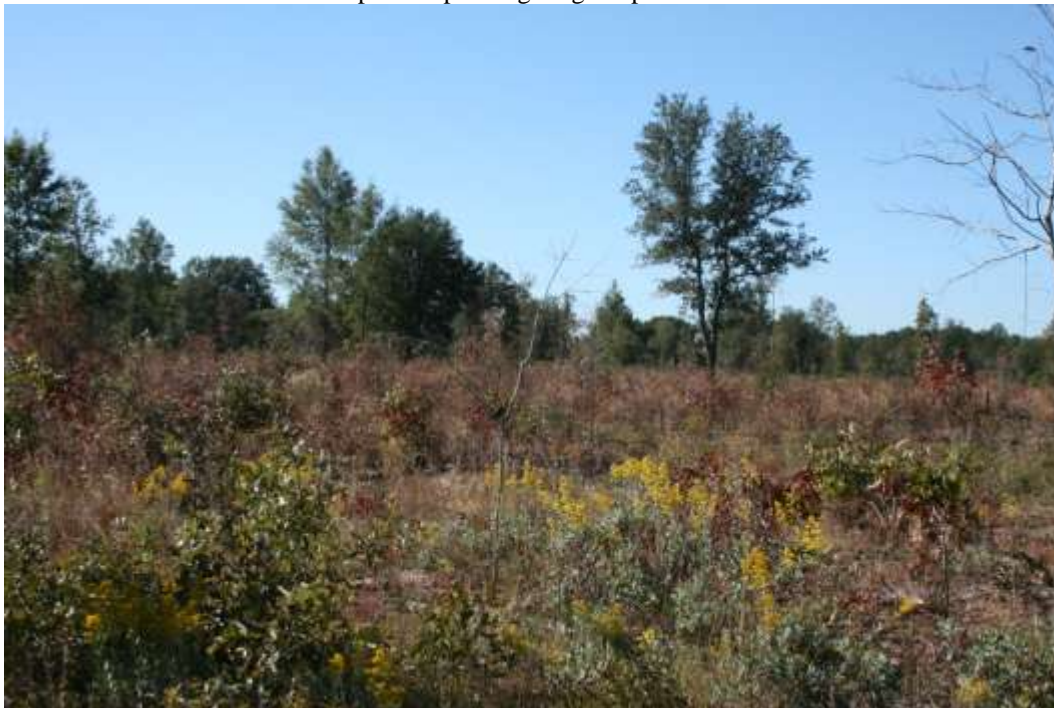
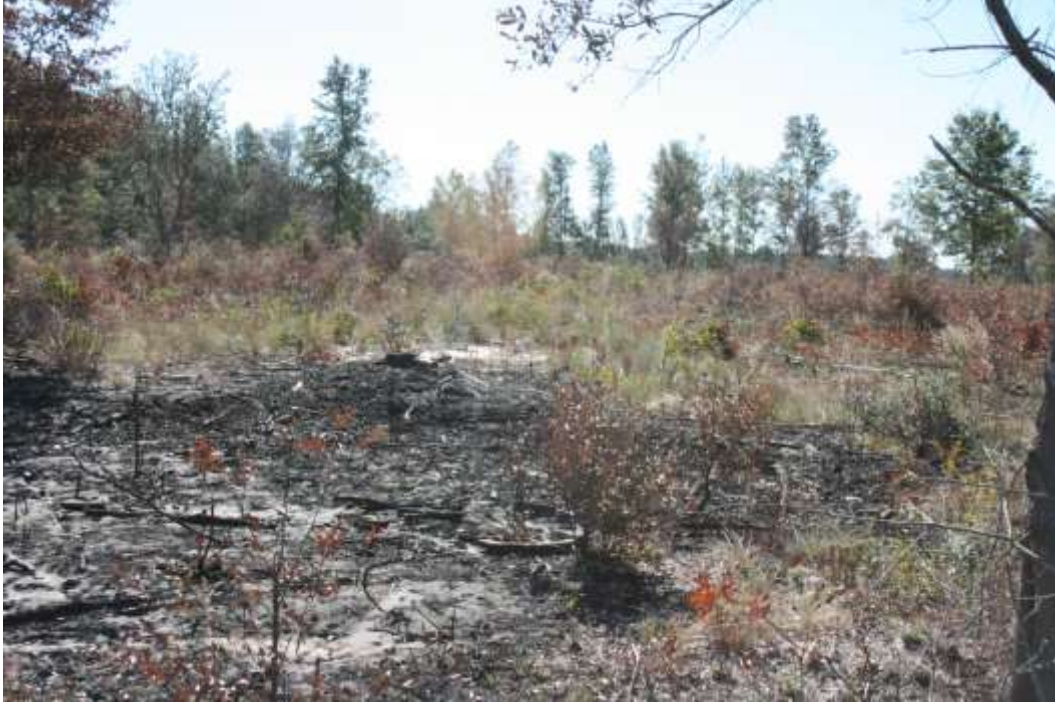
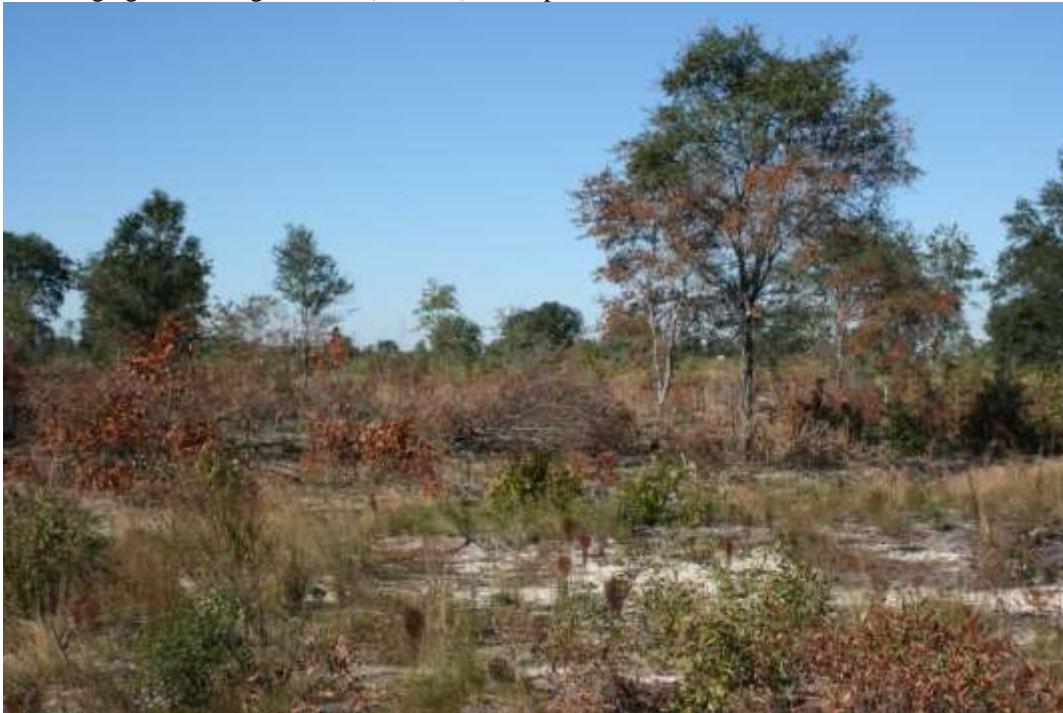
Pedestrian Transect M5: Burned prior to planting longleaf pine

M5: Staging area with good burn (October). Was planted in December with LLP.

M5: shows natural wire grass regeneration following slash pine harvest

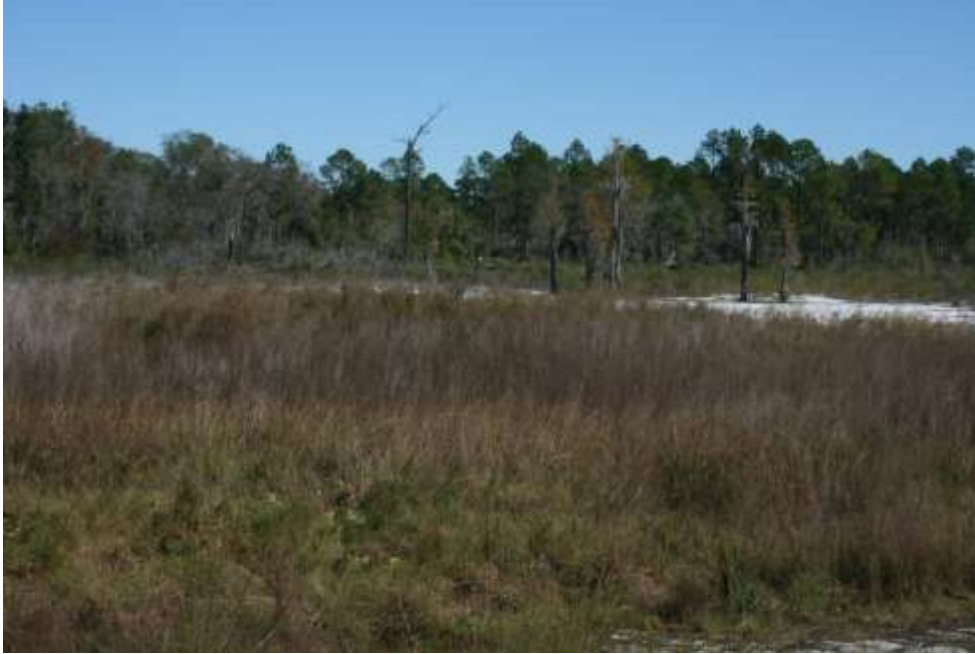
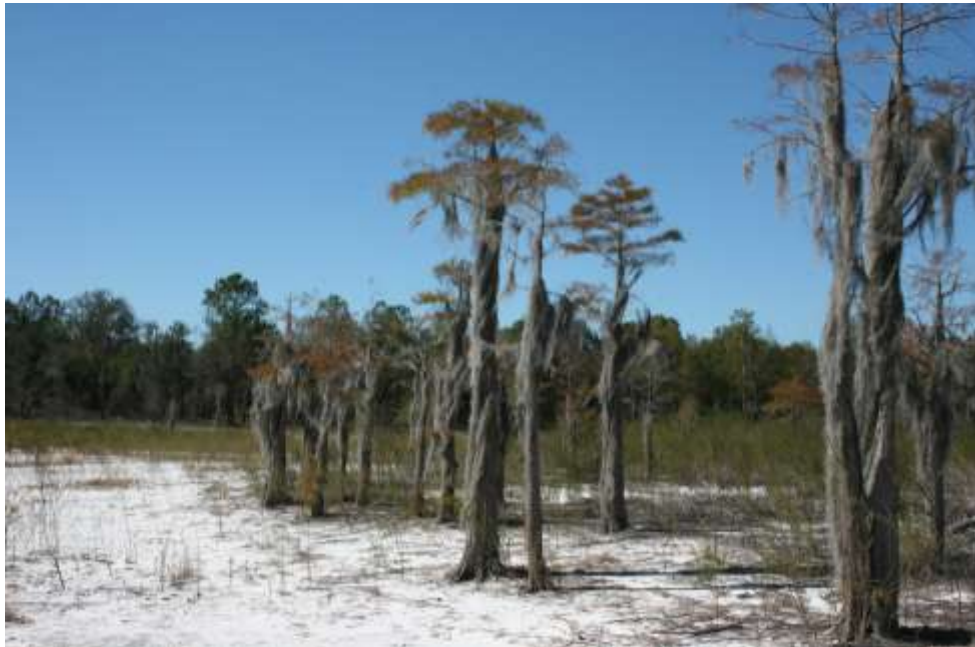
Pedestrian Transect M6: Note: Portions with pools of water, note water lily starting to grow

M6: Most of Garret Pond remains dry, but with good re-generation of smooth barked St. Johns Wort.

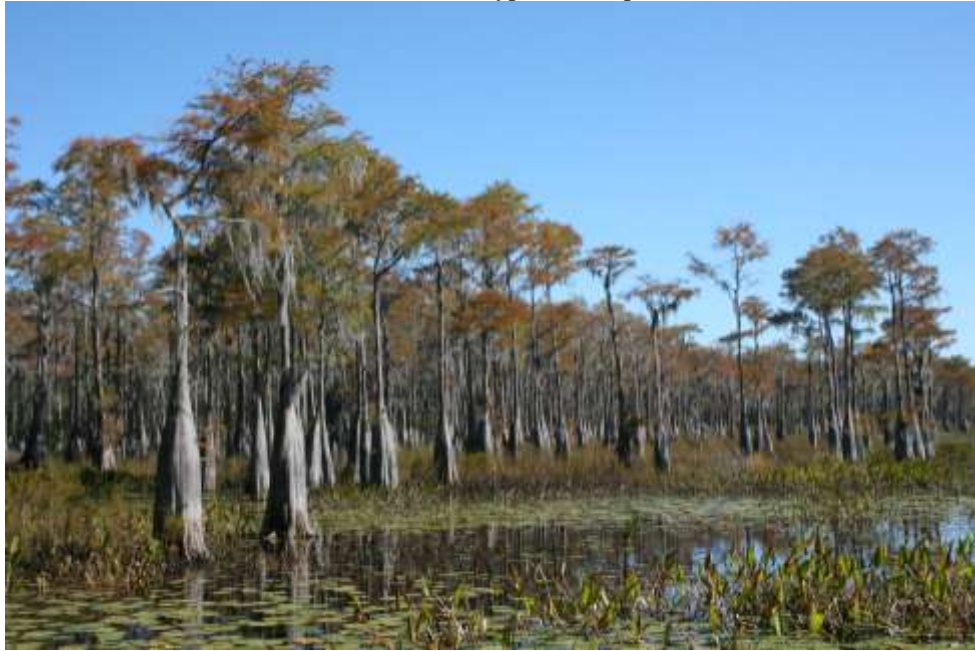
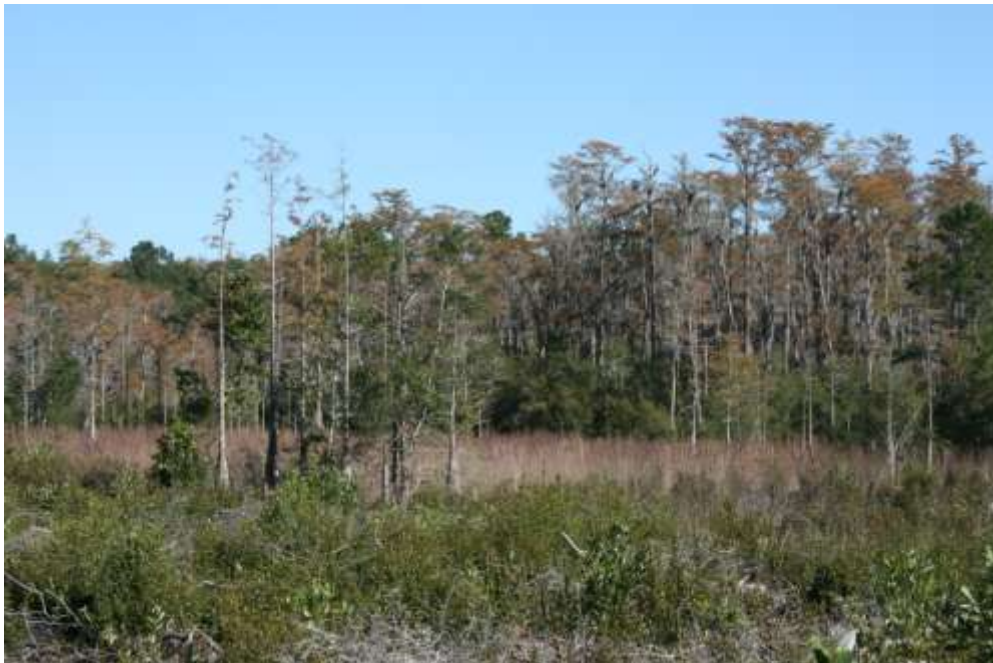
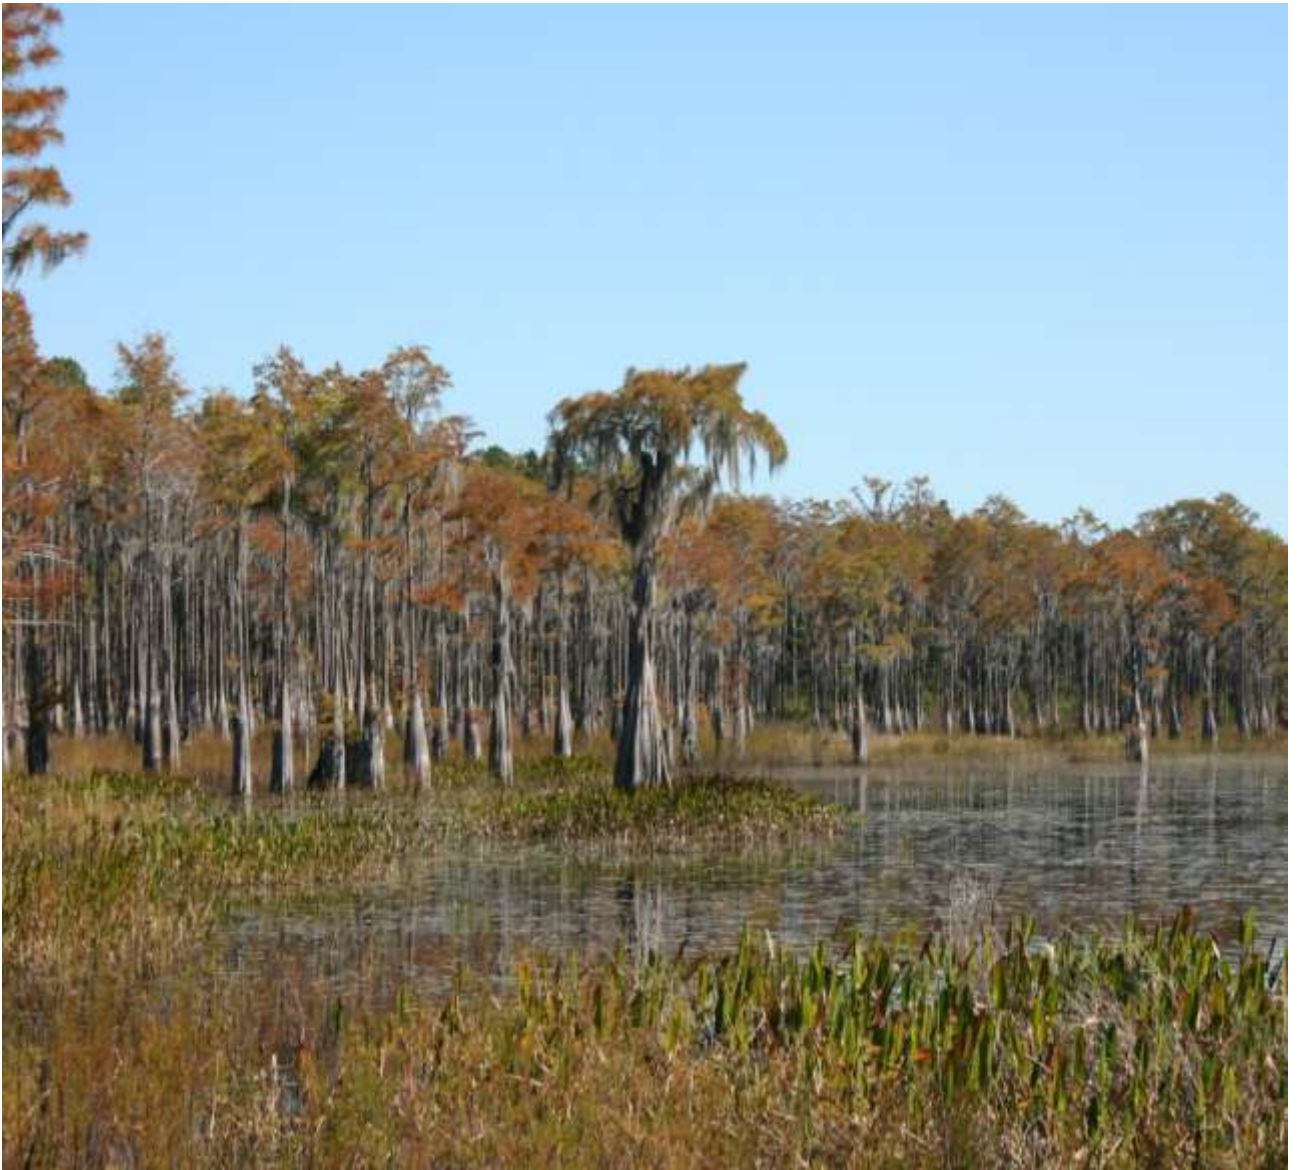
Pedestrian Transect M7: Cypress with pickerel weed

M7: Showing area where Gyro-Trac was used to remove black titi edge (Flatwood vegetation historic)

M7: Cypress with fall color

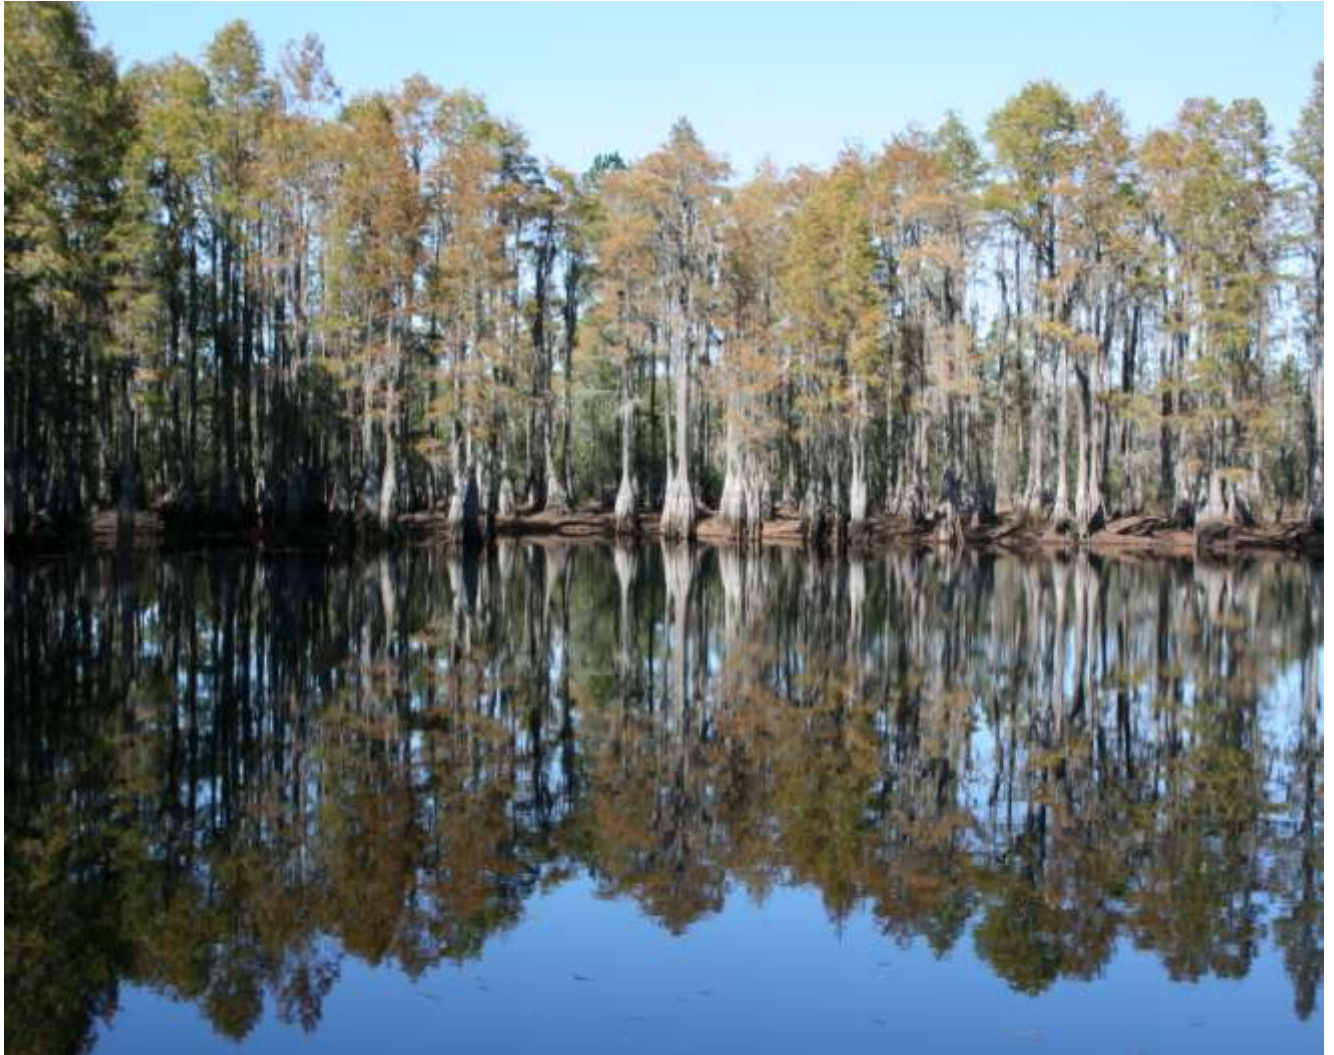
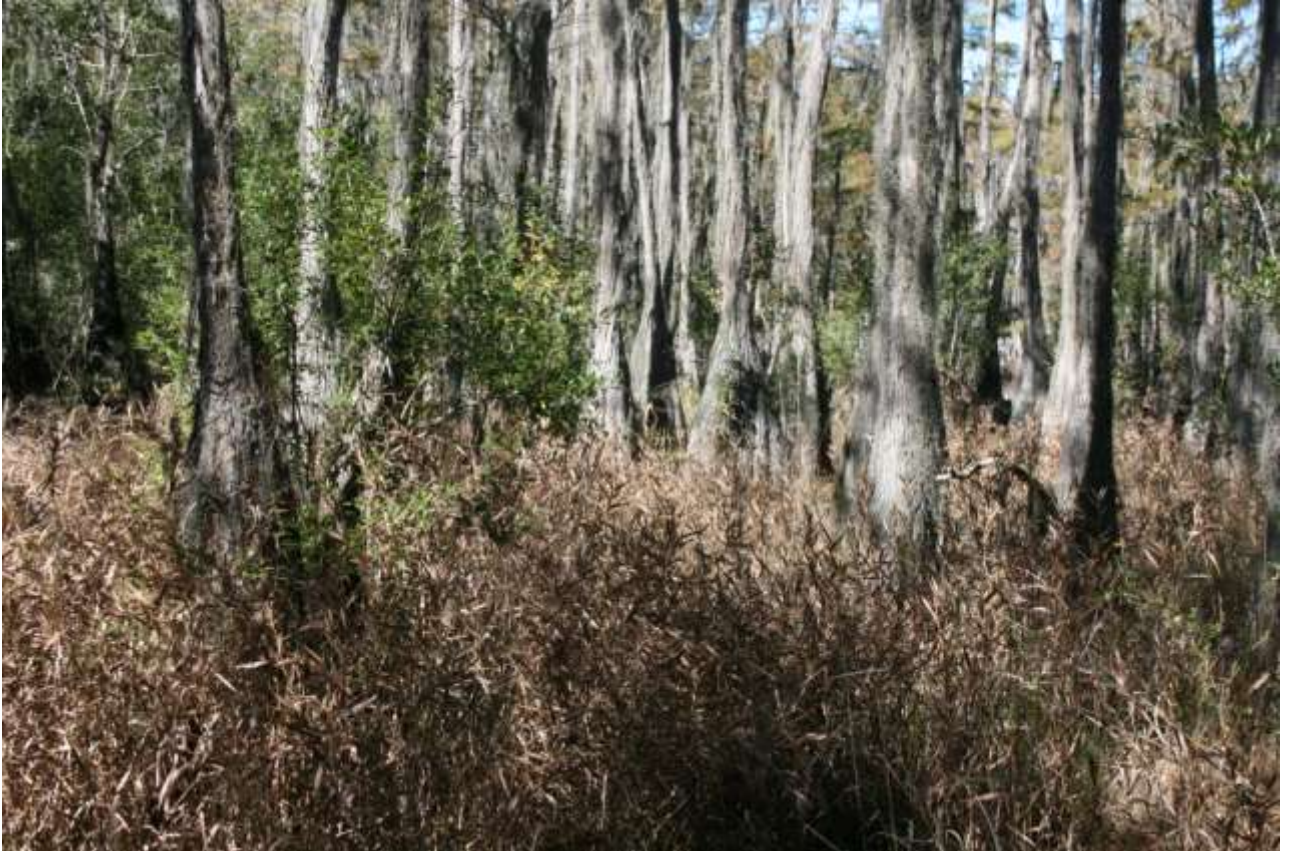
Pedestrian Transect M8: Green Pond

M8. Forested wetland, water slightly above soil surface, good grown of herbaceous species.
