Sand Hill Lakes Mitigation Bank  
Third Annual Report  
December 2008

## **Executive Summary**

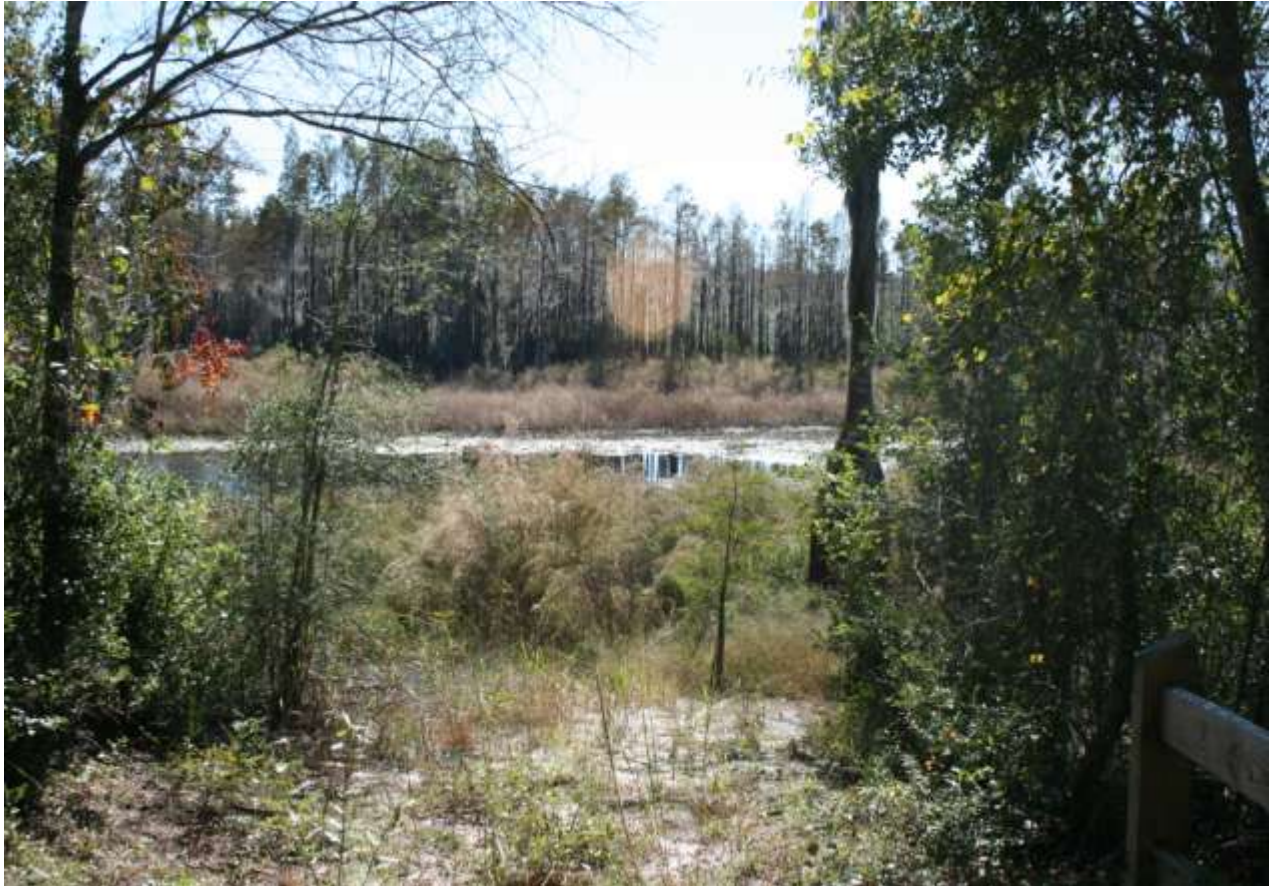
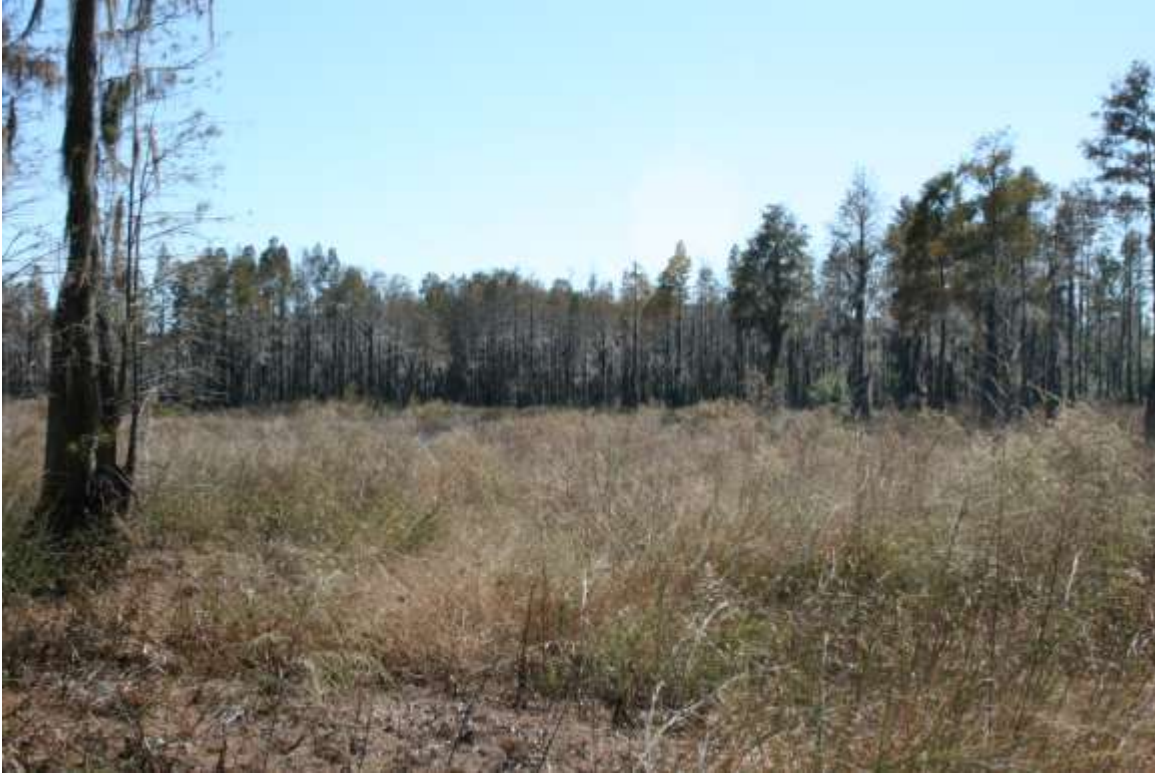
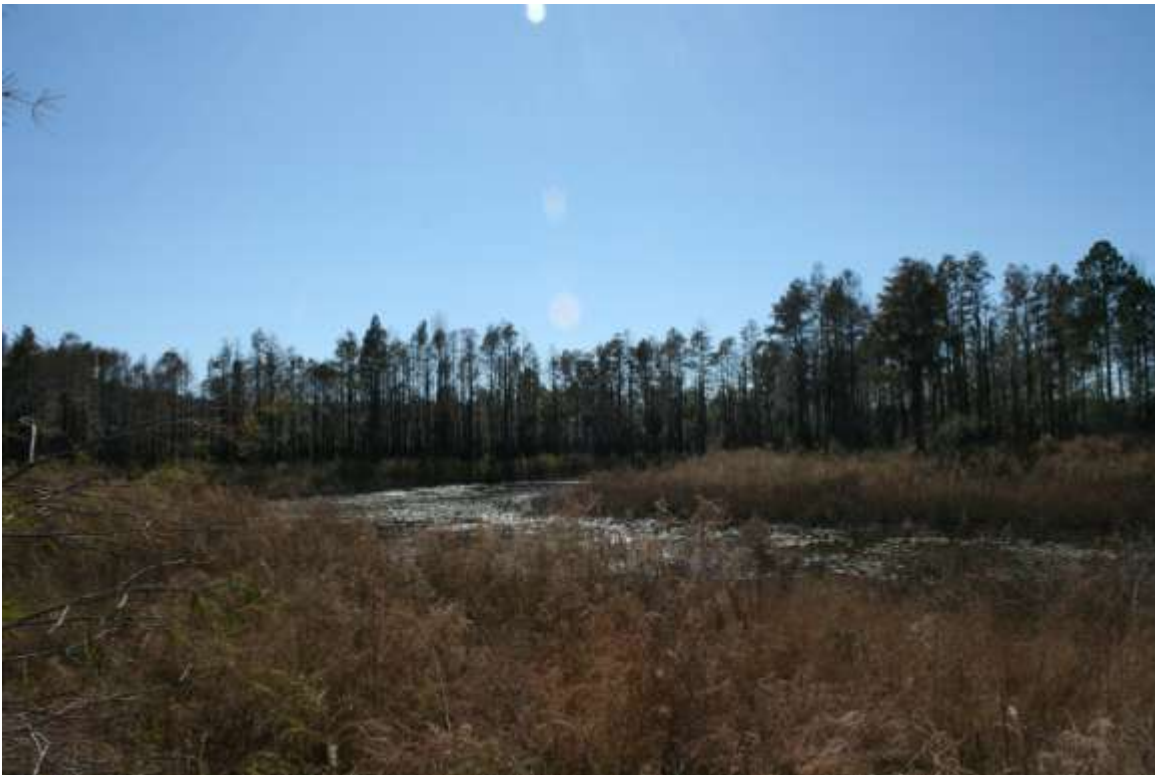
M9:Pedestrian Transect: Green Ponds: Water in Pond

M9: Most dominated by dog fennel, water at or above soil surface, up to 1.5 to 2' in deeper areas.

M9: Water in deeper areas.

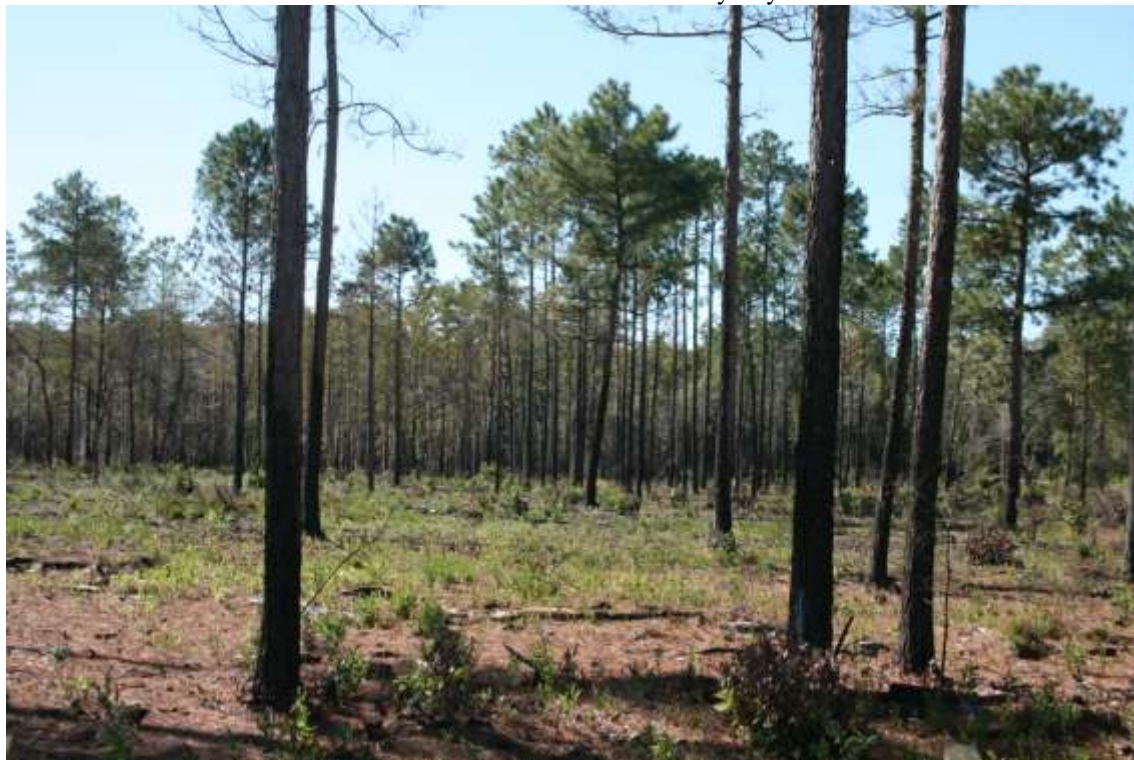
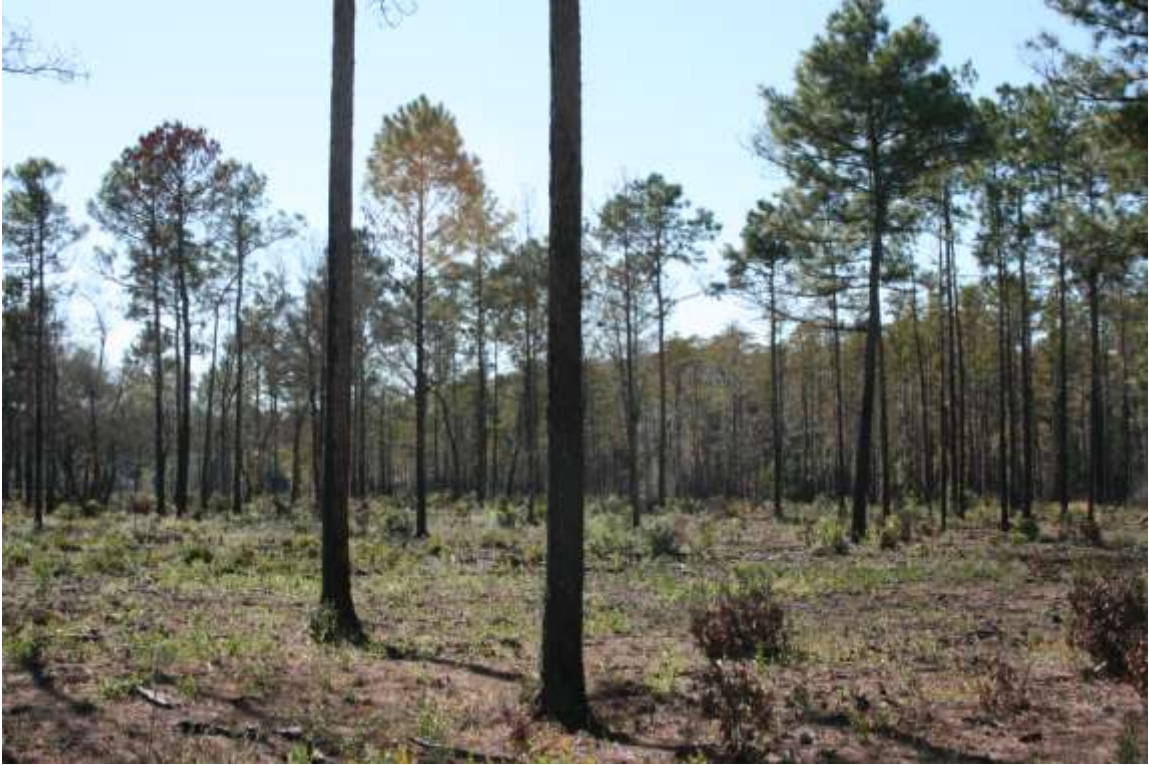
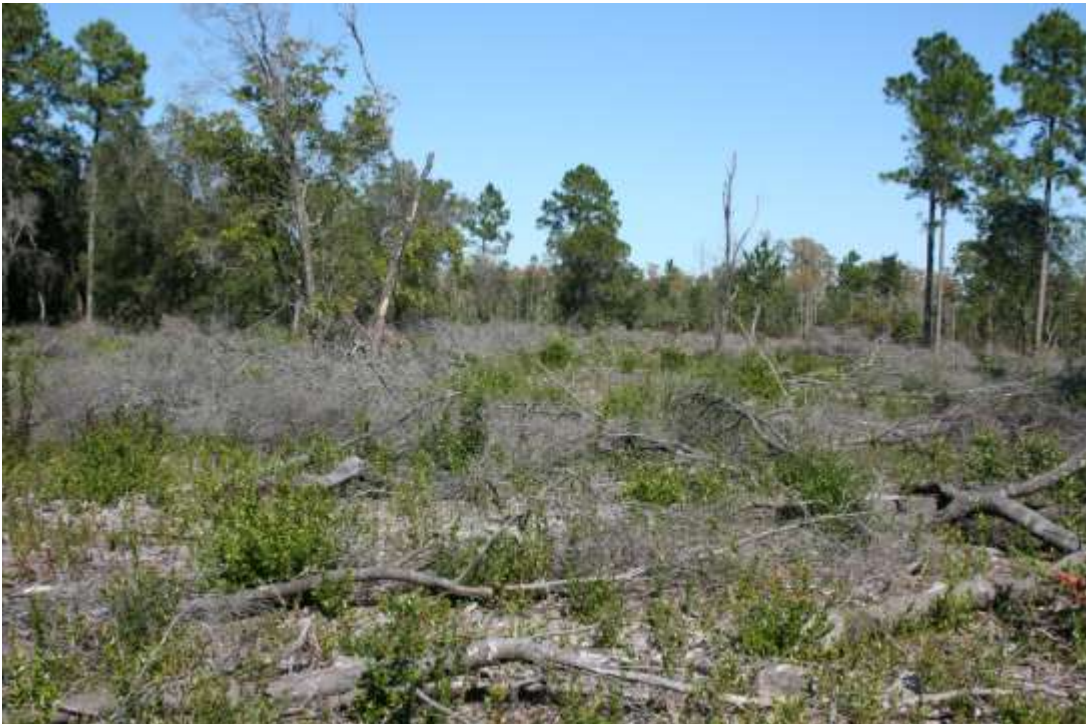
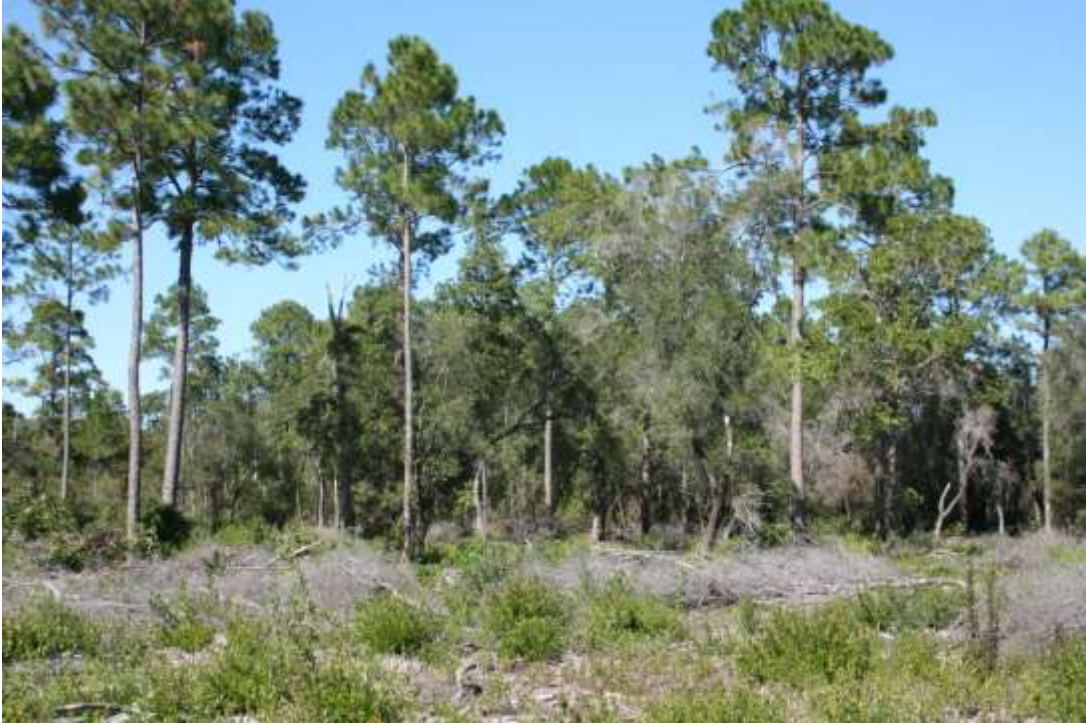
Pedestrian Transect M10: Loblolly Bays

M10: Gyrotracked Shrub area, burned overseeded with wire grass and treated with herbicide for shrubs

M10: Similar to first shot, note the low shrub count.

M10: Add on black titi area adjacent to photos above: Gyro-Trac done in June/will be burned in winter 2007/2008.

M10: Wet flatwoods add on area (see above)

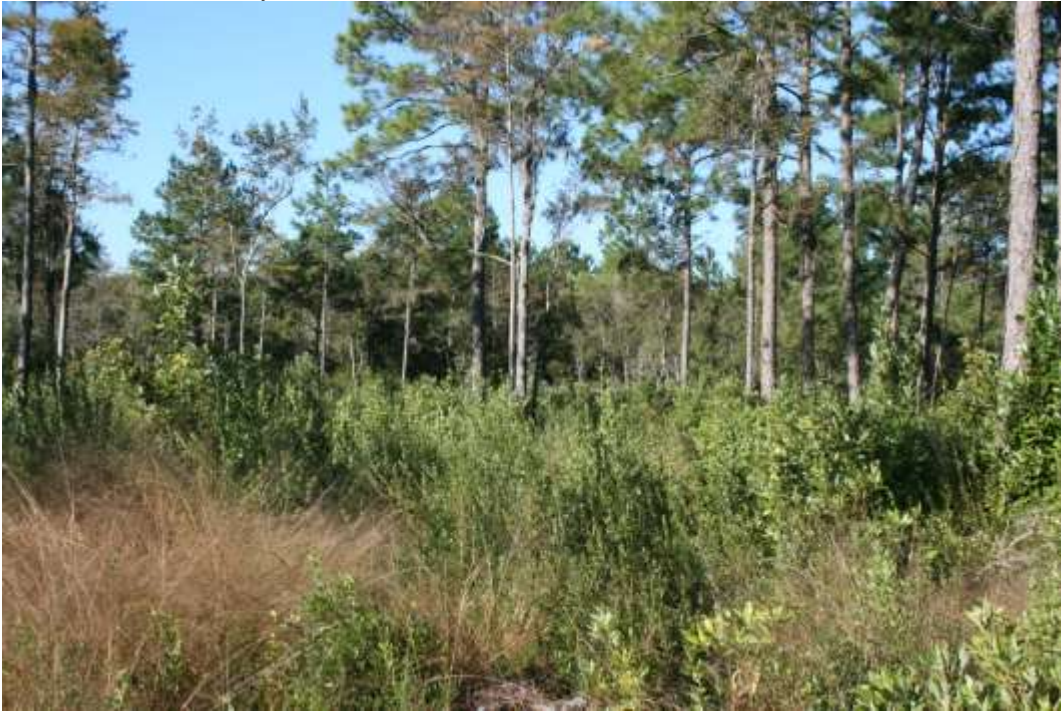
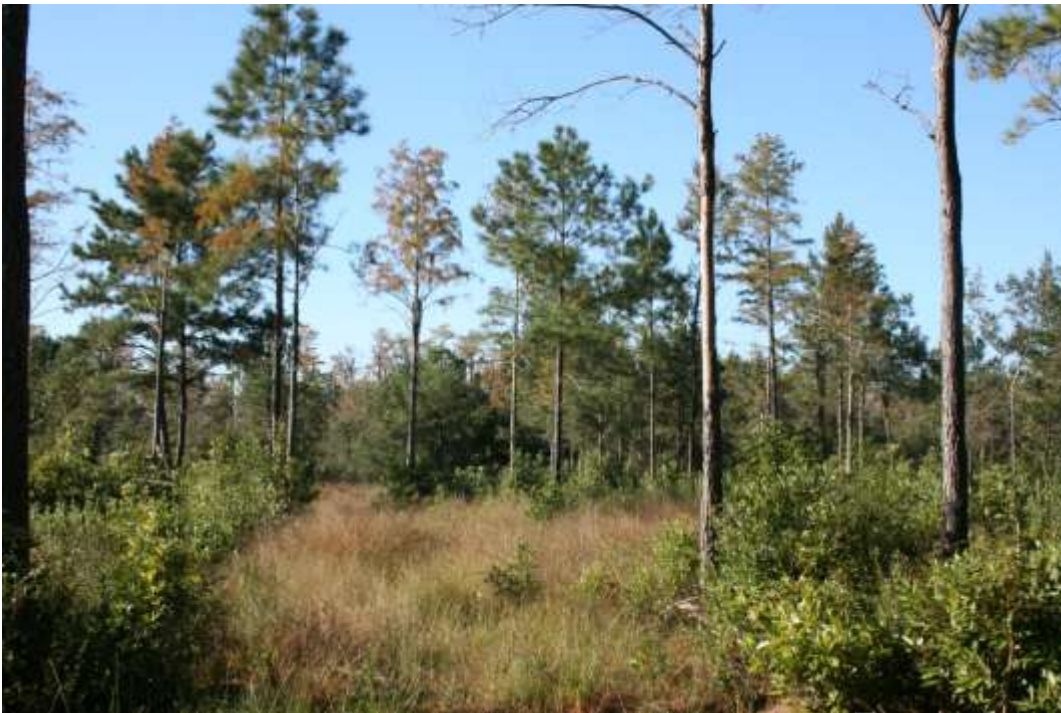
M11. Wet Flatwoods, Gyro-Trac area.

M11. Cypress, pine and herbaceous understory

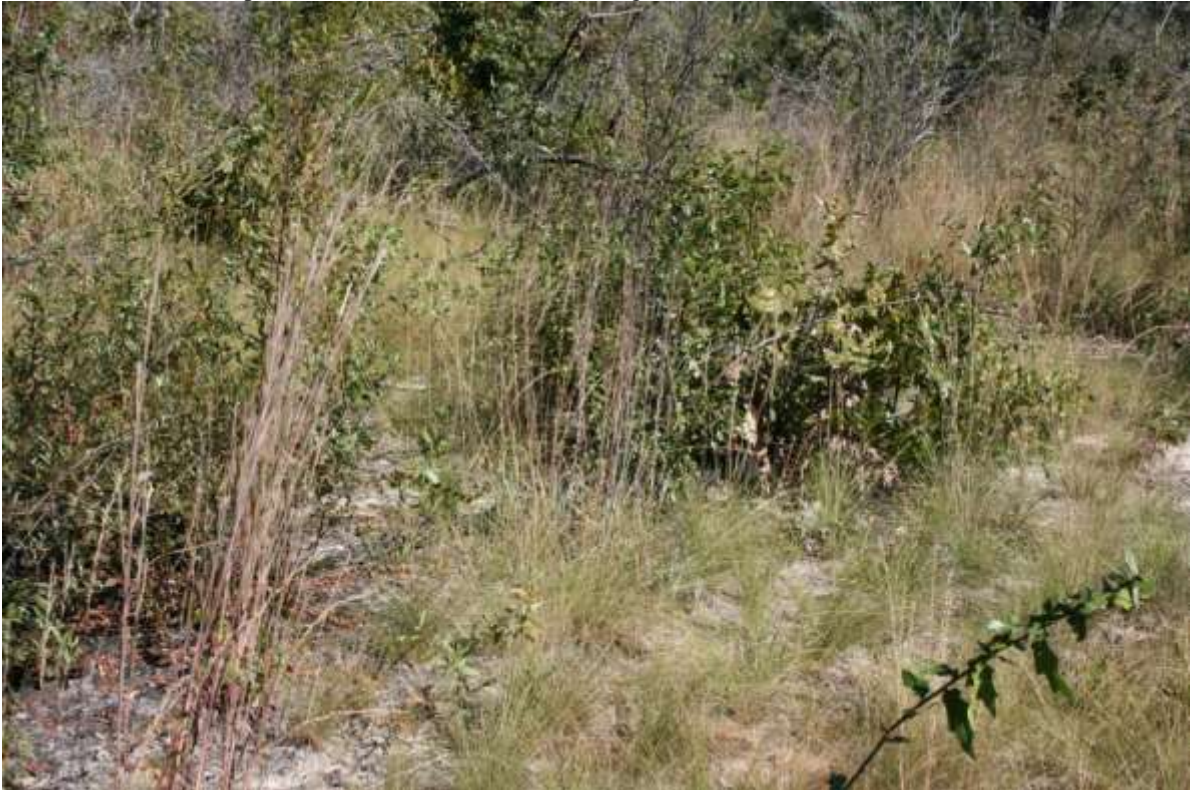
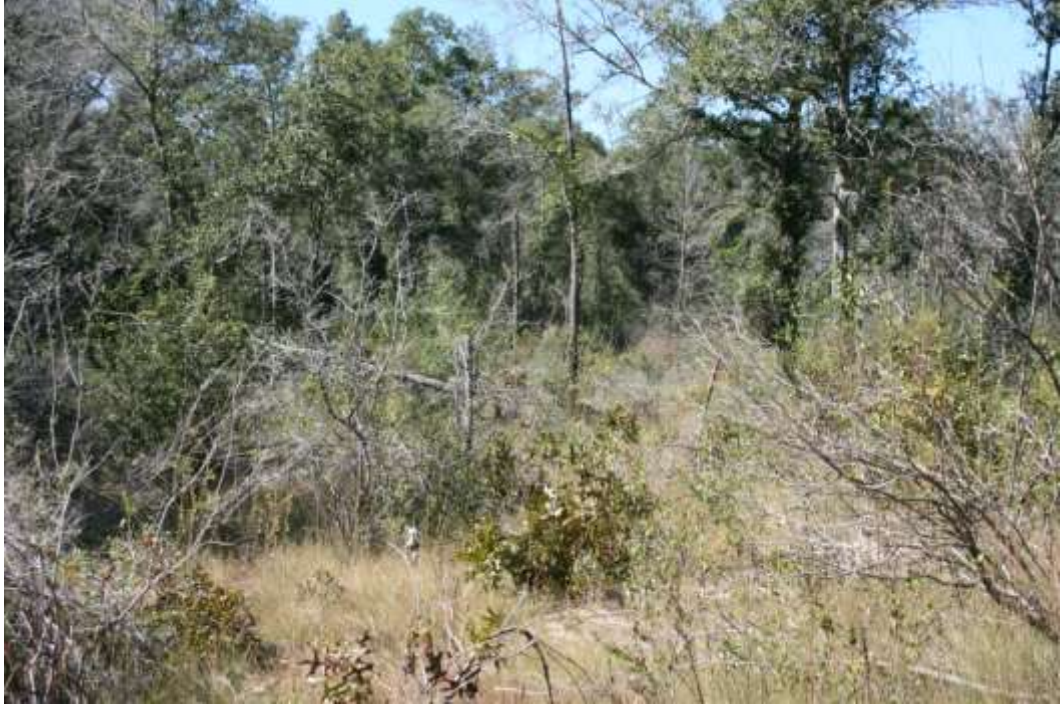
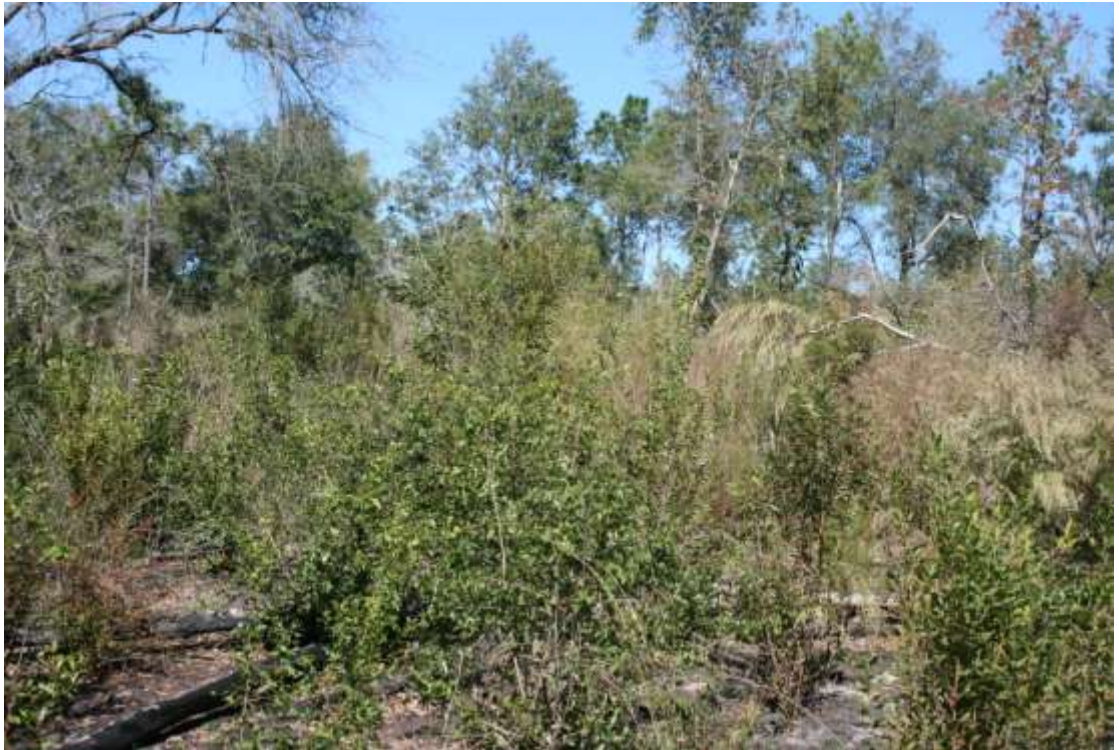
Pedestrian Transect: Upland Sand Hill after burn, not wire grass

M12: The area is a lot more open following the fire

M12: Another shot, more than previous but with a lot of herb cover

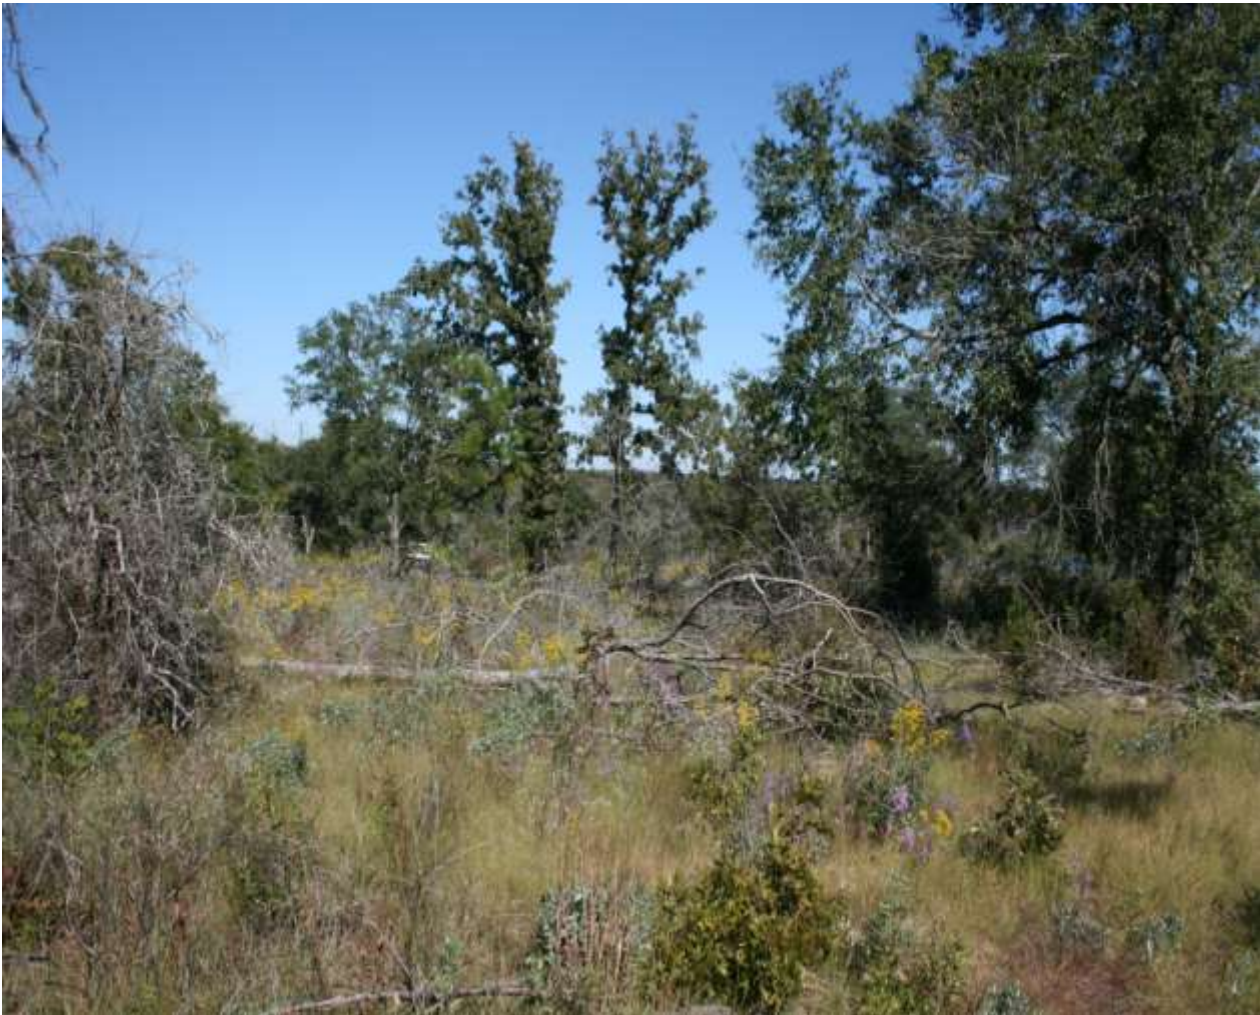
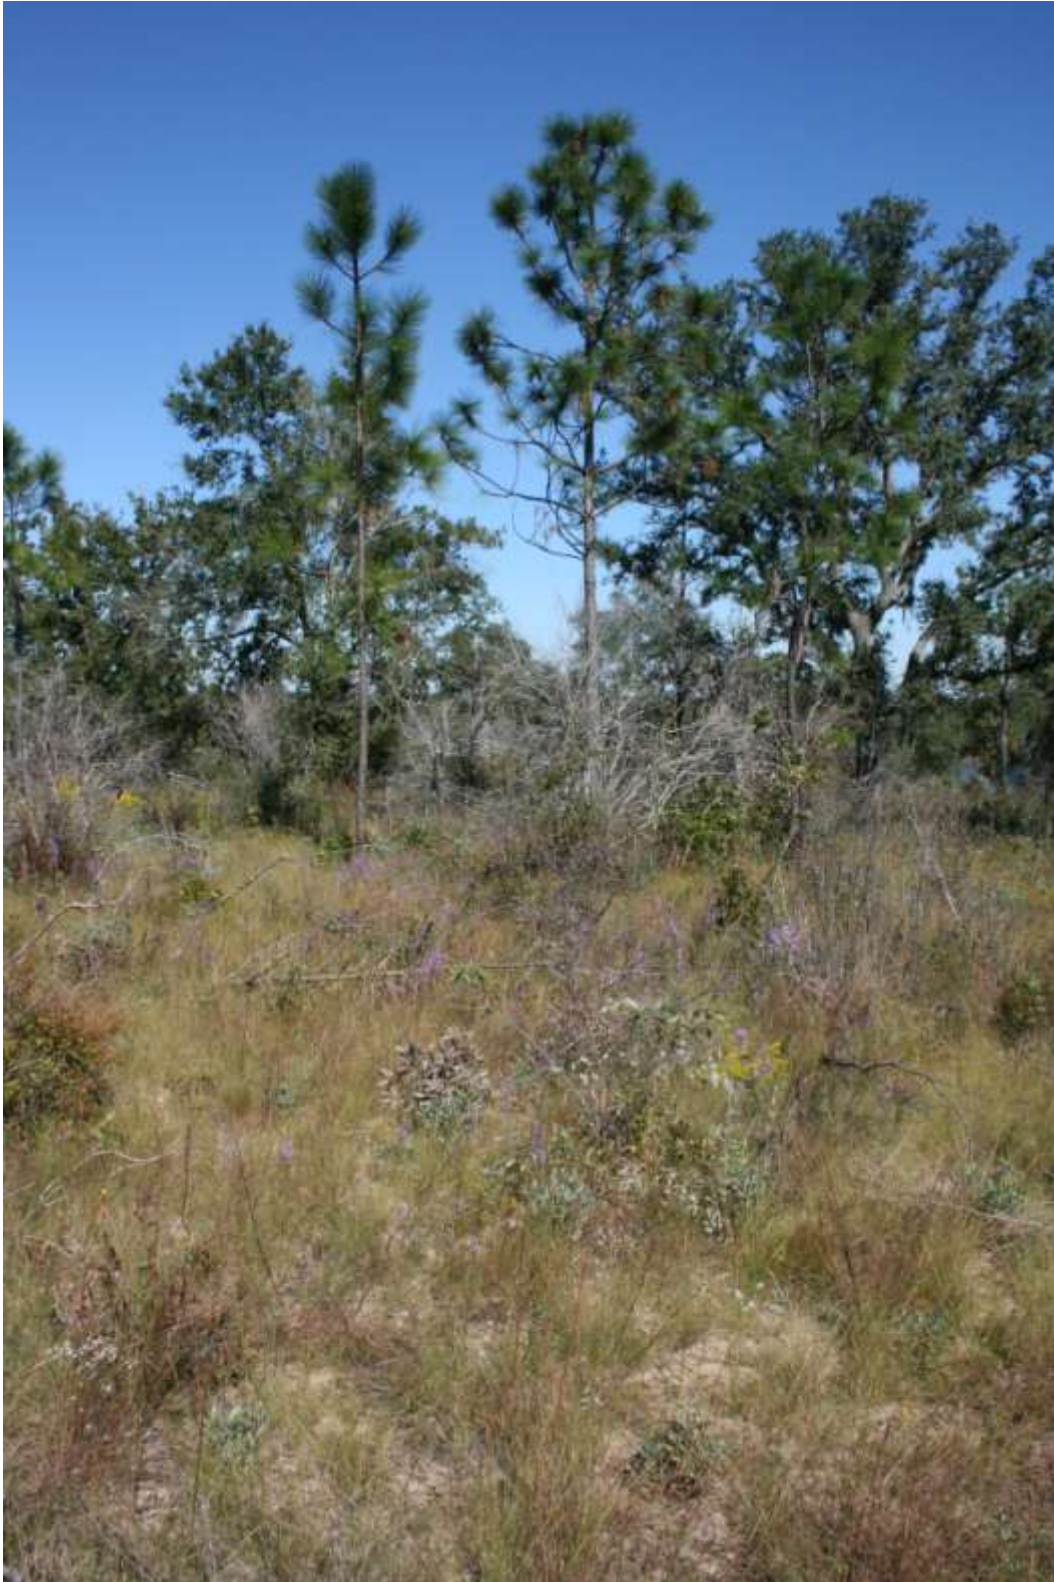
Pedestrian Transect: Upland Sand Hill with oak eradication: Note: Wiregrass and felled oaks

M13: Good wiregrass cover and high species diversity
