Lafayette Creek – Fourth Annual Monitoring Report 2010

Impact: US 331 Freeport Re-alignment; 8.63 Acre impact; CORPS Permit No. SAJ-2001-1118 (IP-DEB) Issued 2/4/05, Walton County

Monitoring date: October 26, 2010

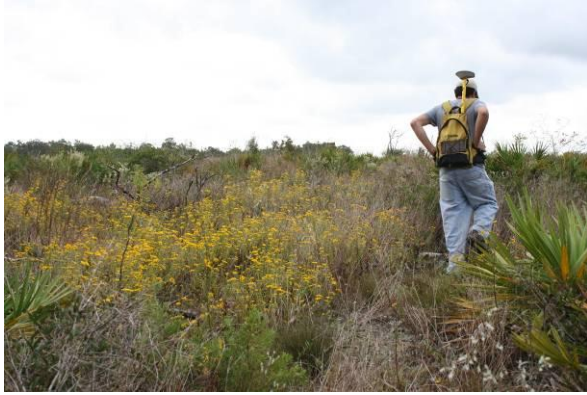
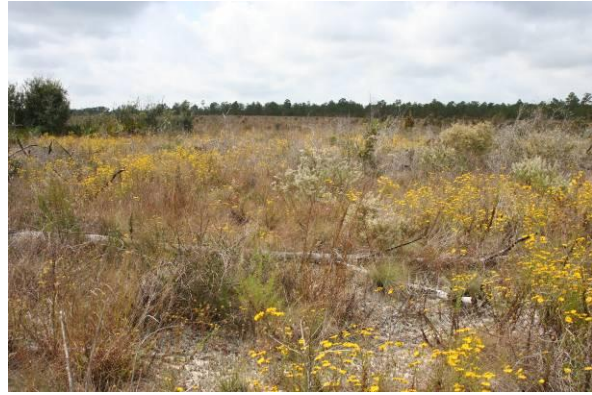
- The sandhill adjacent to the upper ravine has some patchy Bahia grass cover, remaining from before acquisition when the area was an abandoned sod farm. **Herbicide treatments have helped reduce the Bahia grass cover and no large infestations were observed in 2010.**

- The sandhills continue to develop adjacent to the upper ravine, and cover and diversity continue to increase. **The sandhill adjacent to the lower ravine is healthy and wire grass cover continues to increase. No Bahia or cogon grass has been observed in this area.**

Figures 3 & 4. Sandhill adjacent to upper ravine (former Bahia grass pasture)

- Exotics species monitoring for the wetlands and associated upland buffer has been conducted yearly: **2005-2010; completed 2010**
- Patchy cover of Bahia grass and a small patch of cogon grass was observed adjacent to the ravine system. **Areas were treated in August and September 2008 with herbicides designed to eradicate the exotics while not impacting the natives. These areas were treated again in April and July 2009 and have been treated in 2010.**

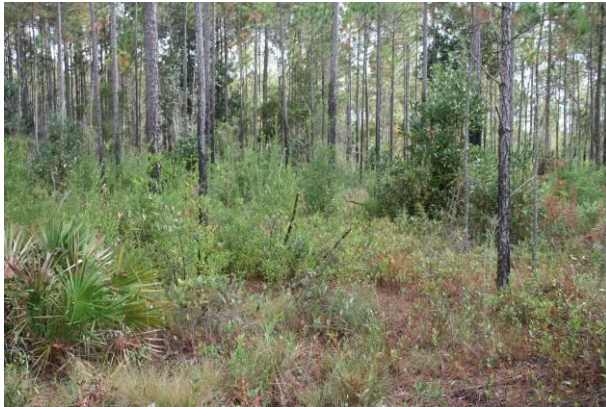
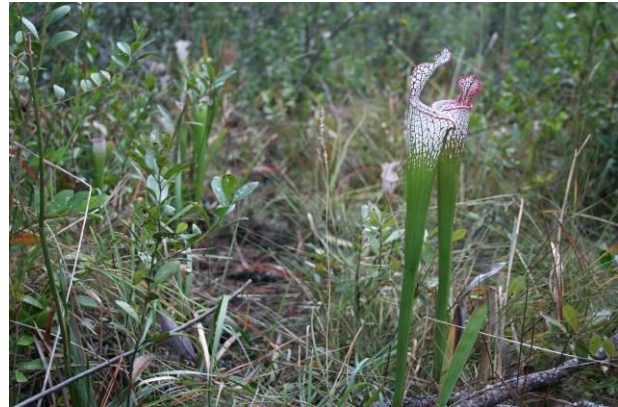
An intact mesic flatwoods community was observed in the eastern portion of the property south of the power line. This community has good mature pine canopy cover and appropriate herbaceous and shrub composition and cover. This mesic flatwoods transitions into a wet prairie ecotone that contains a population of approximately 100 individuals of the state-endangered species White-topped pitcher plant (*Sarracenia leucophylla*). Although there is some invasion of titi (*Cyrilla racemiflora*), this wet prairie is in fairly good condition and should be maintained with prescribed fire to support this state-listed species.

Figures 5 & 6. Mesic flatwoods and *Sarracenia leucophylla* in adjacent wet prairie ecotone.

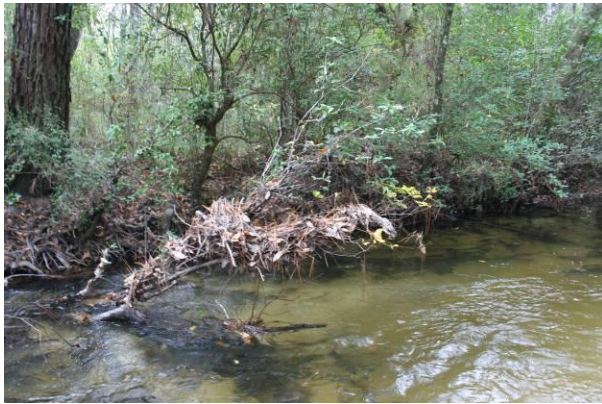
Figure 7. Lafayette Creek stream

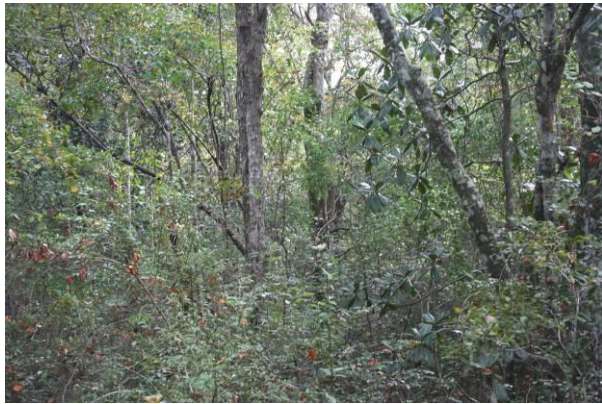
Overall, the community appears healthy and is appropriately diverse and stratified. In the wetland system the fuel load is low to moderate, exhibits an open to moderate shrub layer, open to moderate herbaceous layer, and a closed canopy with seedling recruitment present. Indicators of appropriate hydrology were observed in all of the wetland communities including high water marks, hydric soil indicators, and wetland species dominance. No exotic/nuisance/invasive species were noted during monitoring.

Figure 8. Lafayette Creek floodplain
