LIVE OAK POINT MITIGATION SITE
Annual Monitoring Report, Year 3 of 5
January 6, 2012

Impact: US 331 (from US 98 to Choctawhatchee Bay)
USACE Permit No.: SAJ-2007-1175 IP-AWP, issued 3/3/2008
Mitigation: Live Oak Point, Walton County
Permittee/Consultant: Northwest Florida Water Management District (NFWFMD)
Responsible Party for Monitoring: NFWFMD
81 Water Management Dr.
Havana, FL 32333
Date of Inspection: November 8, 2011
Inspectors: Kim Branciforte, Linda Chaisson, Graham Lewis, Robert Lide

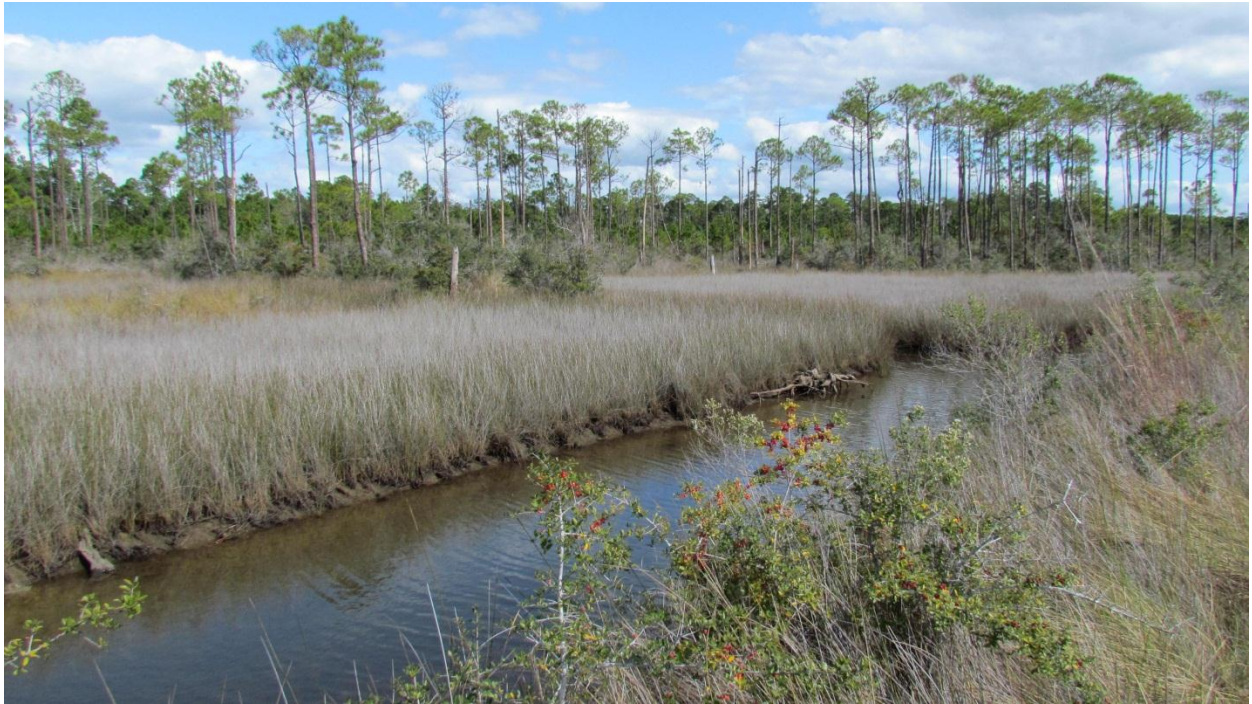
Figure 4. Lee Tract taken from access road, looking east from photo point 2 (11/8/11).

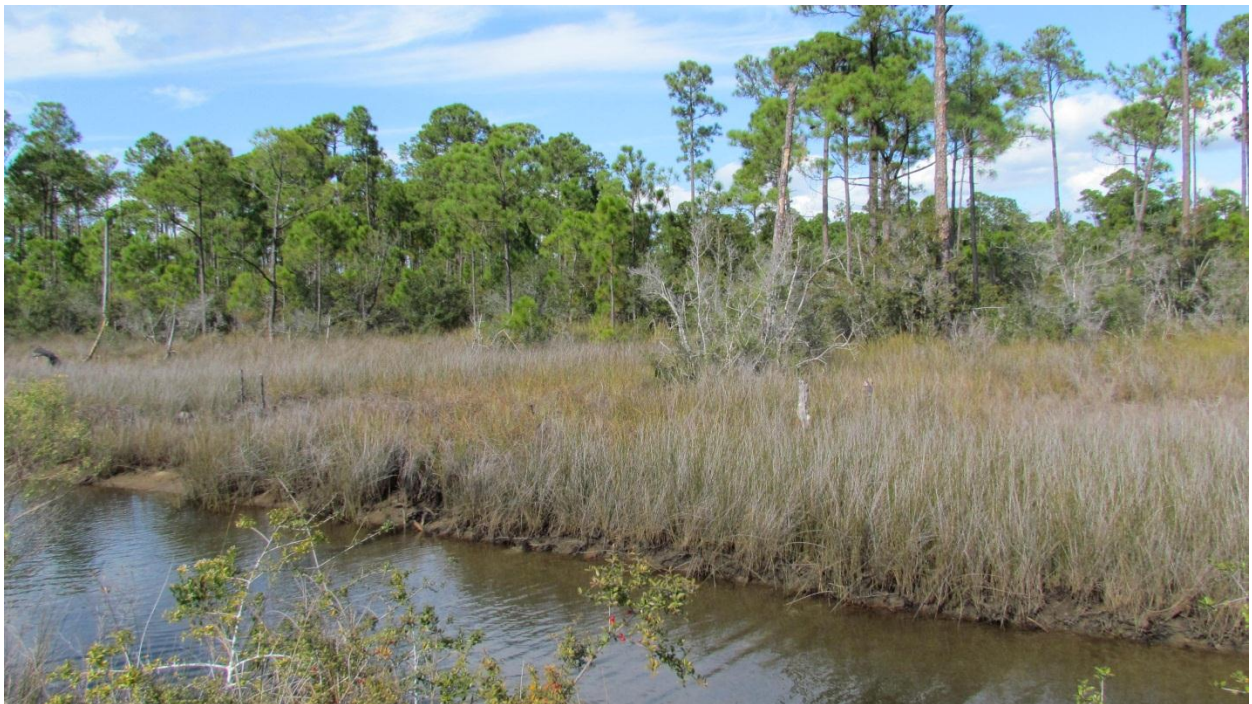
Figure 5. Lee Tract taken from access road, looking north from photo point 2 (11/8/11).

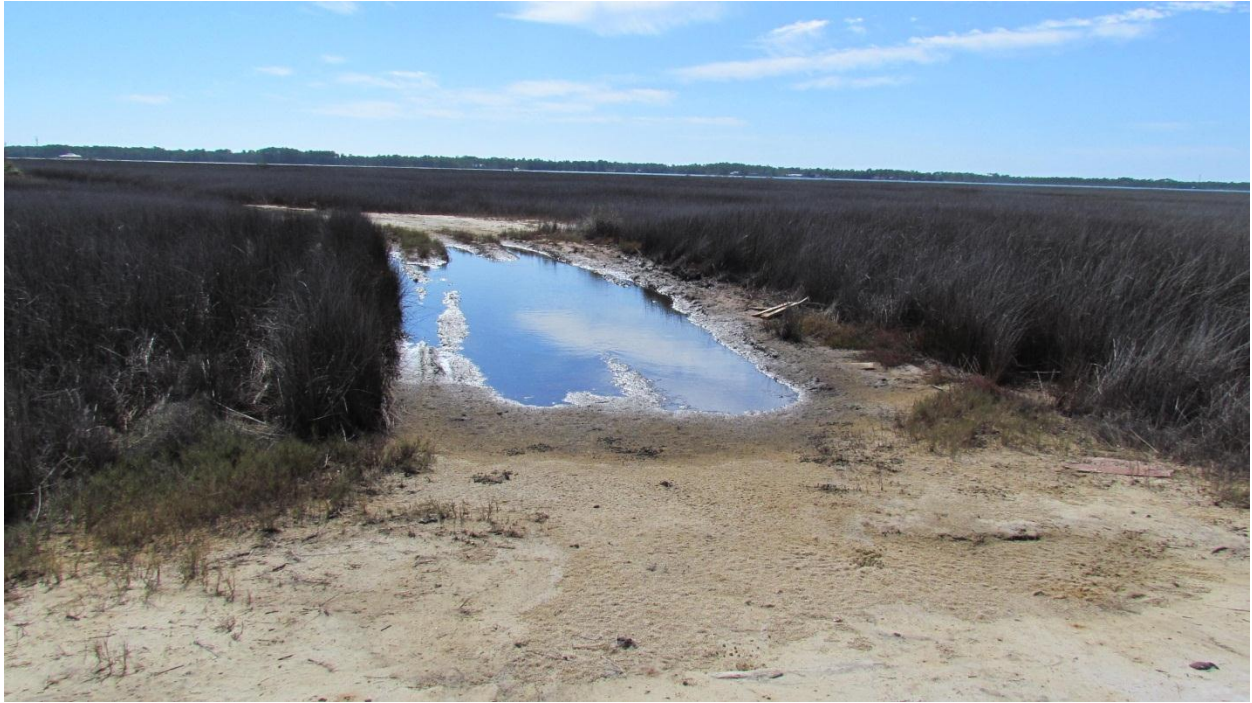
Figure 6. Lee Tract taken from access road, looking south from photo point 3 (11/8/11). Old intersecting road through marsh shows little use unlike main access road. [RTN](#)

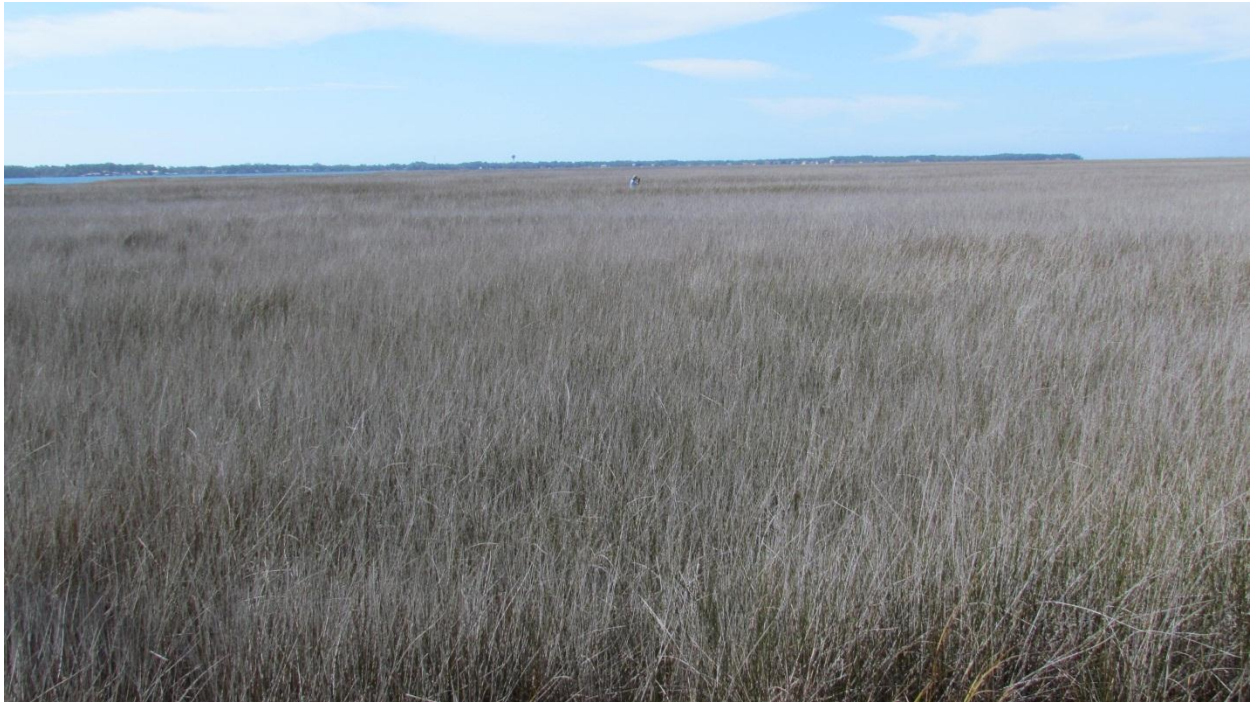
Figure 7. Woolley Tract taken from road, looking west from photo point 4 (11/8/11); note continuous expanse of *Juncus* marsh. Photo includes Woolley Tract and portions of the Section 16 lands owned by the State of Florida/Board of Trustees. [RTN](#)

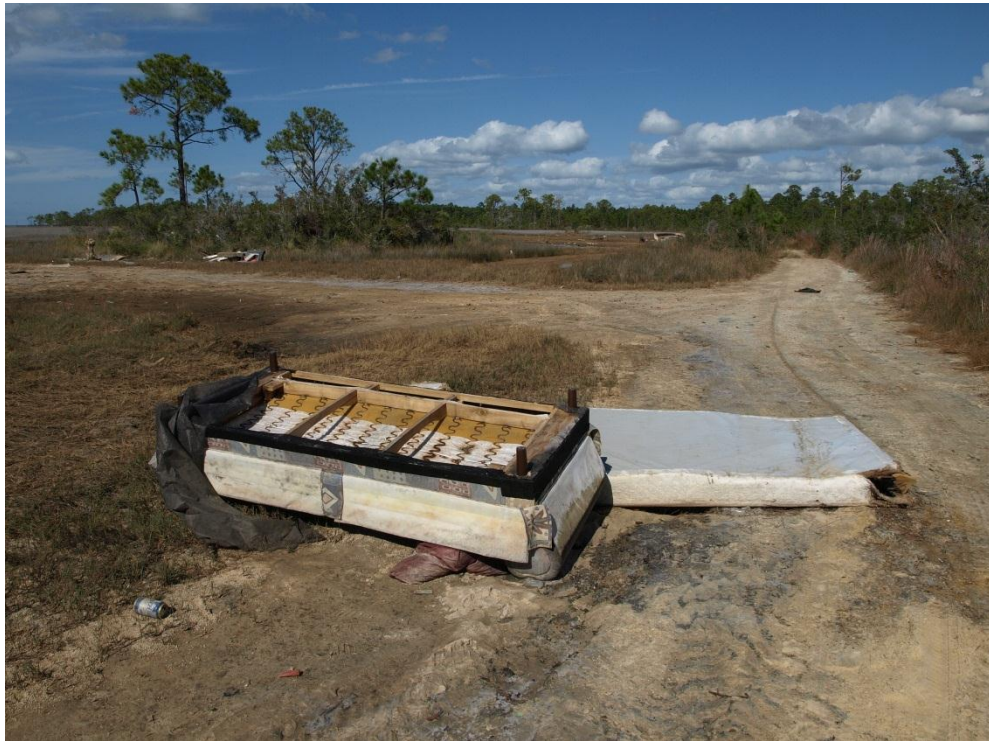
Considerable dumping of trash was noted along the access road ([Figures 8-9](#)) as has been mentioned in previous reports; however, no dumping was noted within either of the mitigation sites. Some debris (e.g., weathered pieces of lumber, plastic bottles) was found on the sites, likely the result of high tides and storm surge. It is unclear what can be done to prevent this illegal dumping along the entry road as the property is not owned by the NFWMD.

Figure 8. Evidence of illegal trash dumping along access road to mitigation sites, photo point 1 (11/8/11).

Environmental conditions appear healthy at both mitigation sites on Live Oak Point based on the 2011 annual monitoring survey. All performance criteria were met. Illegal trash dumping was observed along the entry road but not at either site. A small patch of invasive torpedo grass (*Panicum repens*) was found on the access road; no evidence of invasive/exotic species was observed on either site. It is recommended that plans be developed to burn the Lee Tract as well as investigate the management of illegal dumping offsite along the access road.

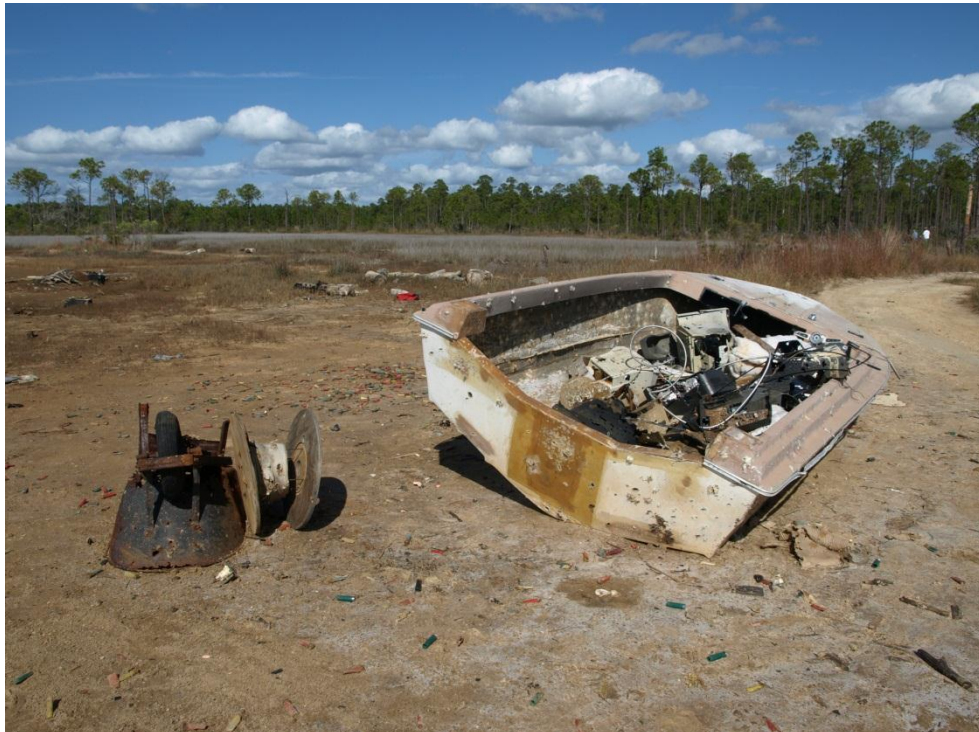
Figure 9. Additional dumping along access road, photo point 1; note scattered trash in background (11/8/11). Lee Tract is located in the upper left corner of photo, north of road.
