Northwest Florida Water Management District

Re: Progress Report 9

Please accept this submittal as the **semi-annual progress report** for the SHLMB.

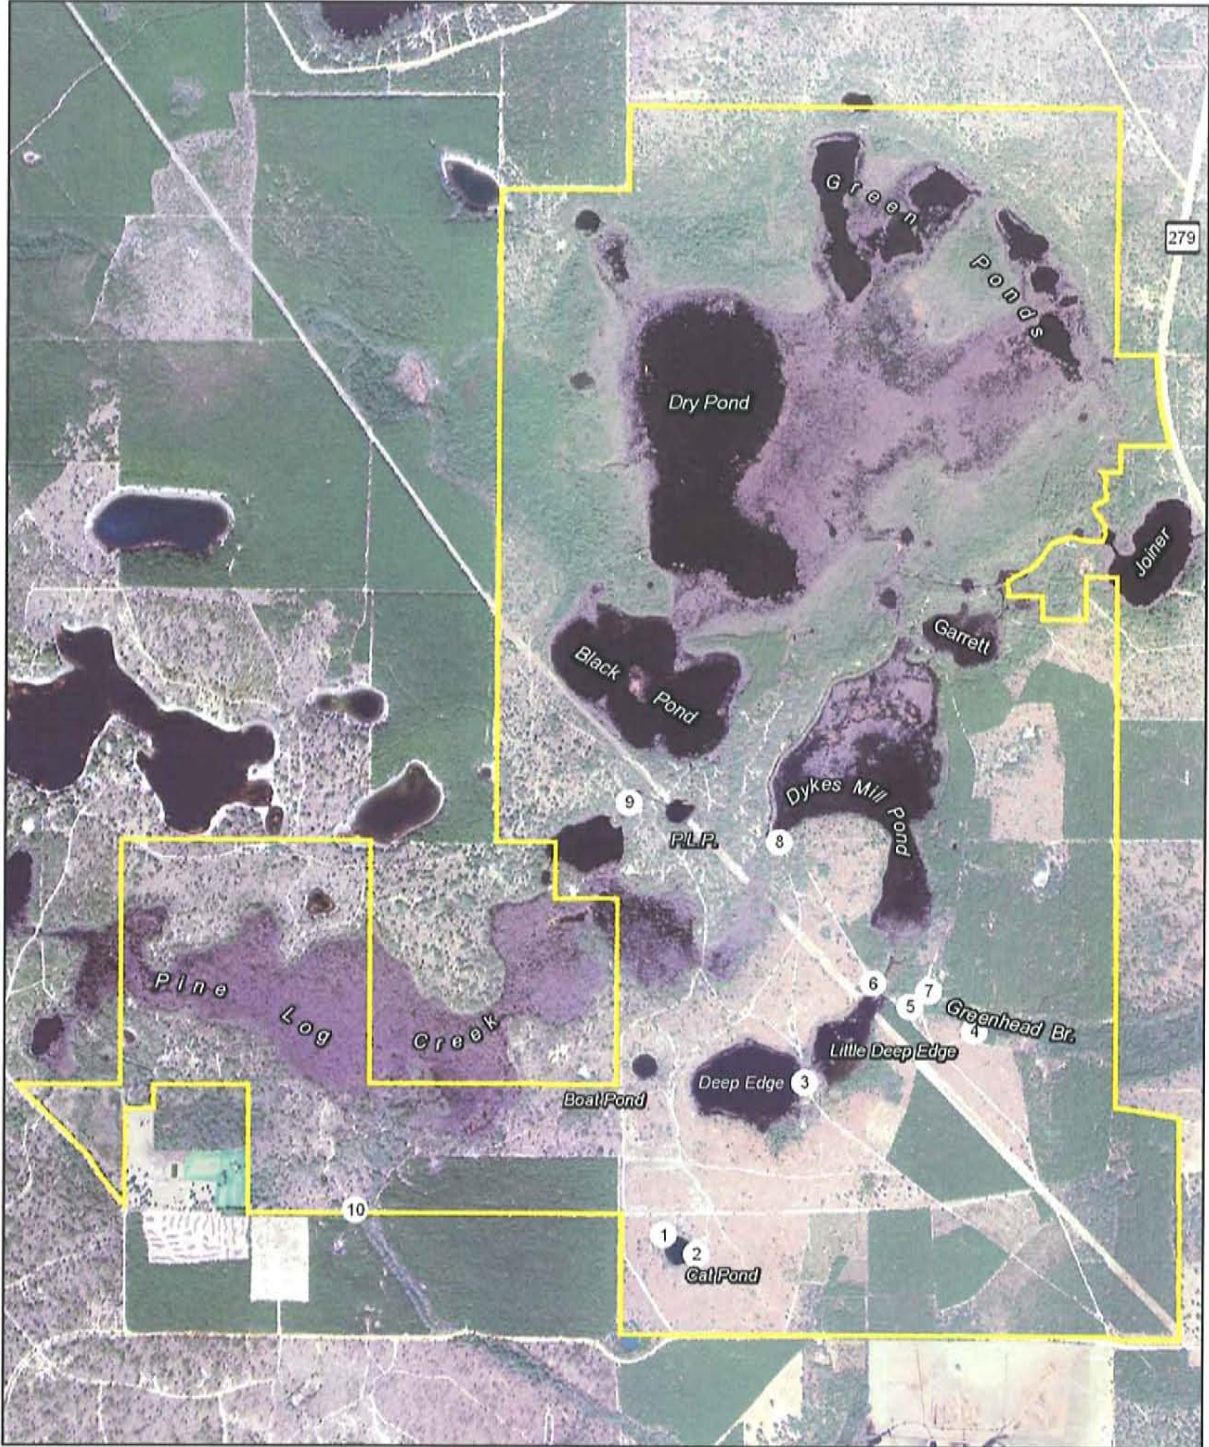
Figure 4 - Erosion Stabilization Sites

3. Due to inappropriate mulch used by the contractor, Bahia grass was introduced into the erosion stabilization areas #1, #2, #3 and #10 in 2007. These areas were treated with herbicide by BRA twice in 2008. These areas were inspected in October of 2008 and a few small patches still remained. Back Forty Solutions has been contracted to treat the Bahia grass in 2009 as needed (Figure 4).

3. Erosion areas identified with Bahia grass cover (Figure 4) will continue to be spot treated as needed.
4. One hundred forty acres of historic wet flatwoods that had dense titi cover reduced with a Gyro-Trac have re-sprouted with dense shrubs. These areas will be treated in early spring and summer with wetland approved herbicide targeting the shrubs cover without impacting the understory. These areas will be burned in the fall/winter 2009-2010.

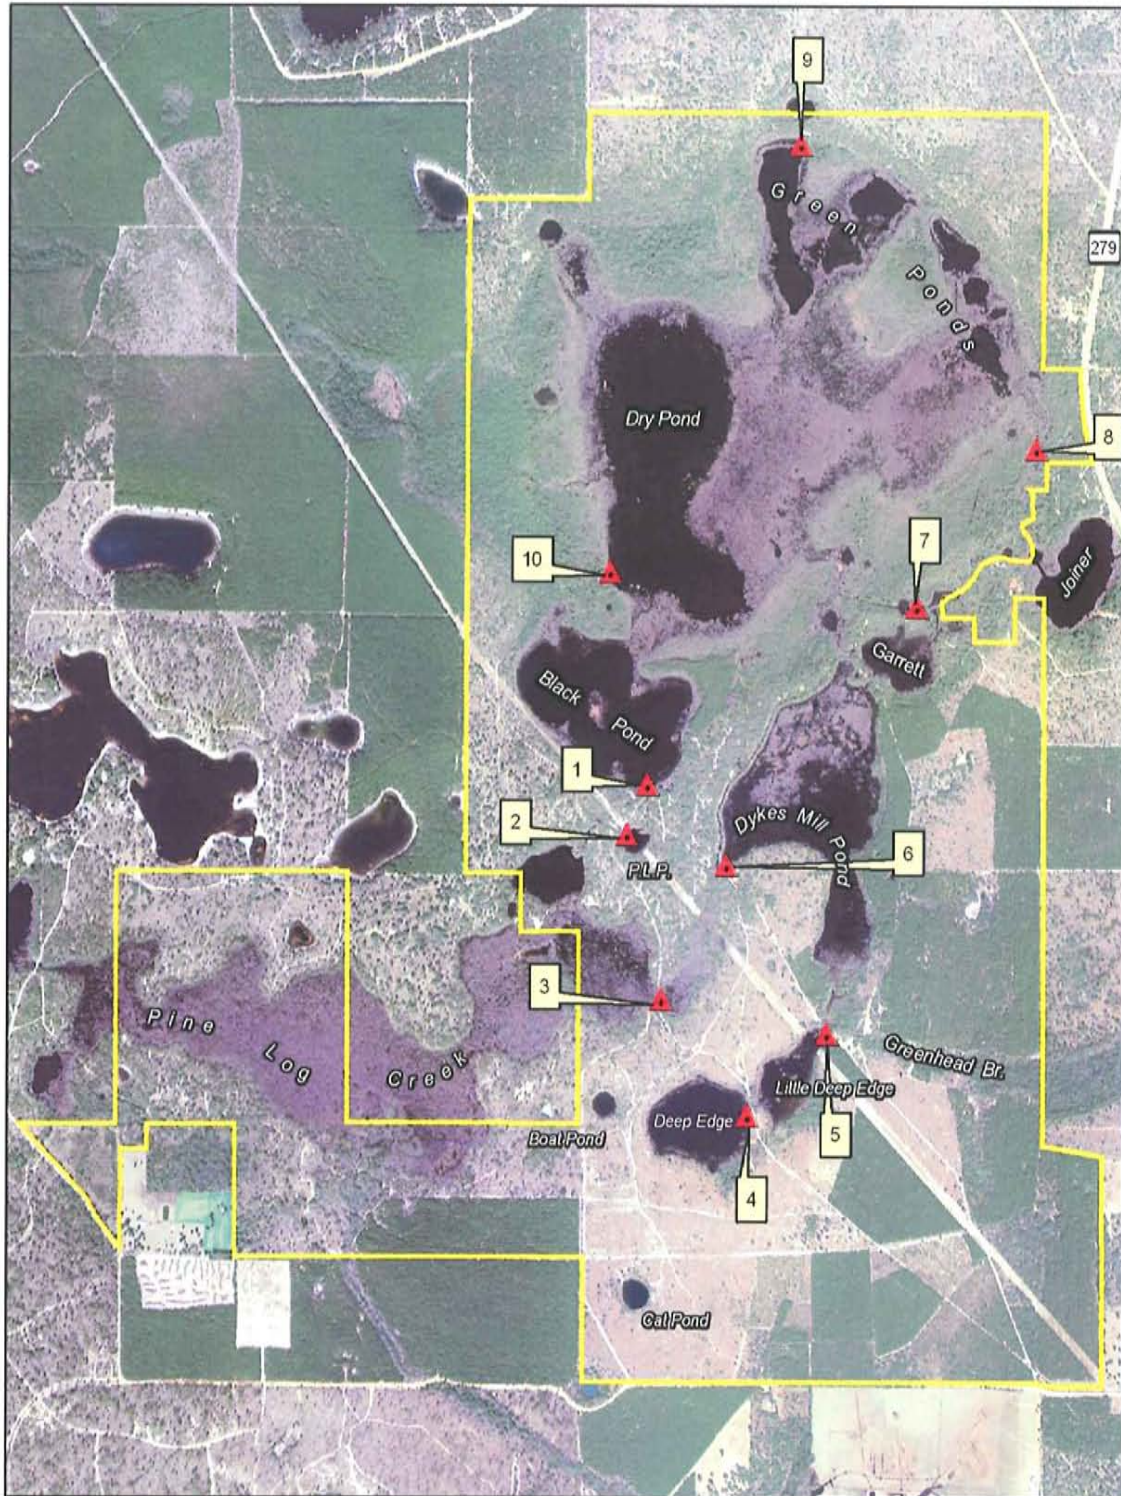
Figure 9 - Water Level Staff Gage Locations

▲ = Staff Gage (Installed 2005)

5. Water Level gauges will continue to be measured in 2009.
6. Thirteen acres of former planted pine adjacent to the field office will have the oak densities thinned to less than 150 trees per acre. (Management Unit 11). This will help to restore the sandhill to the correct densities of oaks and reduce shading of the wire grass.

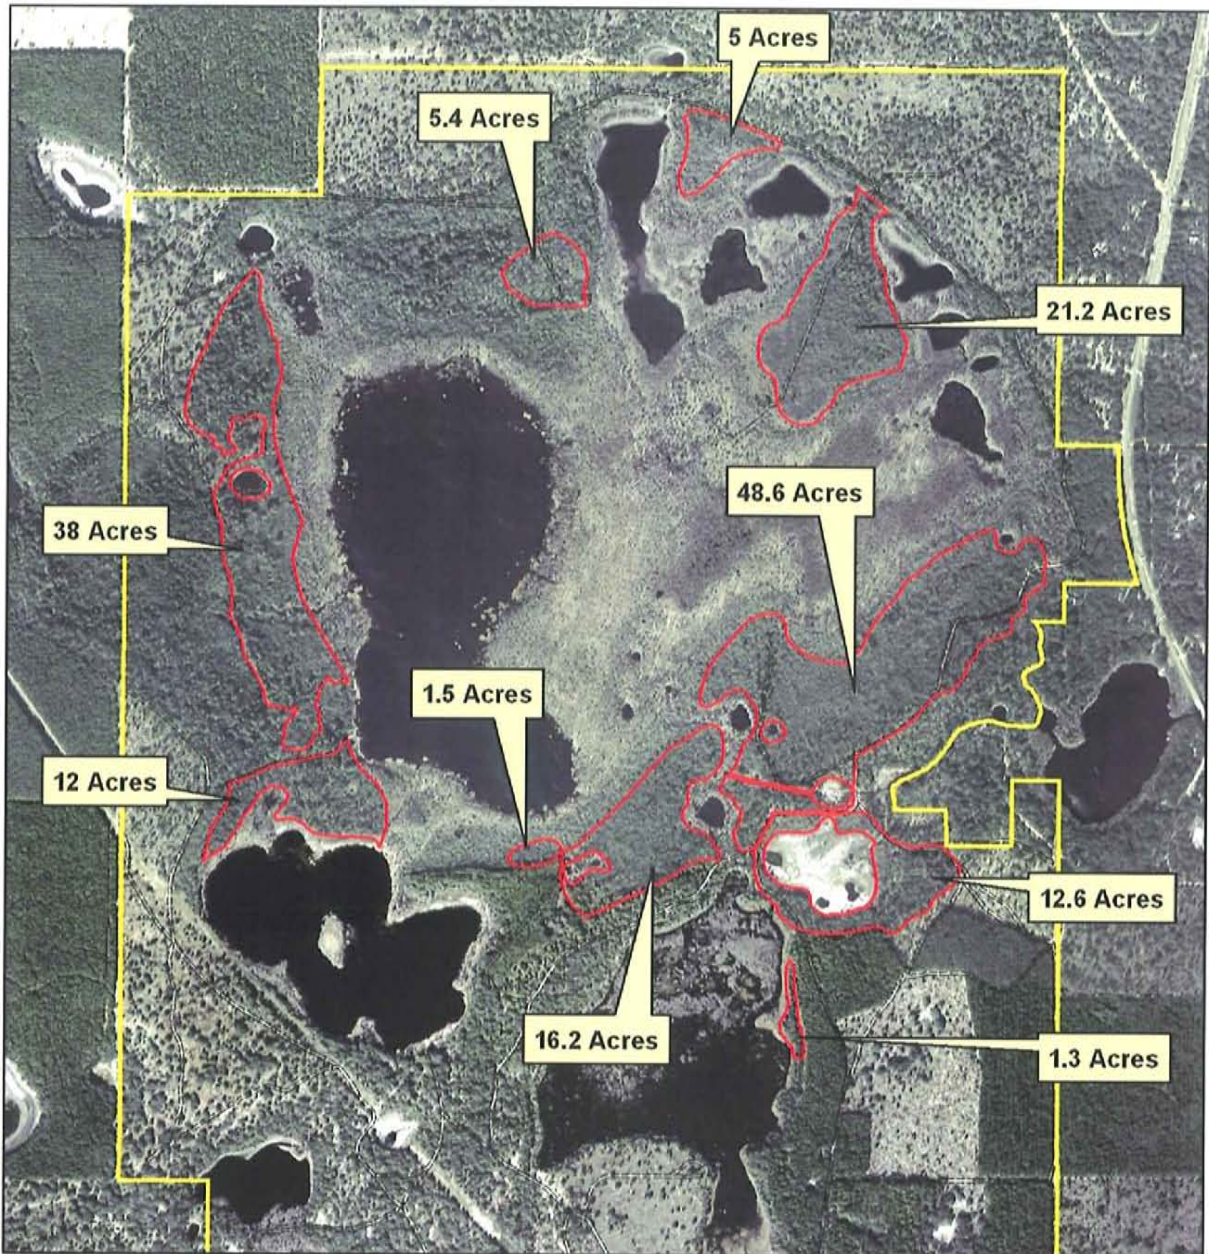
Figure 10 – Pine Flatwood Restoration – Brush Reduction

6. Twenty eight acres of historic wet flatwoods that had dense titi cover reduced with a Gyro-Trac had re-sprouted with dense shrubs. As a test to determine if shrubs could be further reduced without impacting the understory, selective herbicides were employed. The areas targeted were a 12 acre polygon known as the Whale with dense re-sprouts approximately 1-

2' in height, and a 16.2 acre polygon adjacent to Dykes Mill Pond and Dry Pond with re-sprouts 3 - 4' in height. Two treatments, using wetland approved herbicides were conducted 65 days apart by Biological Research Associates. Total shrub cover was reduced from greater than 85% to approximately 15% without impacting the understory vegetation. Following the herbicide treatments, the 16.2 acre polygon was burned and planted with wire grass. Both sites will be further evaluated this summer and fall (Figure 10).

Northwest Florida Water Management District
Sand Hill Lakes Mitigation Bank (SHLMB)
Brush Reduction (Gyro-Track Mulching) - ~165 Acres
Section 6, Township 1 North, Range 14 West
Washington Co., Florida

The greatest challenge at the bank has been restoring historic wet flatwoods. These systems have become dominated by 20' black titi and other shrubs due to fire exclusion. As a first step, the Gyro-Trac was an excellent tool for the initial shrub reduction. However, shrub densities returned following the shrub reduction and burning. Within one year following the Gyro-Trac and burn treatments shrub densities increased to greater than 110 stems per meter squared. Without further treatment, these areas would return to wetland shrub forests within 3 – 5 years. In an effort to further control the shrubs, two test plots (28 acres) were established. Shrubs were treated with wetland approved herbicides that target the shrubs without impacting the understory. Results using this technique have shown excellent results. Shrub cover was reduced from 85% to less than 15% and understory vegetation cover appears healthy and expanding.

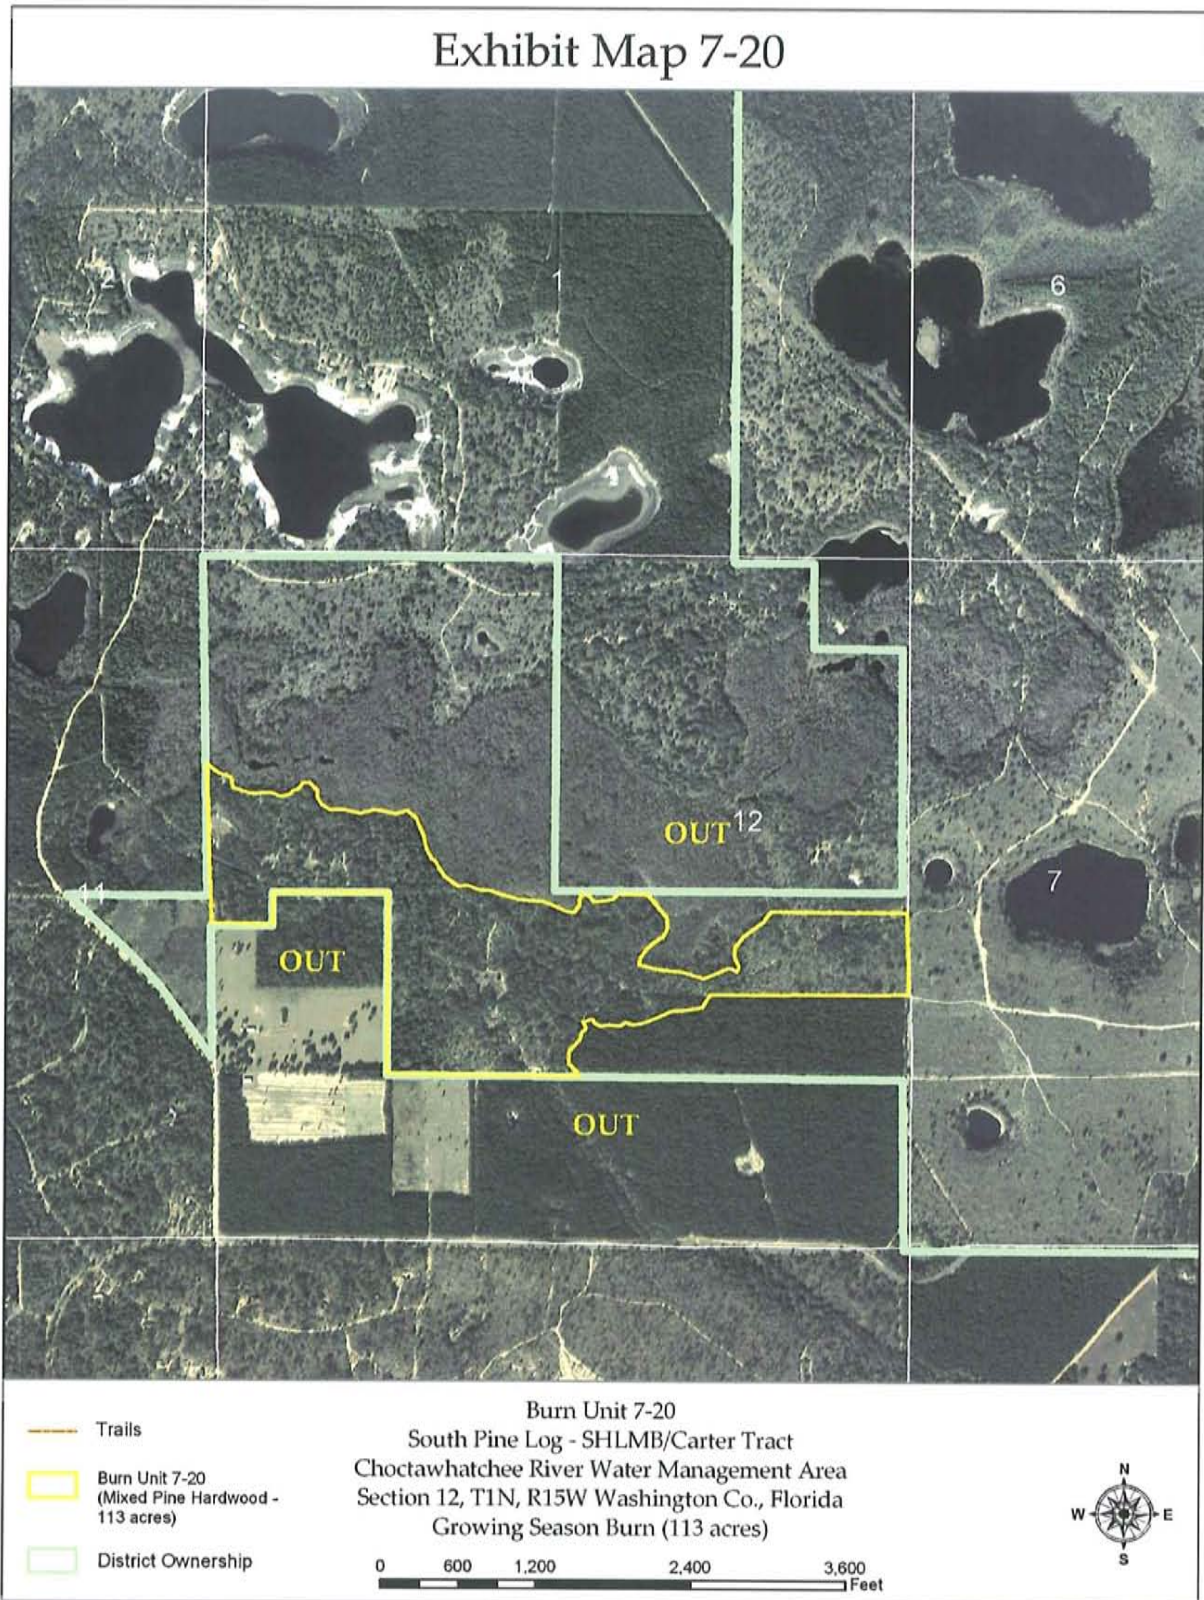
Figure 11. Warm Season Burn – 113 Acres South Pine Log

7. A total of 138 acres of warm season burns were conducted at the SHLMB. A 113 acre burn was conducted adjacent to Pine Log Creek and a growing season burn was conducted for the 25 acres surrounding Garret Pond (Figure 11 and 12).
8. A total of 32 acres of wet wire grass (154,880 tublings) were planted in December 2008 (Figure 13).
9. A total of 53 acres of upland wiregrass (256,520 tublings) were planted in December 2008 (Figure 14).
10. A total of 319 acres of long leaf pine (139,084 seedlings) were planted in December 2008. This completes the re-forestation efforts at the SHLMB (Figure 15).
11. A total of 246 acres of winter burns were conducted at the SHLMB between November 2008 and January 2009. The majority of the burns were site prep burns following timber harvest (208 acres of uplands) as well as 38 acres of wet flatwood restoration (Figures 16-21).
