PERDIDO RIVER WMA – PHASE II MITIGATION SECOND ANNUAL MONITORING REPORT

US 90 Escambia County SAJ-2007-5634 IP-AWP Issued 09/19/08

Mitigation: Perdido River WMA-Phase II

Monitoring Date: November 5, 2009

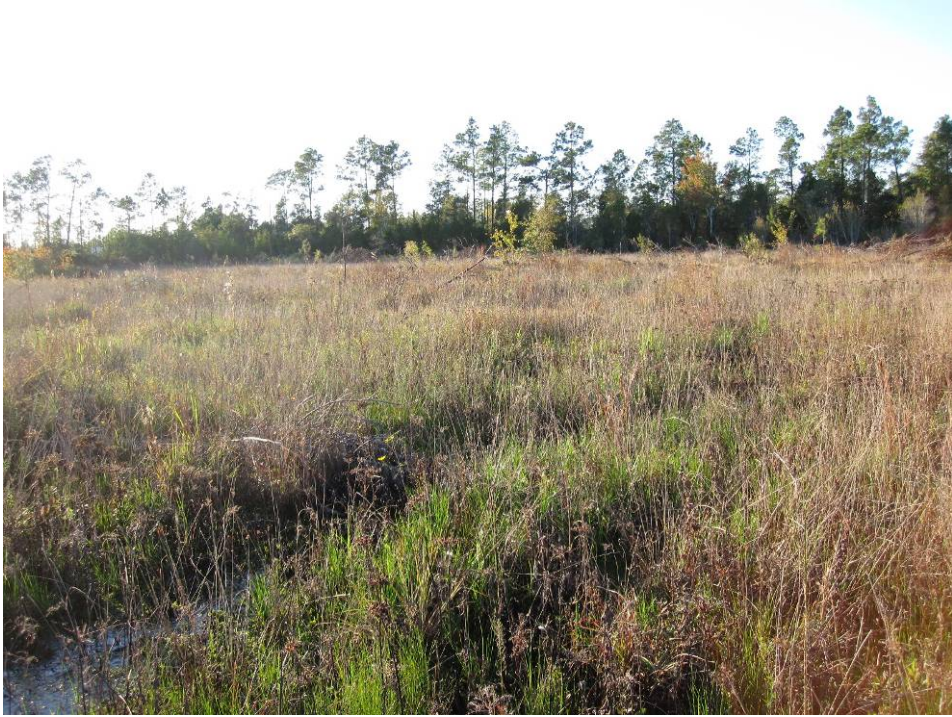
Forested Mixed Wetlands Restoration Area

Area I W: Recovering well, good recruitment

Area I E: Recovering well, good recruitment

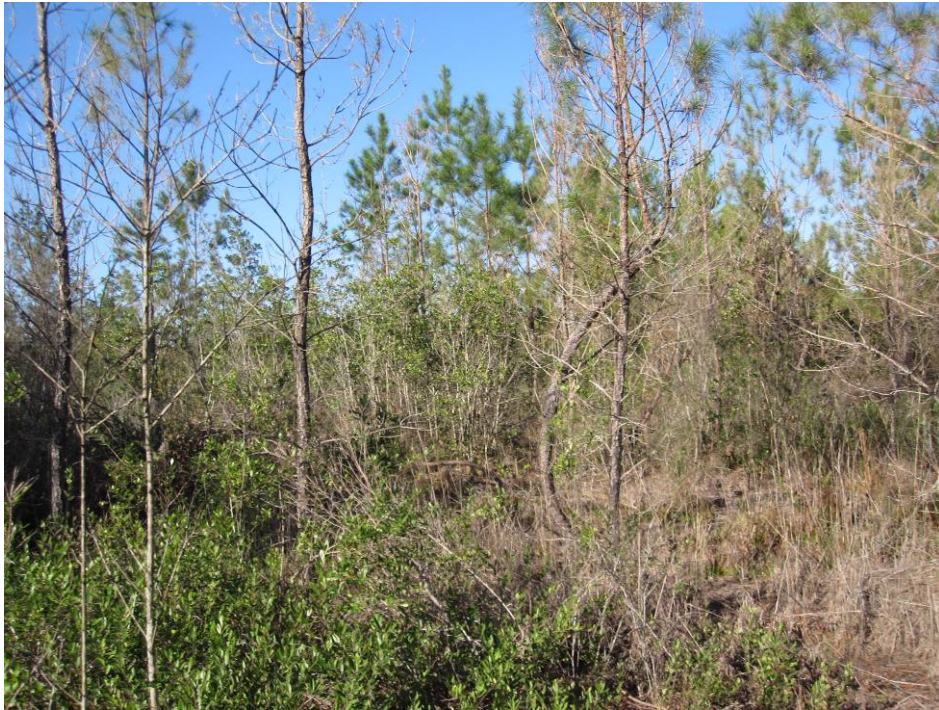
Hydric Pine Flatwoods Restoration Area

Area IV: trending to success; planted pines are intermittently alive and dead (which is good)

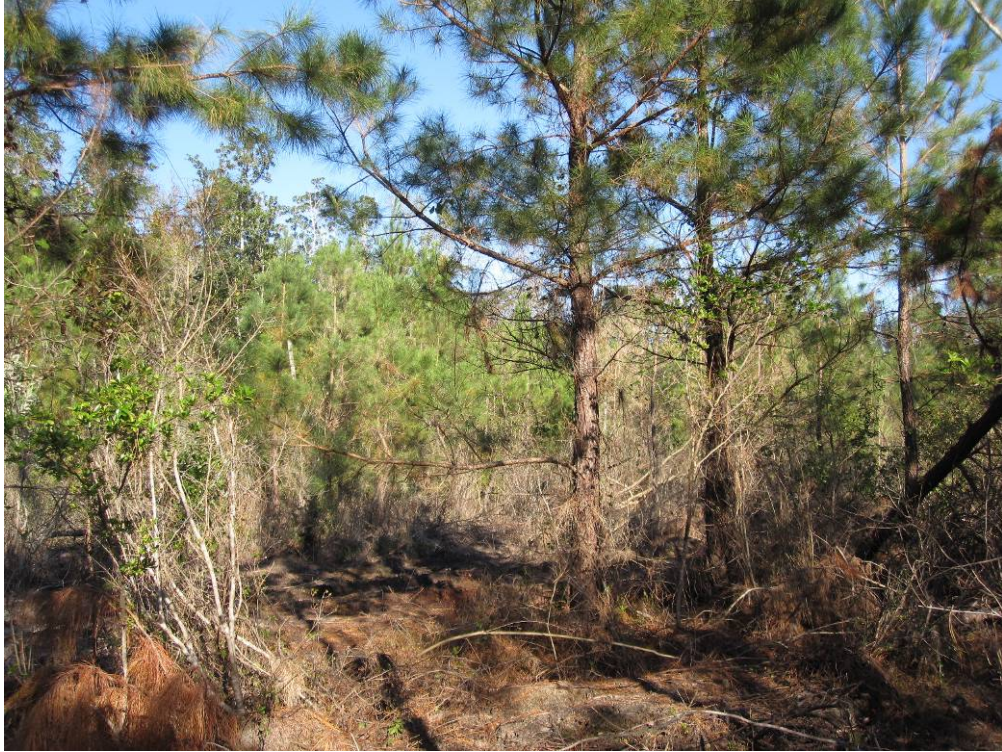
Mesic Pine Flatwoods Enhancement Area

Area V: only slightly drier than IV

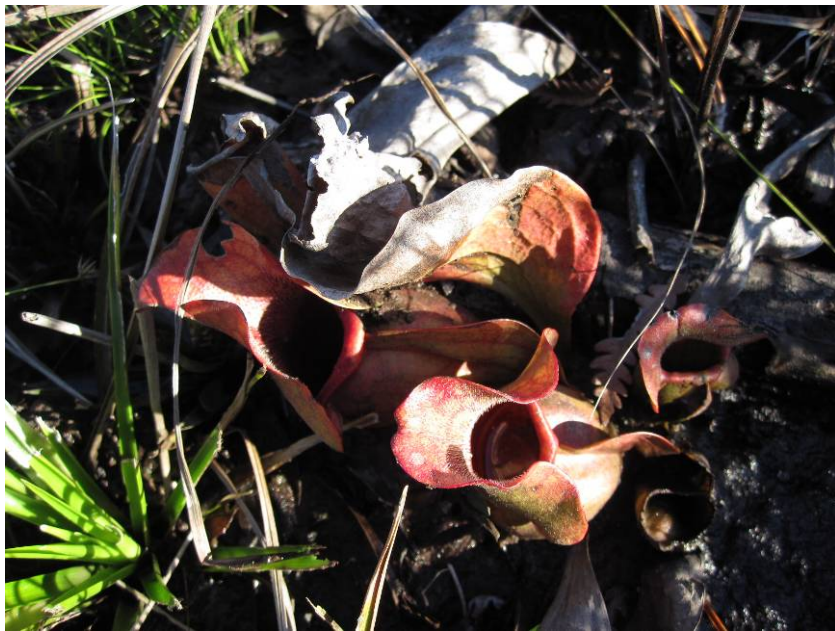
Sarracenia rosea in Area III, Forested Mixed Wetlands Enhancement

Area III: inundated with clear, shallow water; typical of seepage, sphagnum ground cover is common
