Northwest Florida Water Management District

Re: Progress Report 4

Please accept this submittal as the fourth semi-annual progress report for the SHLMB.

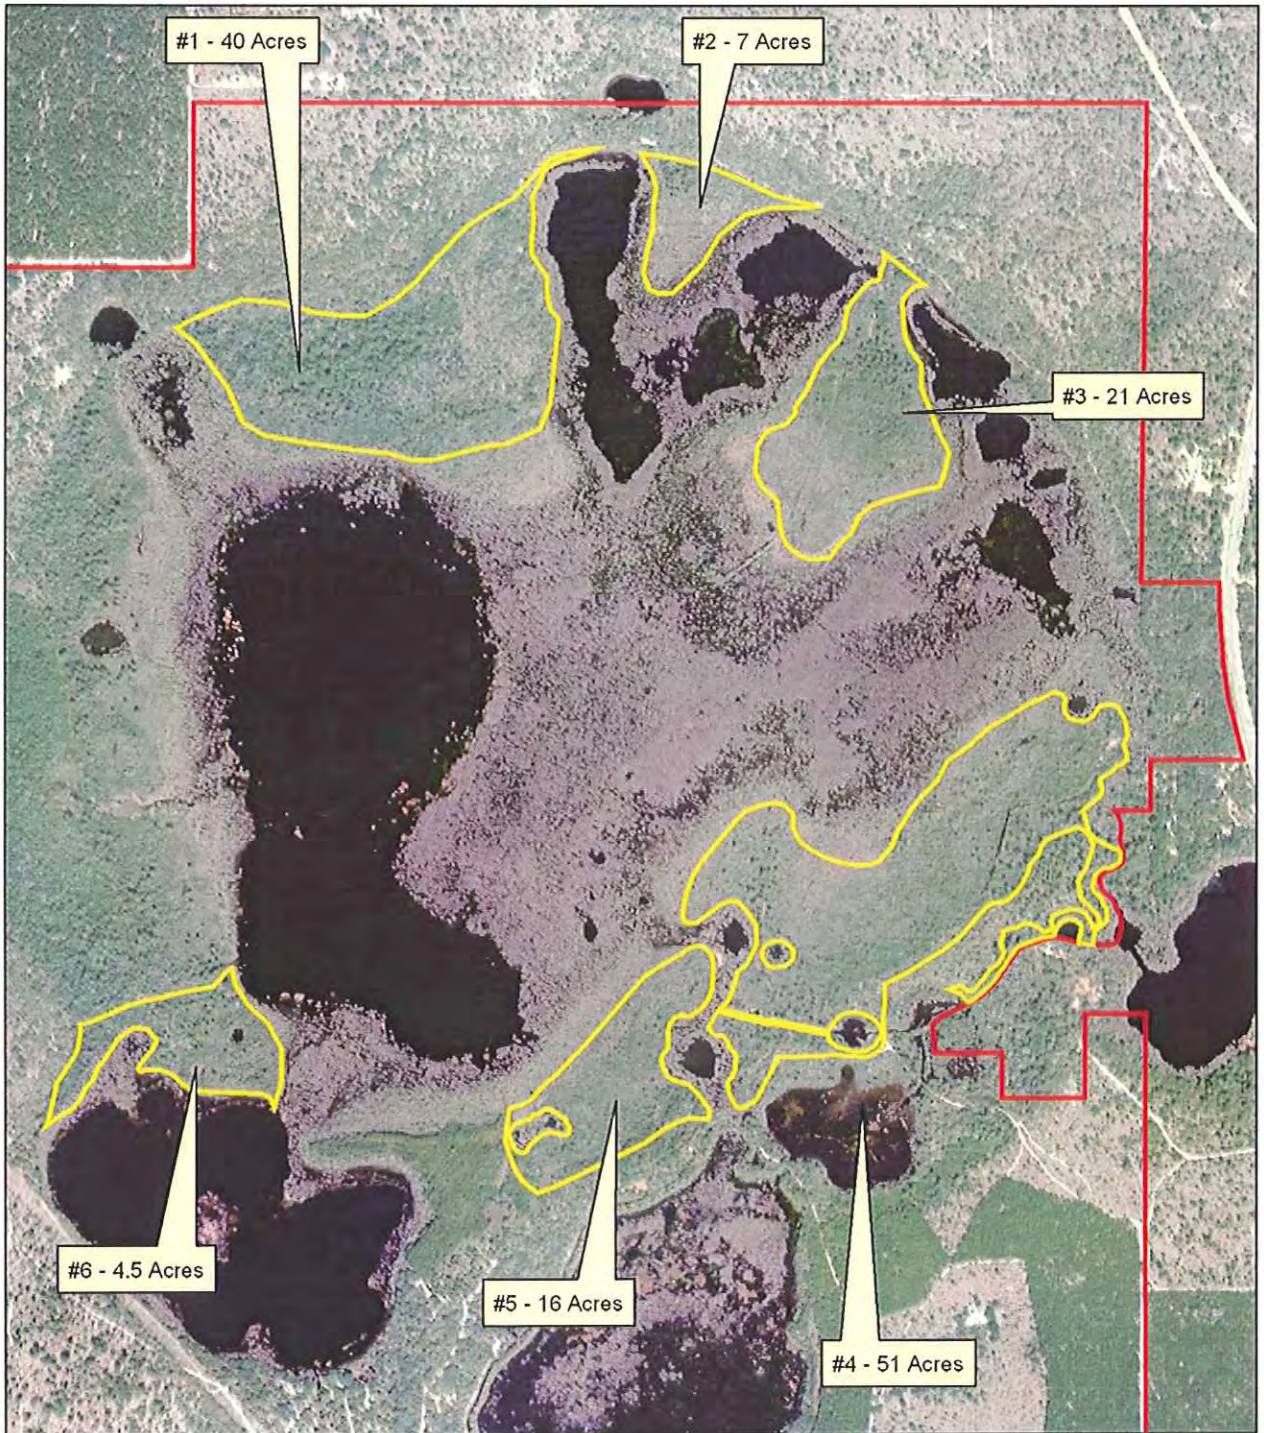
Figure 1. Brush Reduction Polygons

2. A Gyro-track has been used in the wet flatwoods area to reduce the shrub layer (Figure 1). Shrub reduction was initiated in February of 2007 and is expected to be completed by August of 2007. To date approximately 82.5 acres have had shrubs removed. An additional 58 acres will be gyro-tracked by August of 2007.

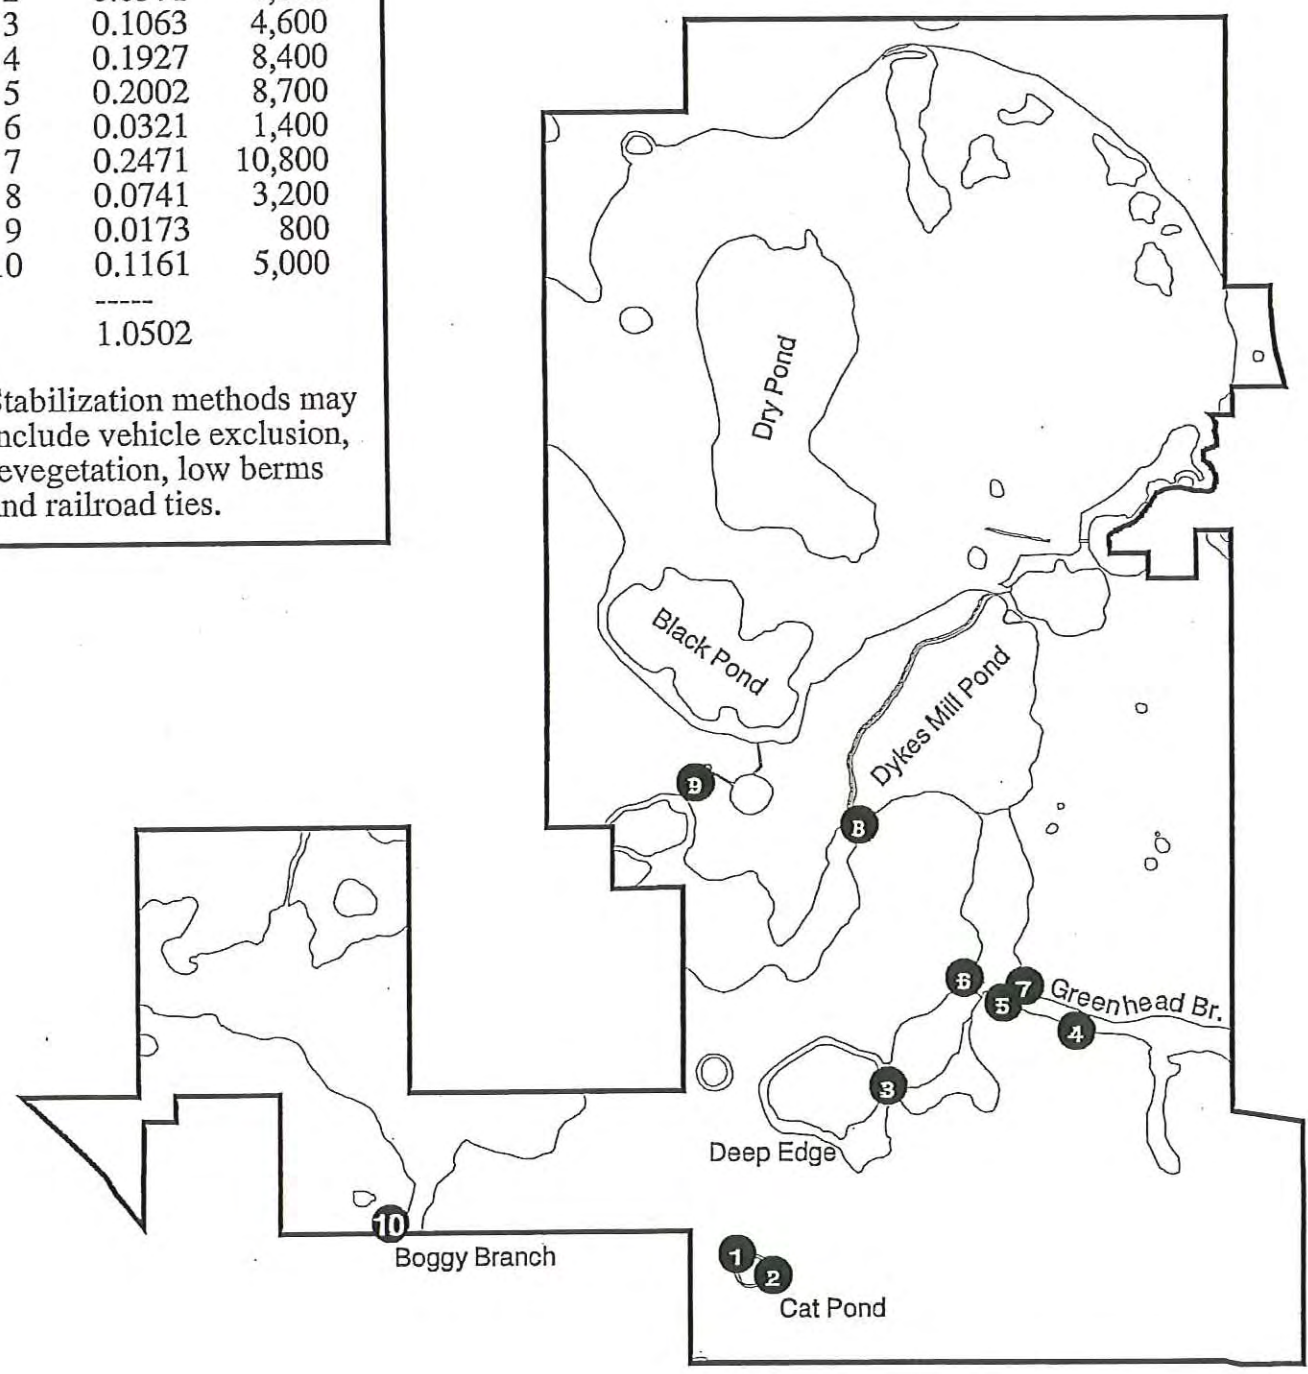
Figure 9 - Erosion Stabilization Sites

4. The remediation of erosion areas #6 occurred as part of erosion control in summer of 2006 (Figure 9). Remediation of three road-fill crossings and remaining 9 erosion areas was initiated January, 2007 and completed in March of 2007 (Figure 9 and 10 and Typical Road Cut Sheet 3 of 7). Silt fences and turbidity barriers were installed and maintained. Following earth moving annual rye grass was planted. Erosion areas were planted within 30 days in accordance with the planting plan (Attachment D). Wire grass was planted on 3' centers.

Stabilization methods may include vehicle exclusion, revegetation, low berms and railroad ties.

-Scattered Bahia grass seedlings have been observed within the erosion stabilization areas #1, #2, #3 and #10. Orange Hill Soil and Water Conservation District inadvertently applied mulch contaminated with Bahia grass seed to the sites listed above. Orange Hill has agreed to herbicide all Bahia grass within these areas using hand sprayers and appropriate chemicals as well as re-plant any damaged plant material.

-Due to the drought, the majority of the planted material in the erosion areas, bridge embankments and road fill removal areas has died. These areas will be re-planted next year in accordance with the planting plan. However, in order to prevent erosion when the summer rains finally begin, the areas will be seeded native grasses or a mixture of native upland meadow species.

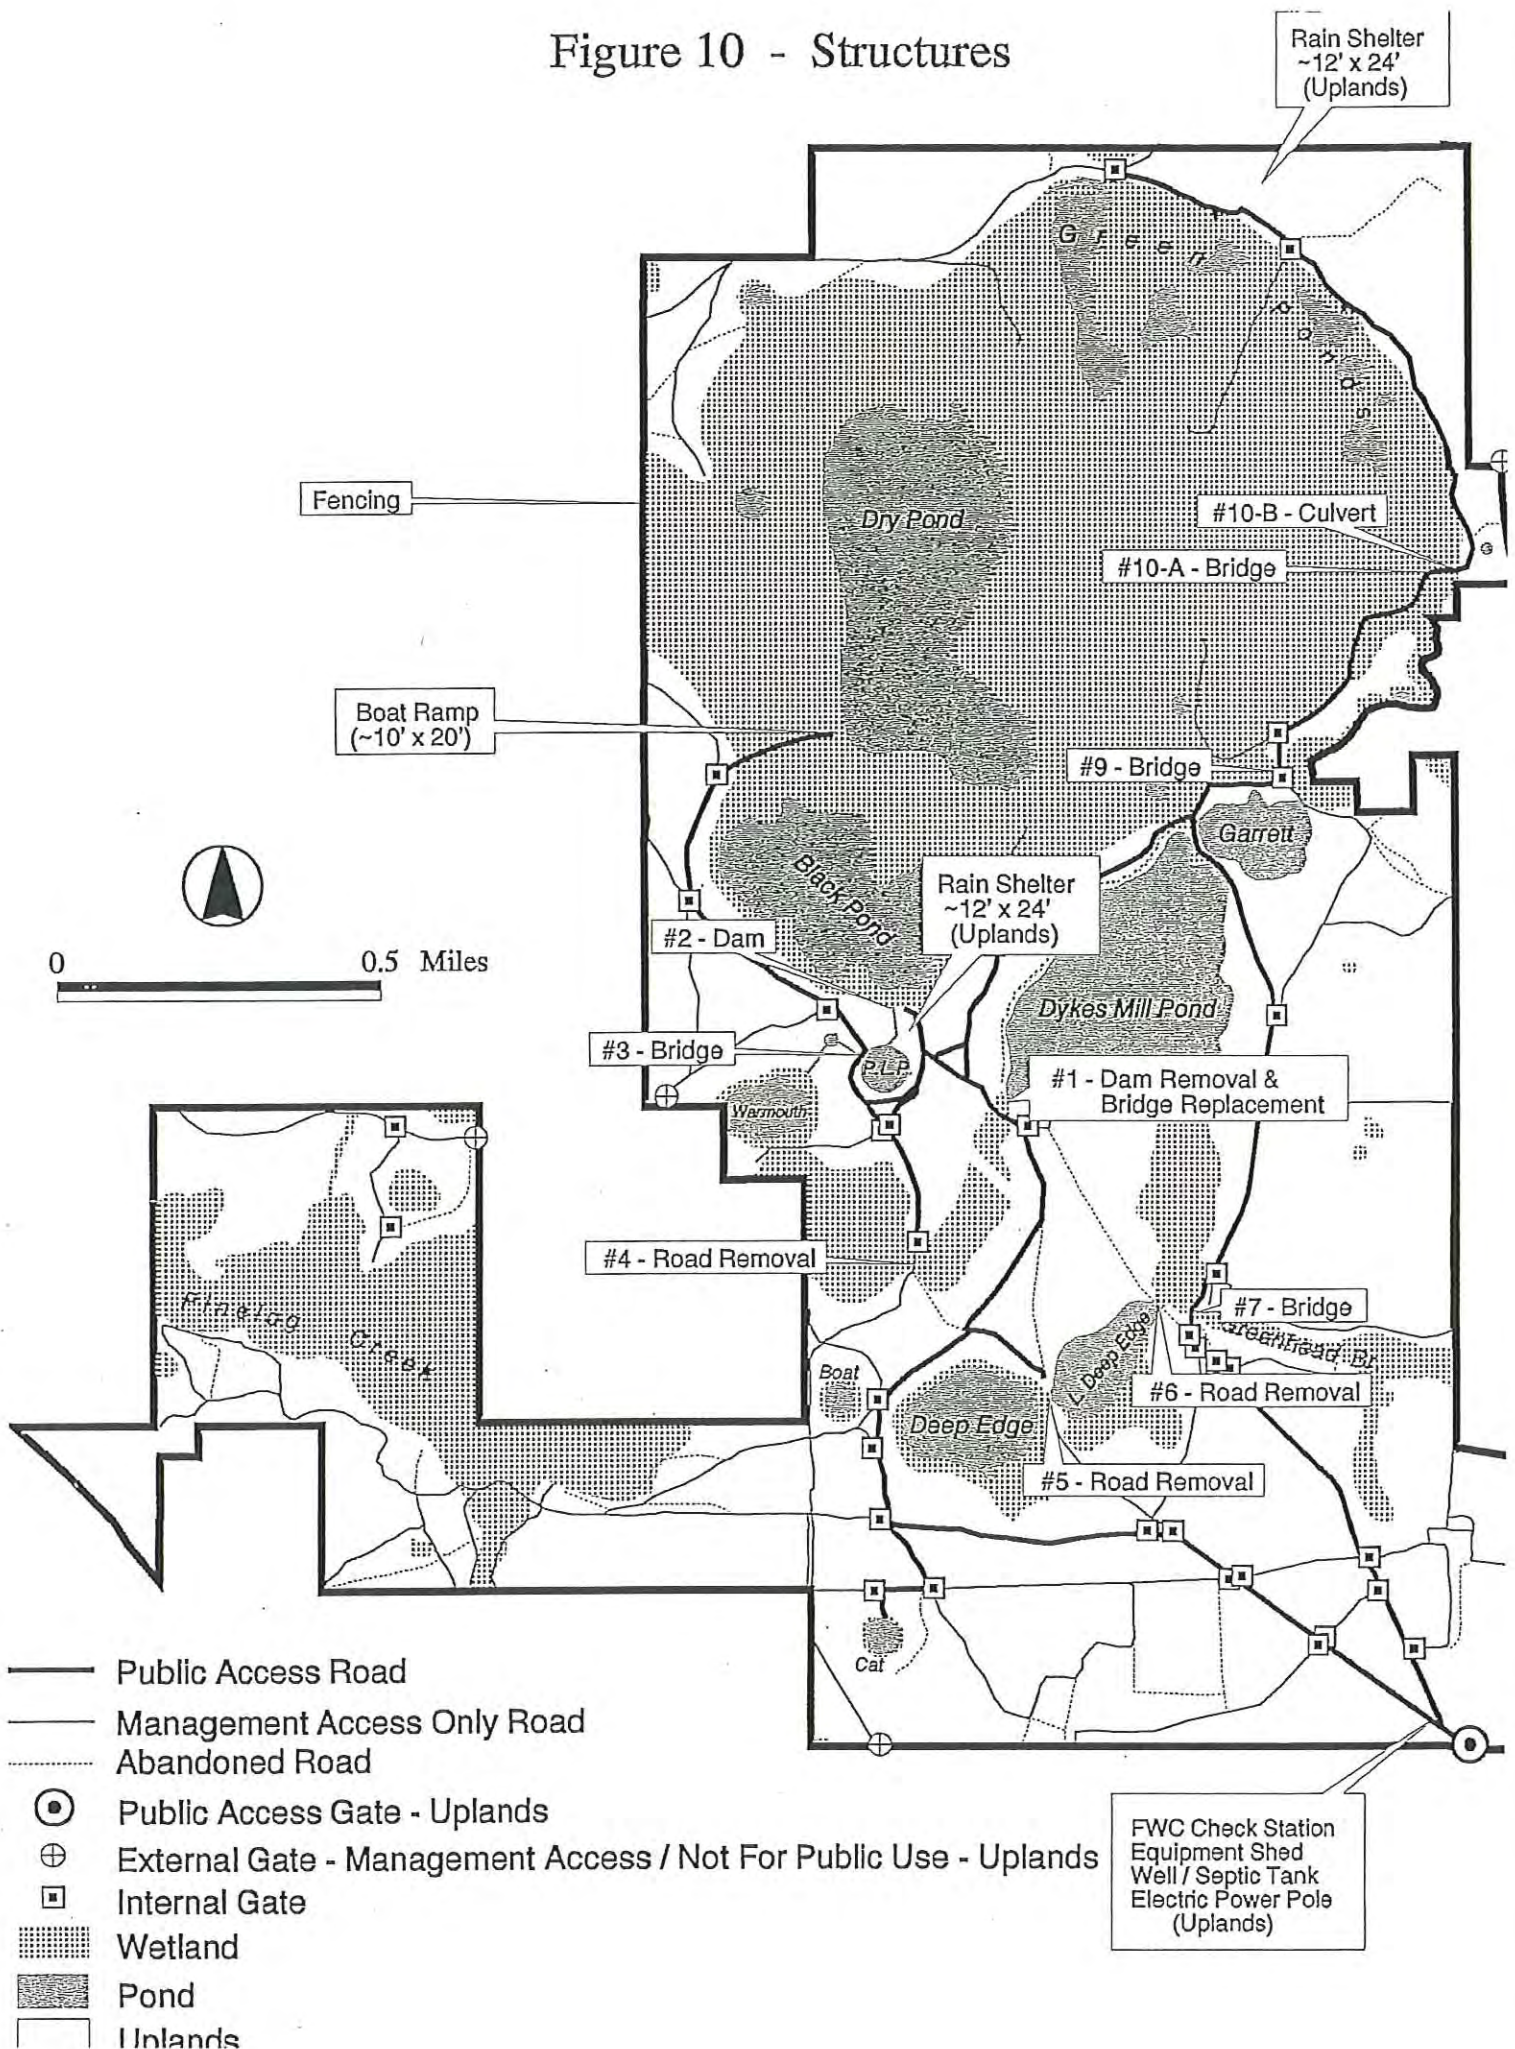
Figure 10 - Structures

3. Construction on three bridges and two culverts was completed in early April of 2007 (Figure 10, Typical Bridge Design Sheet 2 of 7, and Typical Culvert Installation Sheet 4 of 7). All construction was completed in compliance with permit drawings. Permit and as-built drawings have been included for your review (Appendix 1). Photos included in Appendix 2.

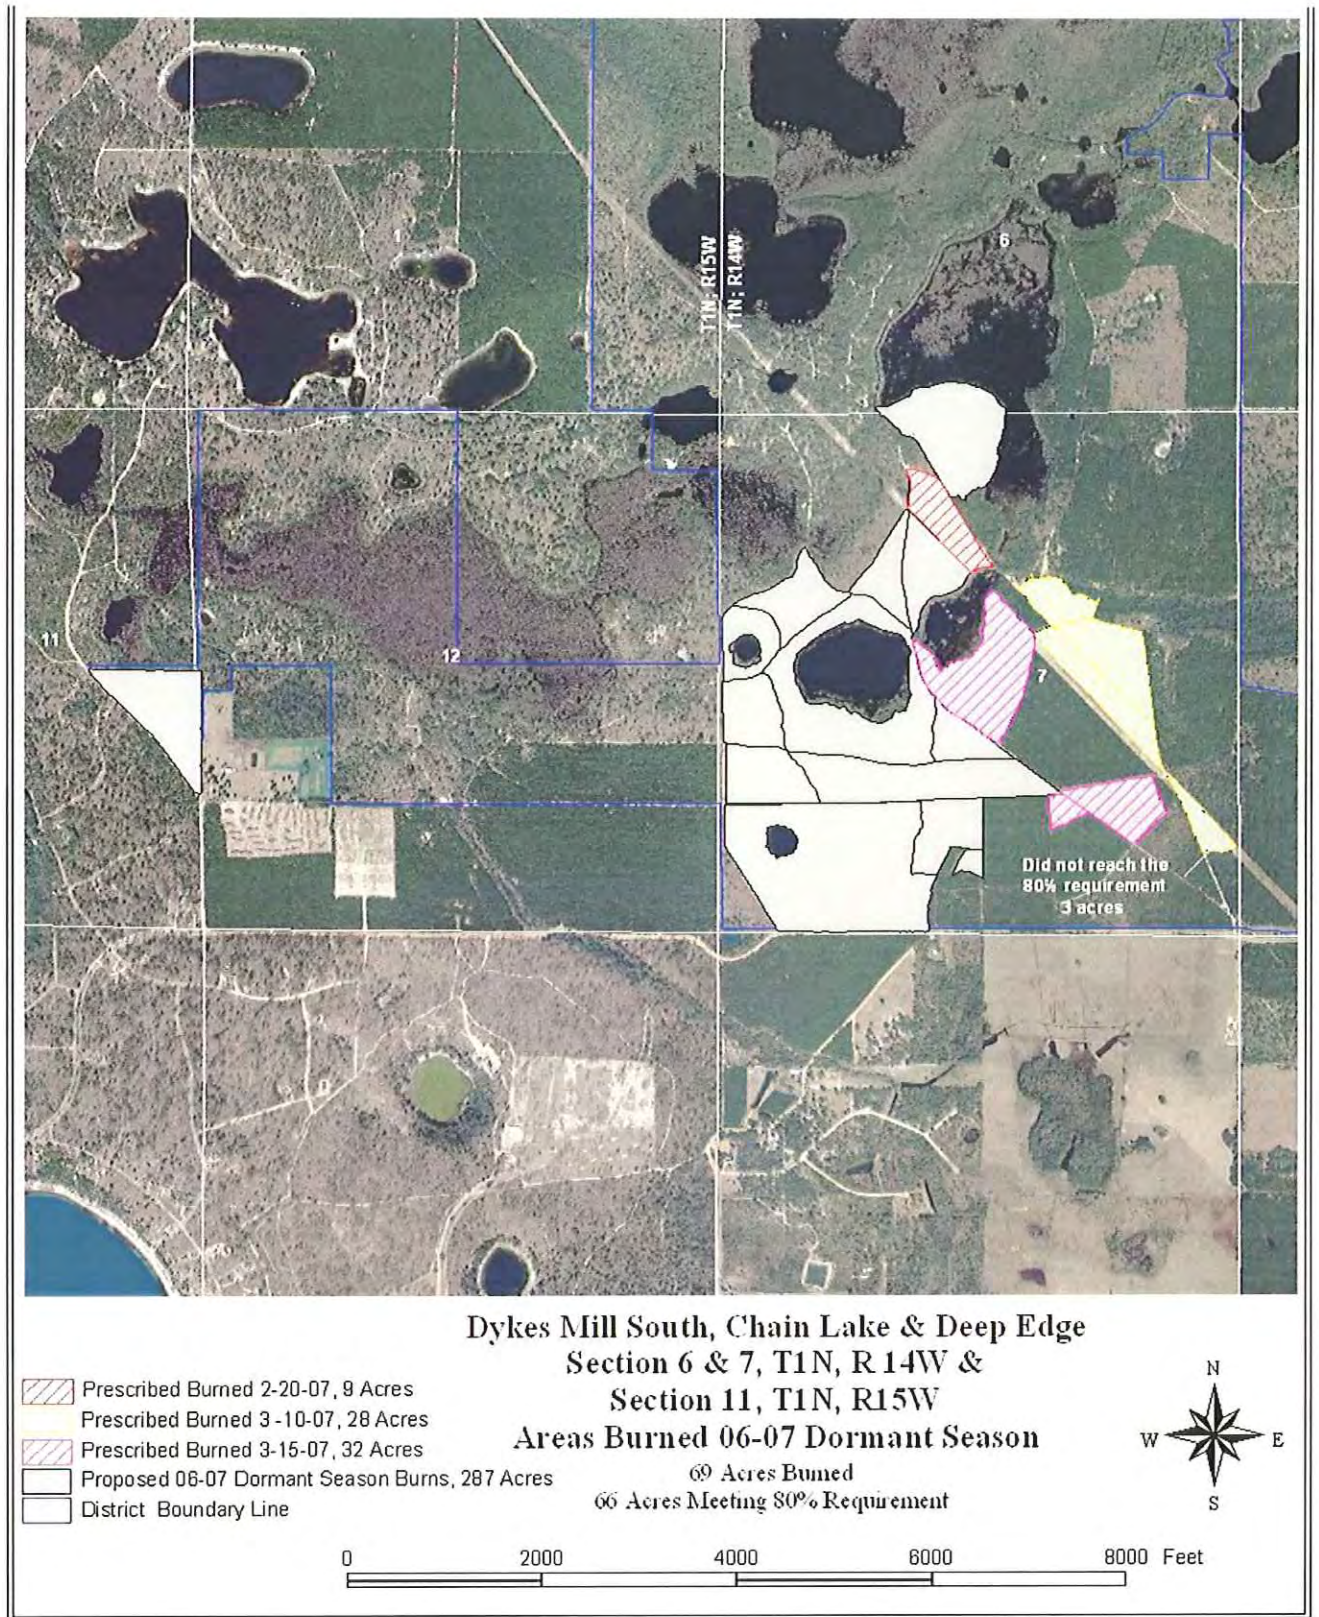
Figure 11. Winter burns at the SHLMB

8. Several winter burns were attempted in 2007. However, due to the drought, low humidity and higher winds than anticipated. Several of the planned burns were postponed due to the danger of wildfire. Completed, attempted or postponed winter burns are shown in Figure 11.

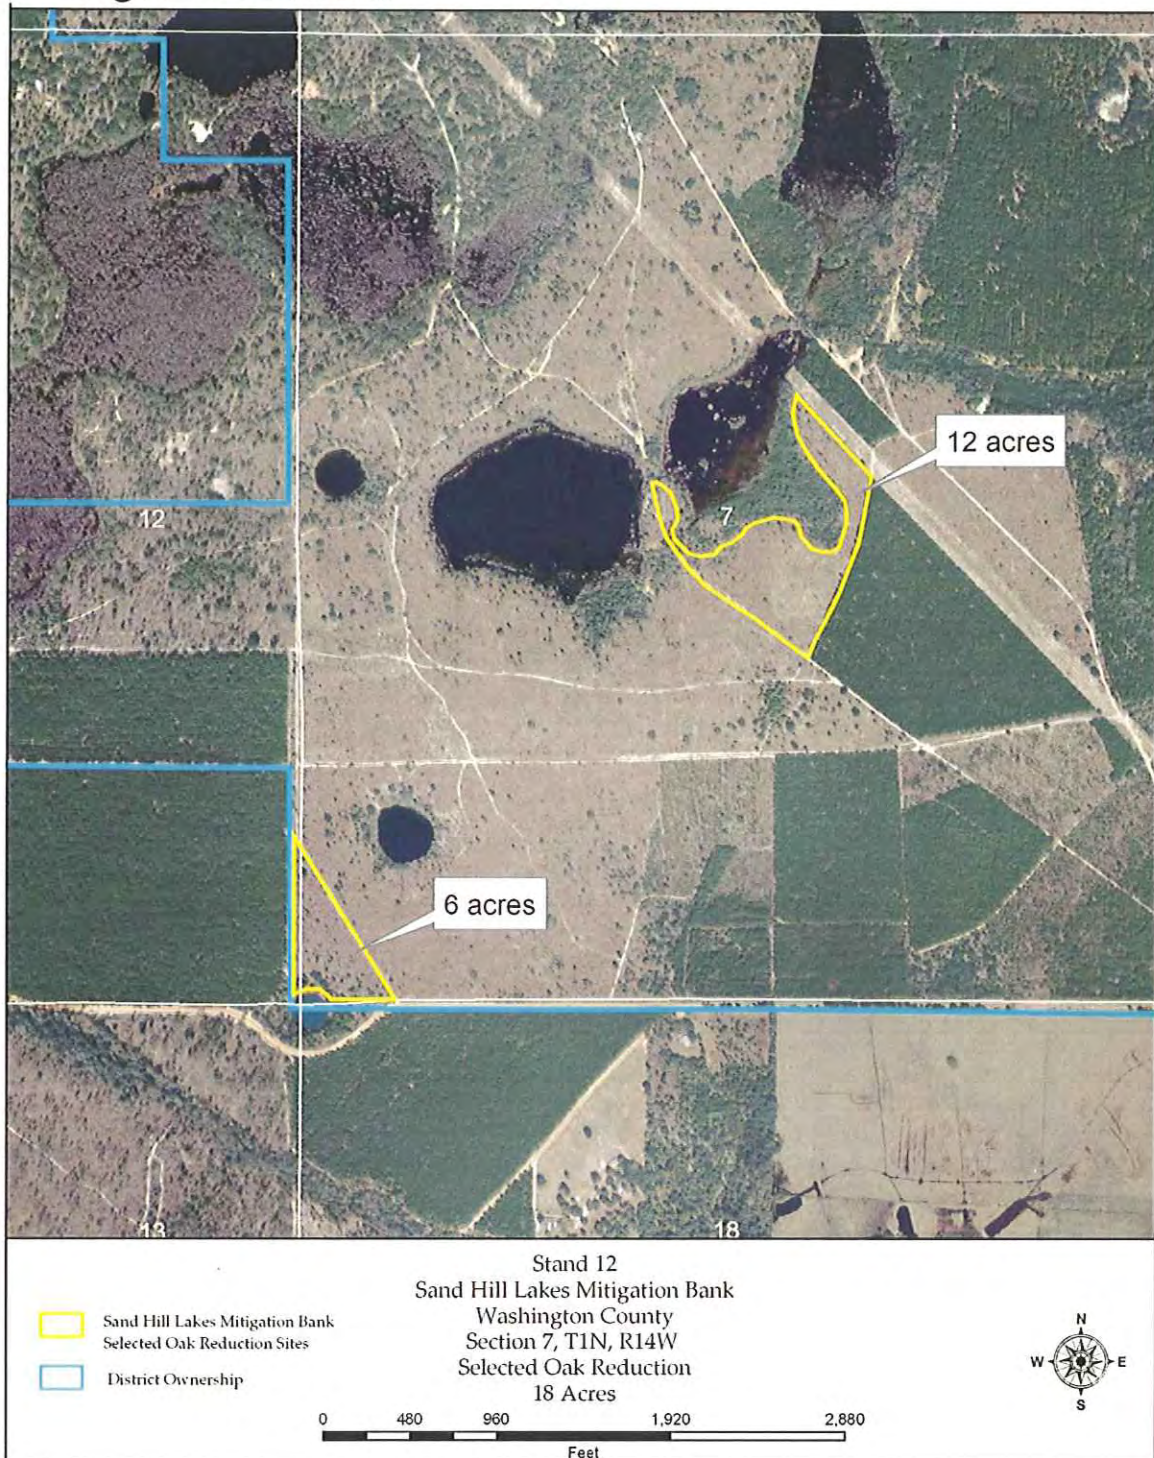
Figure 12. 2007 Oak Reduction: Adjacent to Little Deep Edge and Cat Pond

1. Oak trees will be thinned in approximately 6 acres surrounding Cat Pond and 18 acres adjacent to Little Deep Edge (Figure 12). These two areas contain high quality sand hill community that has been degraded by dense oak stands. Thinning of oaks within these areas should improve the quality of the sand hill habitat.

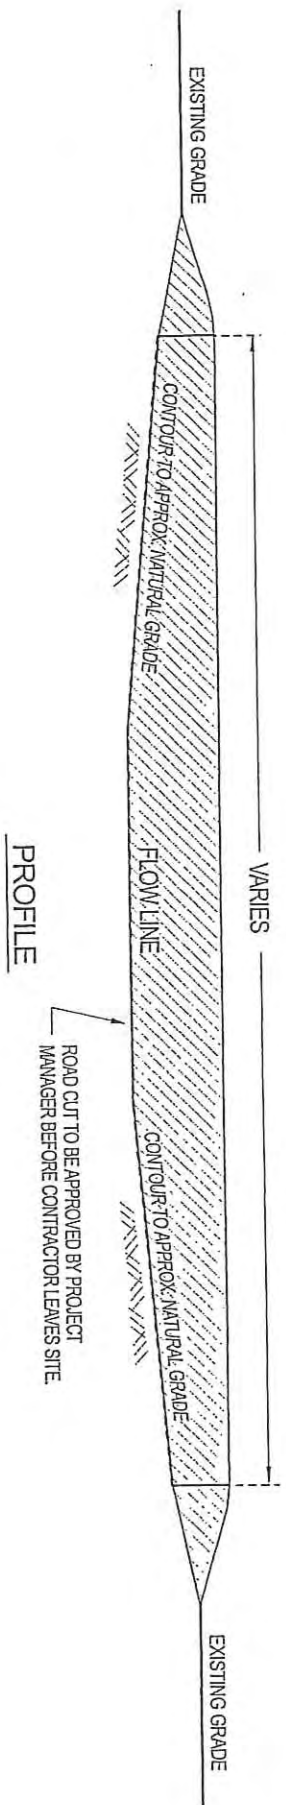
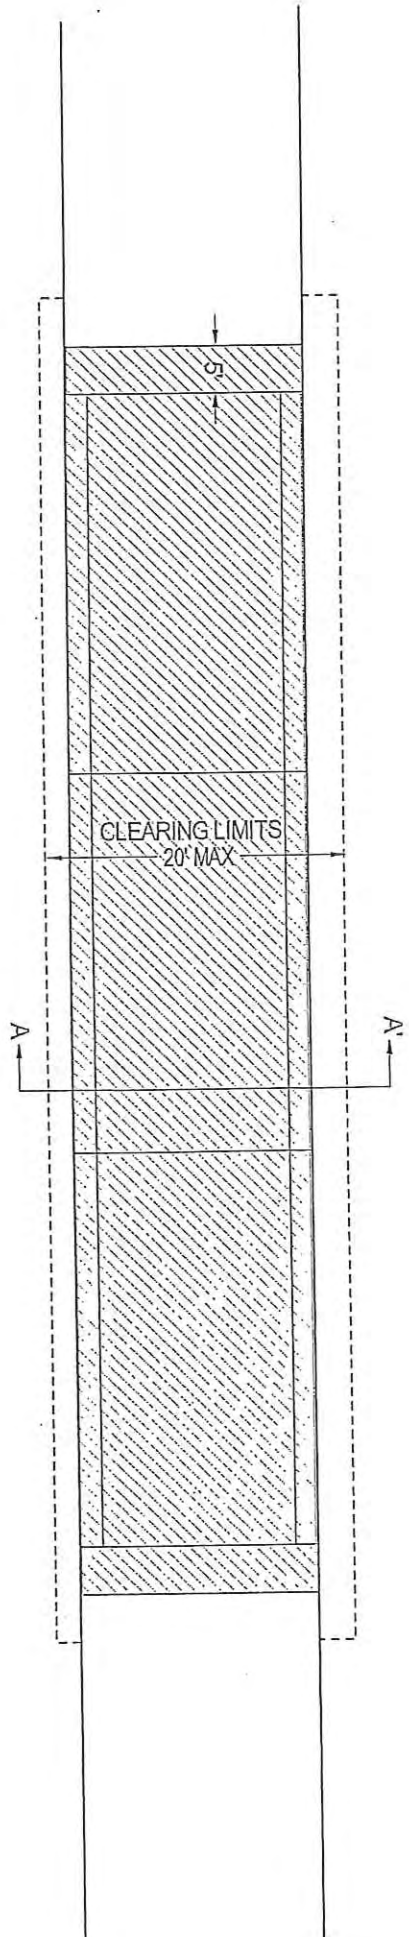
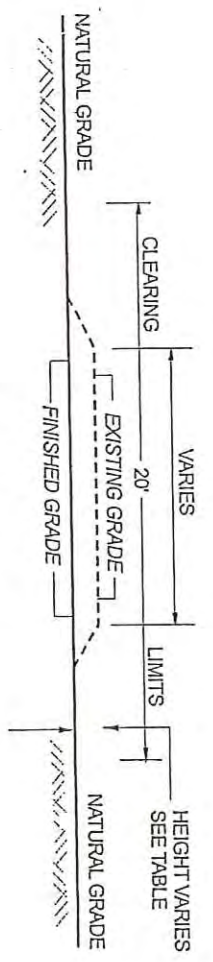
TYPICAL ROAD CUT

1. REMOVED MATERIAL TO BE PLACED IN ERODING UPLANDS OR OTHER APPROPRIATE UPLAND DISPOSAL SITE.
2. ALL MATERIALS TO BE PROVIDED FROM SITE.
3. VEGETATION ALONG SIDES OF ROAD TO BE REMOVED BY CONTRACTOR WHERE NECESSARY. REPLANT FORMER ROAD FOOT PRINT TO MATCH SURROUNDING COMMUNITY.

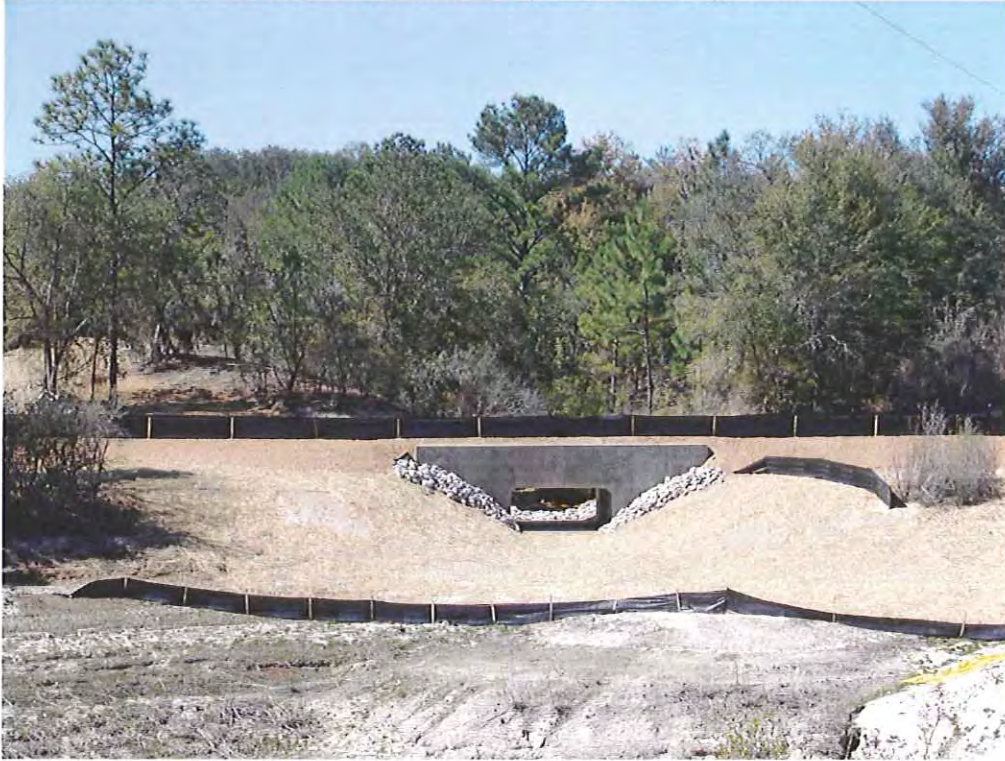
Culvert Construction at Powerline Pond (Pond Near Dry) March 2007

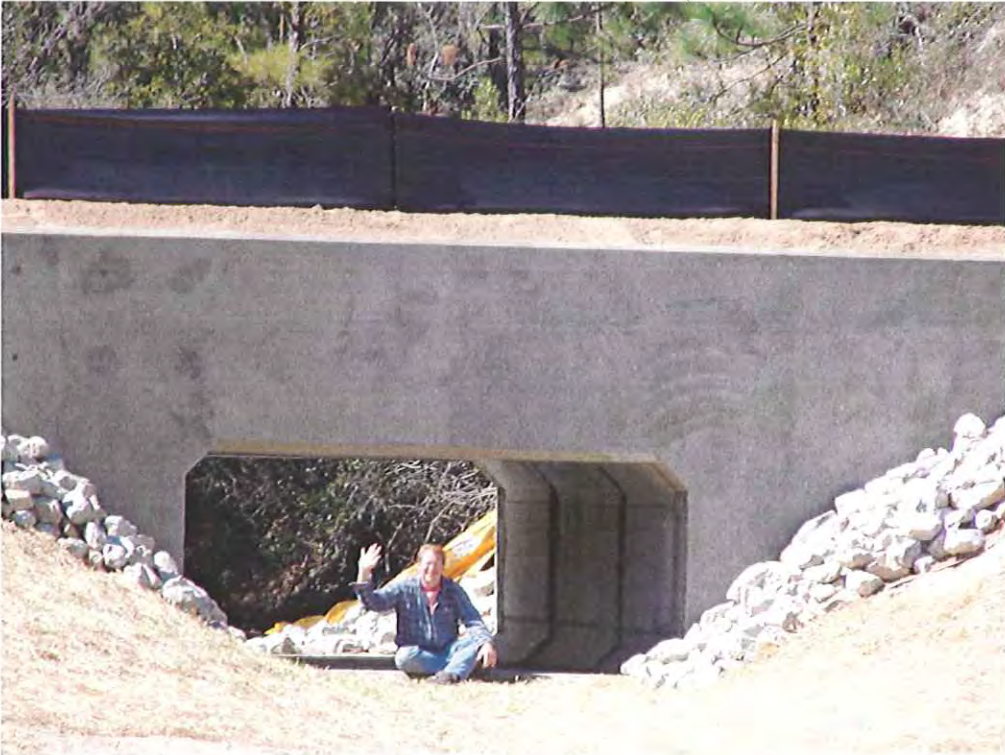
Culvert Construction at Powerline Pond (March 2007)

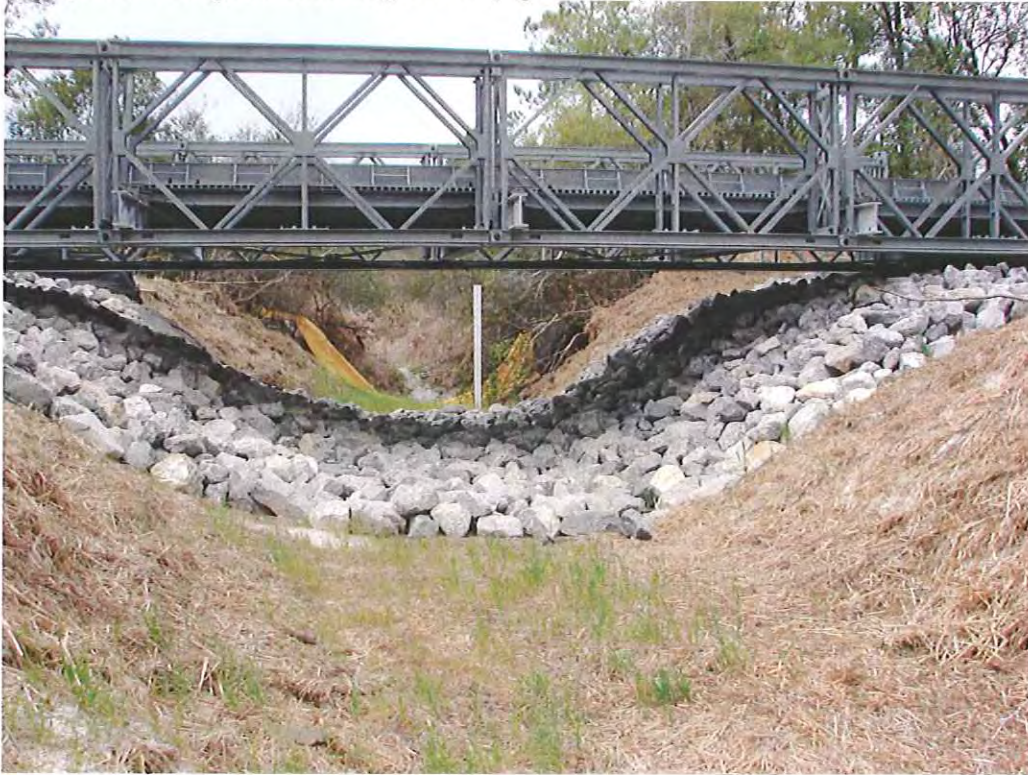
Completed Bridge at Pine Log Creek (April 2007)

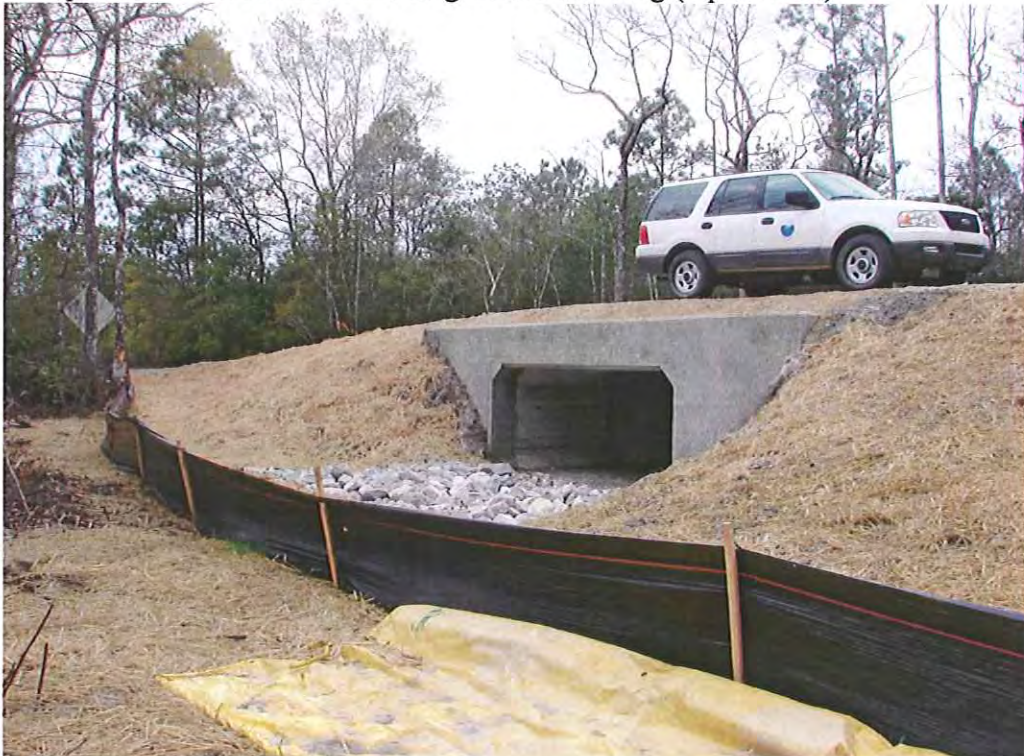
Completed Culvert at Old Pine Log Creek Crossing (April 2007)

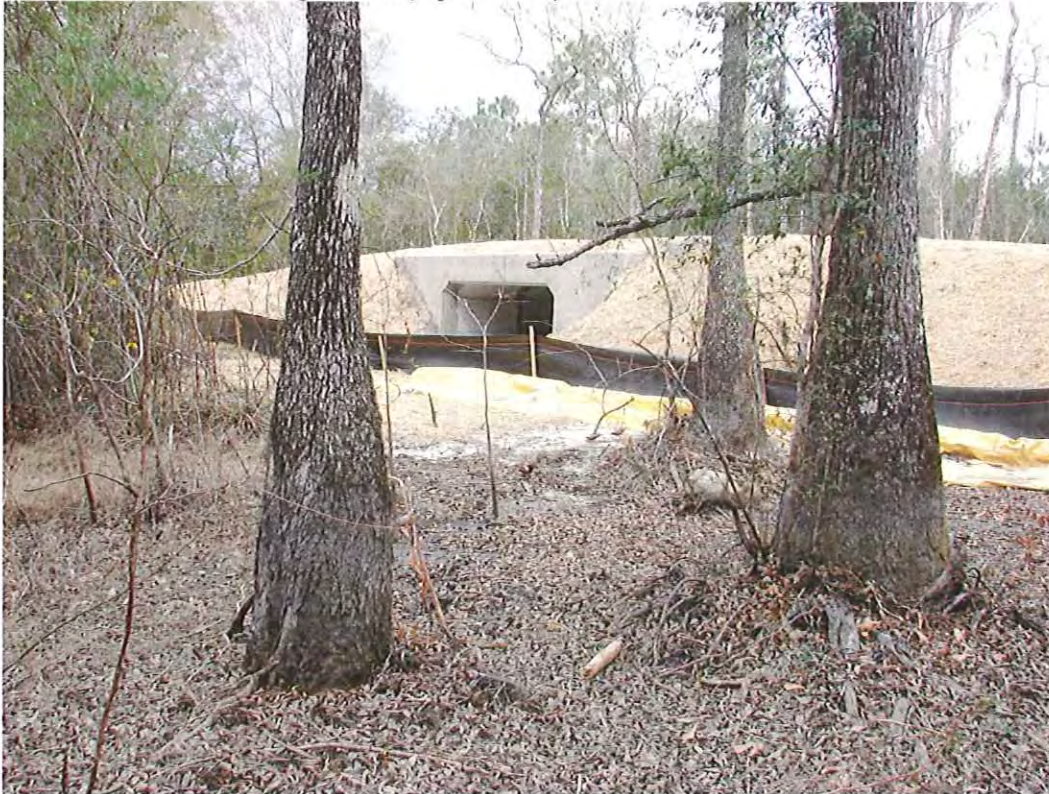
Culvert at Old Pine Log Creek (April 2007)

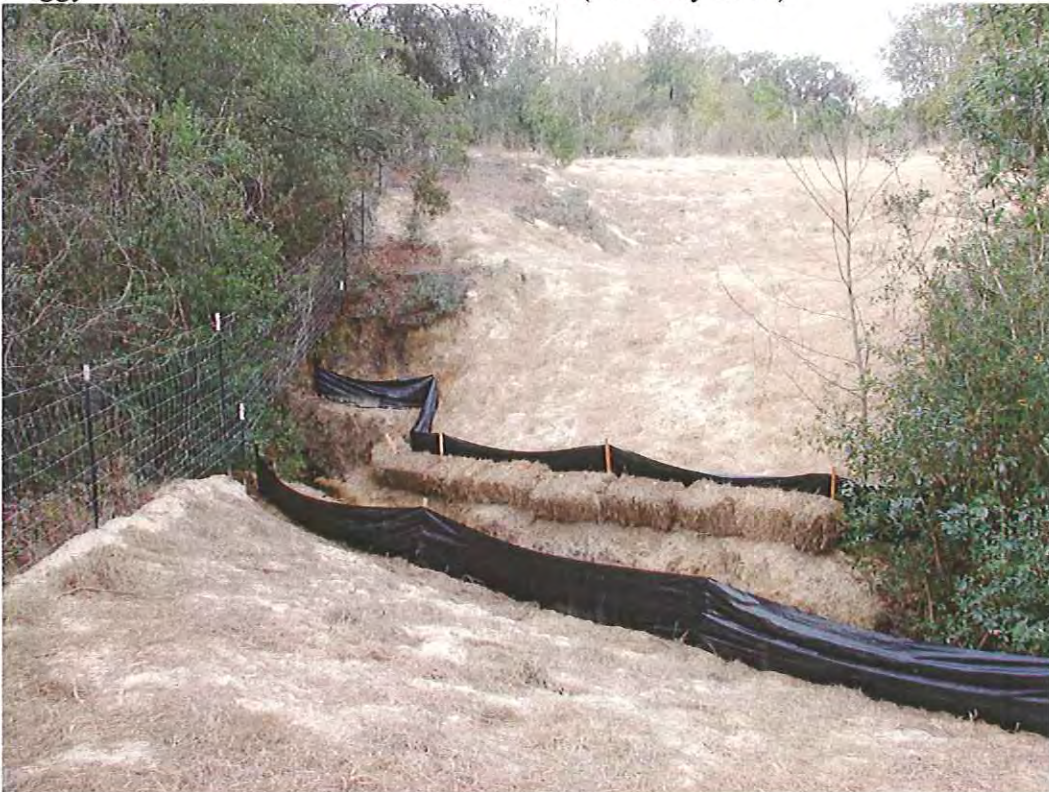
Boggy Branch Erosion Restoration Site #10 (February 2007)

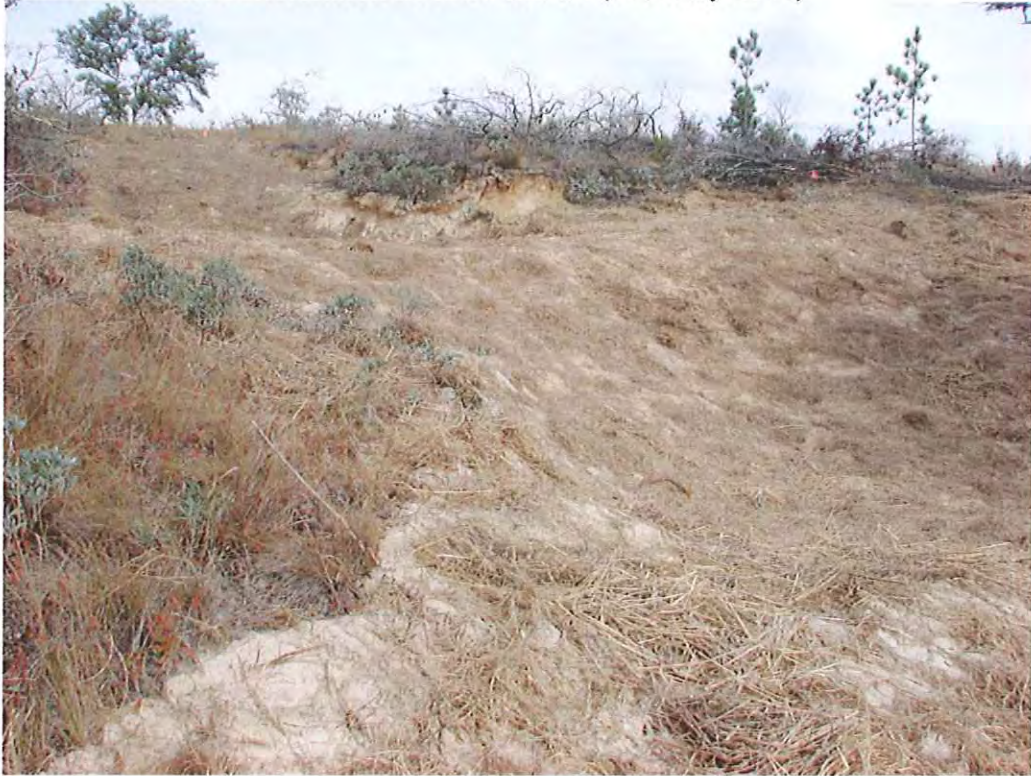
Cat Pond Erosion Restoration Sites #1 and #2 (February 2007)

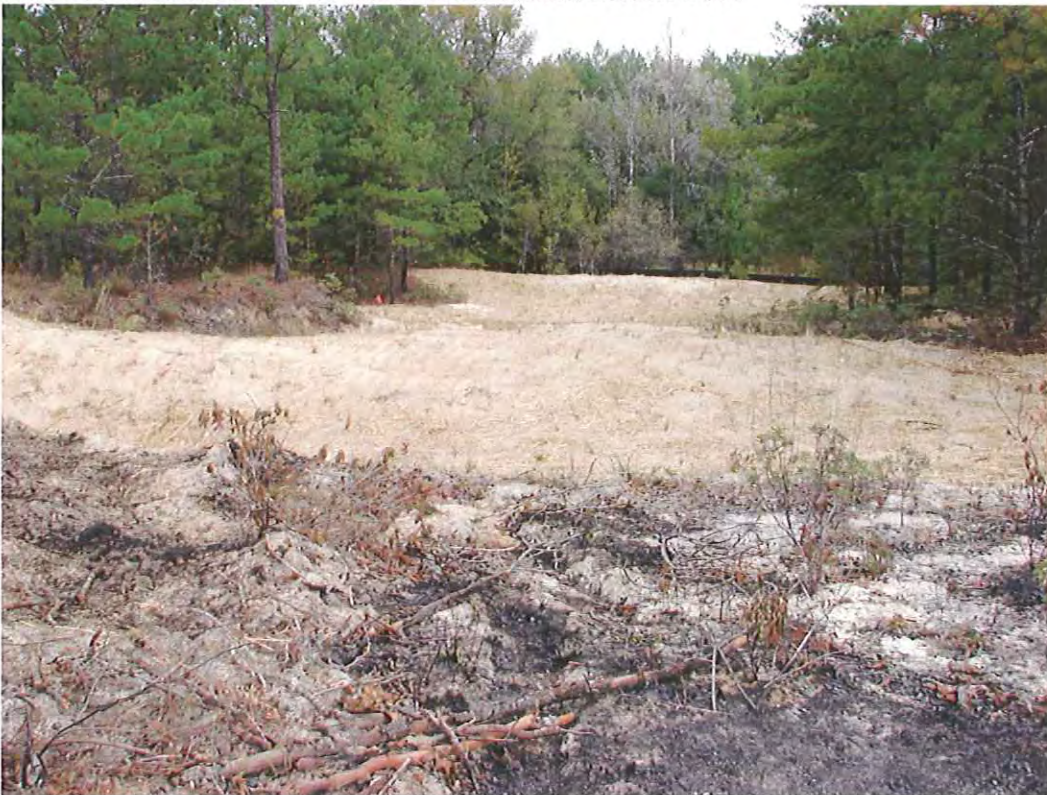
Erosion Control Site #4 at Greenhead Branch March 2007

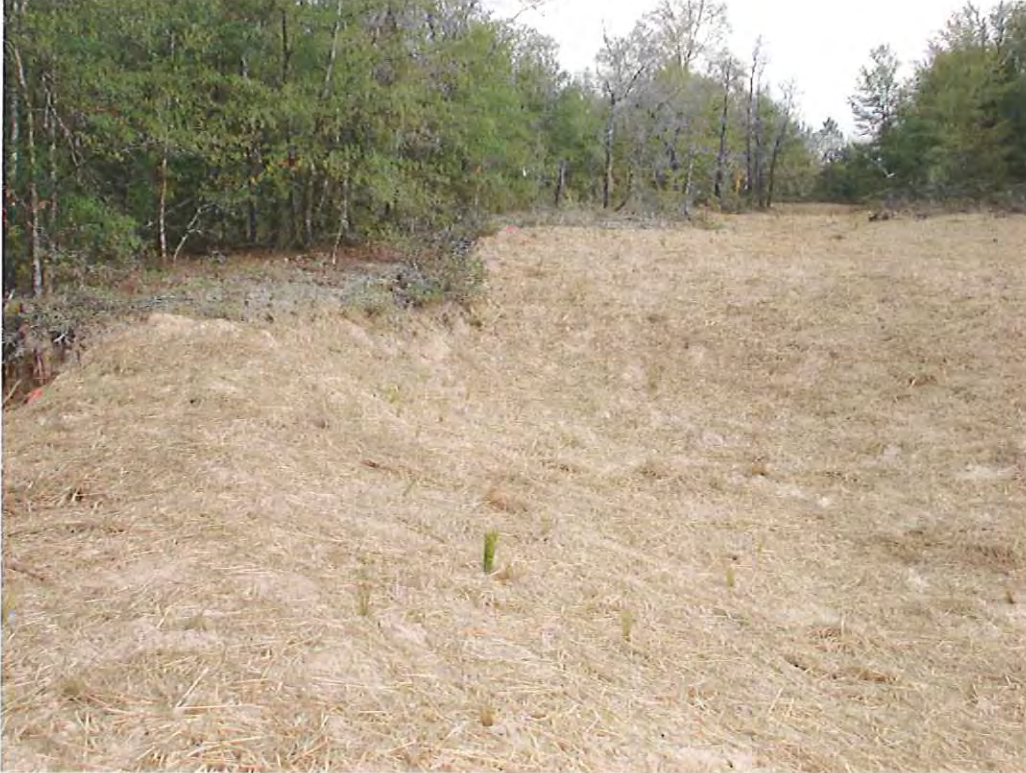
Erosion Control Site #7 at Greenhead Branch March 2007

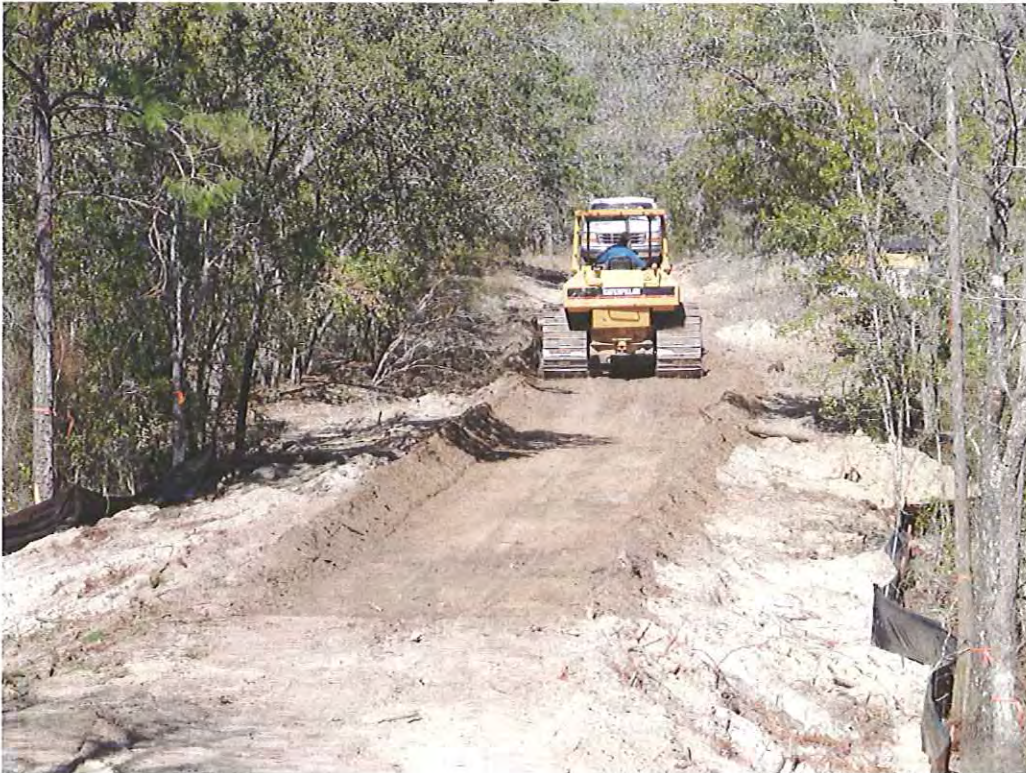
Roadfill Removal Between Little Deep Edge and Greenhead Branch (March 2007)

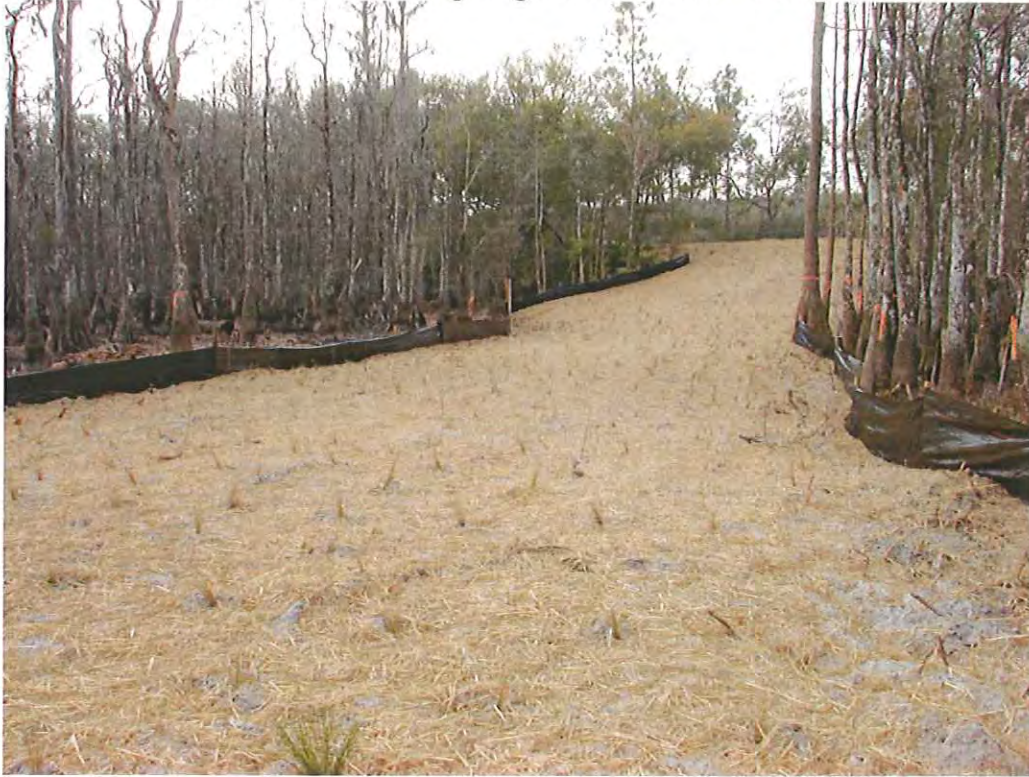
Road Removal Between Little Deep Edge and Greenhead Branch March 2007

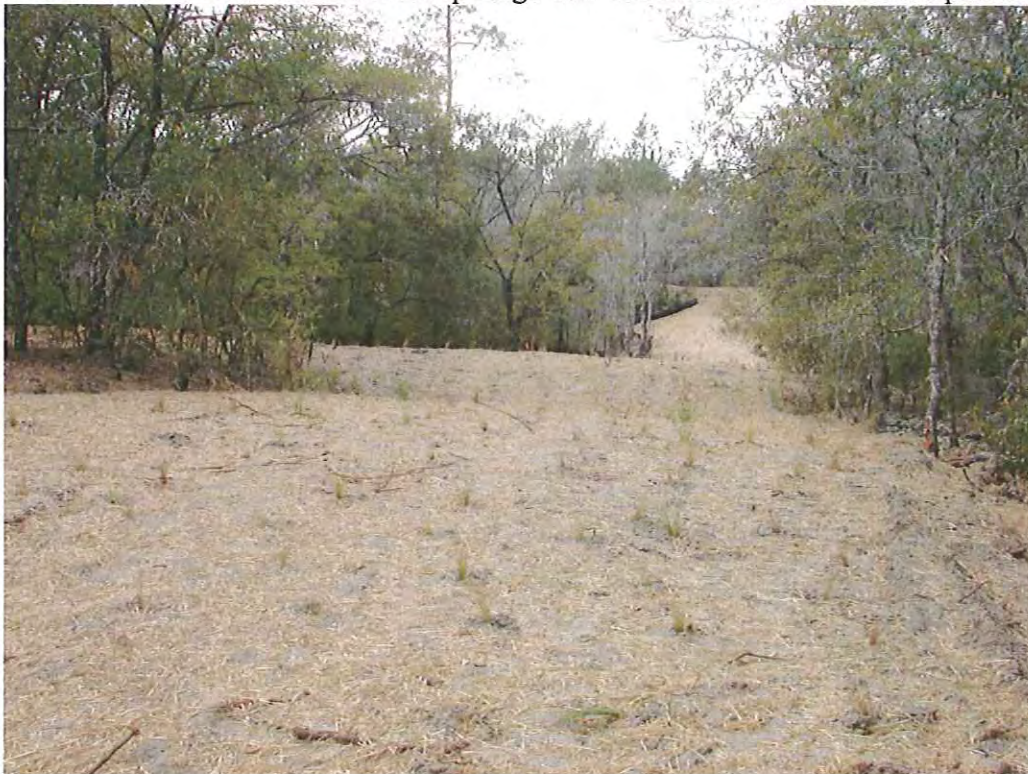
Road Removal Between Little Deep Edge and Greenhead Branch from Uplands
