Northwest Florida Water Management District

Re: Progress Report 4

Please accept this submittal as the fourth semi-annual progress report for the SHLMB.

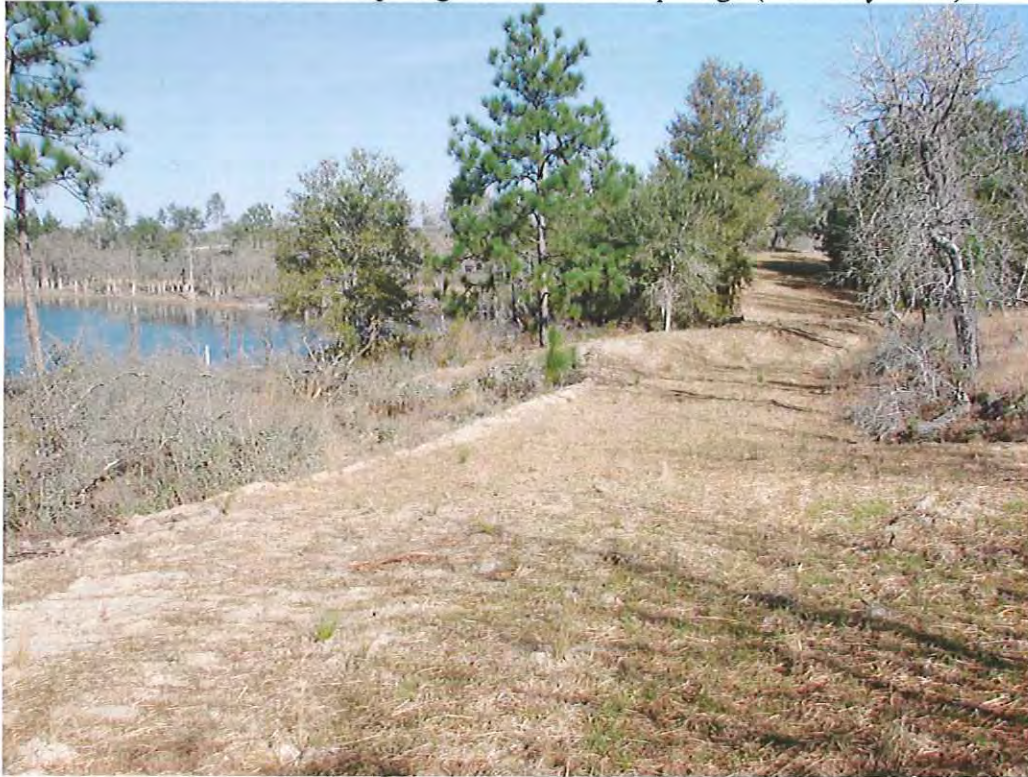
Road Removal Between Deep Edge and Little Deep Edge (February 2007)

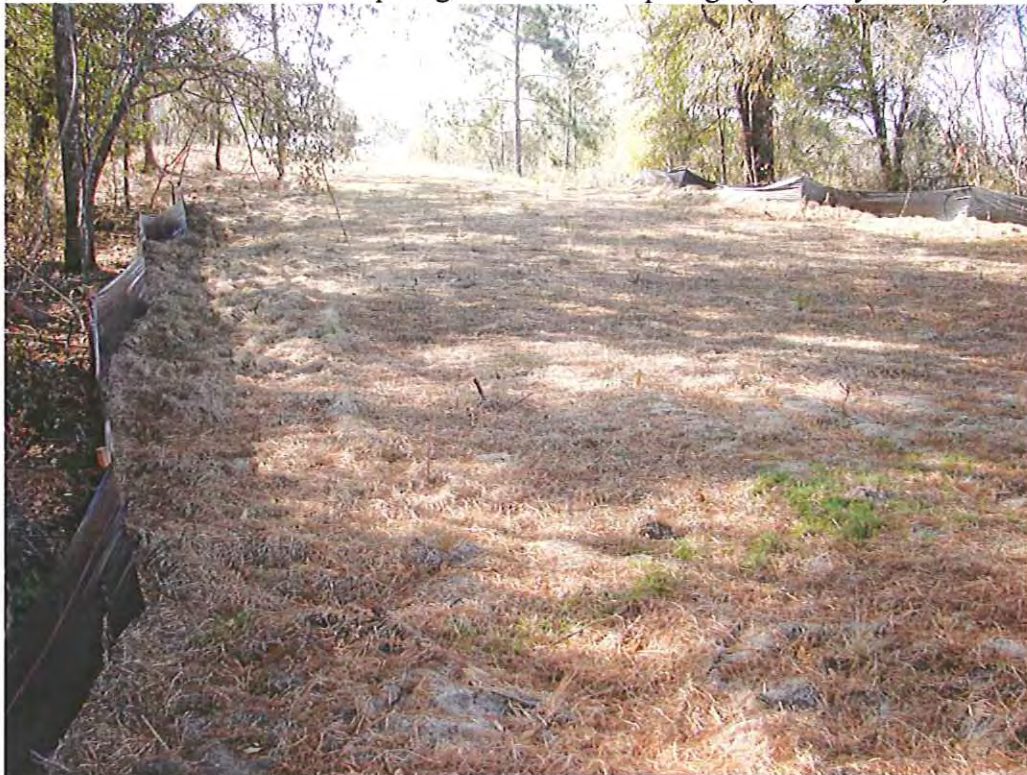
Road Removal Between Deep Edge and little Deep Edge (February 2007)

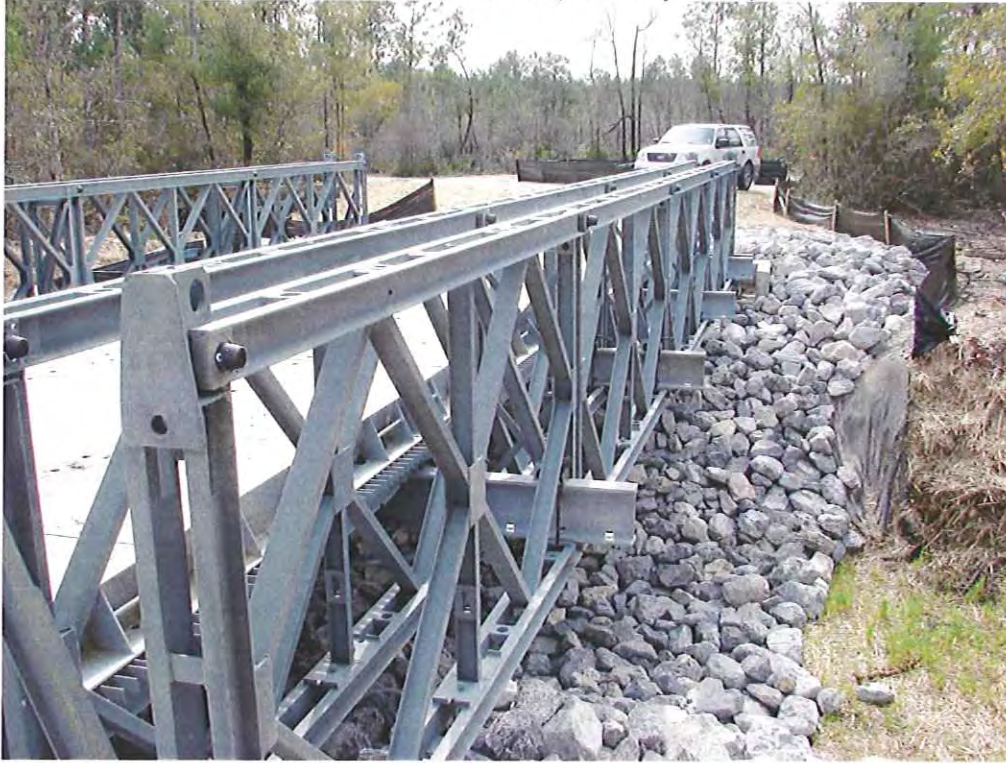
Bridge Construction at Greenhead Branch (February 2007)

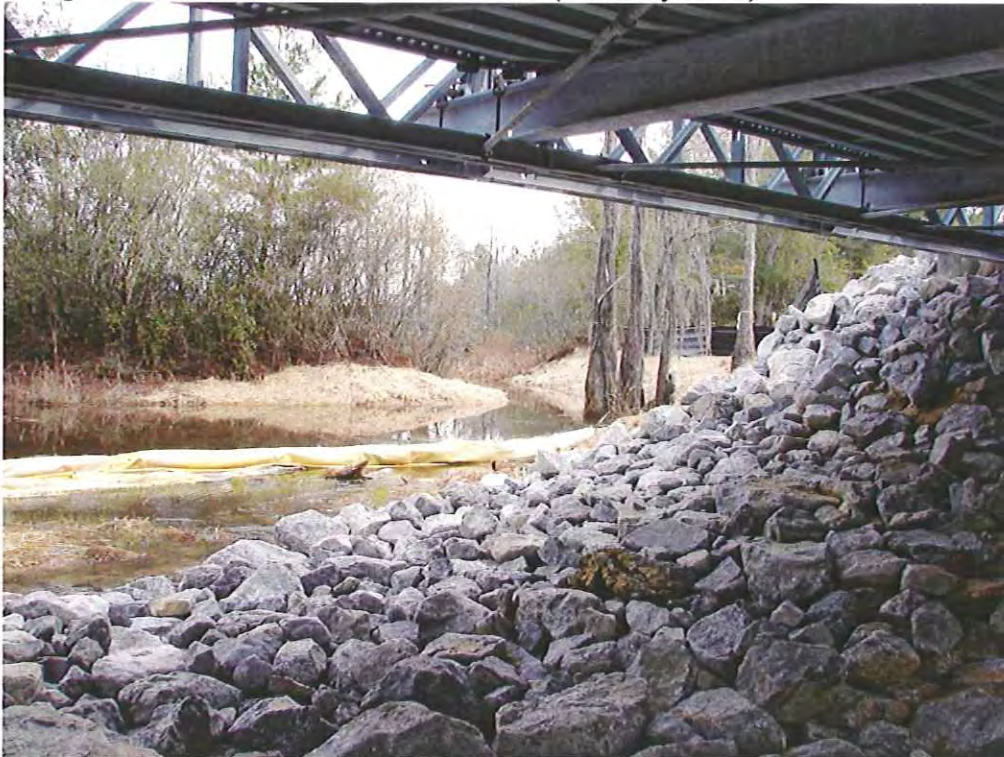
Bridge Construction at Greenhead Branch (February 2007)

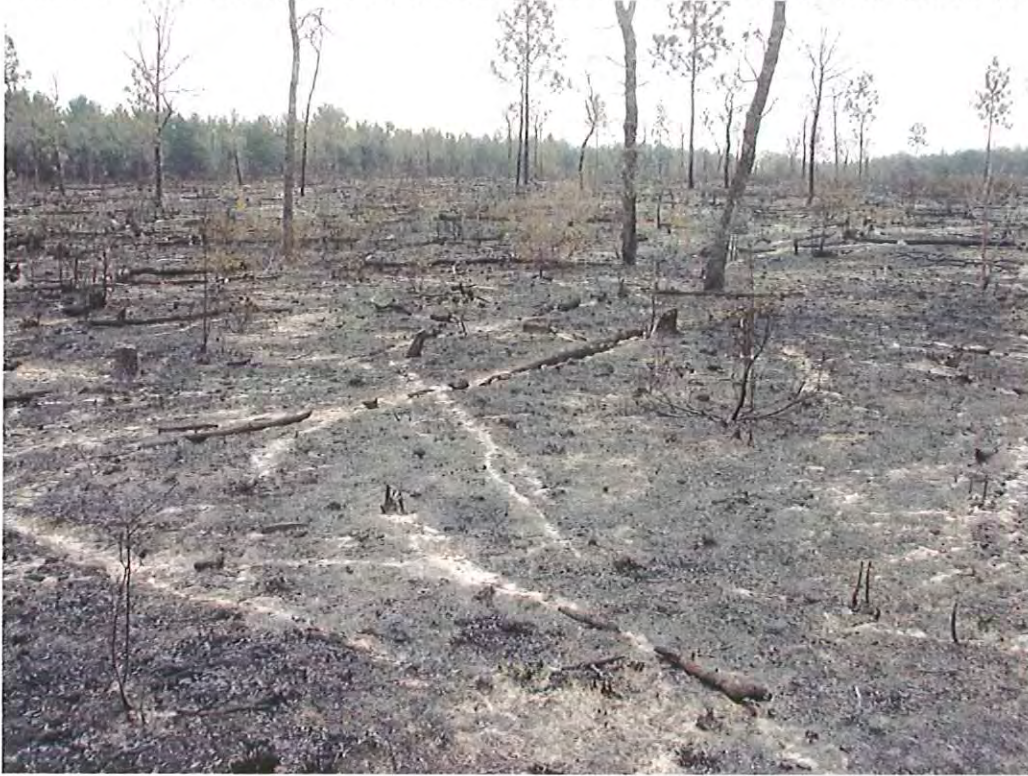
-An intense winter burn occurred adjacent to Greenhead Branch in Management Unit 12. Nearly all of the planted long leaf pine seedlings were destroyed. The site will be evaluated this fall for survivorship of long leaf pine. The area will be re-planted during the winter of 2007 if few to no long leaf pine trees survived.

Winter Burn in Management Unit 12 Adjacent to Greenhead Branch March 2007

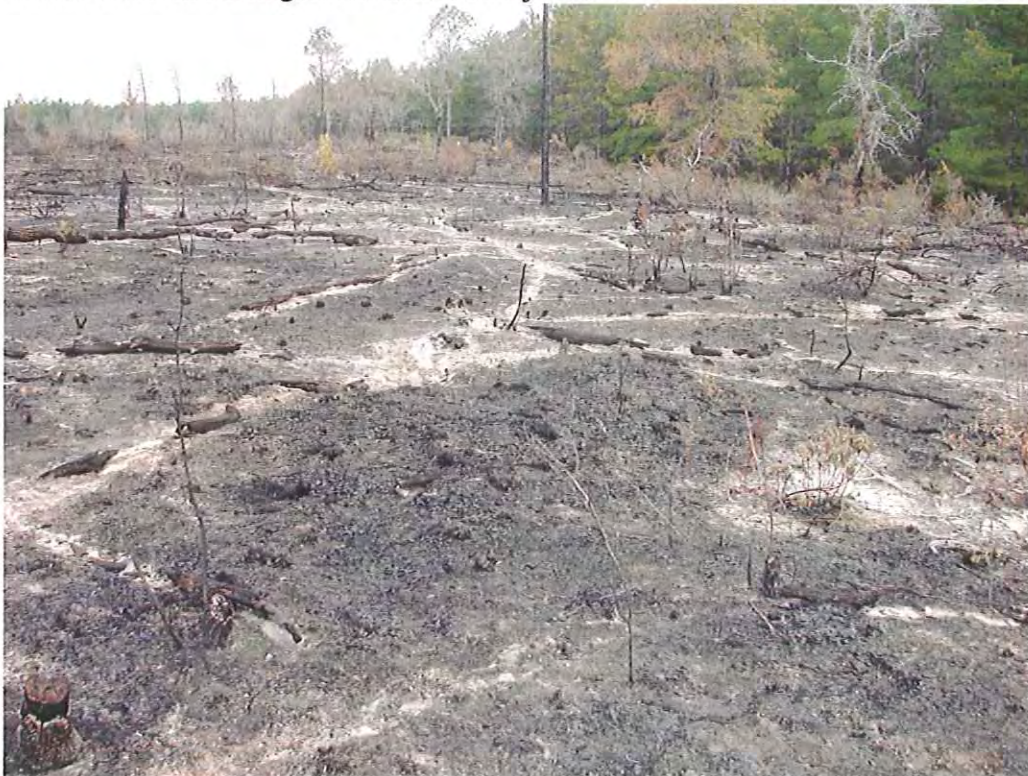
Winter Burn in Management Unit 12 Adjacent to Greenhead Branch March 2007

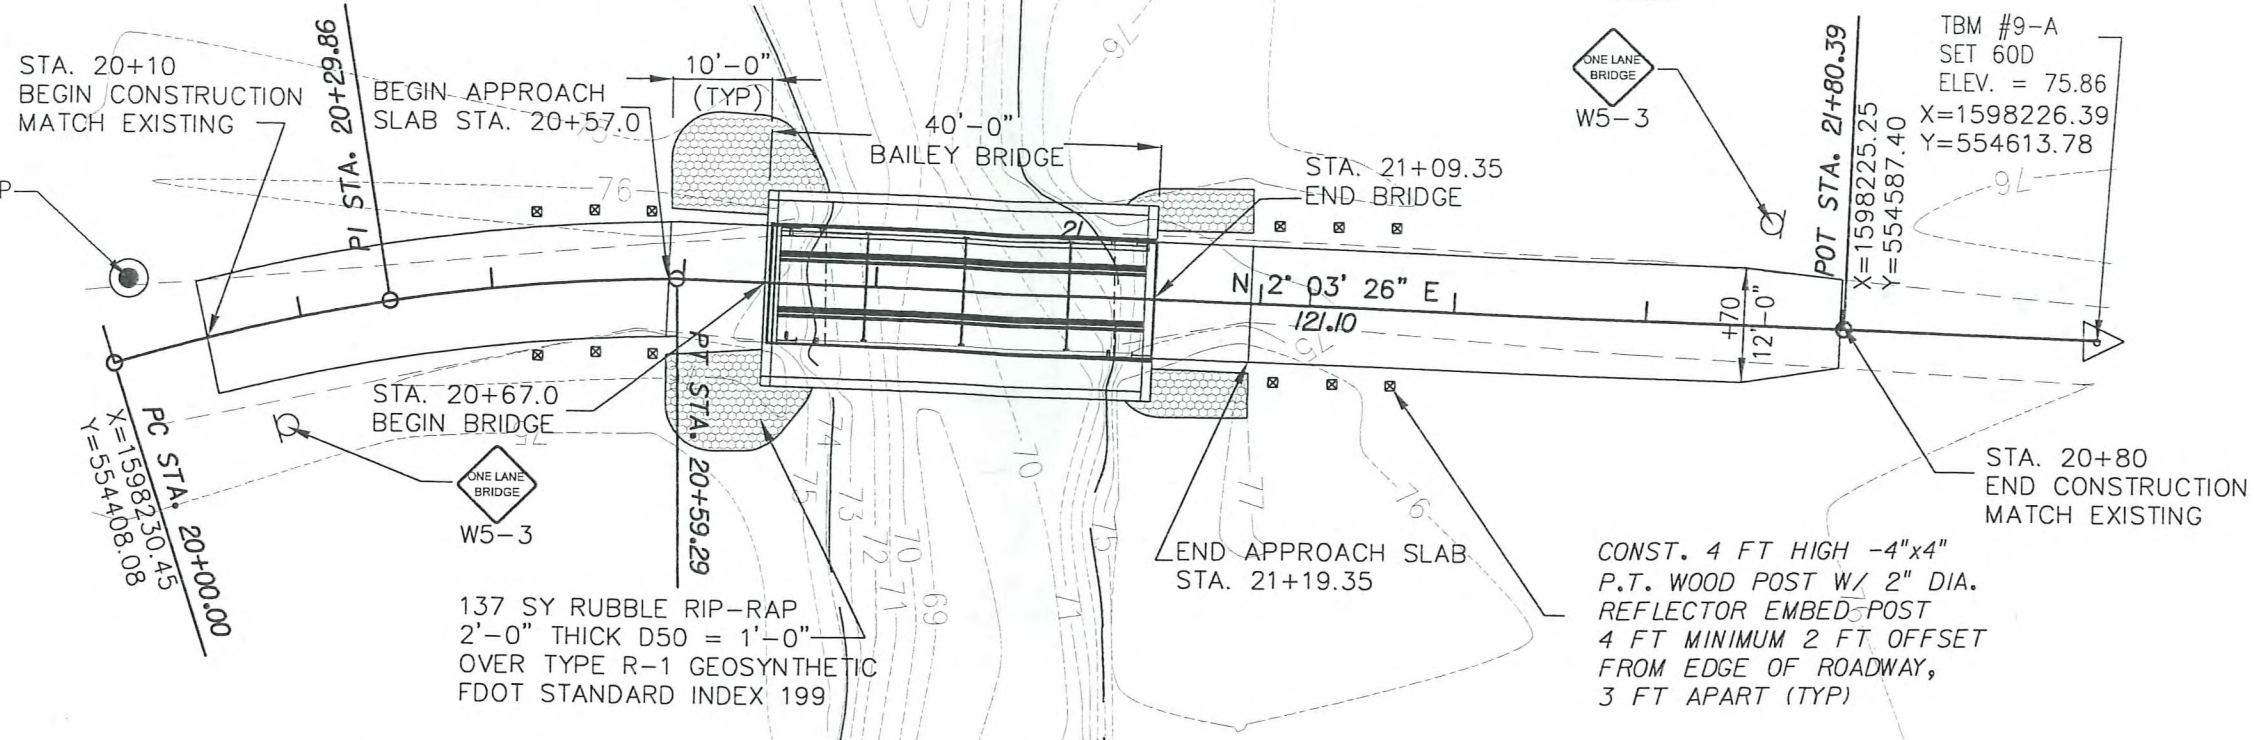
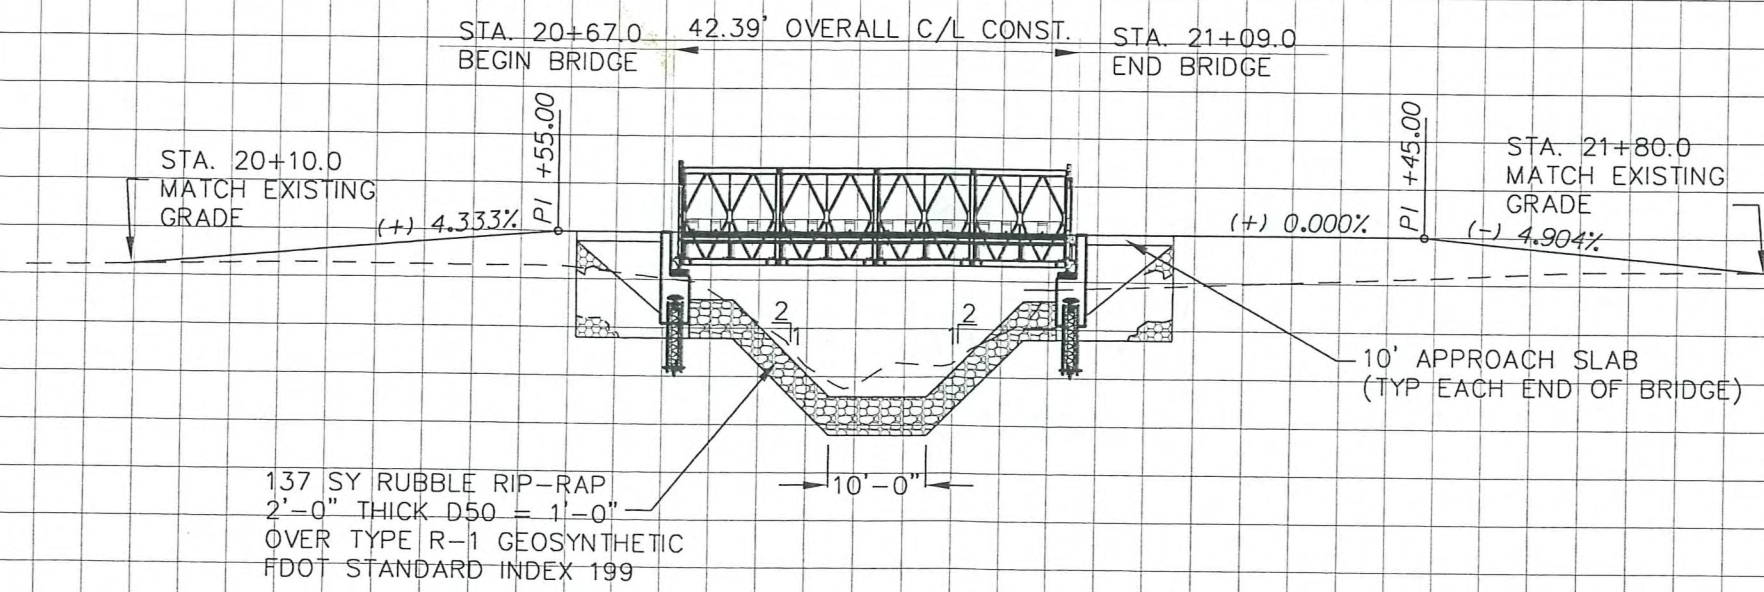
137 SY RUBBLE RIP-RAP
 2'-0" THICK D50 = 1'-0"
 OVER TYPE R-1 GEOSYNTHETIC
 FDOT STANDARD INDEX 199

CONST. 4 FT HIGH -4"x4"
 P.T. WOOD POST W/ 2" DIA.
 REFLECTOR EMBED-POST
 4 FT MINIMUM 2 FT OFFSET
 FROM EDGE OF ROADWAY,
 3 FT APART (TYP)

10' APPROACH SLAB
 (TYP EACH END OF BRIDGE)

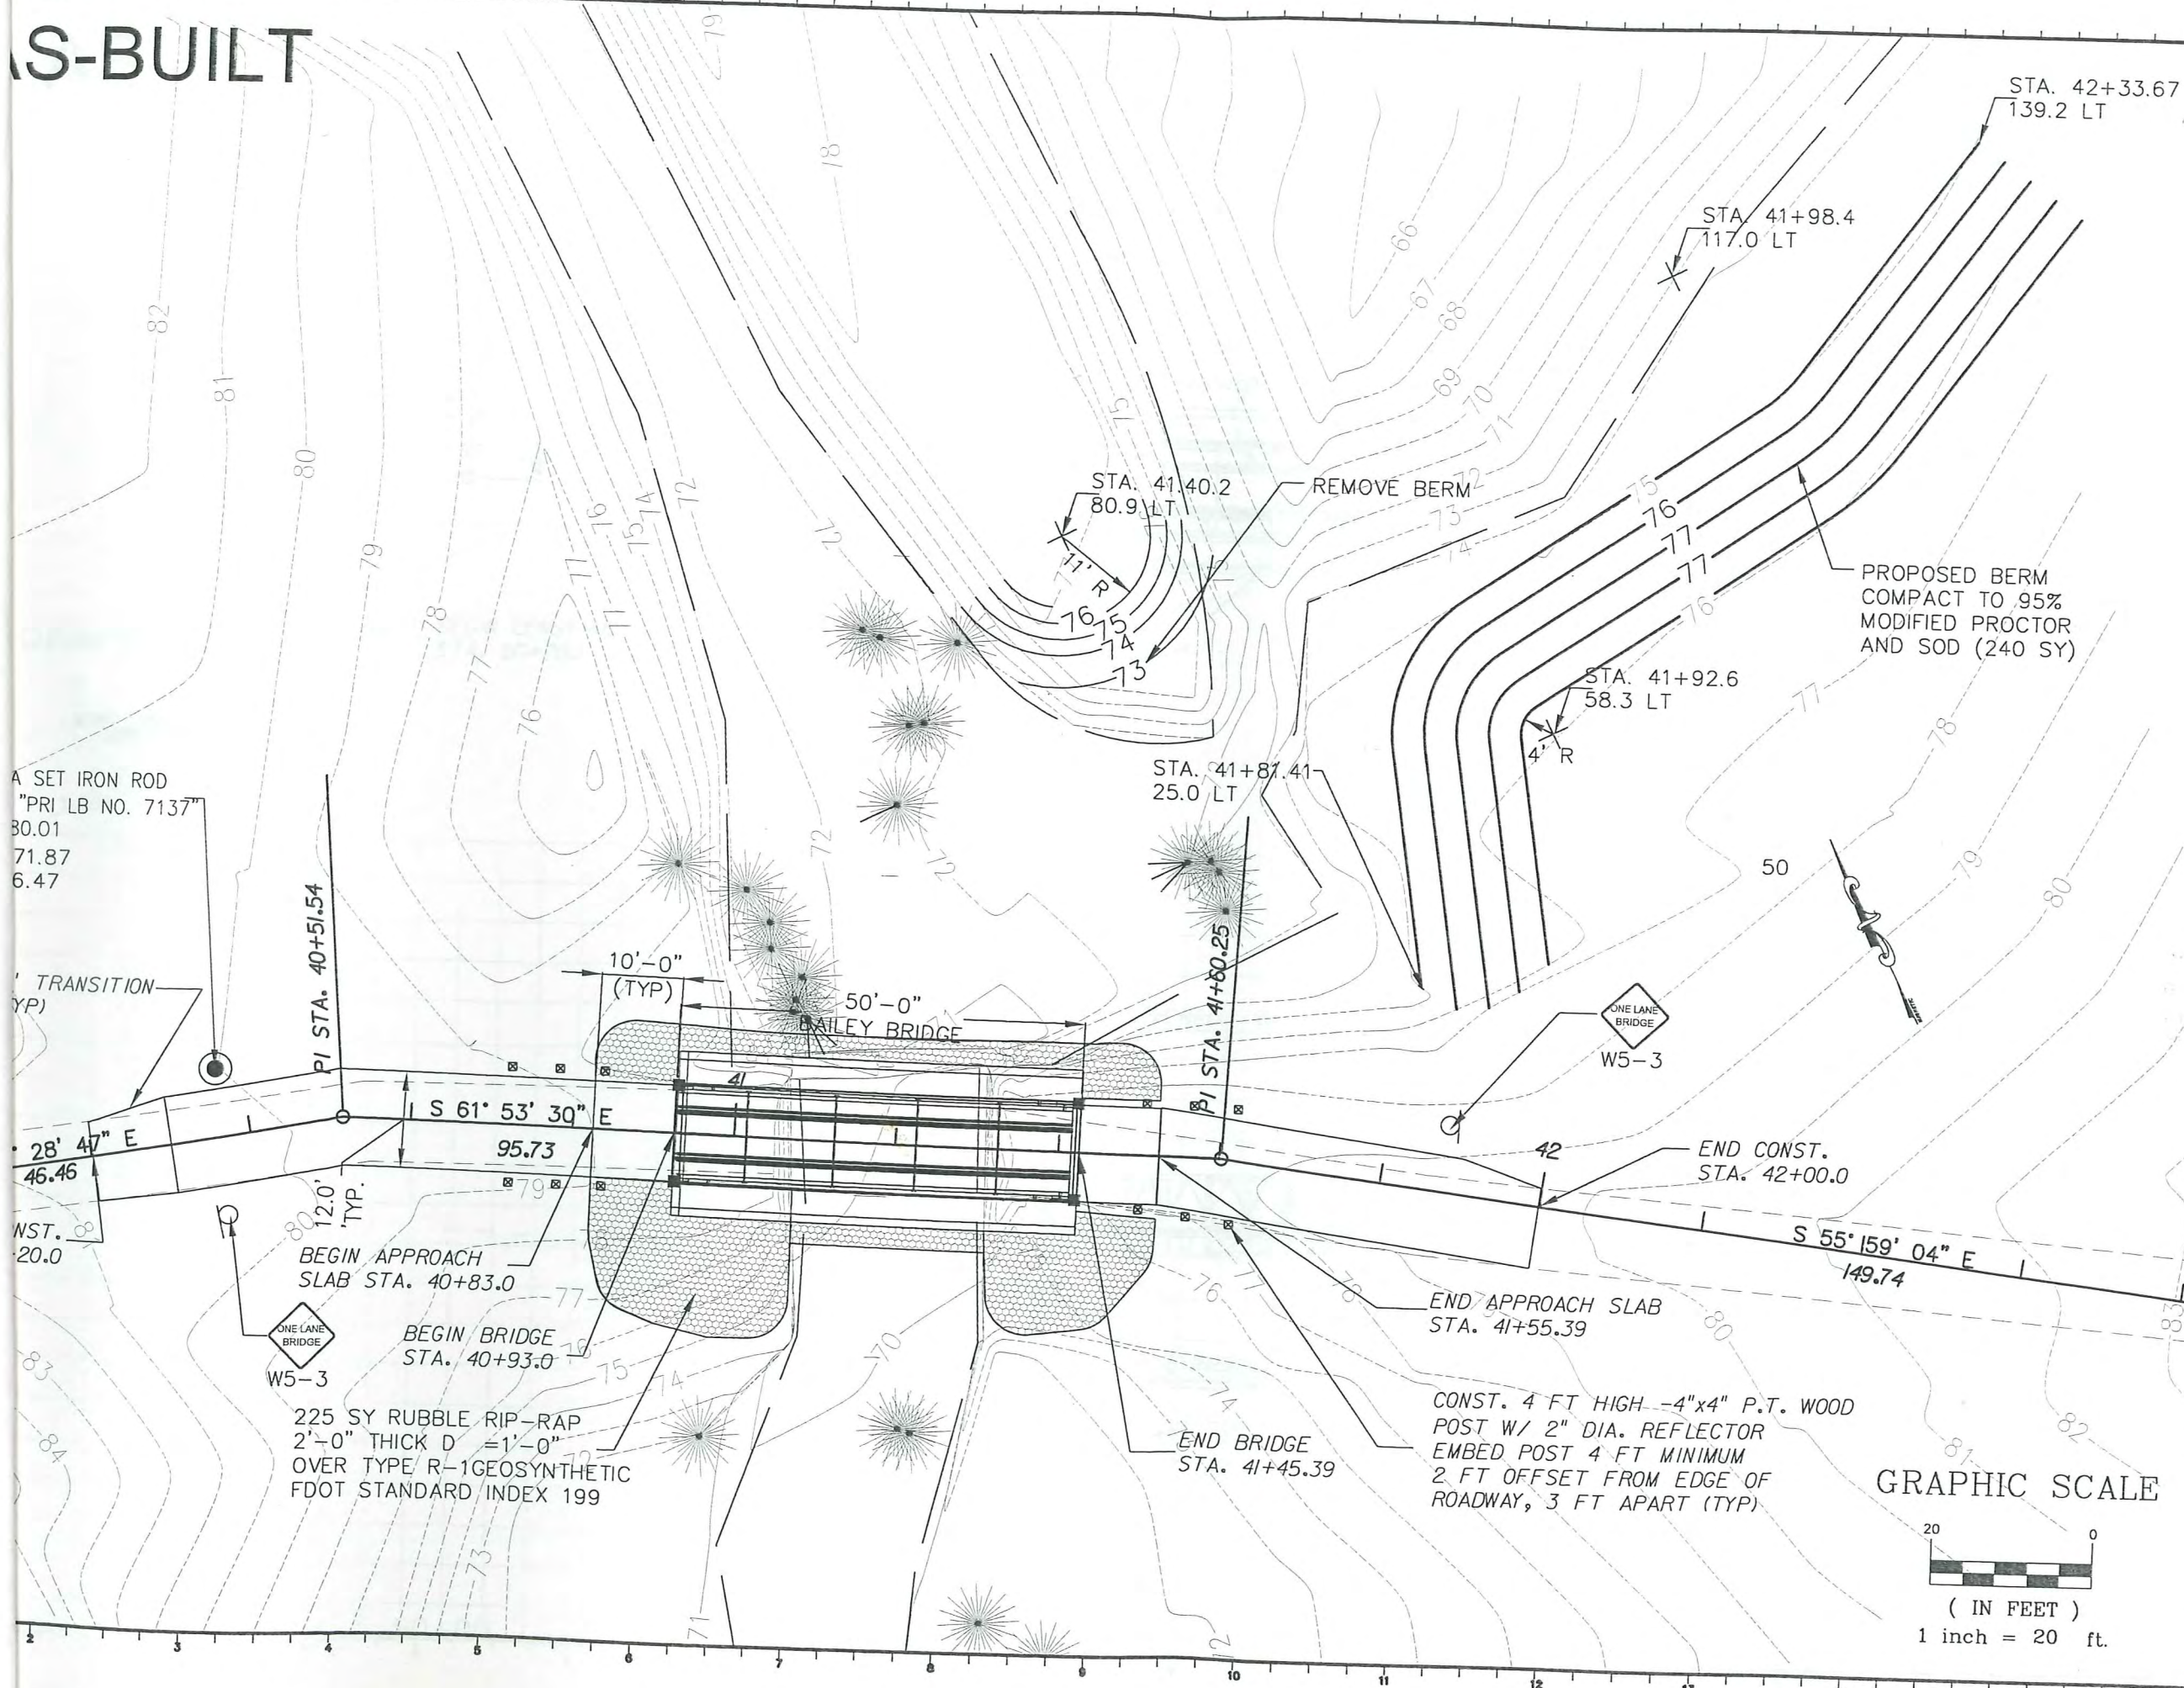
BEGIN APPROACH
SLAB STA. 40+83.0

BEGIN BRIDGE
STA. 40+93.0

225 SY RUBBLE RIP-RAP
2'-0" THICK D = 1'-0"
OVER TYPE R-1 GEOSYNTHETIC
FDOT STANDARD INDEX 199

10'-0" (TYP)
50'-0" BAILEY BRIDGE
