PERDIDO RIVER WMA – PHASE II MITIGATION

UWRMP Section 5.1.4 Supplement (with 1/12/12 Addendum)

January 15, 2009

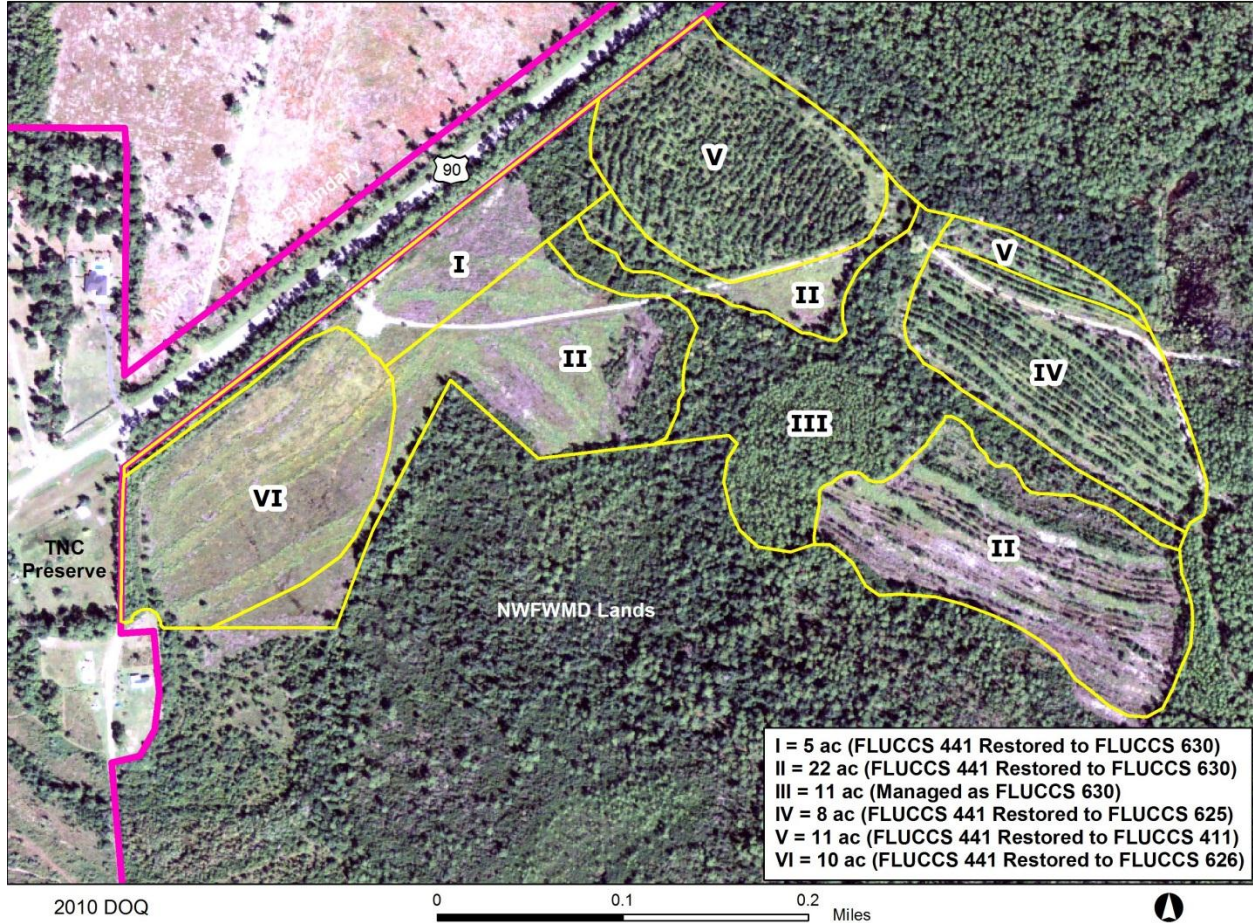
Perdido River WMA (Phase II) - Revised Restoration Polygons

Using adaptive management to ensure restoration of appropriate vegetation communities, the restoration polygons have been modified as follows:
