Environmental Assessment Report

BH Stone Road Drainage Improvements

SECTION 1, TOWNSHIP 3 SOUTH, RANGE 10 WEST
CALHOUN COUNTY, FLORIDA

April 2012

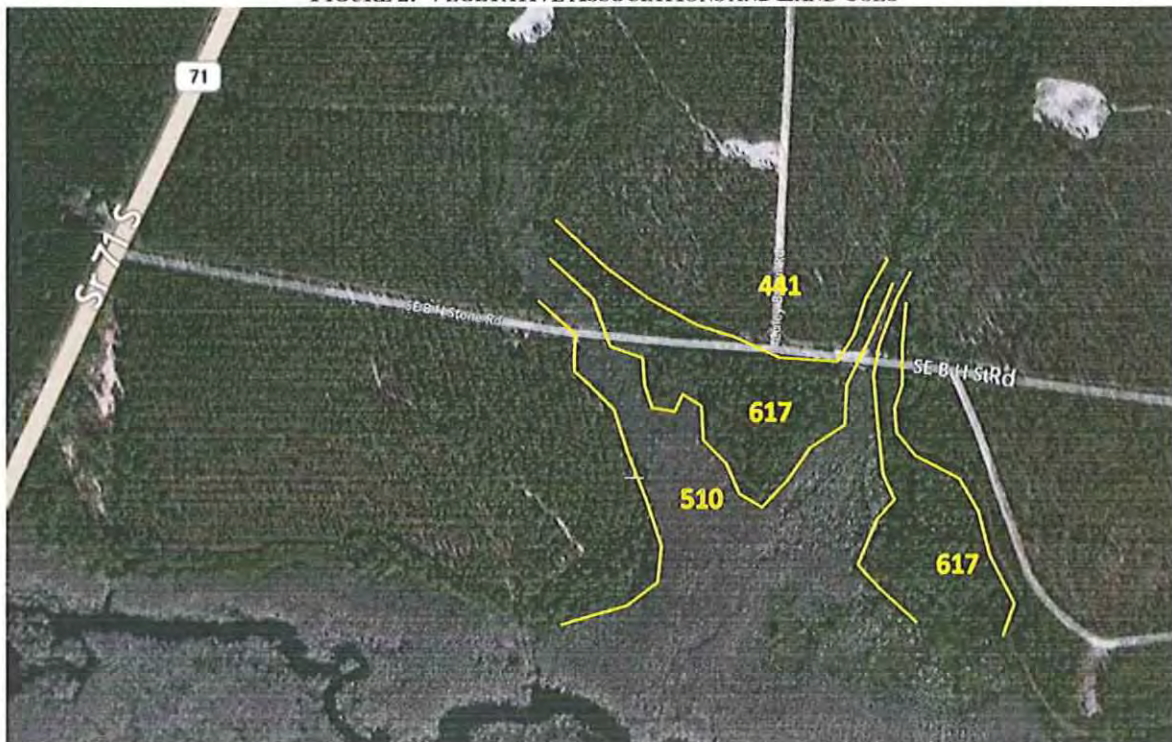
FIGURE 2. VEGETATIVE ASSOCIATIONS AND LAND USES

Table 1 provides a summary of the vegetative associations/land uses on the site per the FLUCCS system. Figure 2 provides a graphic representation of the extent of site habitats/land uses.

The following is a description of the existing FLUCCS habitats/land uses present on the site:

Pine Plantation (FLUCCS 441): These are almost exclusively pine forests artificially generated by planting seedling stock or seeds. These stands are characterized by high numbers of trees per acre and their uniform appearance. Although row patterns often stand out, this is not always the case, especially where stands are as a result of aerial seeding.

Streams and Waterways (FLUCCS 510): This classification is described as rivers, creeks, canals and other linear water bodies.

Mixed Wetland Hardwood (FLUCCS 617): This category is reserved for those wetland hardwood communities which are composed of a large variety of hardwood species tolerant of hydric conditions yet exhibit an ill-defined mixture of species.

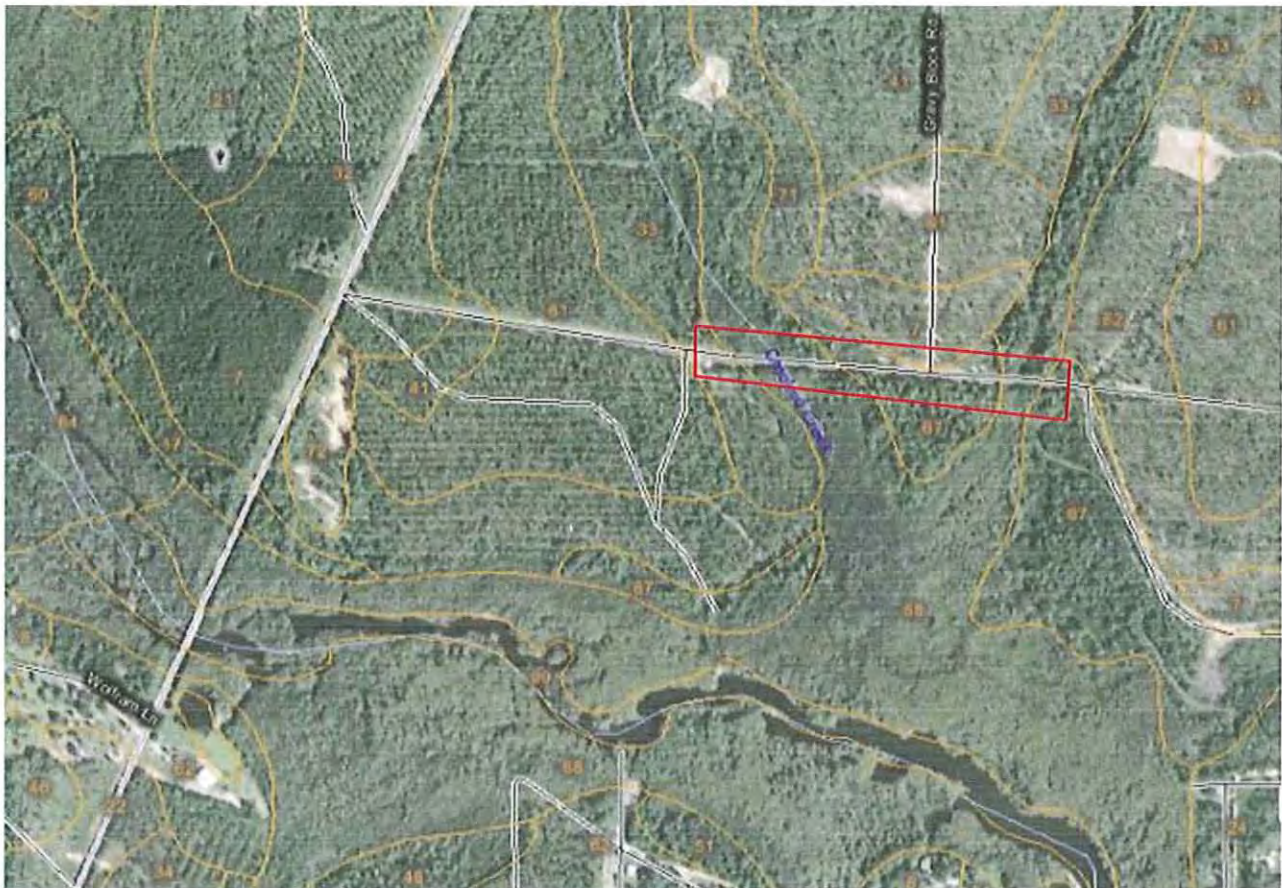
FIGURE 3. SOIL UNITS

According to the *Soil Survey of Calhoun County, Florida* (NRCS), three soil units are present in the project area: (7) Blanton sand, 0-5% slopes, (67) Alapaha loamy sand 0-2% slopes, and (68) Croatan, Kinston and Surrency, frequently flooded. An exhibit depicting the soil map is provided as Figure 3.

Blanton sand, 0-5% slopes (7): is a moderately well drained soil is on summits and shoulders in the uplands. Slopes are smooth to convex. Typically, the surface layer is dark grayish brown sand about 4 inches thick. The subsurface layer is light yellowish brown sand to a depth of 40 inches, pale yellow sand to a depth of 60 inches, and pale yellow loamy sand that has mottles in shades of gray, yellow, and red to a depth of 68 inches. The subsoil is yellowish brown sandy loam that has mottles in shades of gray, yellow, and red to a depth of 80 inches or more. The seasonal high water table is at a depth of 42 to 72 inches from January through March and from June through September. The available water capacity is very low or low in the surface and subsurface layers and moderate in the subsoil. Typically, this map unit supports the Mixed Hardwood and Pine ecological community, which has several variations. In mature, natural stands, the hardwoods replace the pines. The natural climax vegetation is thought to be a beech-magnolia-maple association. The trees that characterize this community are loblolly pine, white oak, pignut hickory, American beech, and flowering dogwood. The herbaceous plants and vines include aster, partridge pea, poison ivy, violet, Virginia creeper, and wild grape. Grasses include broomsedge bluestem, longleaf uniola, low panicum, and spike uniola.

Alapaha loamy sand, 0-2% slopes (67): is a poorly drained soil on flats, on footslopes, and in poorly defined drainageways in the Coastal Plain uplands. Slopes are smooth to concave. Typically, the surface layer is very dark gray loamy sand about 6 inches thick. The subsurface layer is loamy sand. It is dark gray to a depth of 16 inches and is gray and has mottles in shades of gray, yellow, and red to a depth of 28 inches. The subsoil is gray sandy loam to a depth of 48 inches; is gray sandy loam that has plinthite and has mottles in shades of gray, yellow, and red to a depth of 62 inches; and is gray sandy clay loam that has plinthite and has mottles in shades of gray, yellow, and red to a depth of 80 inches or more. The seasonal high water table is at the surface to a depth of 7 inches from December through March and from June through September. The available water capacity is low in the surface and subsurface layers, moderate in the upper part of the subsoil, and low in the lower part of the subsoil. Typically, this map unit supports the North Florida Flatwoods ecological community, which has only slight variations in composition. Slash pine and water oak are the main trees. Herbaceous plants and shrubs include blackberry, dog fennel, gallberry, greenbrier, saw palmetto, and wax-myrtle. Grasses and grass-like plants include chalky bluestem, yellow Indiangrass, low panicum, pineland threeawn, and sedges.

Croatan, Kinston, and Surrency soils, frequently flooded (68): consists of very poorly drained very poorly drained Croatan and Surrency soils and poorly drained Kinston soils on flood plains along creeks and streams. Typically, the surface layer of the Croatan soil is black muck to a depth of 28 inches. The substratum is gray sandy loam to a depth of 40 inches and is gray sandy clay loam to a depth of 80 inches or more. In areas of the Croatan soil, the seasonal high water table is at or near the surface during most of the year. The available water capacity is very high in the surface layer and moderate or high in the layers below. Typically, the surface layer of the Kinston soil is very dark gray fine sandy loam about 6 inches thick. The substratum is light brownish gray sandy clay loam to a depth of 27 inches, gray sandy clay loam to a depth of 47 inches, and light gray loamy sand to a depth of 80 inches or more. In areas of the Kinston soil, the seasonal high water table is at or near the surface during most of the year. The available water capacity is moderate or high throughout. Typically, the surface layer of the Surrency soil is very dark gray mucky sand about 6 inches thick. The subsurface layer is grayish brown loamy sand to a depth of 22 inches. The subsoil is light gray sandy loam to a depth 31 inches and is gray sandy clay loam that has mottles in shades of gray, yellow, and red to a depth of 80 inches or more. In areas of the Surrency soil, the seasonal

high water table is at or near the surface during most of the year. The available water capacity is low throughout. In this map unit, flooding is likely to occur often under usual weather conditions. On the average, flooding occurs more than 50 times in 100 years. The chance of flooding is more than a 50 percent in any year but is less than 50 percent in all months in any year. The average duration of the flooding ranges from 7 to 30 days in areas of the Croatan soil, from 2 to 30 days in areas of the Kinston soil, and is more than 30 days in areas of the Surrency soil. Many areas are isolated by meandering stream channels. Excess water ponds in low-lying areas for very long periods after heavy rains. Typically, this map unit supports the Bottomland Hardwoods ecological community, which is extremely diverse. Understory growth is profuse where light enters through the openings in the canopy. Common trees include black willow, green ash, river birch, swamp chestnut oak, sweetgum, American sycamore, water hickory, water oak, and willow oak. Common herbaceous vines include crossvine, greenbrier, peppervine, poison ivy, trumpet creeper, and wild grape. Dothan sandy loam, 0-2 percent. Within the mapped area, a "wet spot" symbol is noted within the vicinity of the isolated wetland area that was identified on the property. An exhibit depicting the soil map is provided as Figure 3.
