St. Marks River Mitigation Bank

Westervelt Ecological Services, LLC
2128 Moores Mill Road, Ste B
Auburn, AL 36830
334-821-1999

Bosso, Dentzau & Imhof, Inc.
1300 West Government Street
Pensacola, Florida 32302
850-434-1935

May 2011

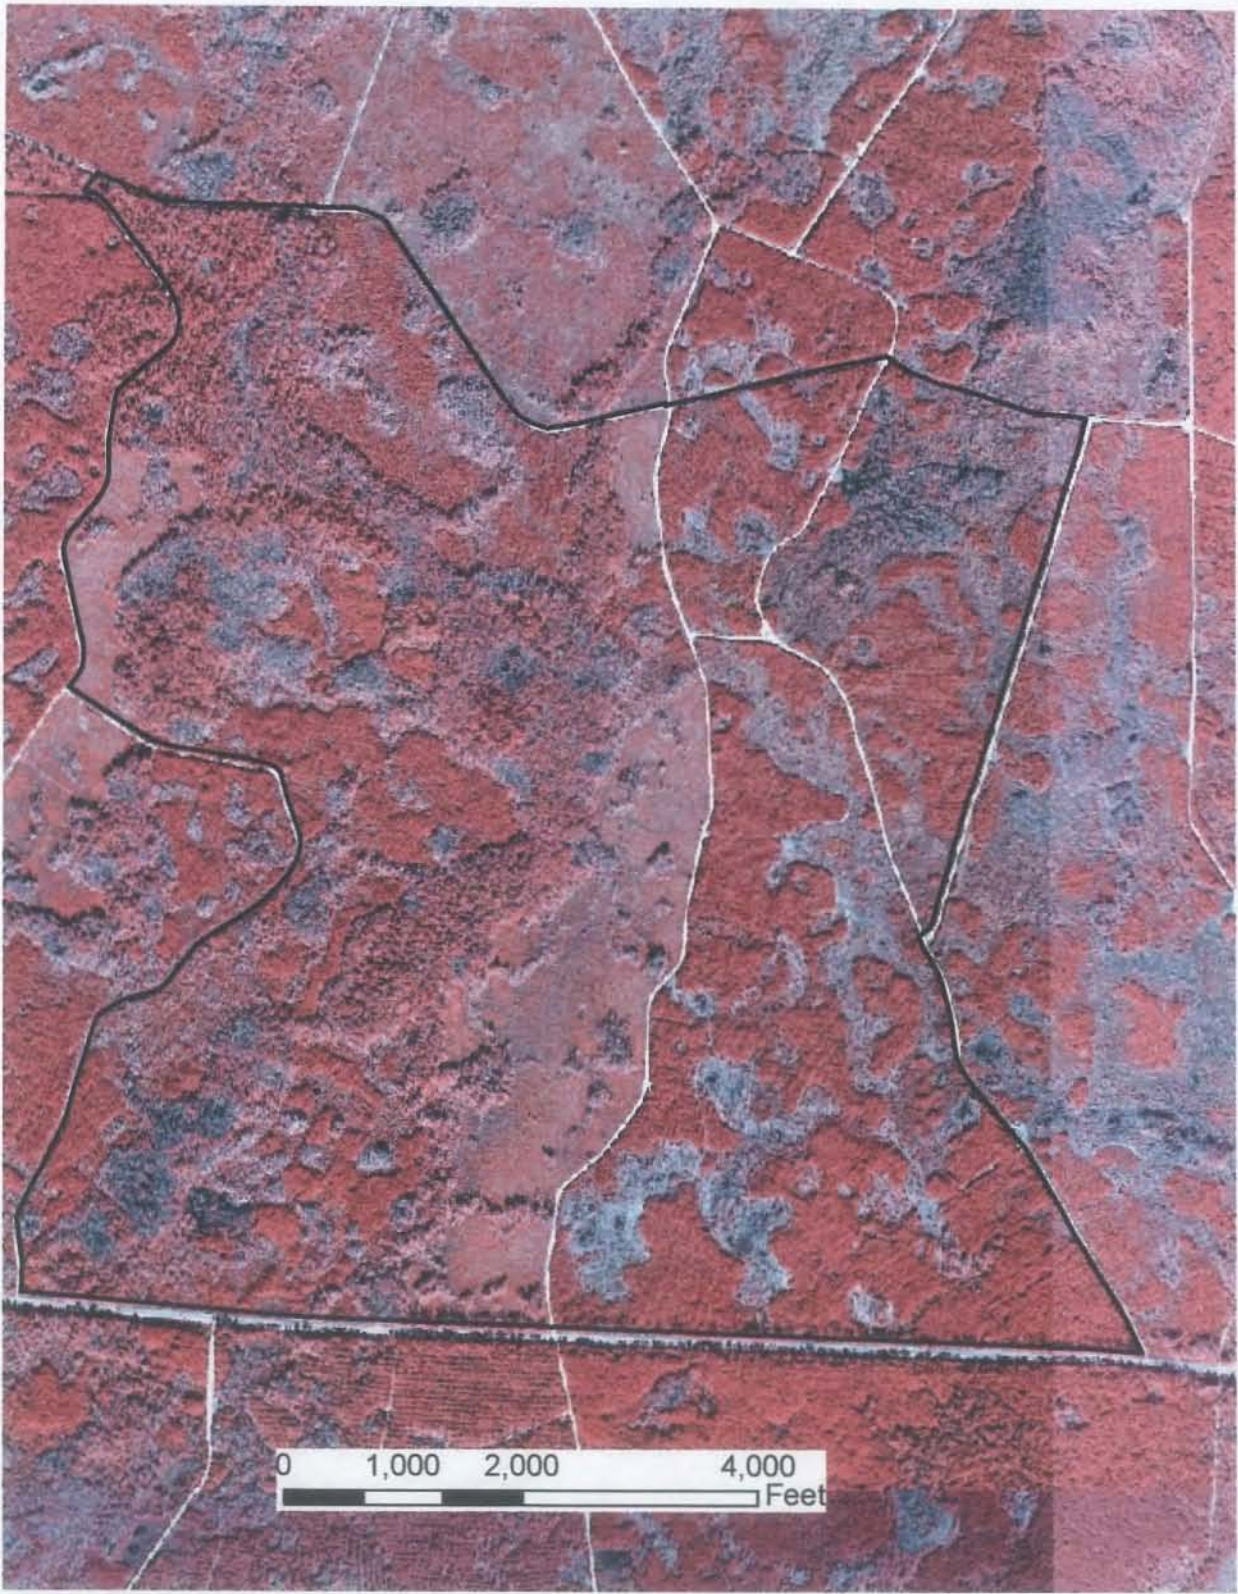
Figure 9- 1999 Aerial Photograph

The site conditions in 1999 are reflected in Figure 9. Substantial impacts associated with timber production are evident, and the conversion of historic habitat types to pine plantation is clear. The road network in place at this time is substantially similar to existing conditions.

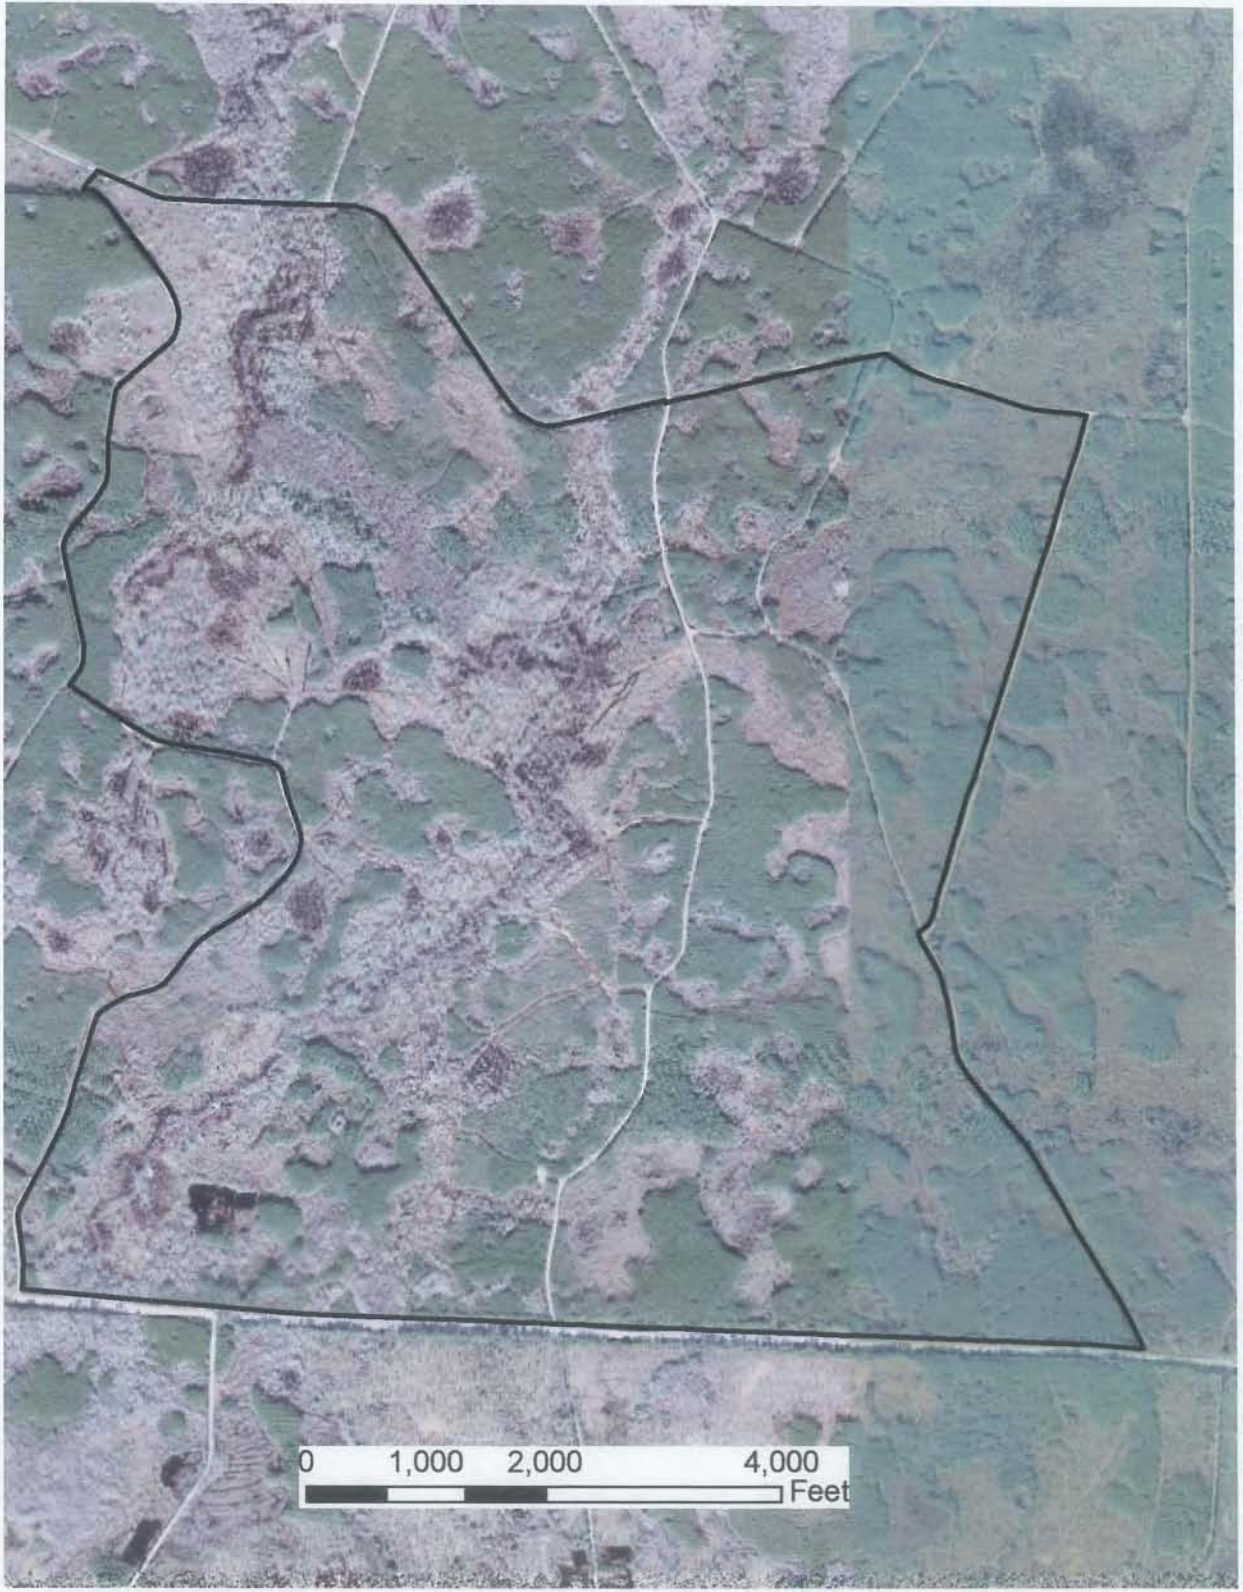
Figure 10 - 2007 Aerial Photograph

Figure 10 depicts the Bank with 2007 aerials which were used, along with on the ground inspections, to classify existing natural communities. The most demonstrable changes between 1999 and 2007 are the impacts associated with harvesting hardwood timber. This is evident in the skidder trails, altered signatures, and extra spur logging roads not evident in 1999.

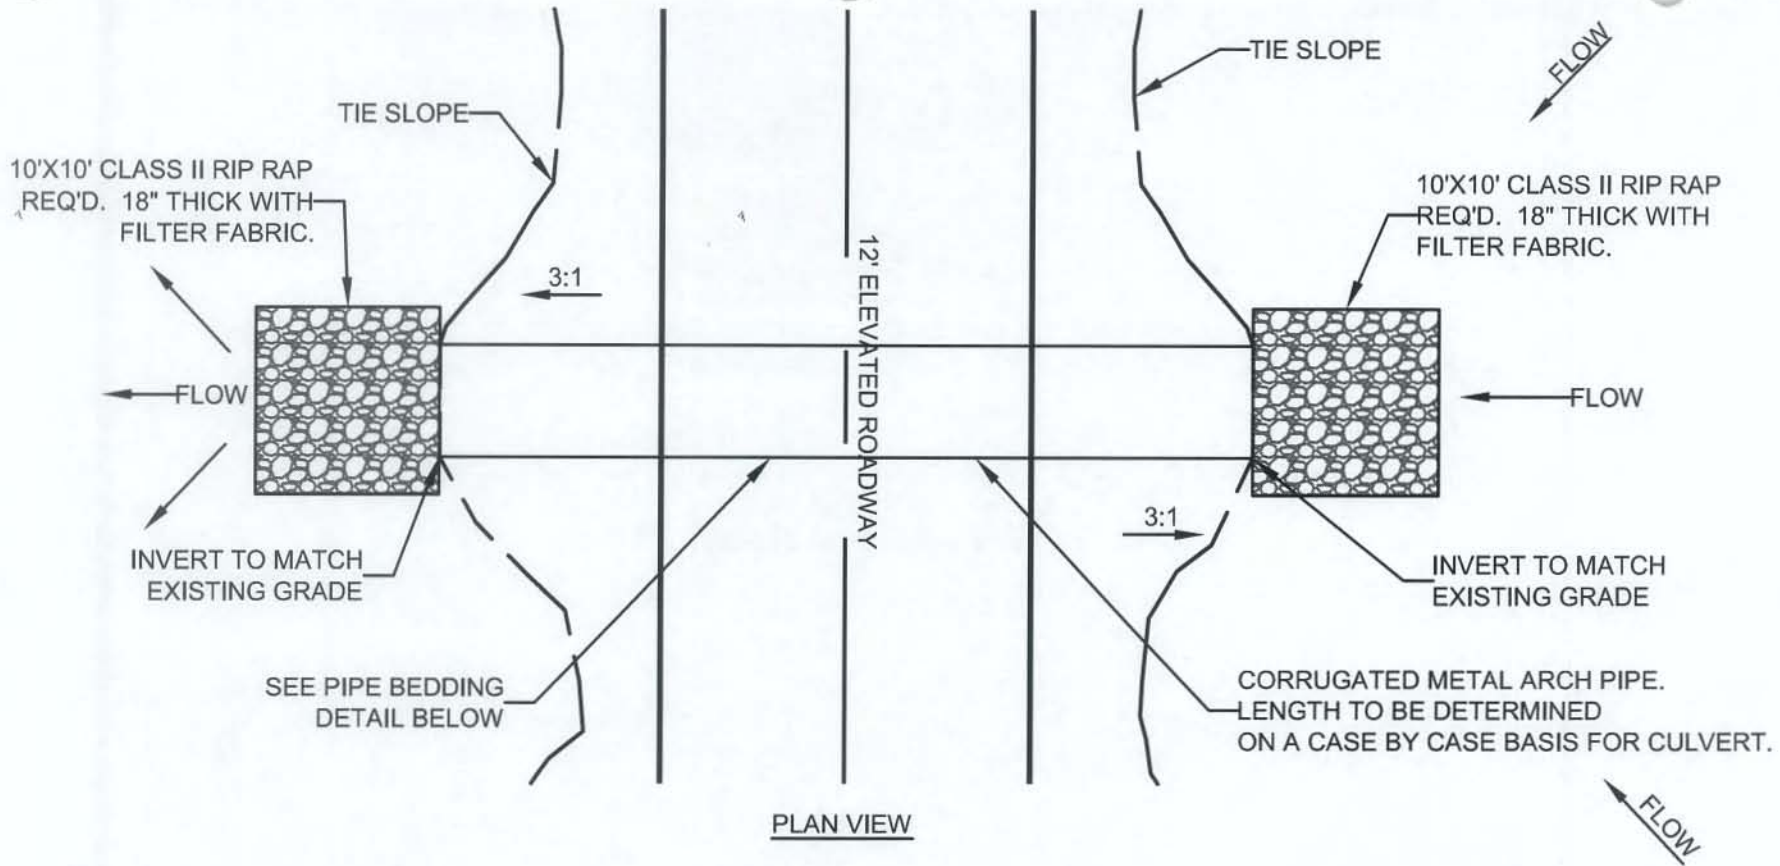
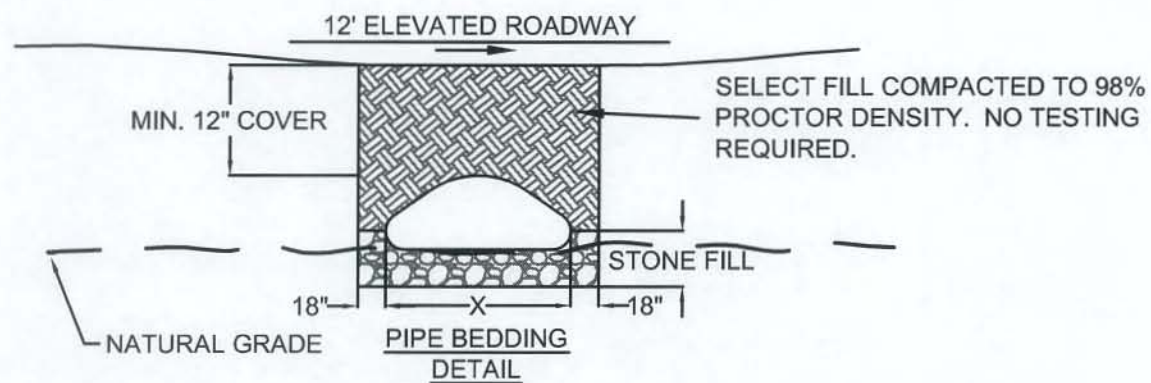
TYPICAL C.M.P. CULVERT INSTALLATION DETAIL

PLAN VIEW

PIPE BEDDING
DETAIL

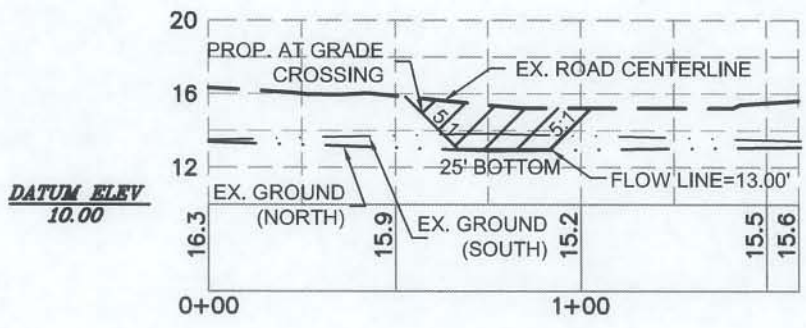
FIGURE 18

PLAN VIEW

SCALE:
1"=50' H
1"=10' V

HYDROLOGICAL DATA		
STRUCTURE	FLOW RATE (MAX)	WATER DEPTH
NO EXISTING STRUCTURE	---	---
25' LOW WATER CROSSING	425.5 CFS	36"

CROSS SECTION VIEW
A-A

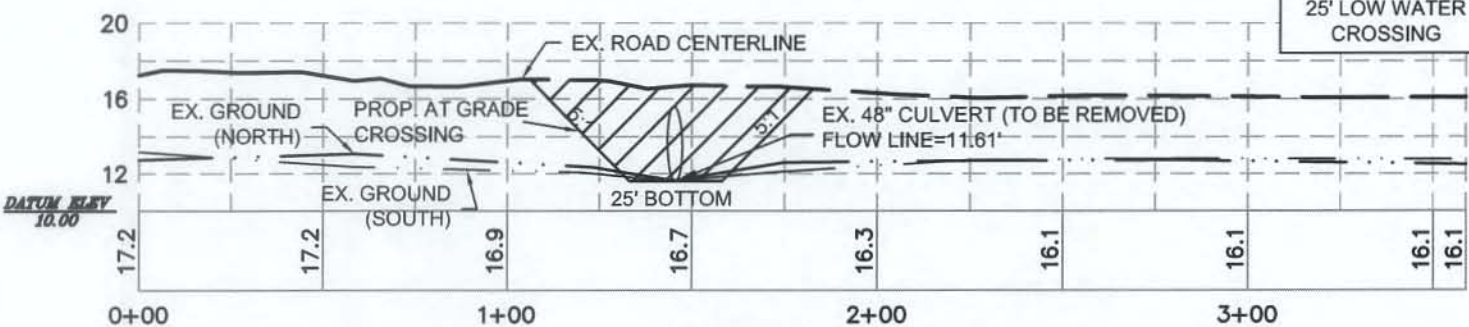
FIGURE 19

PLAN VIEW

STRUCTURE	FLOW RATE (MAX)	WATER DEPTH
48" CORRUGATED METAL PIPE	45.6 CFS	45"
25' LOW WATER CROSSING	425.5 CFS	36"

**CROSS SECTION VIEW
B-B**

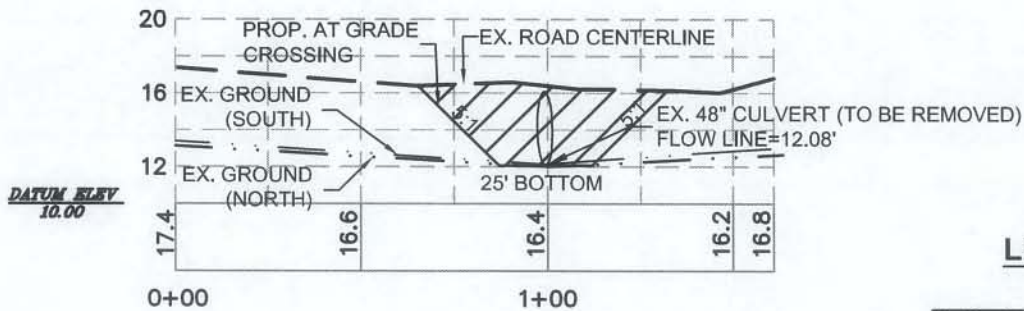
FIGURE 20

PLAN VIEW

SCALE:
1"=50' H
1"=10' V

HYDROLOGICAL DATA		
STRUCTURE	FLOW RATE (MAX)	WATER DEPTH
48" CORRUGATED METAL PIPE	45.6 CFS	45"
25' LOW WATER CROSSING	425.5 CFS	36"

CROSS SECTION VIEW
C-C

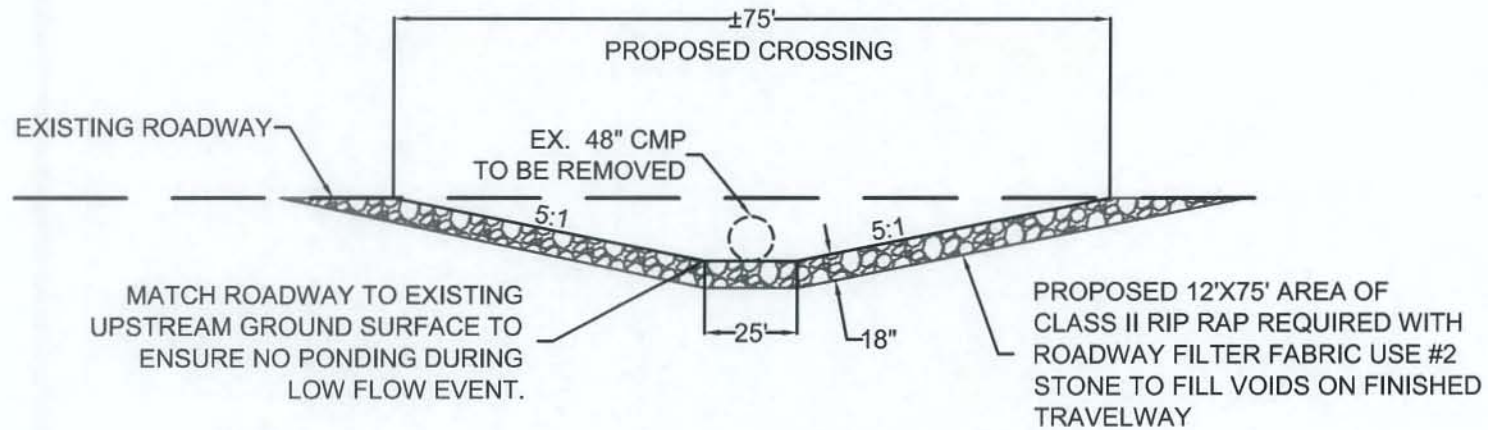
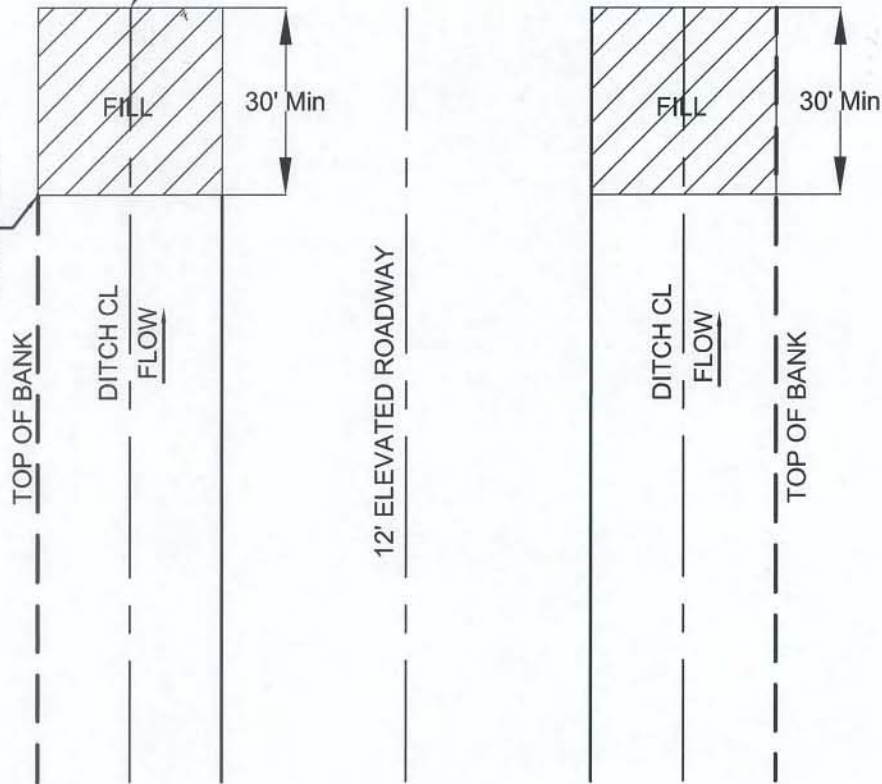
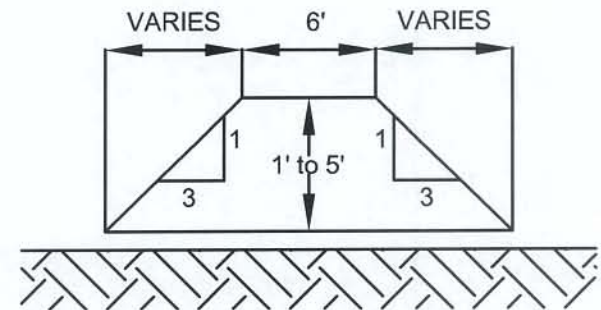
DITCH BLOCK DETAIL

PROPOSED DITCH BLOCK CONSISTING OF
A MINIMUM OF 30' OF COMPACTED EARTH.
TO RESTORE PRIOR DRAINAGE CHARACTERISTICS.

DISTURBED AREA TO BE
SEEDED AND MULCHED
IMMEDIATELY AFTER
COMPLETION OF THE
DITCH BLOCK.

1. EACH DITCH BLOCK WILL VARY IN SIZE BASED ON SPECIFIC SITE CONDITIONS.
2. FILL IS TO BE GENERATED ONSITE BY AT GRADE CROSSINGS AND NEW CULVERT INSTALLATIONS.
3. SEE FIGURE 18 FOR DITCH BLOCK LOCATIONS.

TOTAL NUMBER OF PROPOSED DITCH BLOCKS = 40

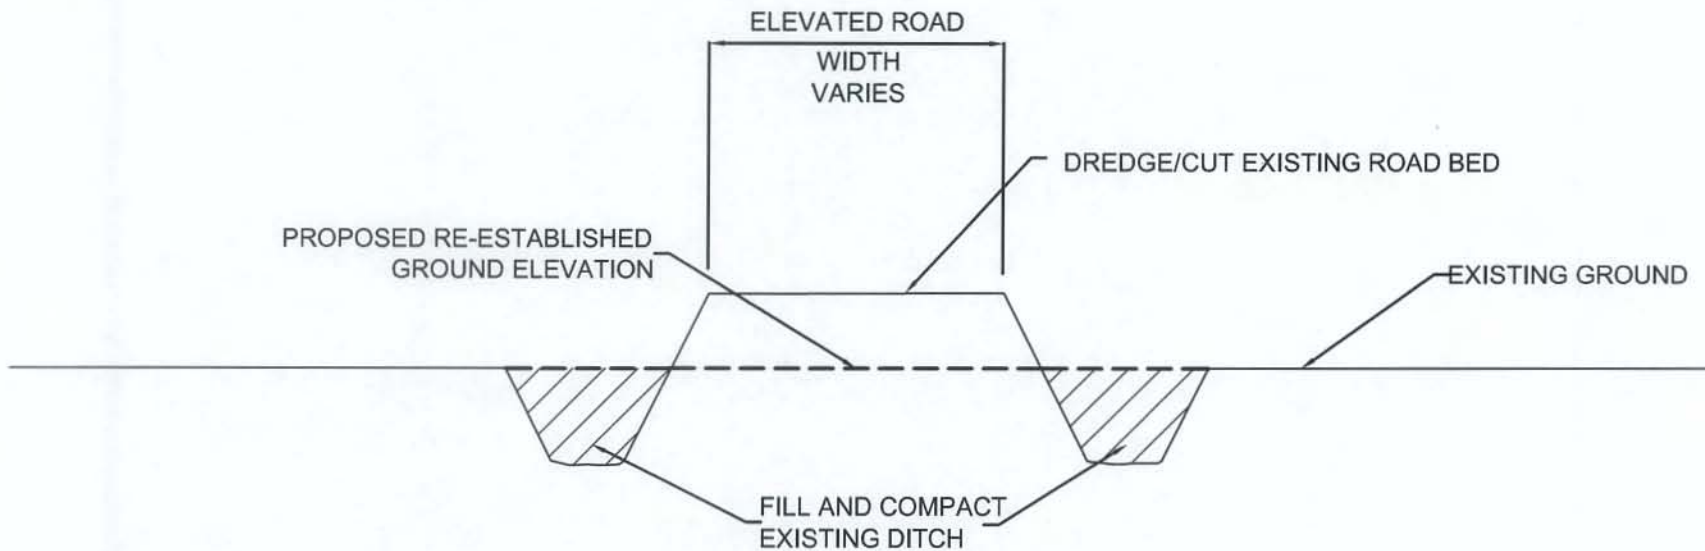
1. REMOVAL OF ROAD SHOULD RESTORE ORIGINAL DRAINAGE. USE EXISTING GROUND FOR TIE ELEVATIONS ALONG THE ROADWAY. REMOVE ANY CULVERTS.
2. ESTABLISH SEEDING AND MULCHING IMMEDIATELY AFTER WORK IS COMPLETED.
3. SEE FIGURE 16 FOR ROAD REMOVAL LOCATIONS.
