**GROUND WATER FLOW PATTERNS
IN THE ECONFINA CREEK SPRINGS
WASHINGTON AND BAY COUNTIES, FLORIDA**

**PREPARED BY:
NORTHWEST FLORIDA
WATER MANAGEMENT DISTRICT
JULY 2004**

Water Resources Special Report 04-03

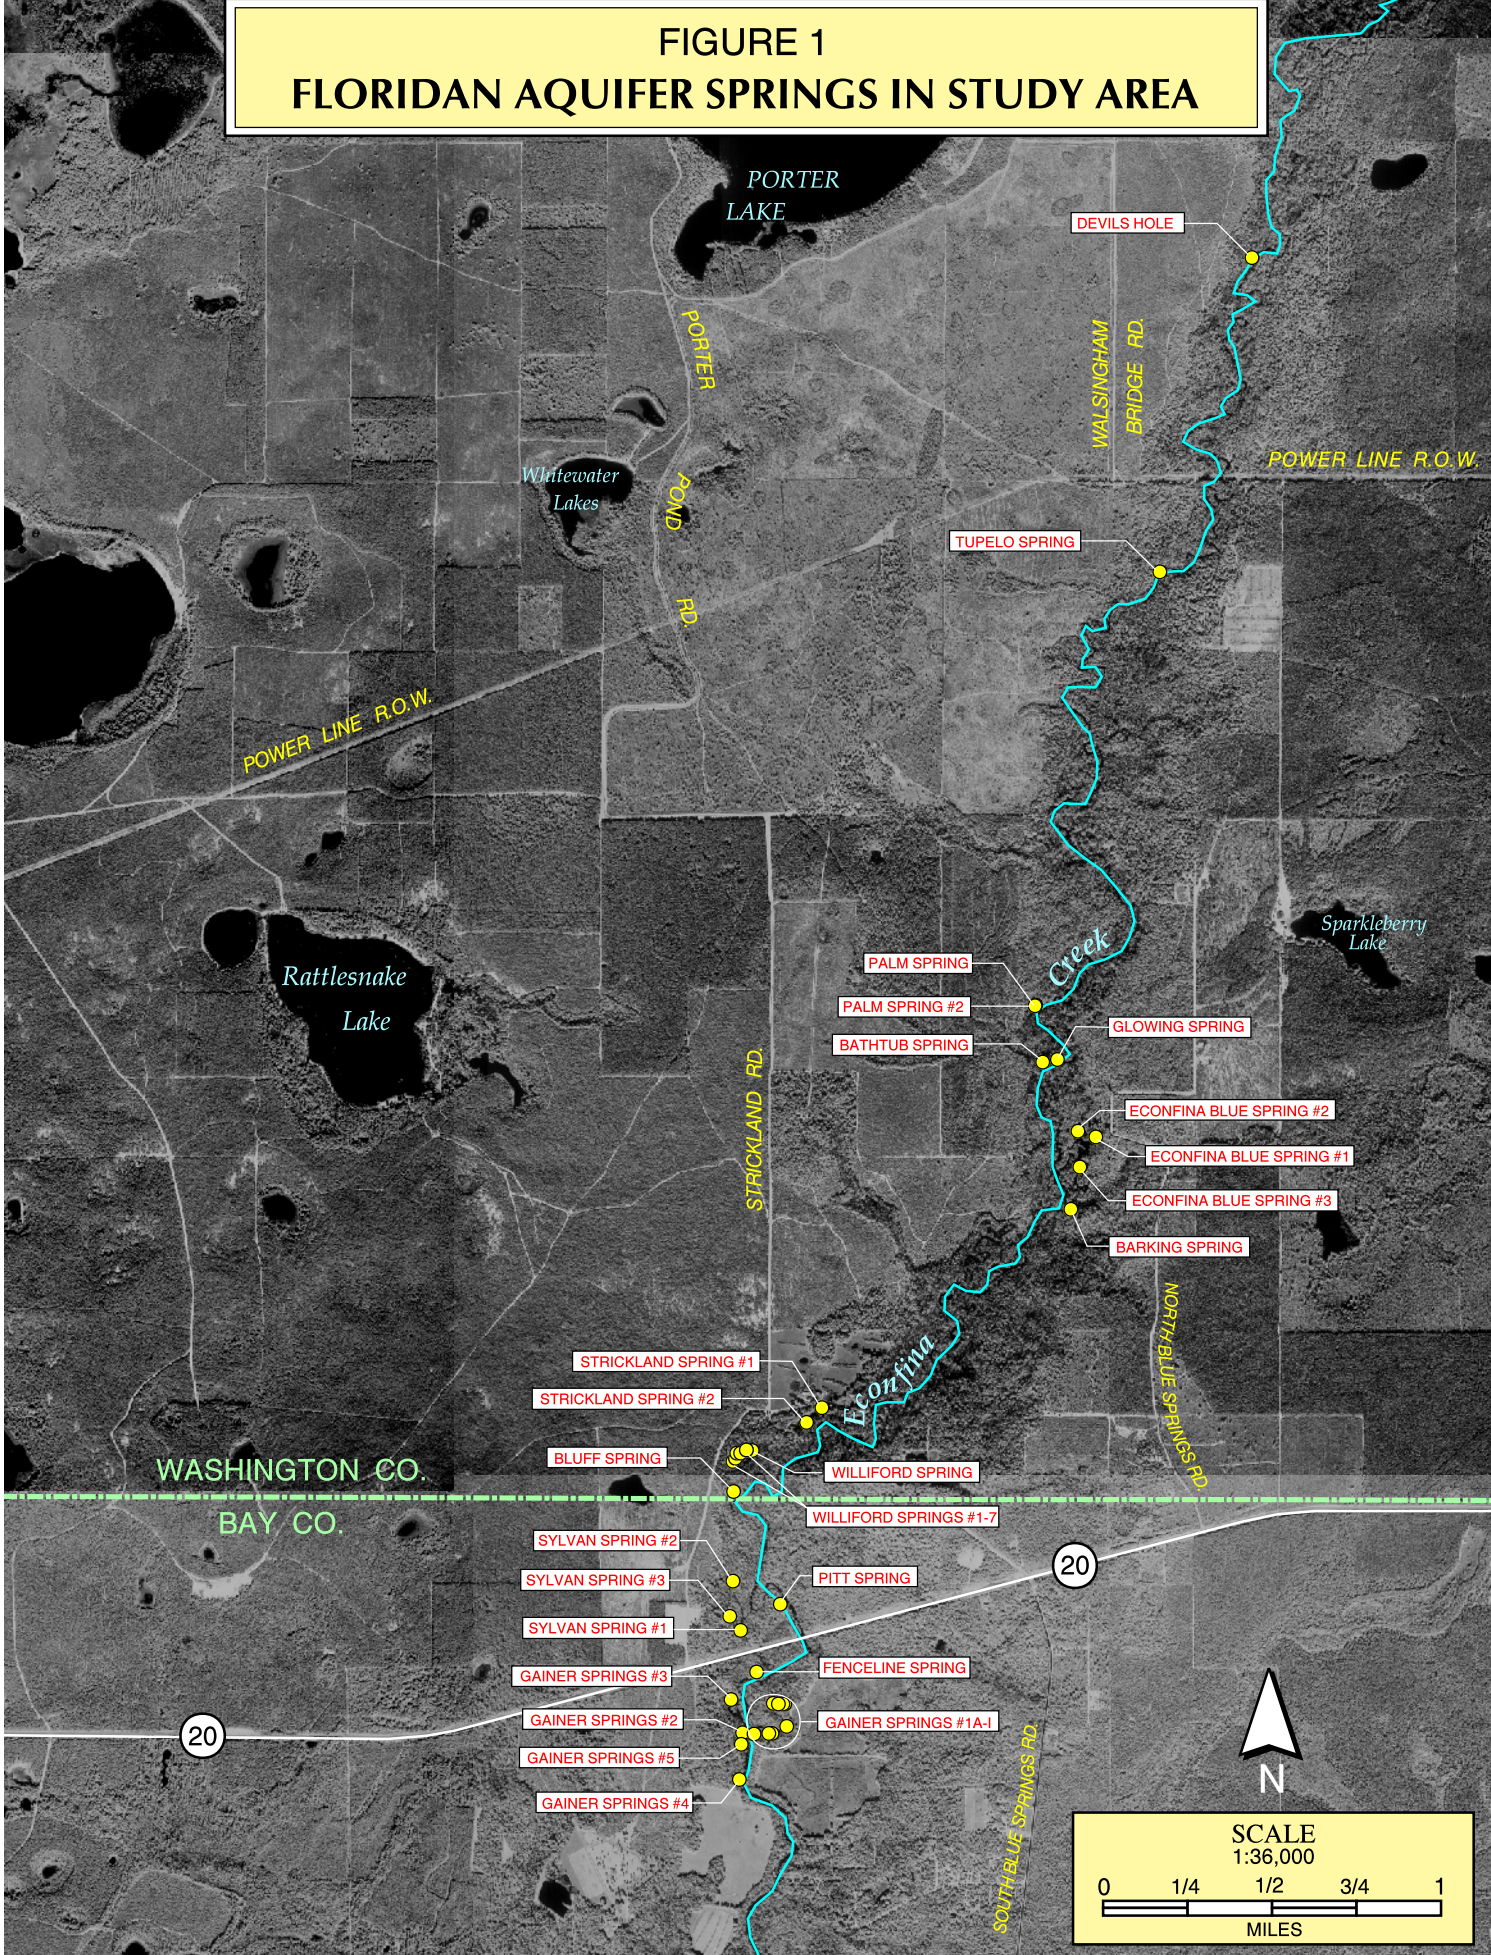
FIGURE 1 FLORIDAN AQUIFER SPRINGS IN STUDY AREA

The known Floridan Aquifer springs located along Econfina Creek (Figure 1) are found in Washington and Bay counties. This portion of Econfina Creek lies within the Bennett, Fla USGS 7.5 minute topographic quadrangle, both north and south of State Highway 20. The study area is at the southern extent of the Dougherty Karst Plain within the Sand Hill Lakes physiographic subregion. The karst aquifer underlying the area is developed in a sequence of southward dipping Miocene aged and older carbonates.
