Sand Hill Lakes Mitigation Bank

Mitigation Banking Instrument

Northwest Florida Water Management District
81 Water Management Drive
Havana, FL 32333-4712
850-539-5999

February 2006

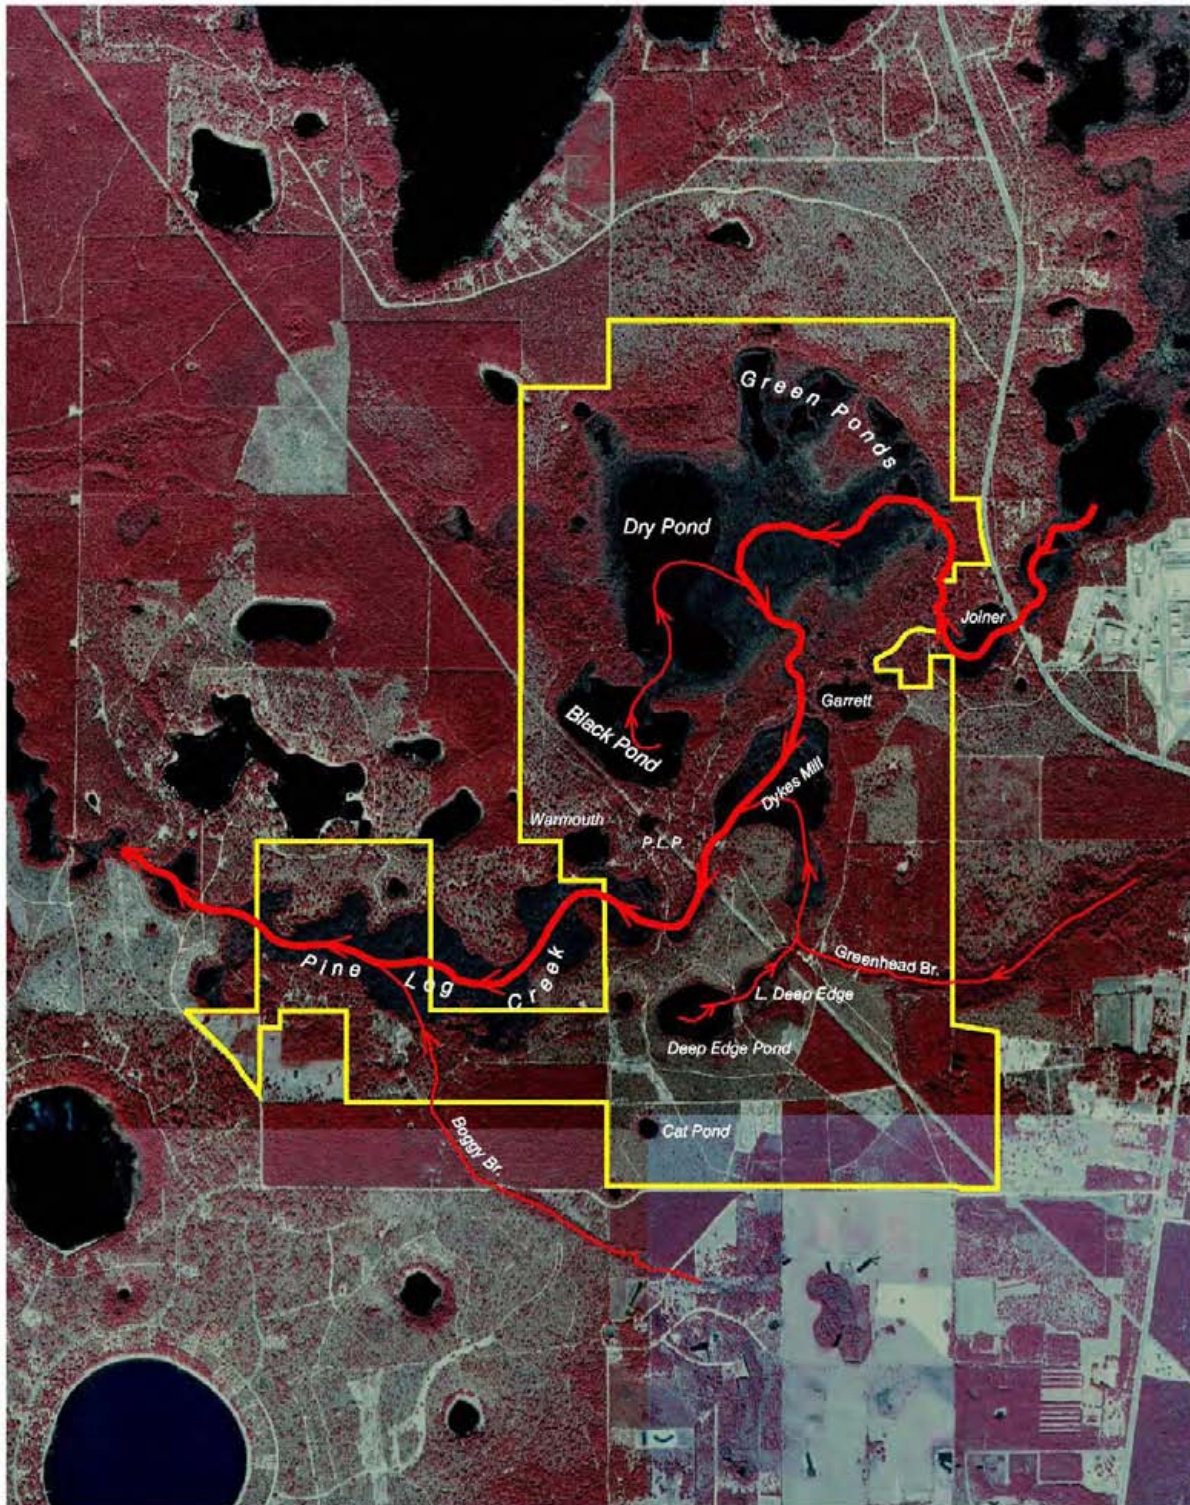
Unaltered Surface Flow Paths (Pre-1900)

→ Surface Water Flow Path

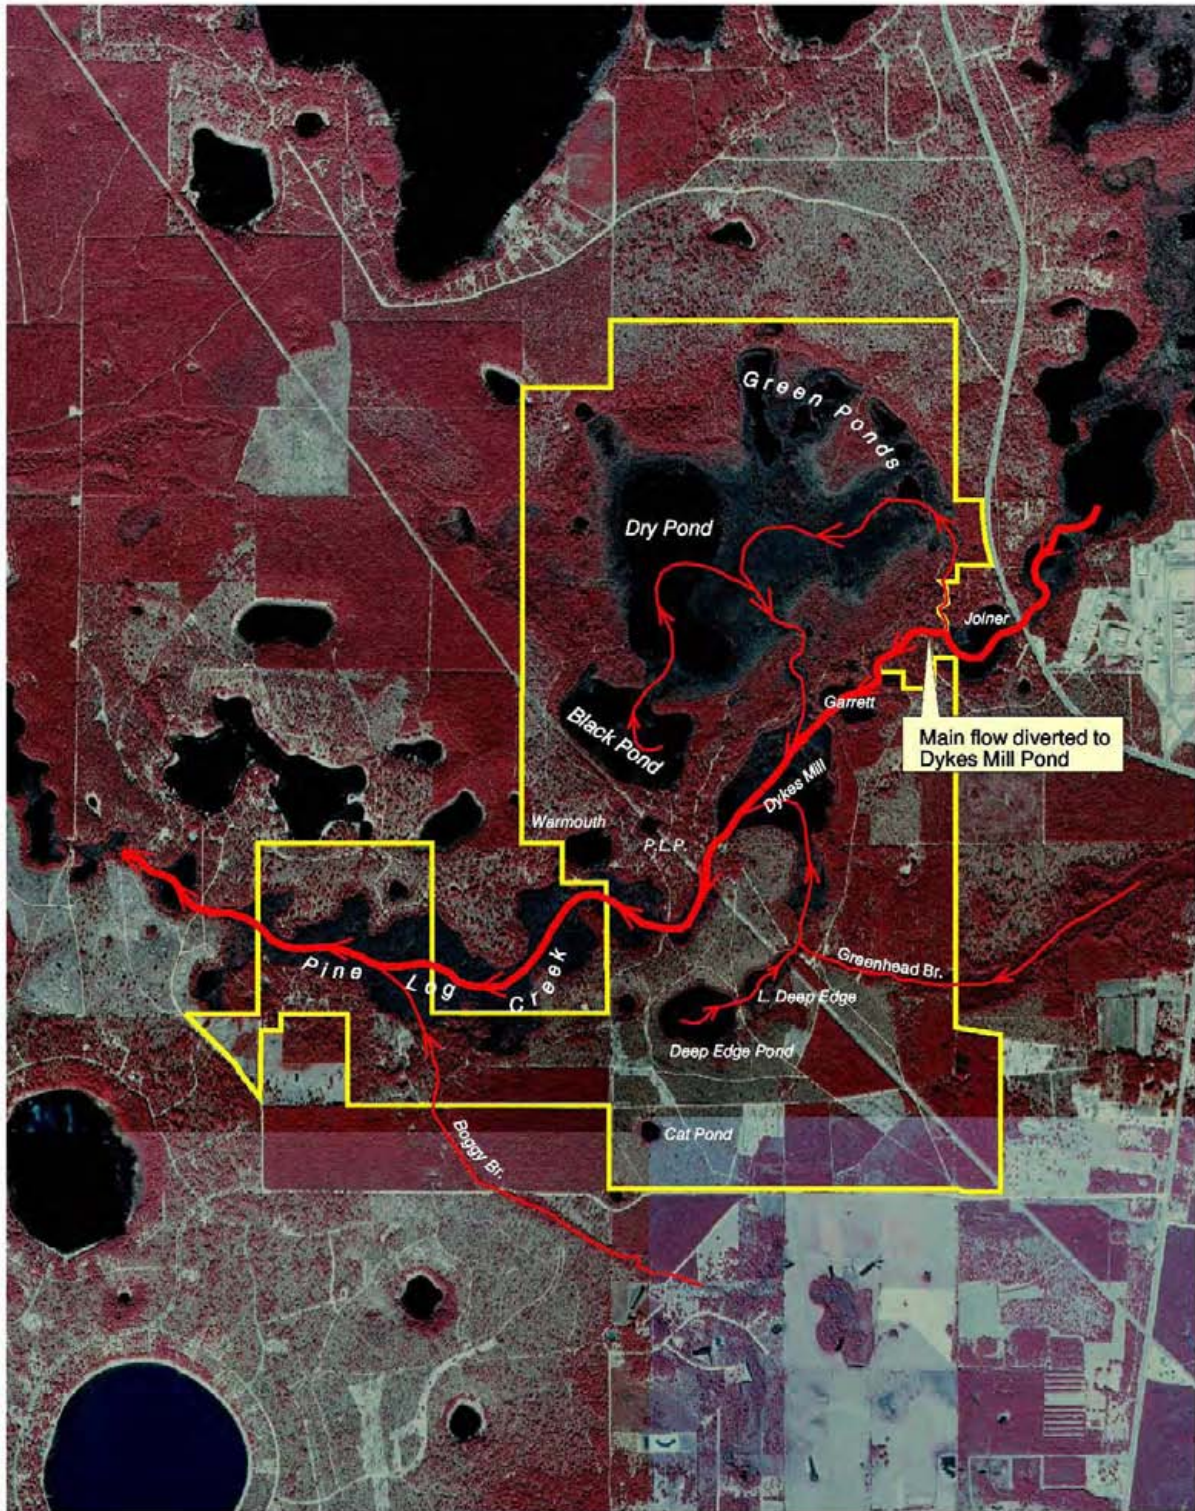
Altered Surface Flow Paths (Ca. 1900)

→ Surface Water Flow Path

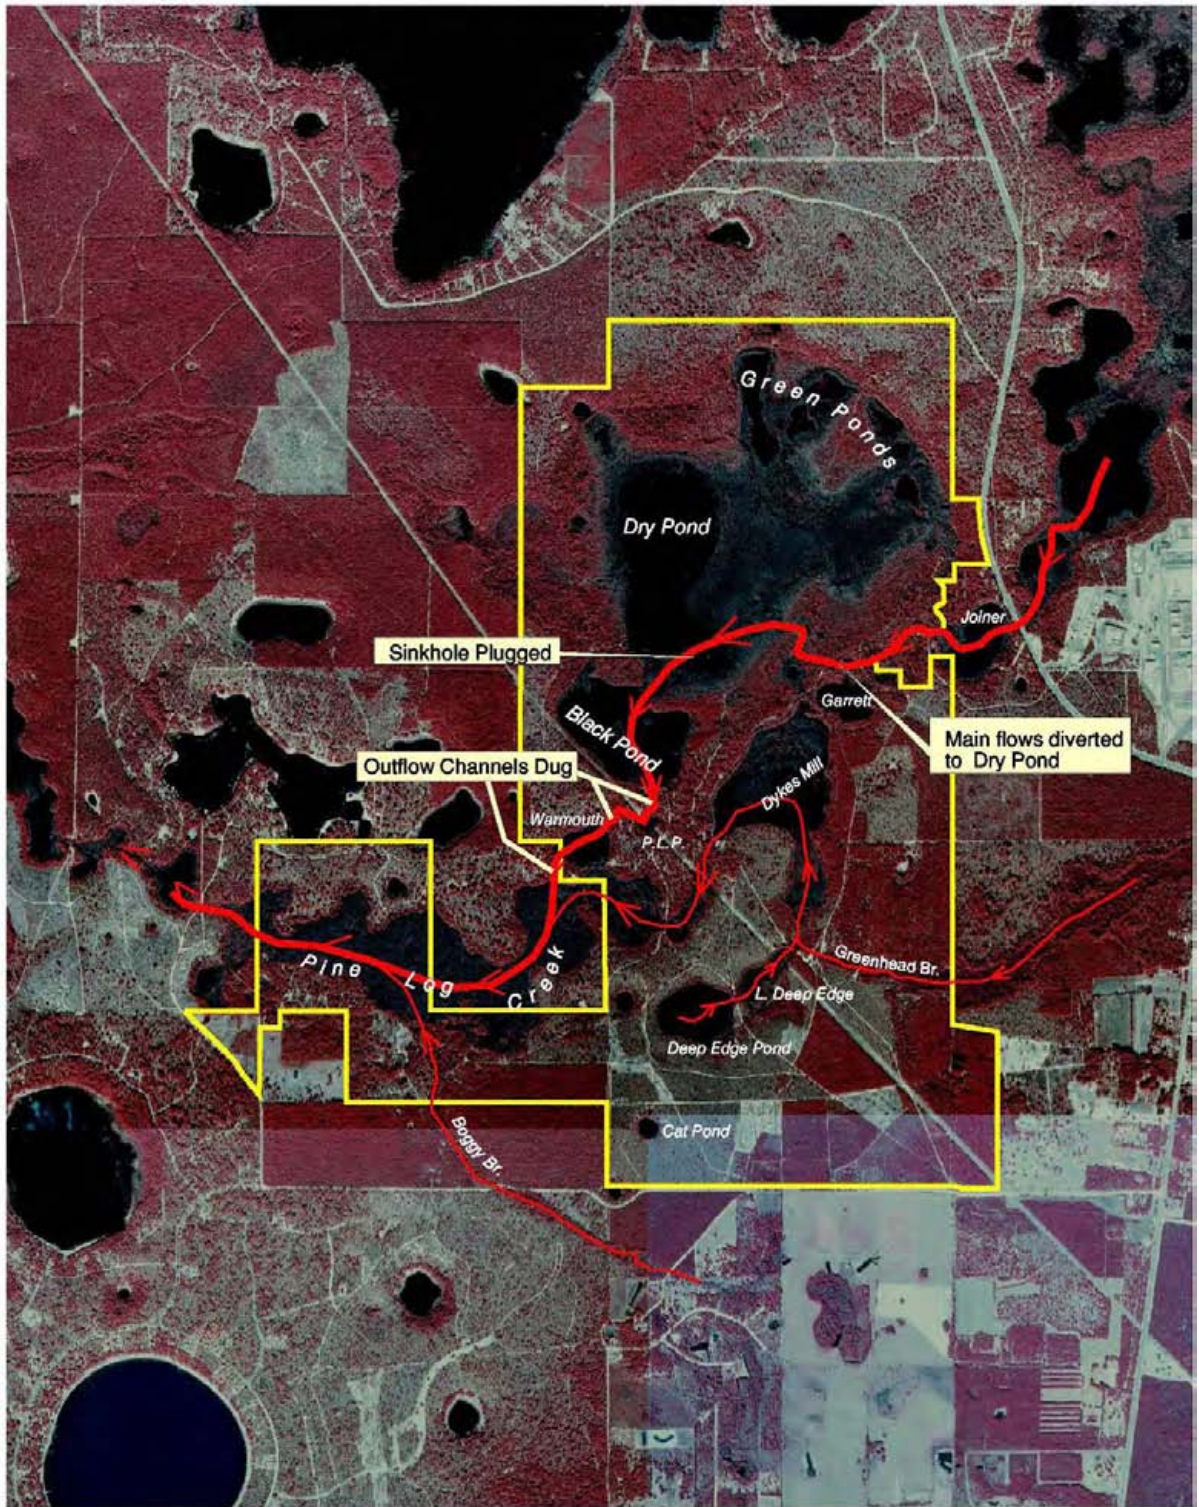
Altered Surface Flow Paths (Post-1950s)

→ Surface Water Flow Path
