Sand Hill Lakes Mitigation Bank, Oblique Aerial, Looking Approximately Northeast, 11/20/2013 (Photo #82)

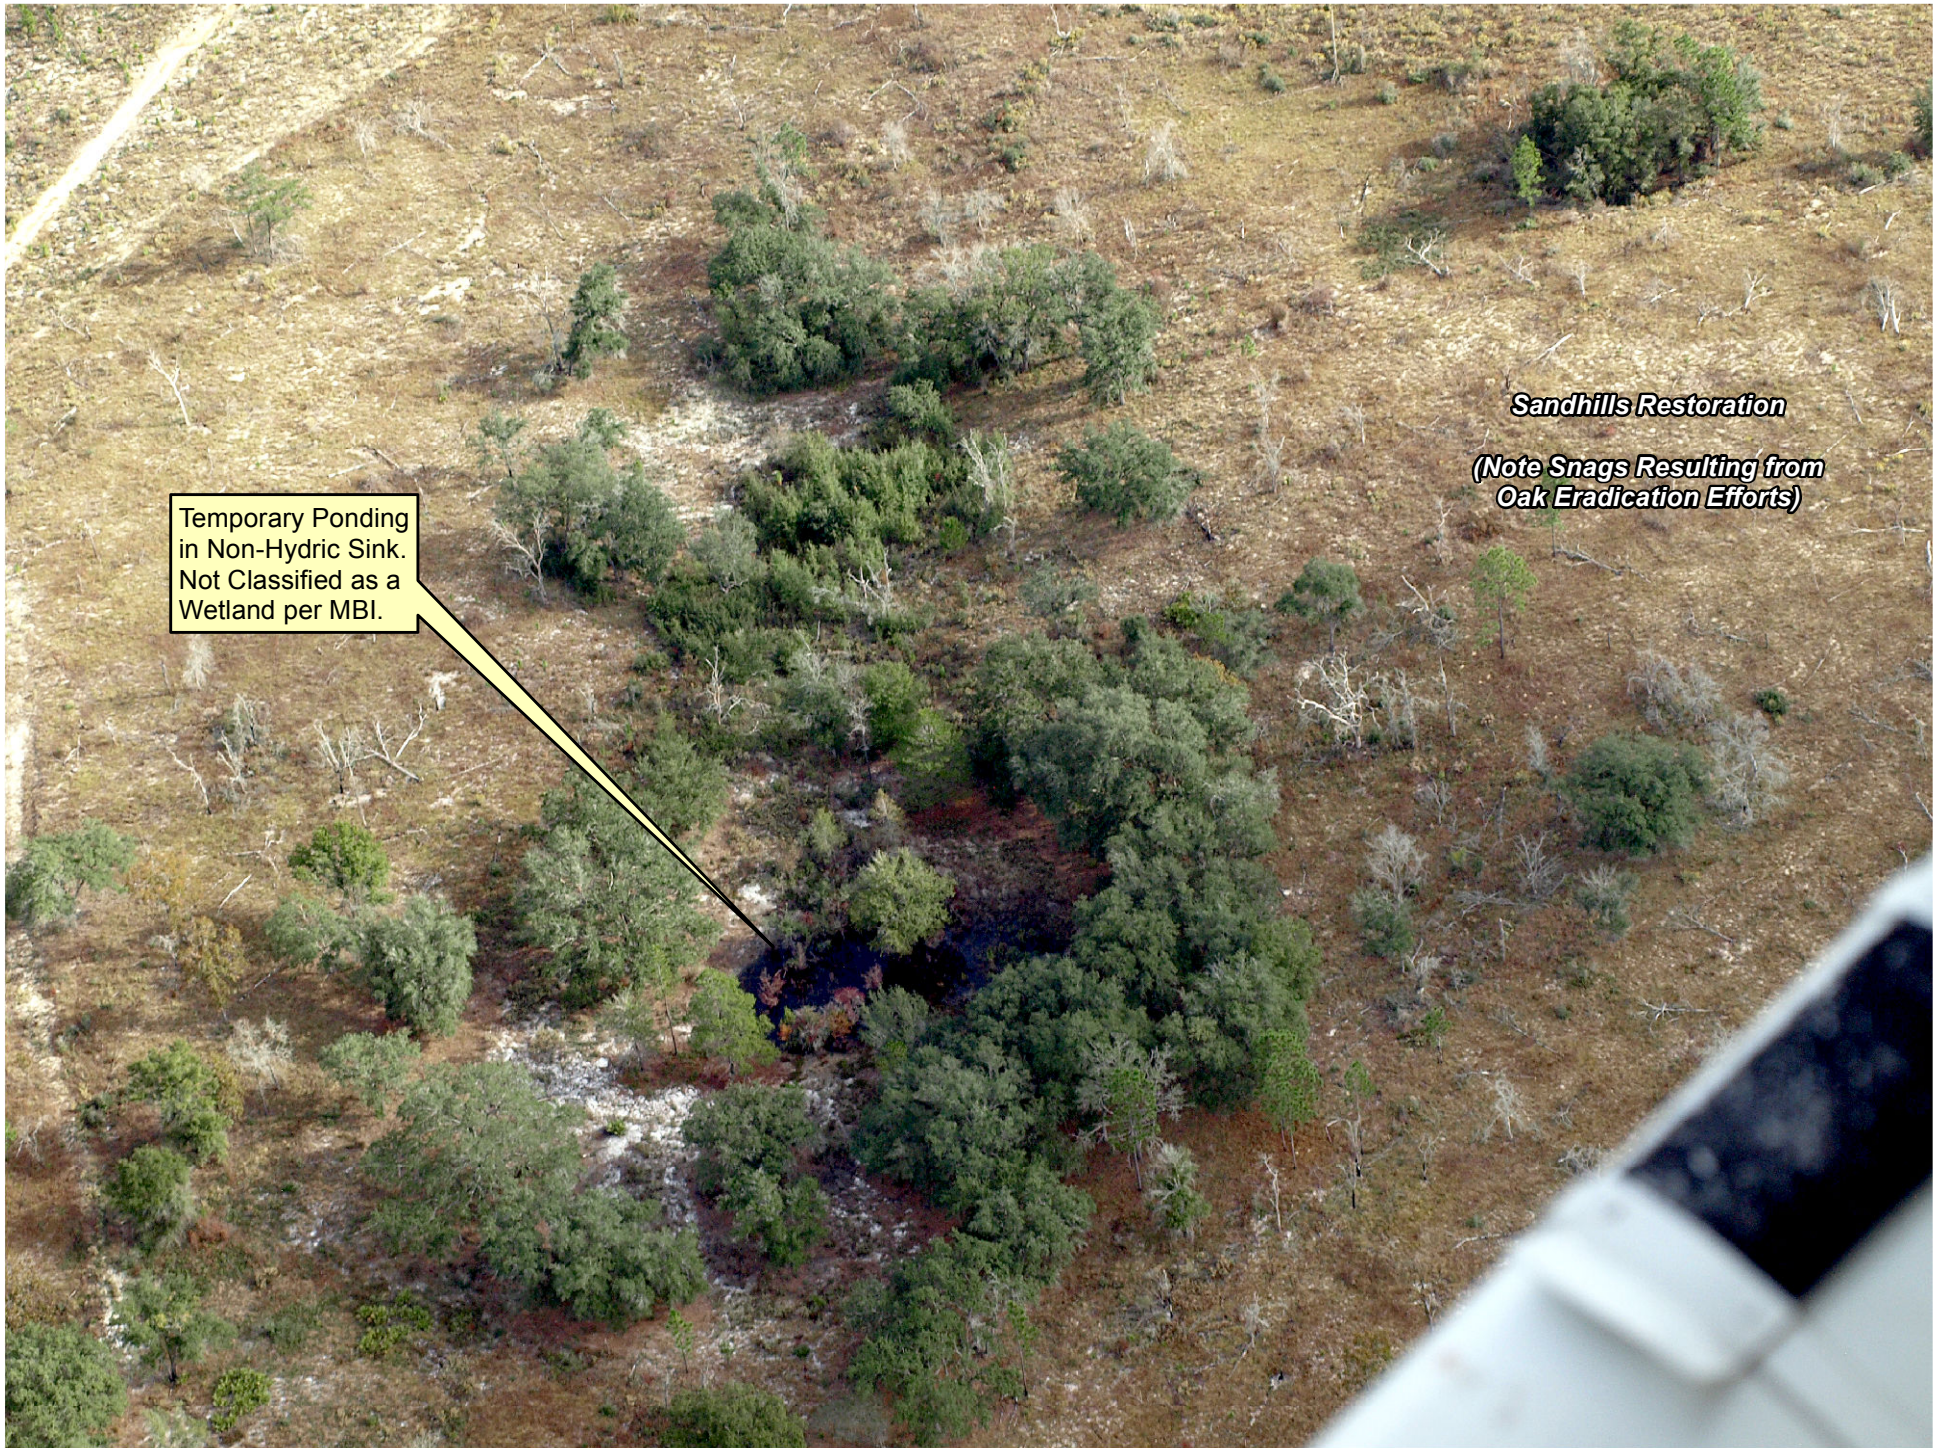
Temporary Ponding
in Non-Hydric Sink.
Not Classified as a
Wetland per MBI.

Sandhills Restoration
(Note Snags Resulting from
Oak Eradication Efforts)
