# **PRELIMINARY BRIDGE REPLACEMENT REPORT**

**Financial Project ID: 413478-1-32-01**

**CR 375 over Syfrett Creek  
Bridge No. 590018  
Section No. 59050000**

**Wakulla County**

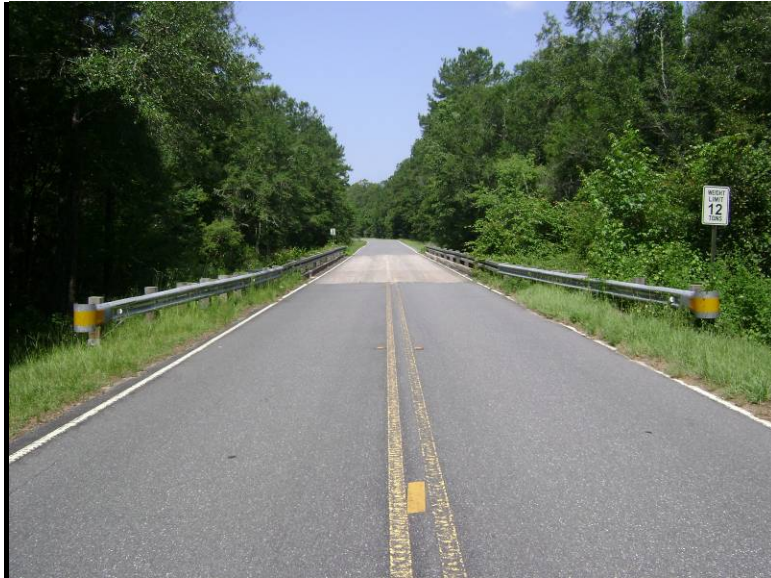
**Photo 1**

Looking west from approximately 100' east of the bridge.

Note: The bridge is posted at 12 tons.

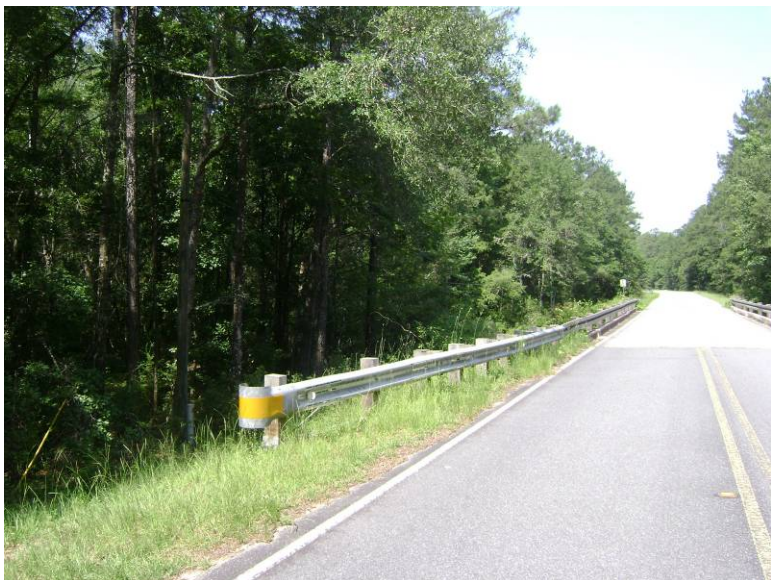
**Photo 3**

Looking west along the south side of the bridge. The majority of the land on the south side of the roadway appears to be floodplain.

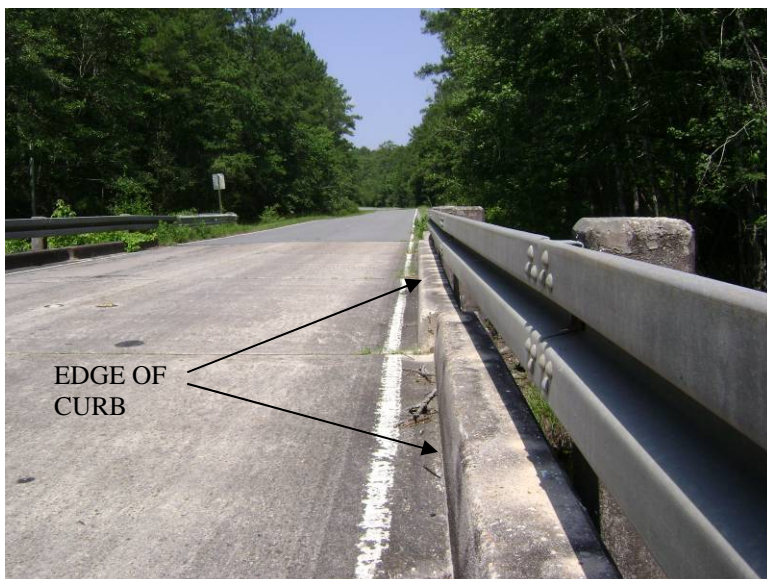
### Photo 6

Looking west along the north side of the bridge. Notice the misalignment of the curb. Several spans have shifted 4" to 5" on this bridge.

This site will require an on-site diversion with a temporary bridge or a new alignment parallel to the existing bridge. At the time of the field review several spans of the bridge deck had shifted horizontally 4" to 5" out of alignment. The substructure also appeared to be in poor condition due to leaning piles and a pole wedged between bent caps for lateral support.

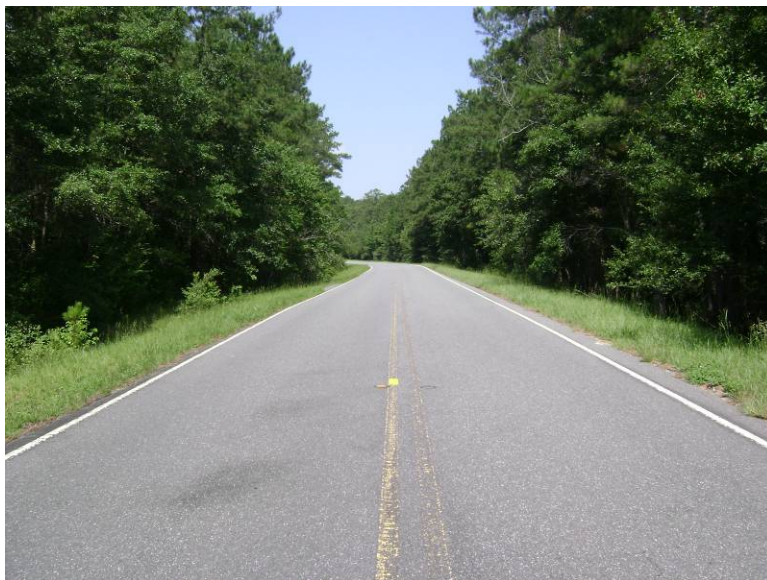
### **Photo 8**

Looking west at the western roadway approach from approximately 100' west of the bridge. A horizontal curve is located west of the bridge.

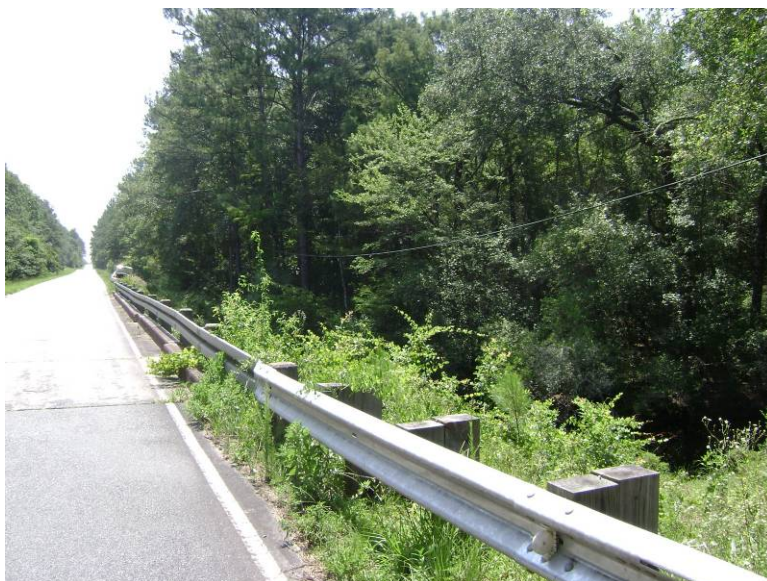
### **Photo 9**

Looking east along the south side of the bridge at the overhead telephone crossing the creek.

- The only utility in the area is located along the south side of the bridge. Telephone is overhead crossing the creek and underground thereafter. Utility impacts are anticipated.

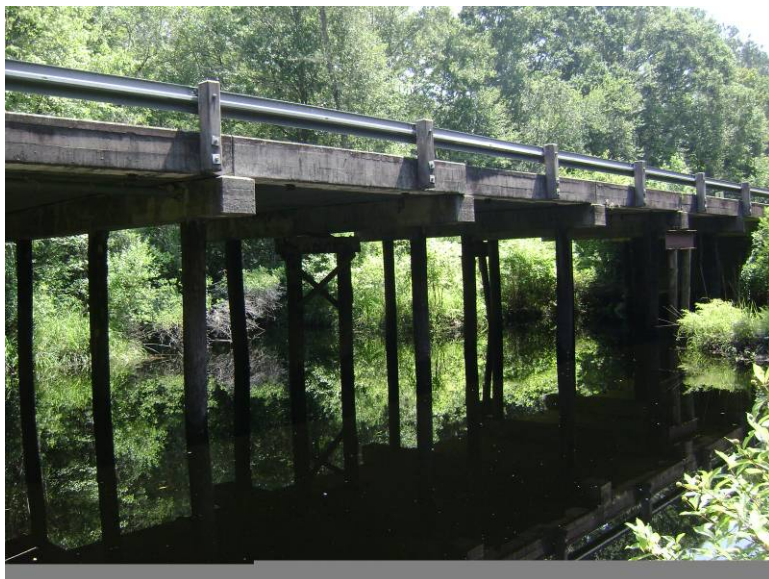
**Photo 12**

Looking north at the substructures of the bridge. Notice the crutch bents and crooked piles.

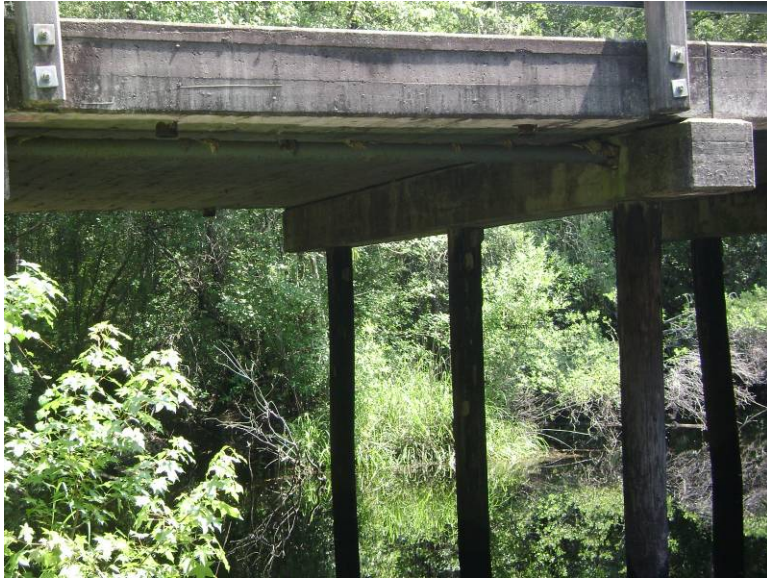
**Photo 13**

Looking north at one of the spans where a pipe strut has been placed between the bent caps to longitudinally support the bents.

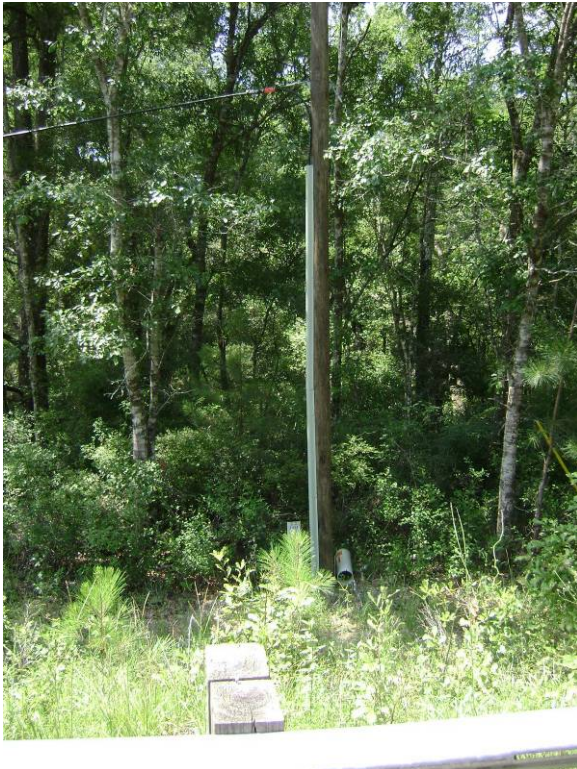
**Photo 14**

Looking south at the overhead telephone pole. Buried telephone goes overhead at this location adjacent to the southwest corner of the bridge. This is the only utility observed on the field review.
