MEGINNIS ARM SHORELINE RESTORATION MITIGATION SITE
Annual Monitoring Report, Year 5 of 5
February 23, 2012

PROJECT OVERVIEW

Impact: I-10 (Ochlockonee River to CR 361) in Leon County
USACE Permit No.: SAJ-2005-1406 IP-SEG, Issued 4/6/06
Mitigation: Meginnis Arm Shoreline Restoration
Permittee/Consultant: FDOT
Responsible Party for Monitoring: Northwest Florida Water Management District (NFWFMD)
81 Water Management Dr.
Havana, FL 32333
Date of Inspection: February 21, 2012
Inspectors: Graham Lewis, Leigh Brooks

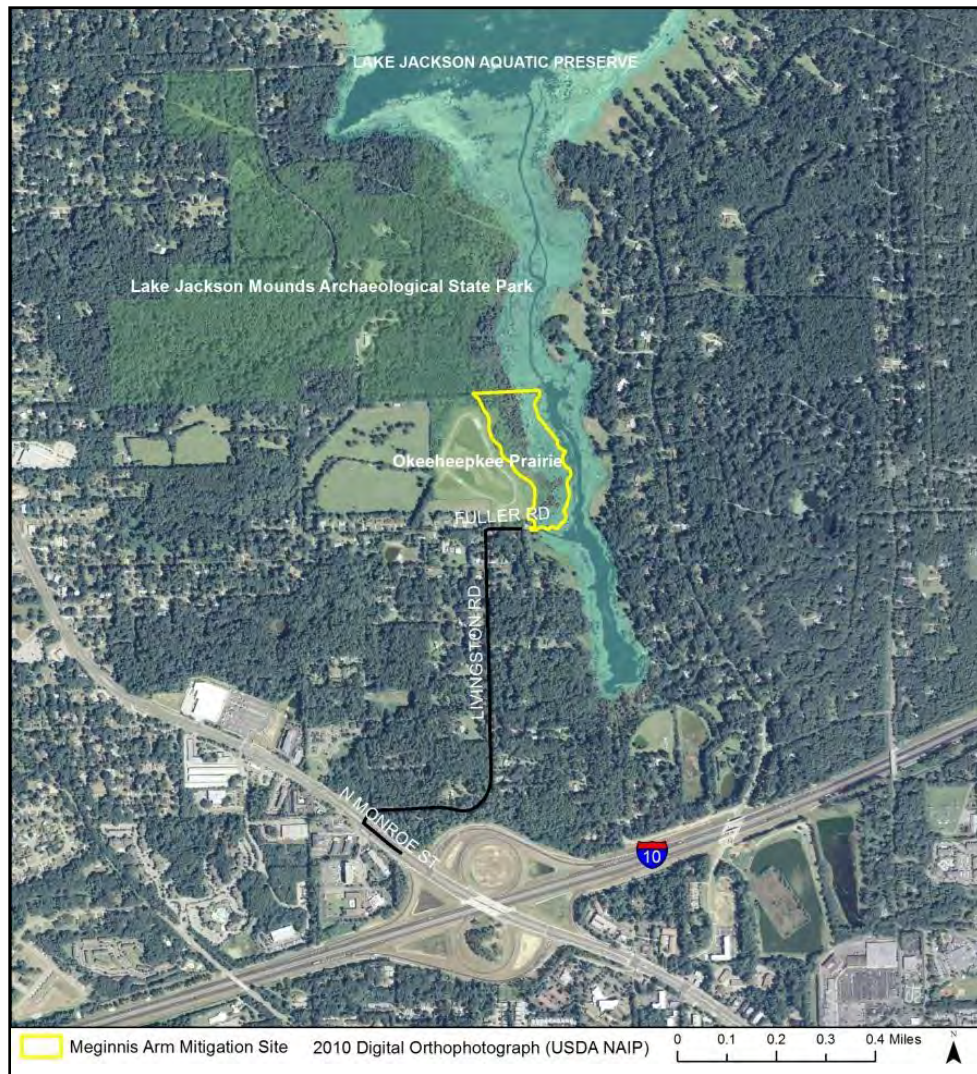
Figure 2. Meginnis Arm Shoreline Restoration Site.

The Meginnis Arm mitigation site is located in Leon County at the south end of Lake Jackson and just north of I-10 ([Figures 1](#) and [2](#)). The site is on the western side of Meginnis Arm, bounded on the south by the county-owned Fuller Landing Road boat ramp and on the north by Lake Jackson Mounds Archaeological State Park. From the I-10 interchange at US 27/Monroe Street, head north on US 27 and take the first right turn onto Okeeheepkee Road. Immediately turn right on Livingston Road. Follow the road 0.8 miles. At T, turn right onto Fuller Road. Go about 400 feet to parking area.

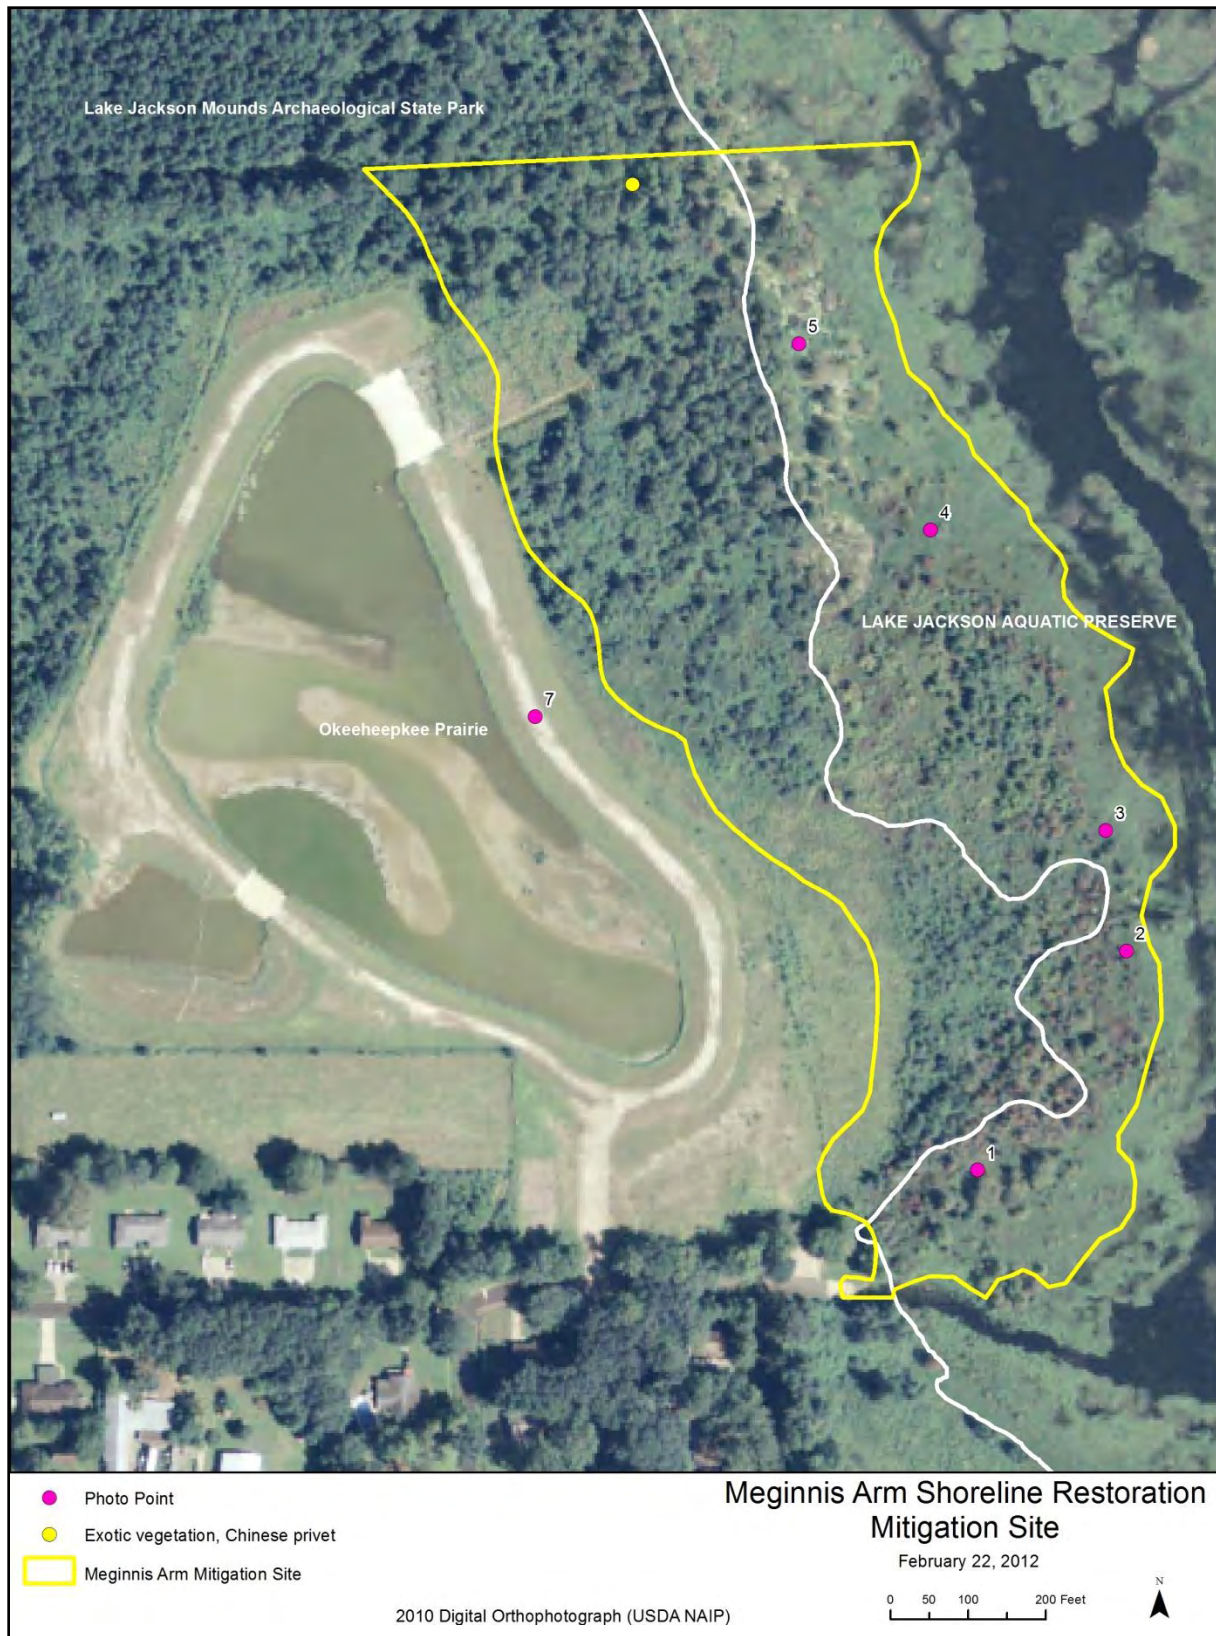
Figure 4. Aerial photograph of Meginnis Arm Shoreline Restoration site after development of Okecheepkee Prairie Regional Stormwater Management Facility. [RTN](#)

The current monitoring was carried out on February 21, 2012, and consisted of a meandering pedestrian survey throughout the site with photographs taken at a variety of points ([Figures 3](#) and [4](#)). Field sheets are attached documenting [site conditions](#) and [observed species](#).

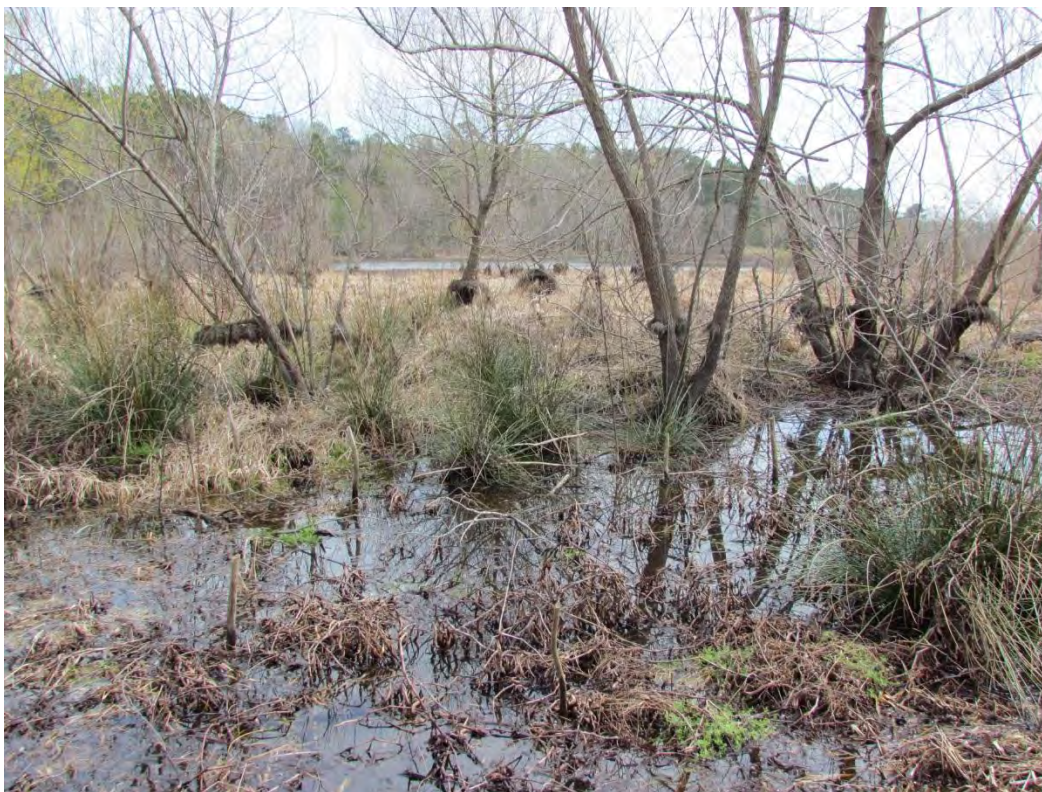
Photo 1. Southern end of wetland site with *Juncus effusus* in foreground. Photo point 1, looking east. 2/21/12. [RTN](#)

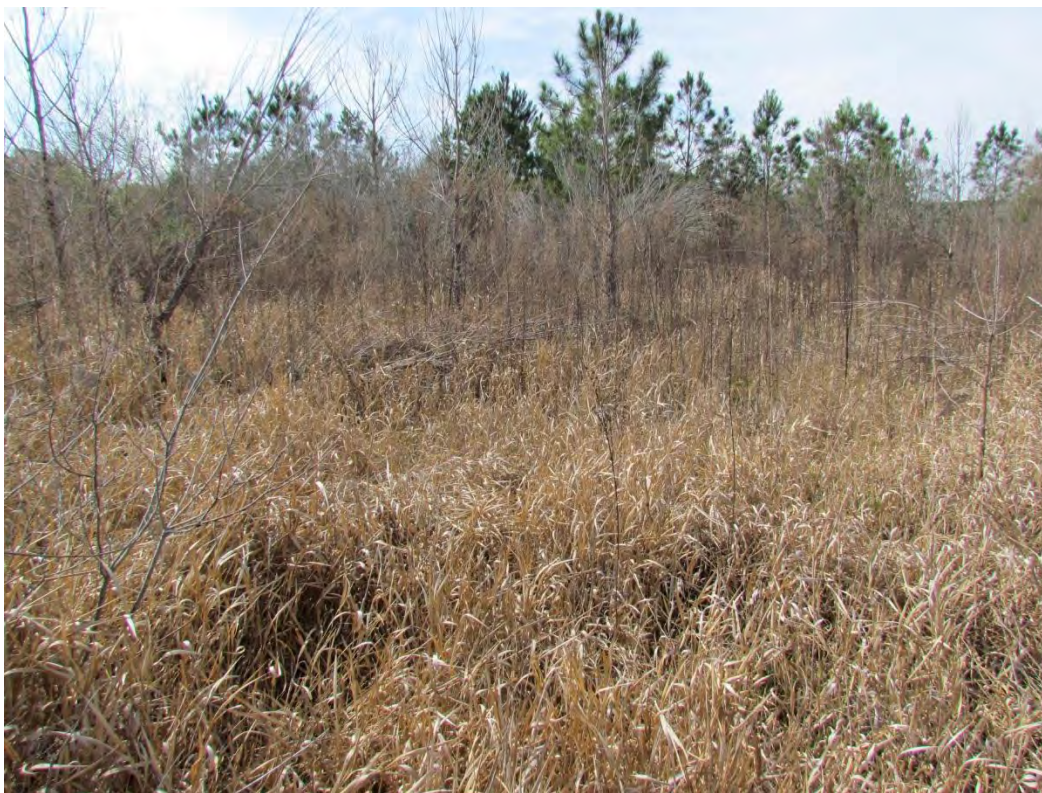
Photo 2. Wetland site with dense herbaceous groundcover. Photo point 2, looking west. 2/21/12.

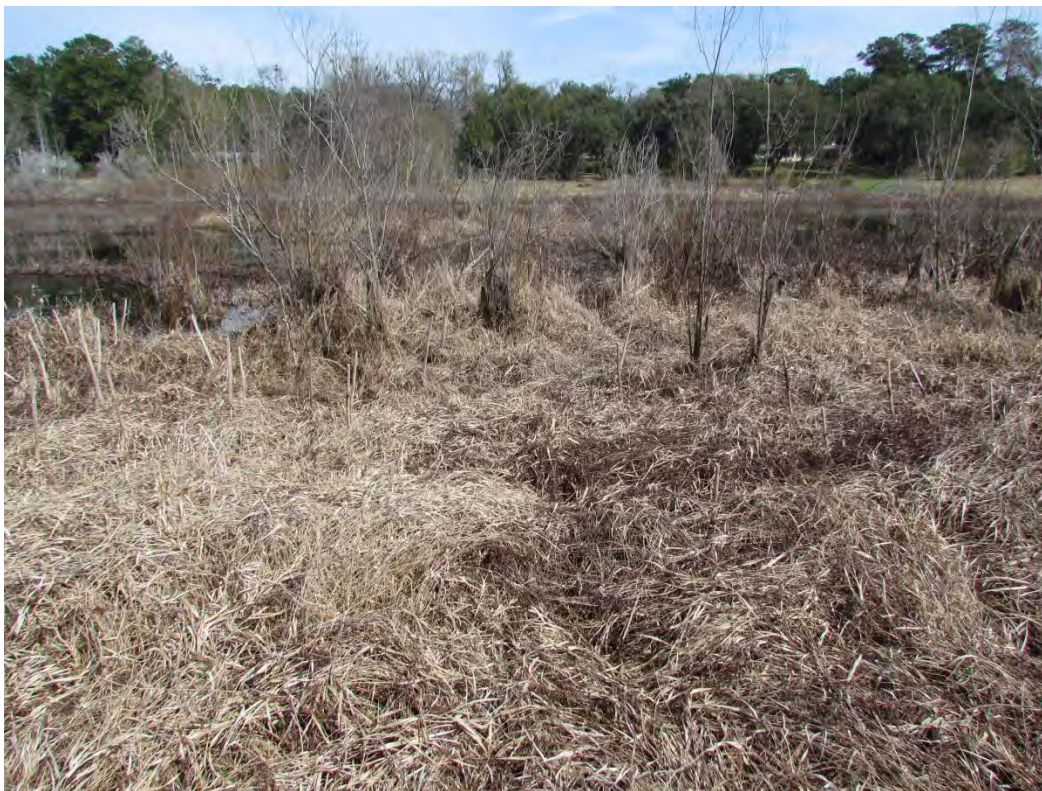
Only one live invasive exotic plant was observed on the mitigation site, a Chinese privet (*Ligustrum sinense*) at the north end by the fence line which the observers flagged. Cut stumps of Chinese tallow trees remained, visible in [Photo 3](#). At the parking area for Fuller Landing Road boat ramp, a large Japanese privet (*Ligustrum japonicum*) in fruit was observed and possibly a small cluster of dormant Chinese tallow; however, this area is not technically on the mitigation site. A few apple snail shells of various sizes were seen in the wetland ([Photo 6](#)). It was not determined if they were native or exotic species although several of the shells were large; none were found living. Apple snail occurrence should be monitor in the future both at this site and throughout Lake Jackson. In addition, several red ant mounds were scattered around the site.

Photo 3. Wetland edge with cut stumps of Chinese tallow visible. Photo point 3, looking east. 2/21/12.

The freshwater marsh is progressing well toward successful restoration of the natural wetland community. Performance standards appear to have been met for this project. Controlling invasive exotic vegetation allowed for recruitment and recovery of native species. Continued periodic inspection and control for exotics will be needed to prevent reinfestation from the many seed sources around Lake Jackson. It is a difficult task to clear and maintain a site for exotic/invasive species when these species occur in adjacent untreated areas; long-term vigilance and continued eradication may be required. As this is the fifth year of monitoring, the District should request release from further annual monitoring requirements; continued, but less frequent surveys can ensure successful exotic control.

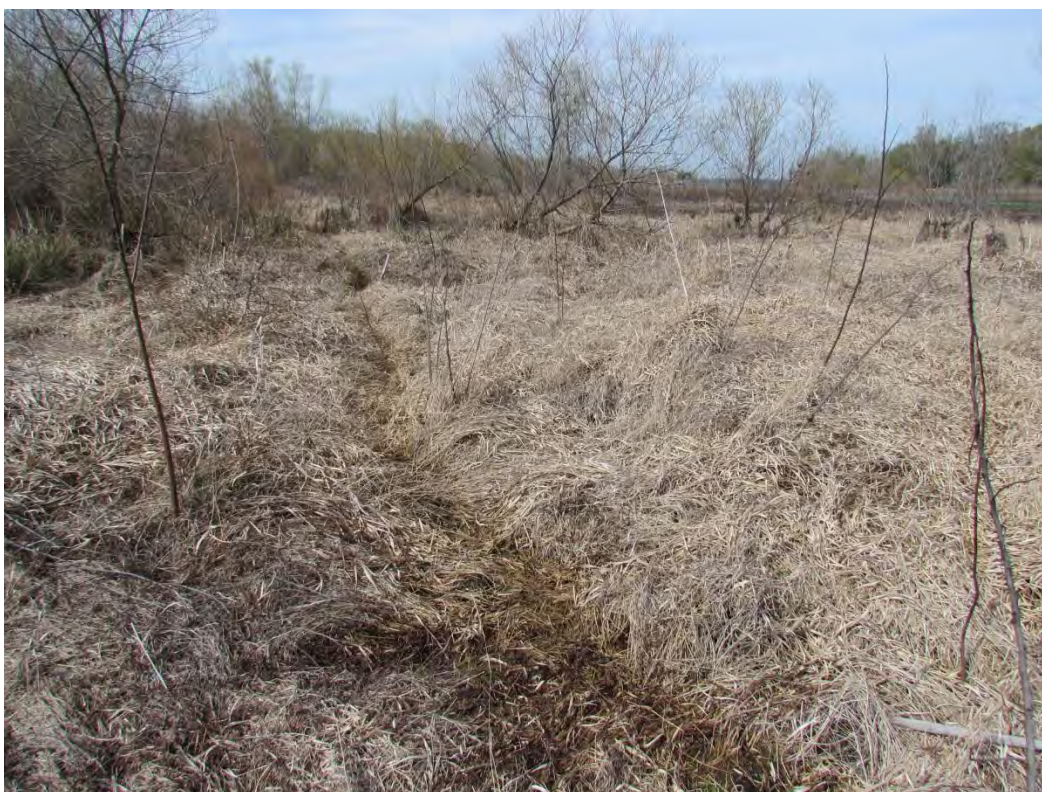
Photo 4. Wetland edge with animal/human trail visible. Photo point 4, looking north. 2/21/12.

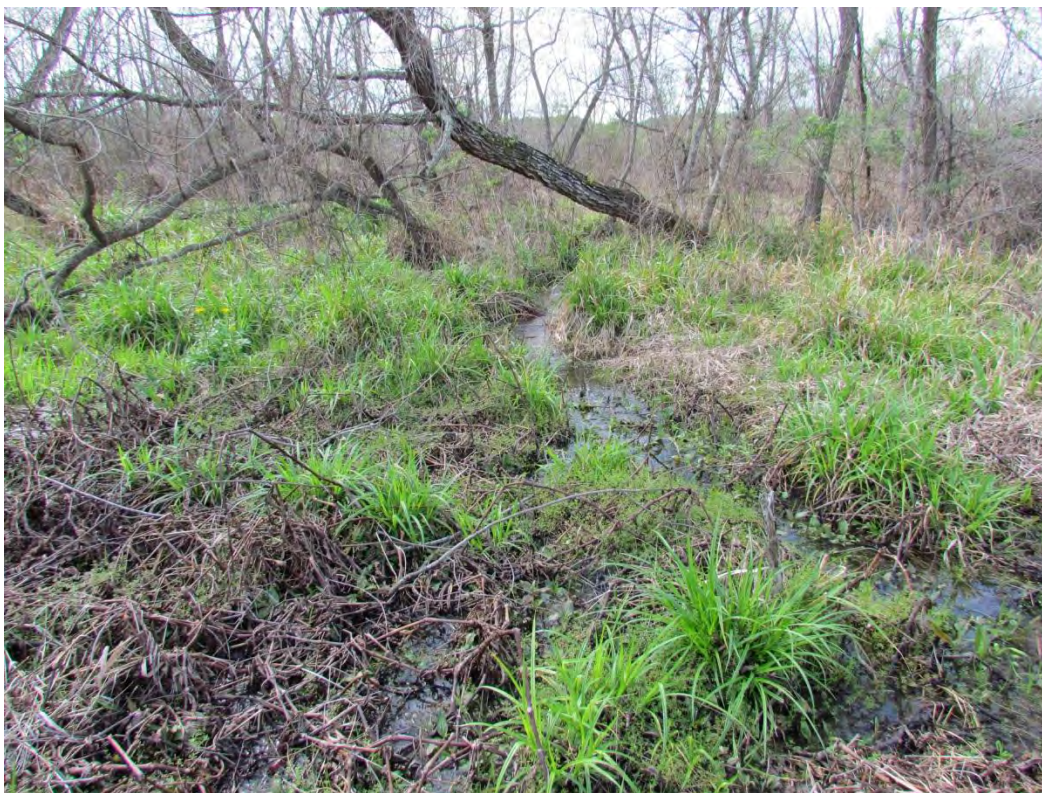
In the transition area between upland and wetland, there were imposing thickets of sawtooth blackberry (*Rubus pensilvanicus*). Loblolly (*Pinus taeda*) and slash (*Pinus elliotii*) pines and wax myrtle (*Myrica cerifera*) dominated the upland portion of the site. Dead pines and wax myrtle were scattered in the lower wetland portion, drowned from previous higher lake levels. The lake level was low at the time of this visit. Roots of willow trees were exposed above the water line, as can be seen in Photo 1. Soft rush ([Photo 1](#)) and marsh mallow were abundant, seeds capsules present on the latter. Dormant or dead grasses, mostly maidencane (*Panicum hemitomon*), created a very thick and dense groundcover ([Photos 2-4](#)). A narrow trail was evident from trampled grasses in this area ([Photo 4](#)), although it could not be determined if animal or human, possibly both. Animal tunnels/burrows were seen in wetland areas and grasses. No pond cypress were observed. A small stream was running from the upland, through a wetland, to the lake. This wetland had a canopy of willows and a groundcover dominated by sedges ([Photo 5](#)). A few butterweed (*Packera glabella*) plants were in bloom in this wetland. The adjacent upland stormwater pond appears to be the source of the discharge as flow was noted leaving the rock area downstream of the discharge overflow structure.

Photo 5. Small stream flowing through willow trees and herbaceous wetland near transition between upland and wetland. Photo point 5, looking west. 2/21/12. [RTN](#)

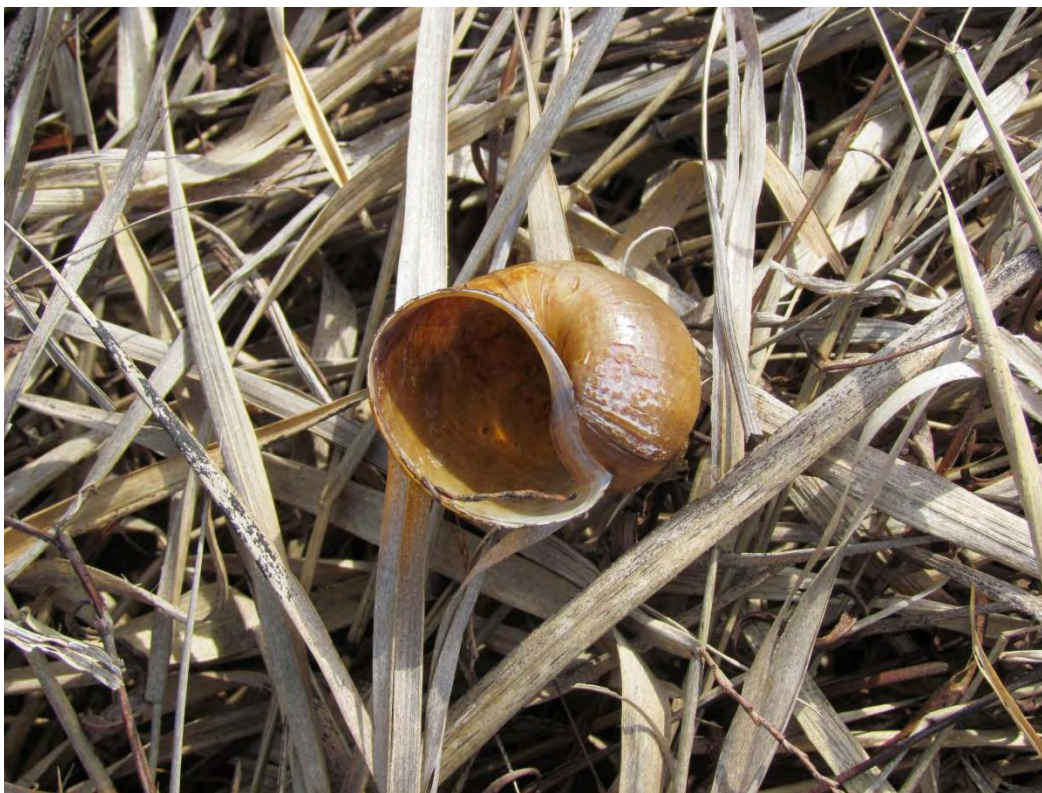
Photo 6. Apple snail; several shells were observed throughout site. 2/21/12. [RTN](#)
