# LIVE OAK POINT LIVING SHORELINES

## 2025 (Fall) Project and Reference Site Monitoring Report

USACE Permit No.: SAJ-2011-00287

FDEP Permit No.: 0387876-001-EI-66

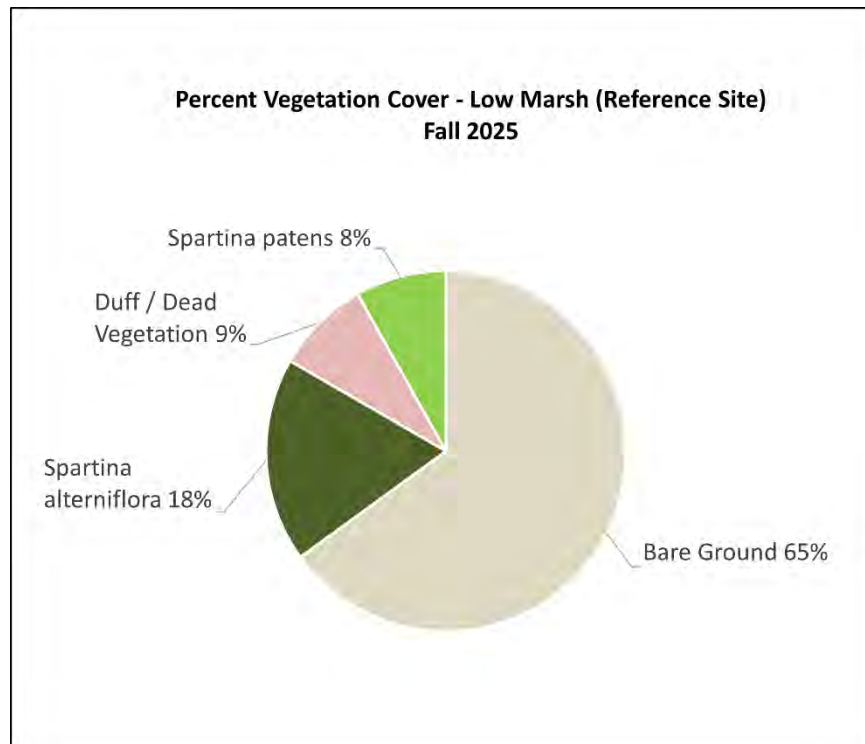
Figure 6. Project Site Low Marsh Vegetation (Average of Transects T1 - T6)

Figure 7. Reference Site Low Marsh Vegetation (Average of Transects T7 - T9)

Average percent cover of live vegetation (derived from vegetation transects) for the low marsh was 36% at the project site compared with 27% for the reference site; for the mid marsh it was 66% at the project site compared with 94% for the reference site; and for the high marsh it was 49% at the project site compared with 45% at the reference site.

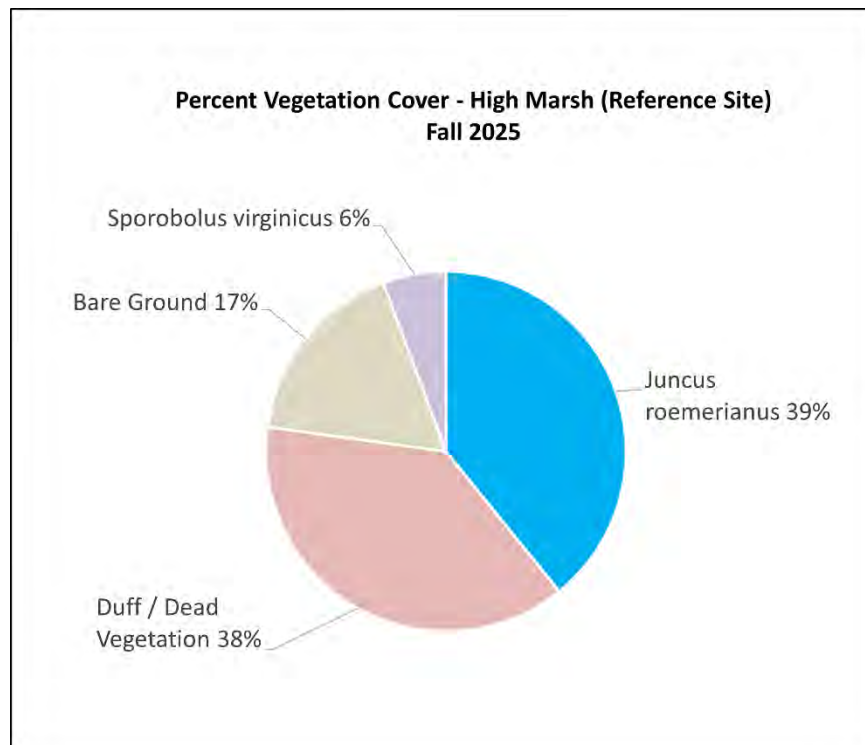
Figure 10. Project Site High Marsh Vegetation (Average of Transects T1 - T6)

Figure 11. Reference Site High Marsh Vegetation (Average of Transects T7 - T9)

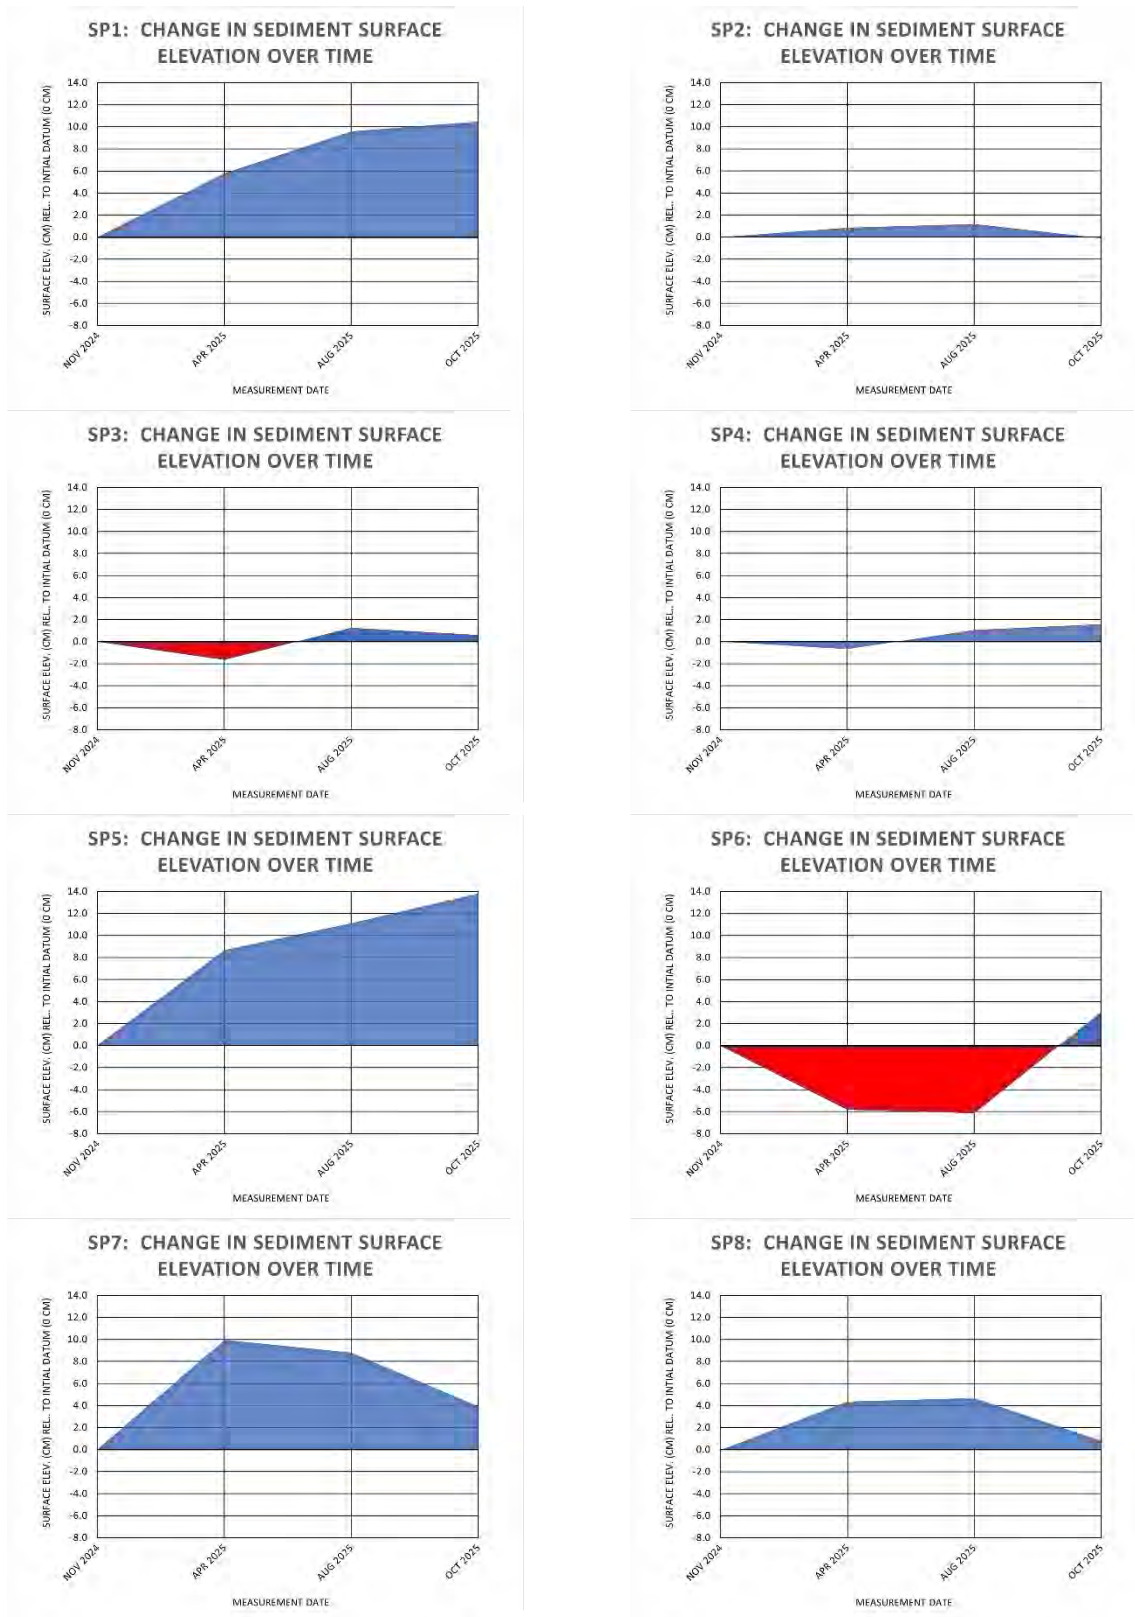
Figure 13. Sediment Accretion Over Time (PVC Post Paris)

Monitoring of the PVC post pairs within the marsh expansion zone (Table 6 & Table 7) began on 11/25/2024 with most recent measurements taken on 10/24/2025. Over the course of 333 days (11/25/2024 – 10/24/2025), average sediment accretion, as measured by the PVC post pairs (SP 1 – SP8), was 4.3 cm (average annualized rate of sediment accretion is 47 mm, well in excess of the  $3\pm$  mm estimated rate of annual sea level rise for northwest Florida<sup>11</sup>).

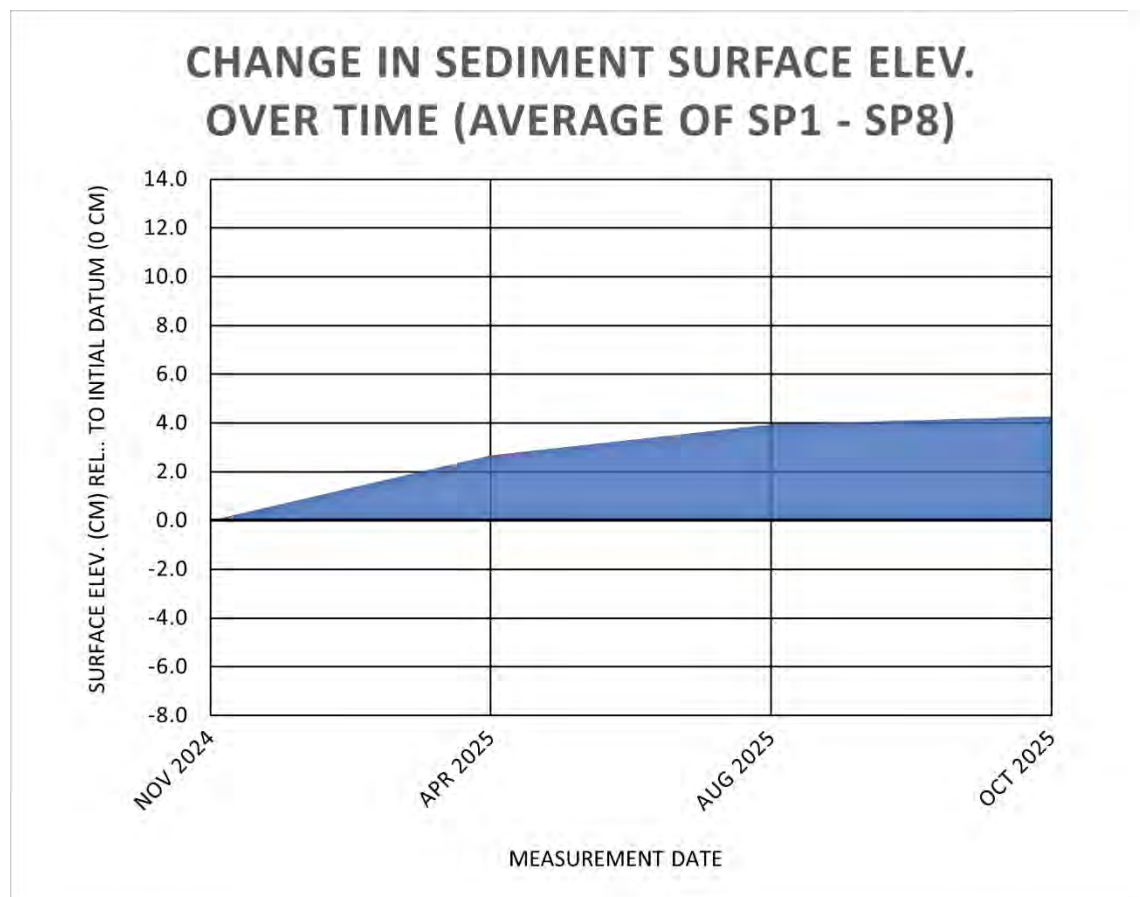
Figure 14. Sediment Accretion Over Time (Average of SP1 - SP8)

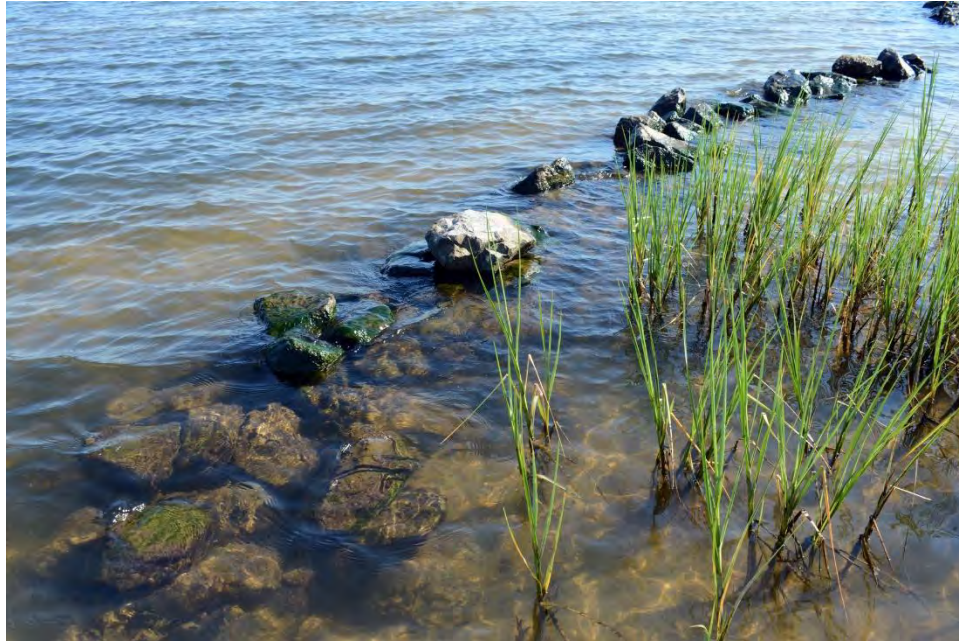
Figure 24. Marsh Expansion Behind Limerock Breakwaters (8/28/2025)

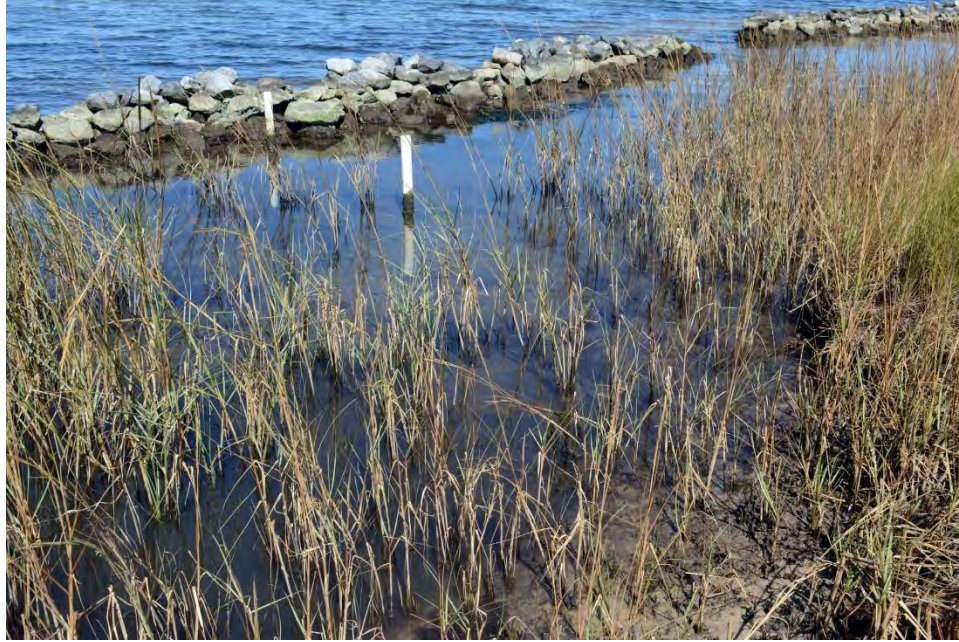
Figure 26. Sediment Accretion Monitoring Station (PVC Post Pairs; Station SP-1) and Marsh Expansion Between Breakwater and Shore (10/24/2025)

Given the limitations of the buried markers (paver bricks) in the existing salt marsh, and to expand the monitoring to include the marsh restoration/marsh expansion zone located between breakwater segments and the current shoreline, eight additional monitoring stations using a different design were established on 11/25/2024. Referred to here as "PVC post pairs," each station (assigned a unique ID of SP1 through SP8) consists of two 2" DIA, SCH 40 PVC pipes (10-FT length) driven approximately 7 ½ FT into the underlying sandy sediments, placed approximately 7 FT apart, and forming a line approximately perpendicular to the existing shoreline. During monitoring events, a rigid cross bar (marked in 1-FT intervals) is temporarily placed on the two PVC posts. At each station, height from the bottom of the cross bar to the sediment surface is measured at six 1-FT intervals (decreasing height measurements over time indicate accretion of sediment).

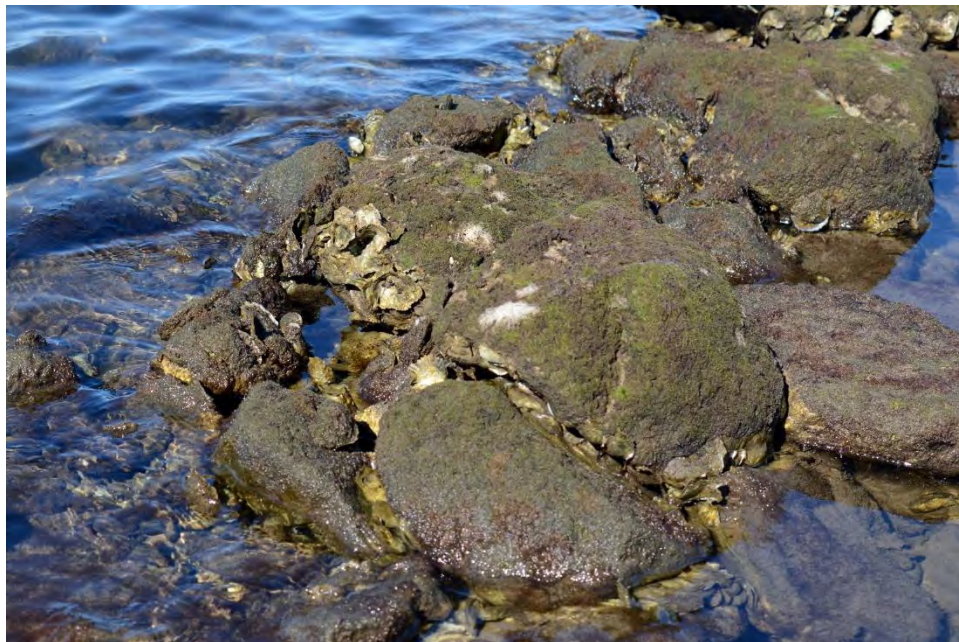
Figure 27. Oyster Colonization on Breakwater (10/24/2025)

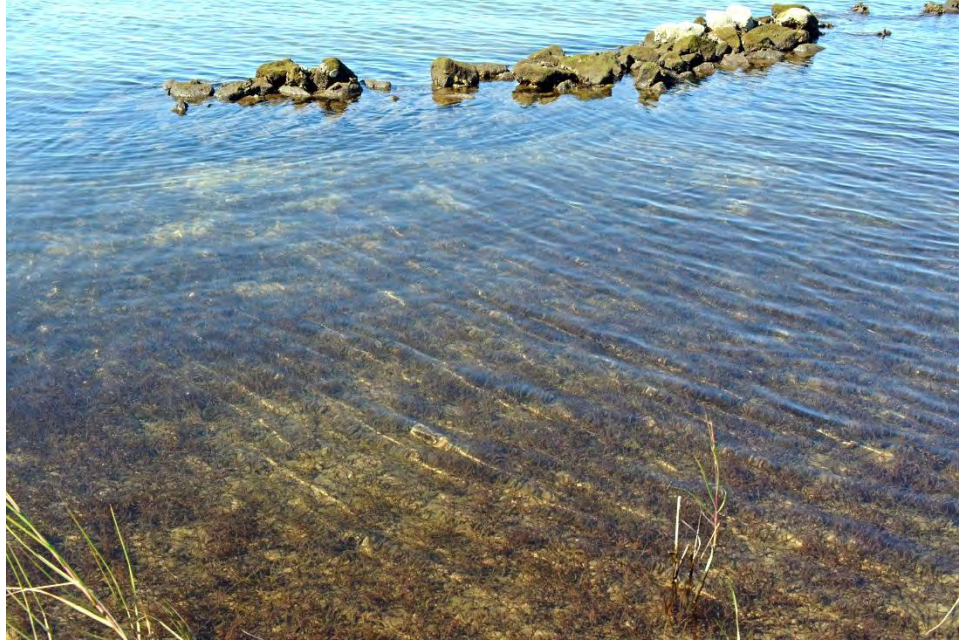
Figure 28. Submerged Aquatic Vegetation (*Halodule wrightii*) Colonization Behind Limerock Breakwater (10/24/2025)
