# **HYDROLOGIC ENGINEERING CENTERS RIVER ANALYSIS SYSTEM (HEC-RAS) MODEL**

## **JACKSON BLUE SPRING SYSTEM**

### **FINAL REPORT**

**Northwest Florida Water Management District**

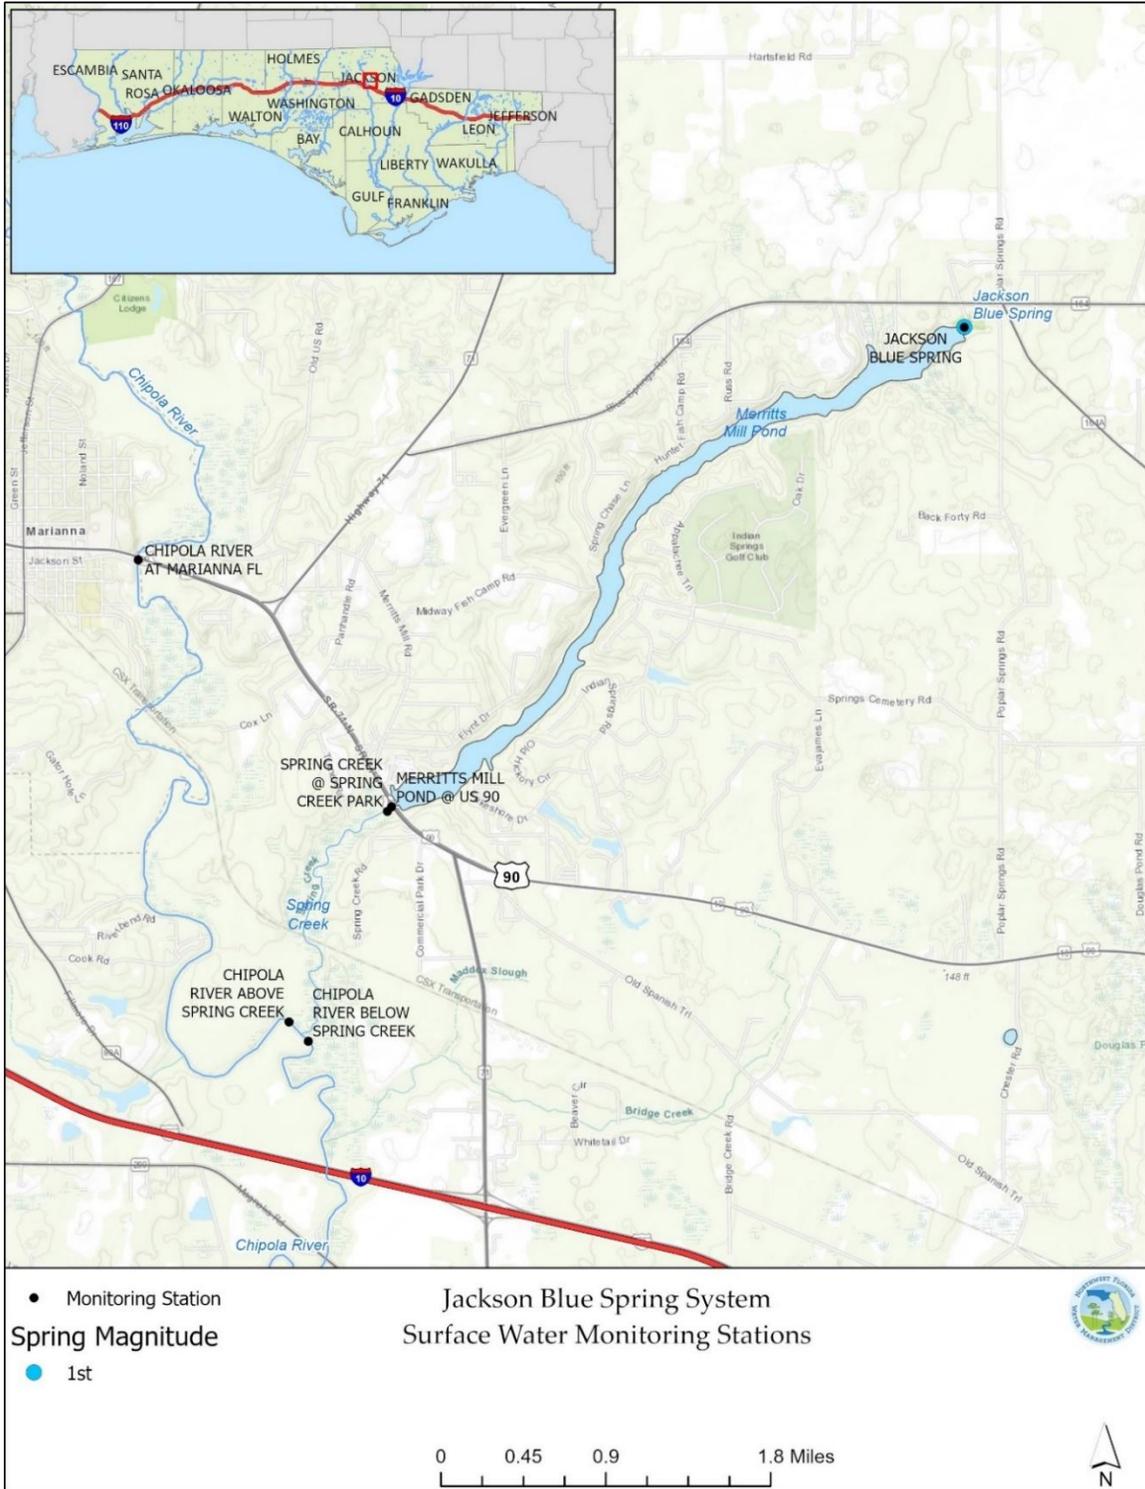
**Figure 1: Jackson Blue Spring MFL Study Area and Surface Water Monitoring Stations**

Four boundary conditions (three flow, and one stage) were used in the model setup and are contained in the model Data Storage System (DSS) file (JacksonBlueMFL\_2024.dss). These inputs were derived based on surface water monitoring stations along Merritts Mill Pond, Spring Creek, and the Chipola River maintained by the District and USGS and presented in Table 1 and Figure 1, including:

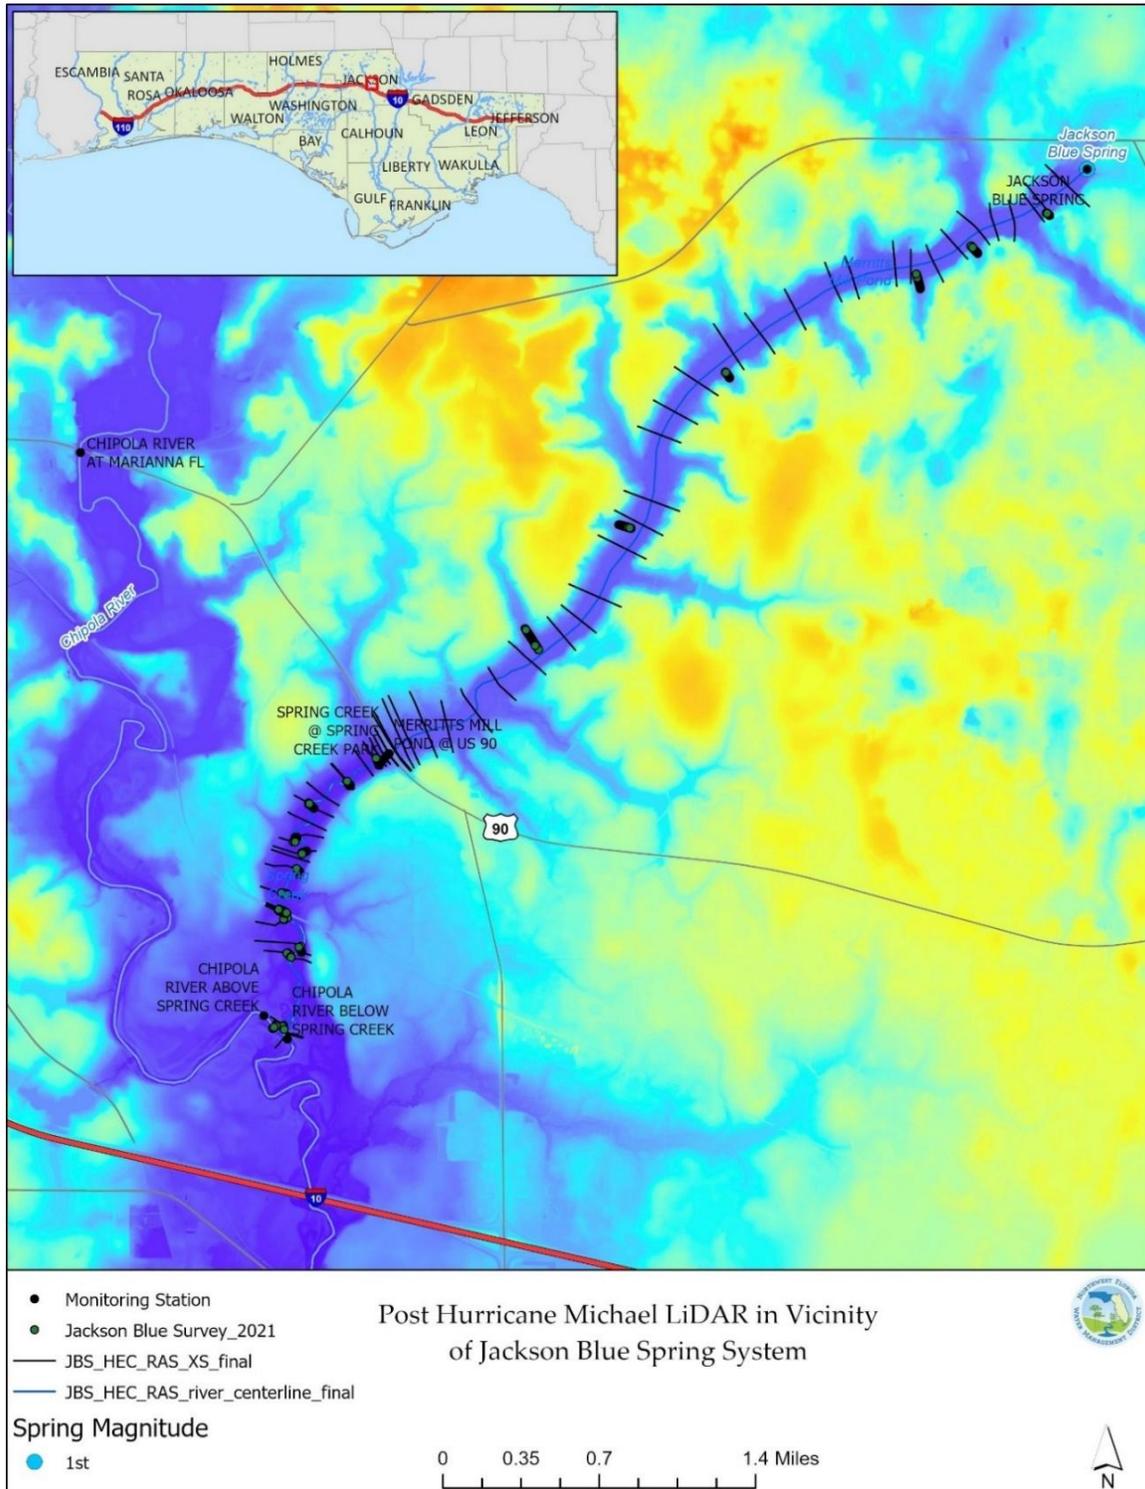
**Figure 2: Post Hurricane Michael LiDAR in Vicinity of Jackson Blue Springs**

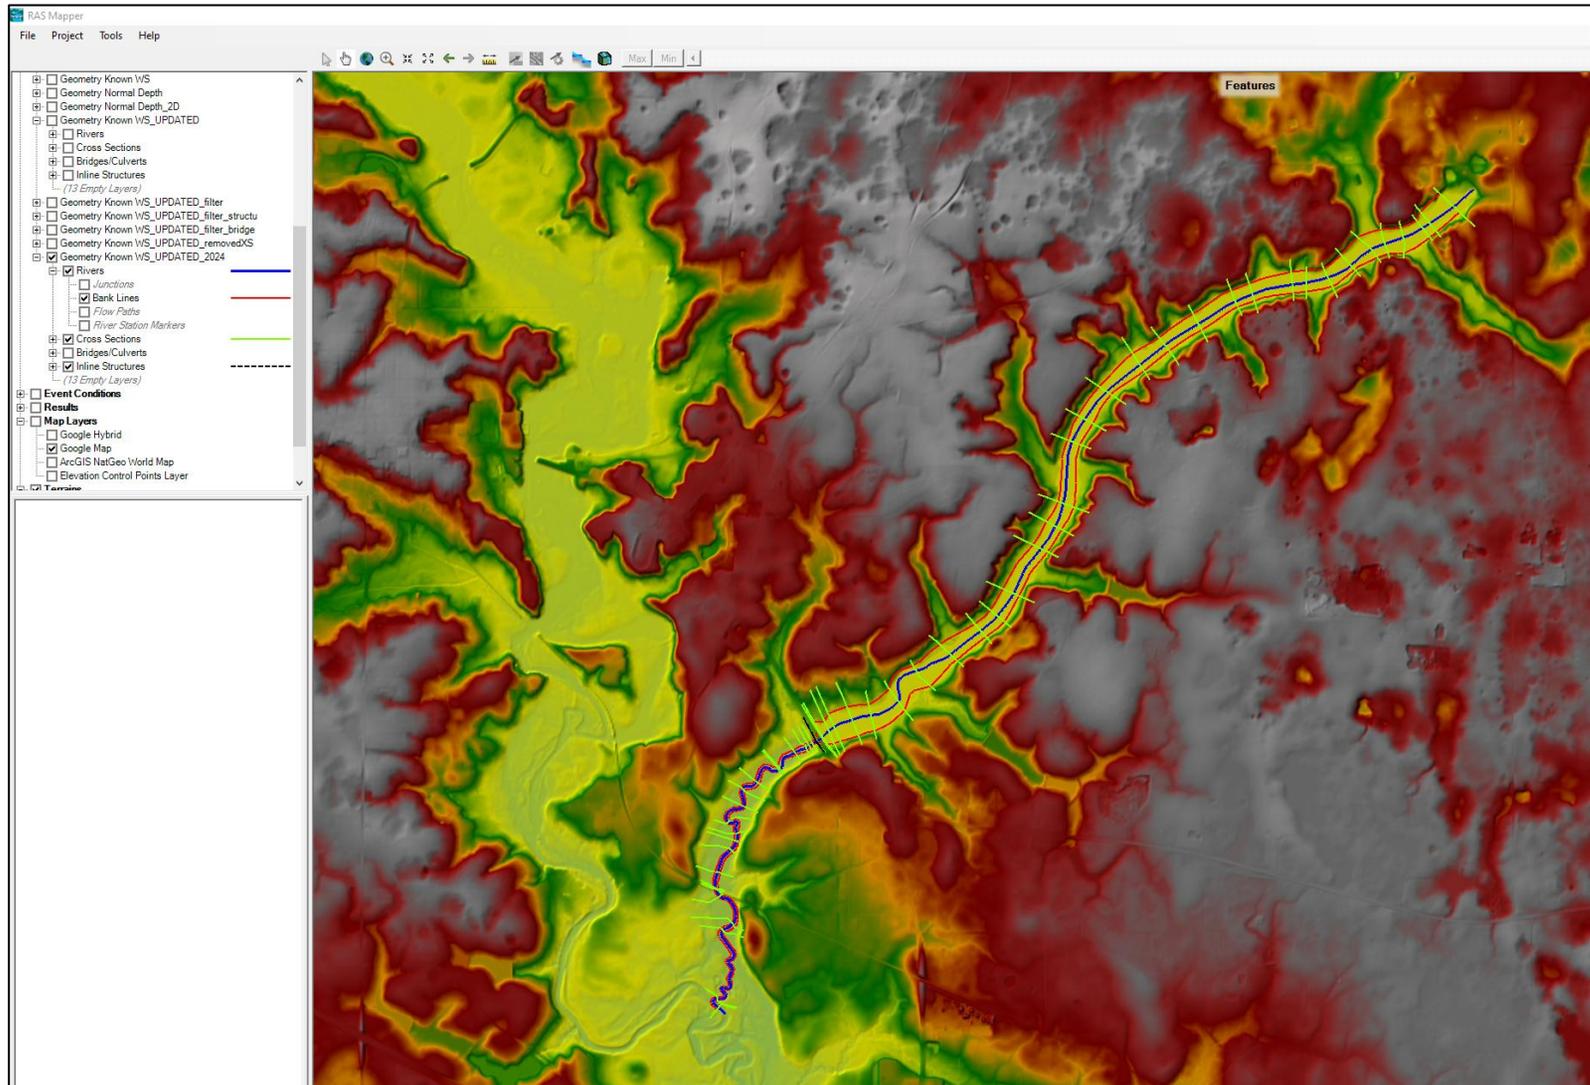
**Figure 3: Model Digitization in RAS-Mapper**

A total of 57 cross sections were digitized within RAS Mapper, extending sufficiently into the floodplain to accommodate high flow scenarios. Cross sections were digitized to coincide with survey locations as well as locations of transects from the FEMA model where applicable. Elevations for all transects were initially determined based on the terrain generated from the post-Michael DEM. Elevation survey points were utilized to replace the terrain-derived elevations within the channel for all cross sections where survey was available (Figure 5). Channel geometry for the remaining cross sections was determined either from existing model bathymetry or interpolated based on the adjacent upstream and downstream transect. For all cross sections, terrain-generated elevations were used for overbank (floodplain) areas. After cross sections were defined in RAS Mapper, each cross section was reviewed in the geometry editor within HEC-RAS. A few minor adjustments were made to the generated elevations from RAS Mapper to be consistent with survey elevations using the geometry editor tools.

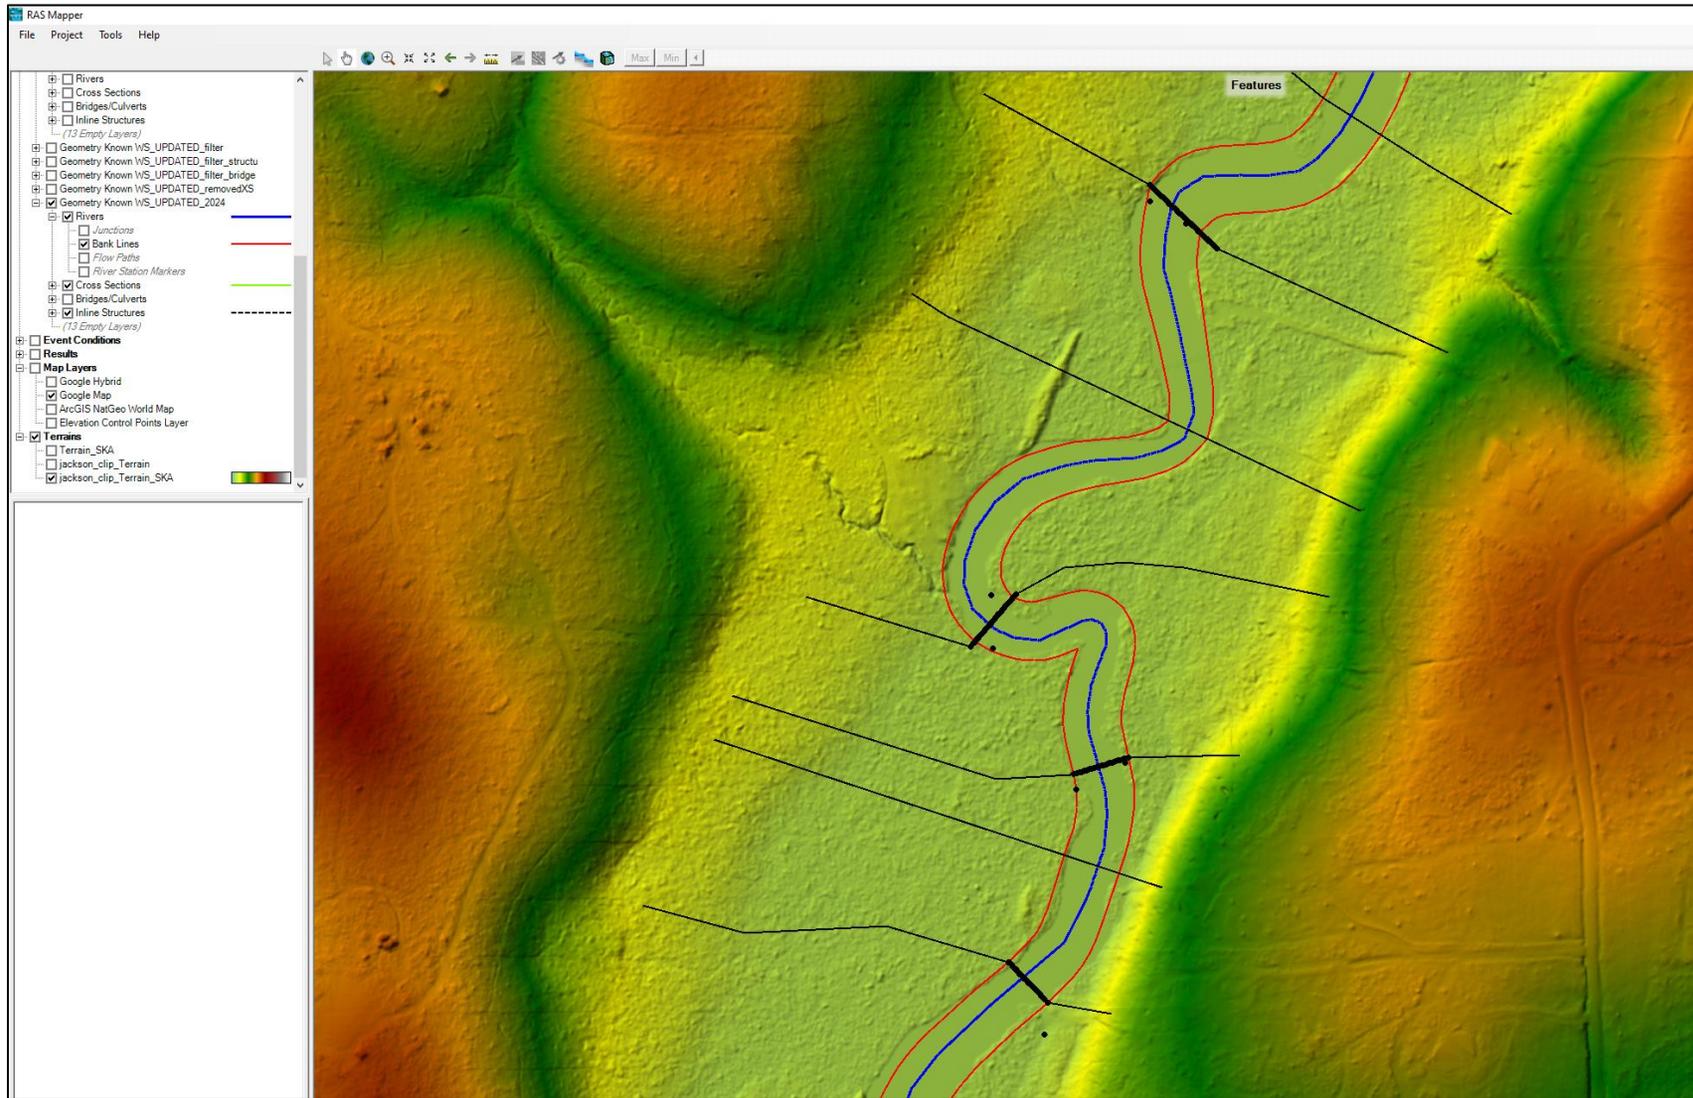
**Figure 5: Digitization of Cross Sections Overlaying Survey Points in RAS Mapper**

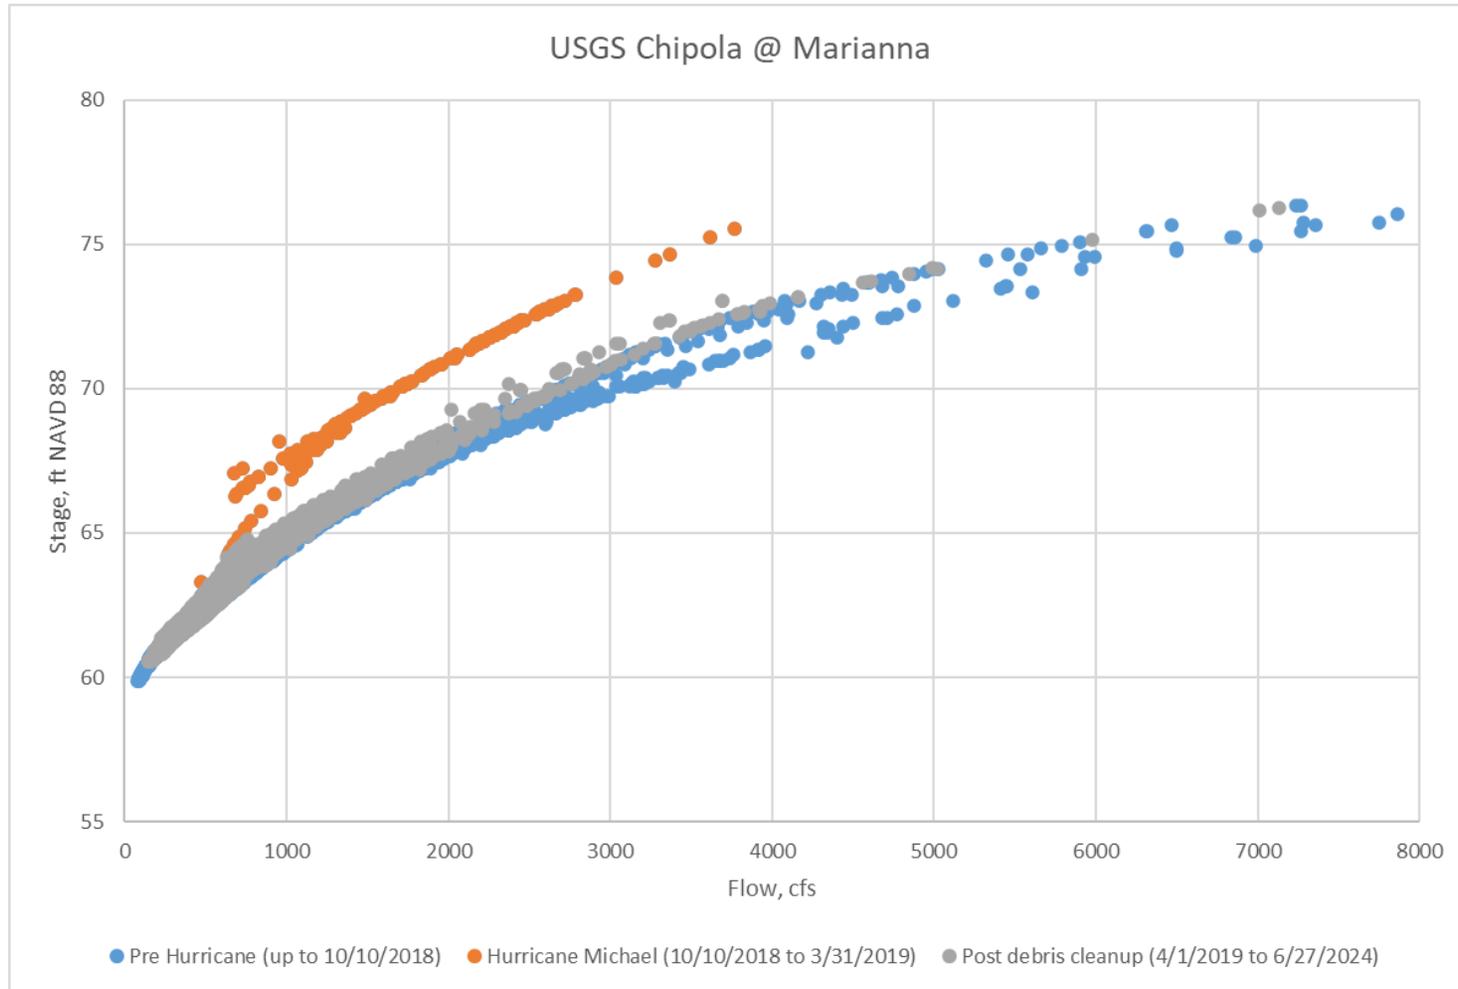
**Figure 6: Comparison of Stage-Discharge Relationships for the USGS Station 02358789 Chipola River @ Marianna**

Analysis of stage-discharge relationships at USGS station 02358789 Chipola River @ Marianna was conducted for three periods (Figure 6). Since this station represents the closest long-term USGS gauge to the Jackson Blue Spring MFL study, the following periods were defined from long-term trends and patterns observed at this station and were assumed to be indicative of the region, including Jackson Blue Spring, Merritts Mill Pond, and Spring Creek:

Review of Figure 6 shows substantial increases in stage for a given flow following Hurricane Michael as compared to historical conditions pre-hurricane. However, upon completion of debris removal in the Chipola River, the stage-discharge relationship returned to conditions similar to pre-hurricane historical conditions, although stages remain slightly elevated for a given flow, likely due to remaining debris in the floodplain.

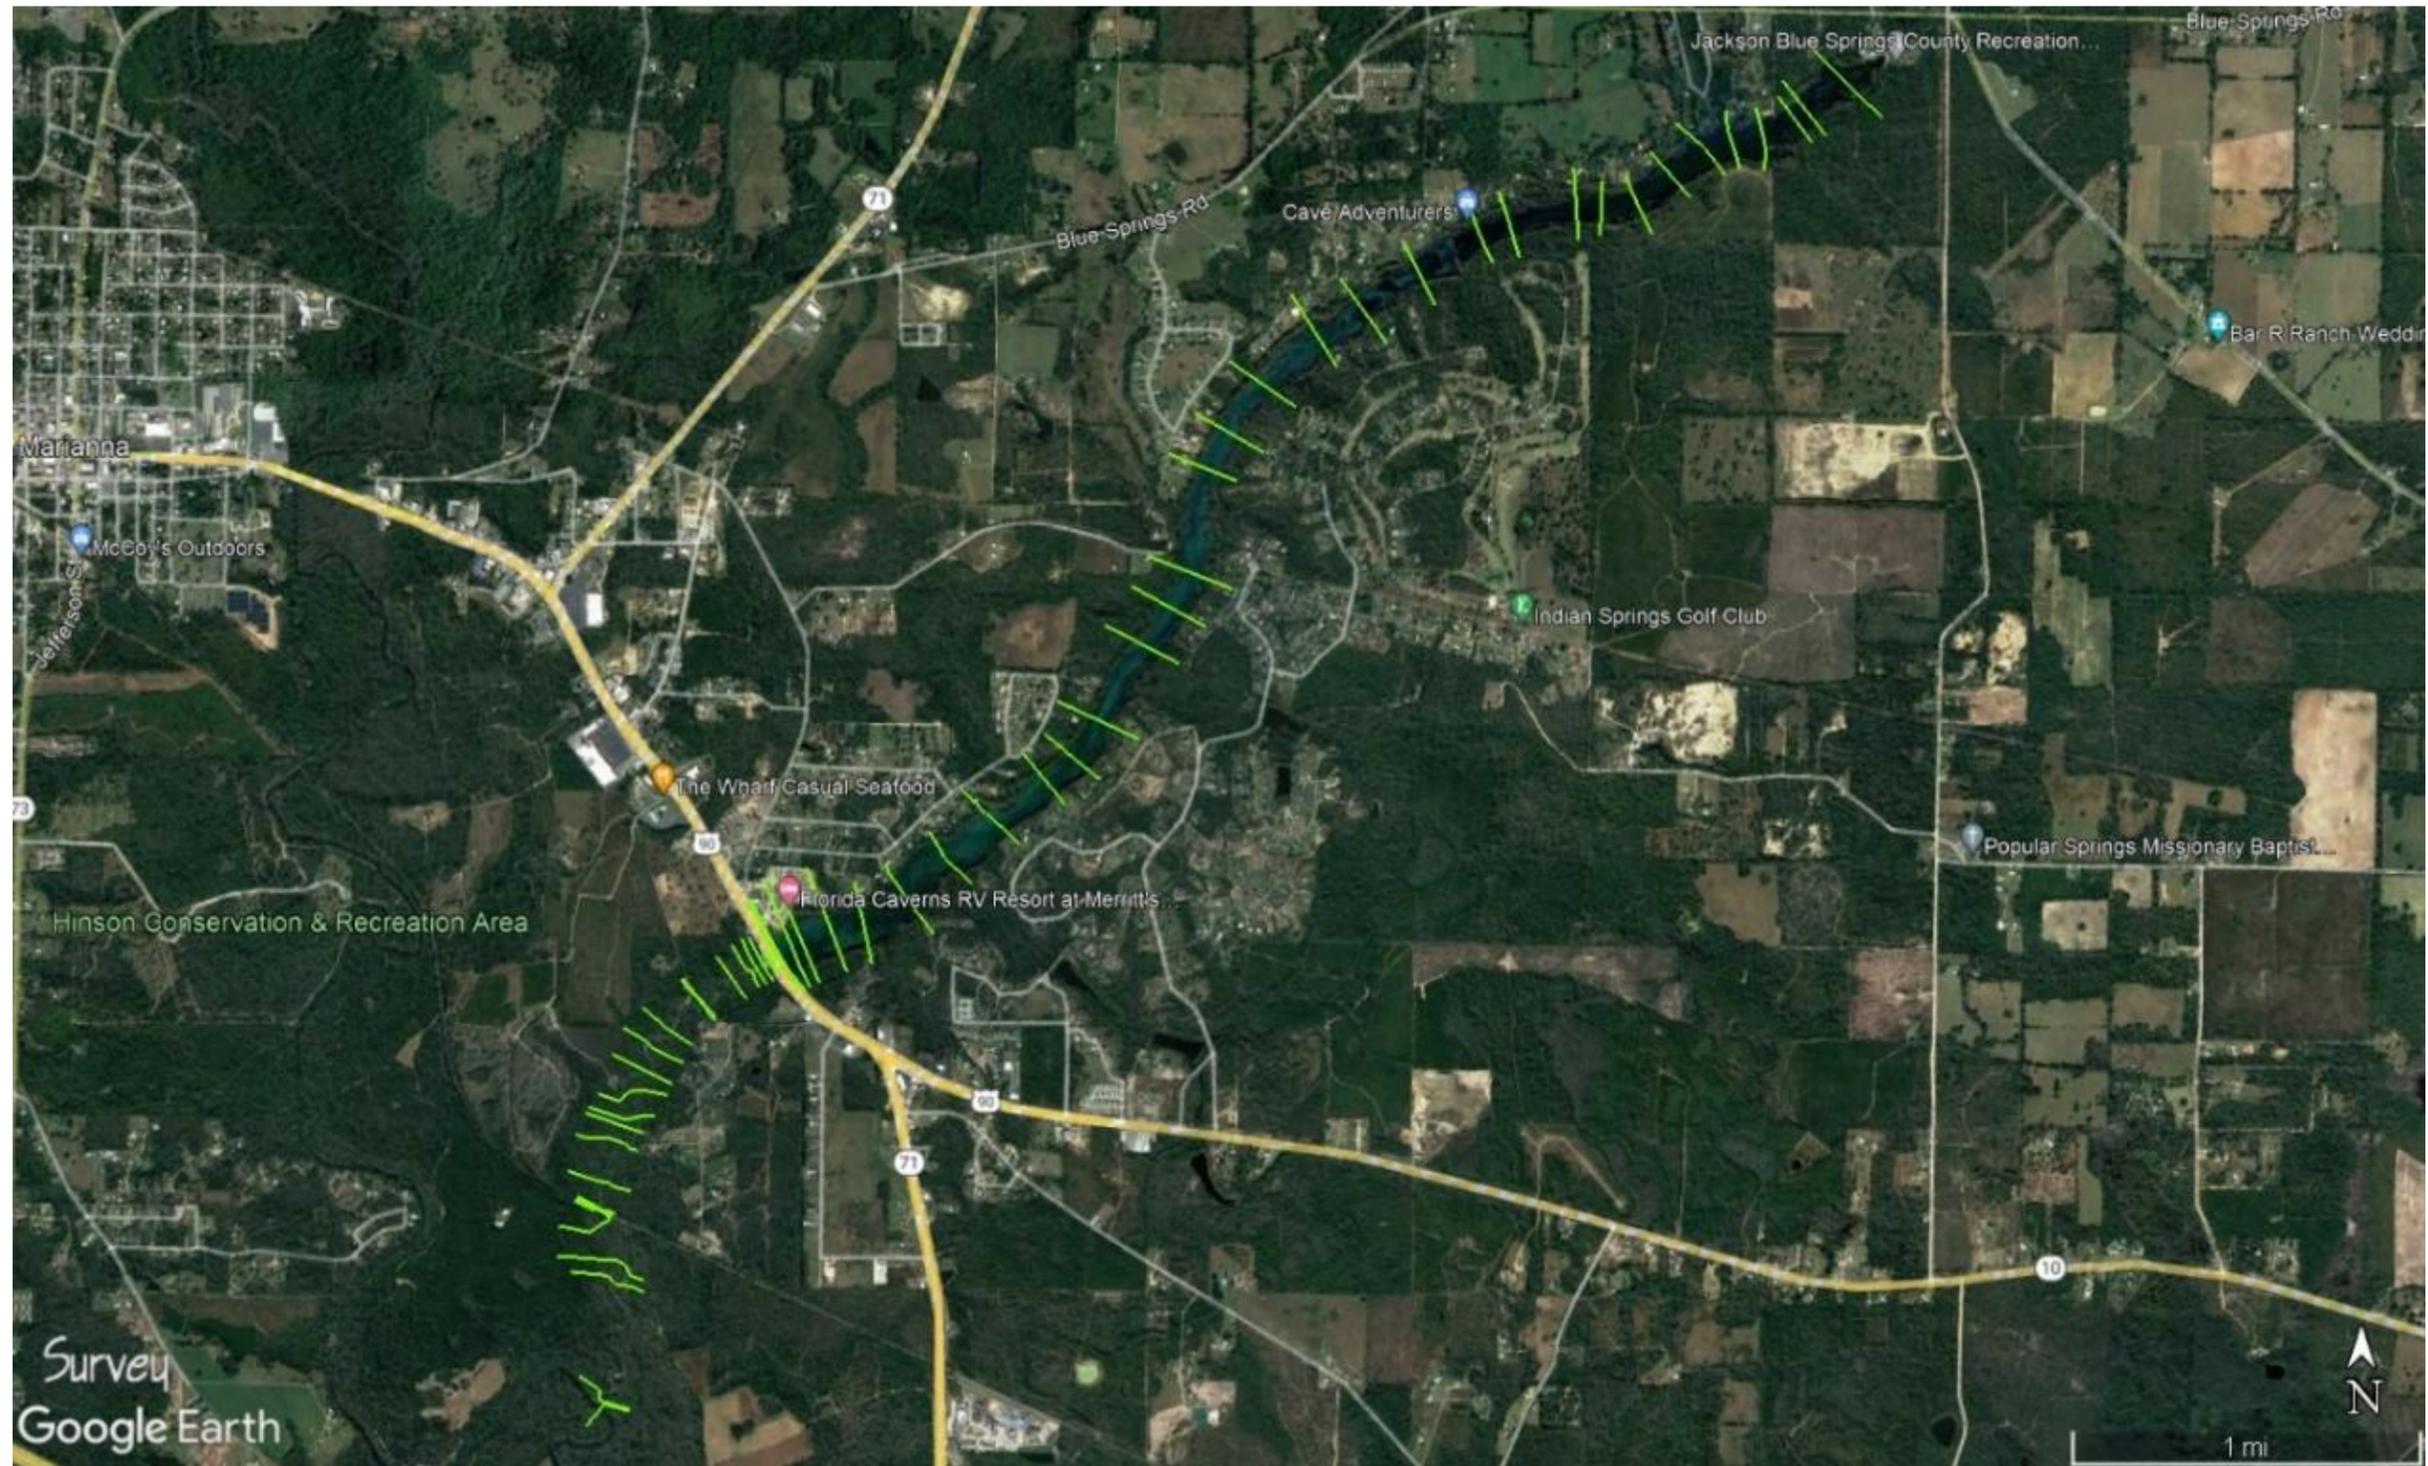
**Figure 7: Jackson Blue Spring System Field Reconnaissance including HEC-RAS Cross Sections**

Field reconnaissance was performed December 6 and 7, 2023, to gather insights on the system and to further inform the model diagnostic, construction, and calibration tasks. In preparation for the field reconnaissance, ATM specified the HEC-RAS cross sections to review along the approximately 6.1-mile reconnaissance trip area. The area of the reconnaissance is shown in Figure 7.

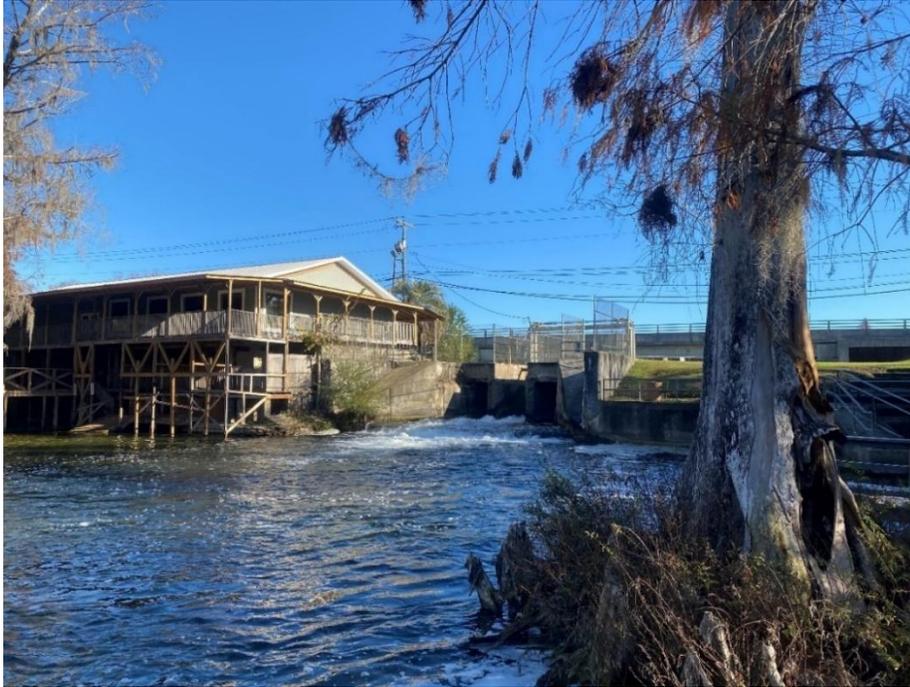
**Figure 8: Merritts Mill Pond Control Structure @ US 90 (Date of Photo: December 6, 2023)**

The Merritts Mill Pond Control Structure @ US 90 was one of the focal points of the reconnaissance. Prior to beginning the kayak trip, a meeting was held with Rett Daniels (Deputy Administrator, Field Operations, Jackson County Public Works) at Spring Creek Park to discuss the operation of the control structure at US 90, operational record keeping, and his observations of water levels in Merritts Mill Pond. He noted that they have had the gates closed most of the time and were not able to raise water levels in Merritts Mill Pond as high as they have in the past. Given the goal of trying to keep water levels high, he did not anticipate opening the gate in the foreseeable future.

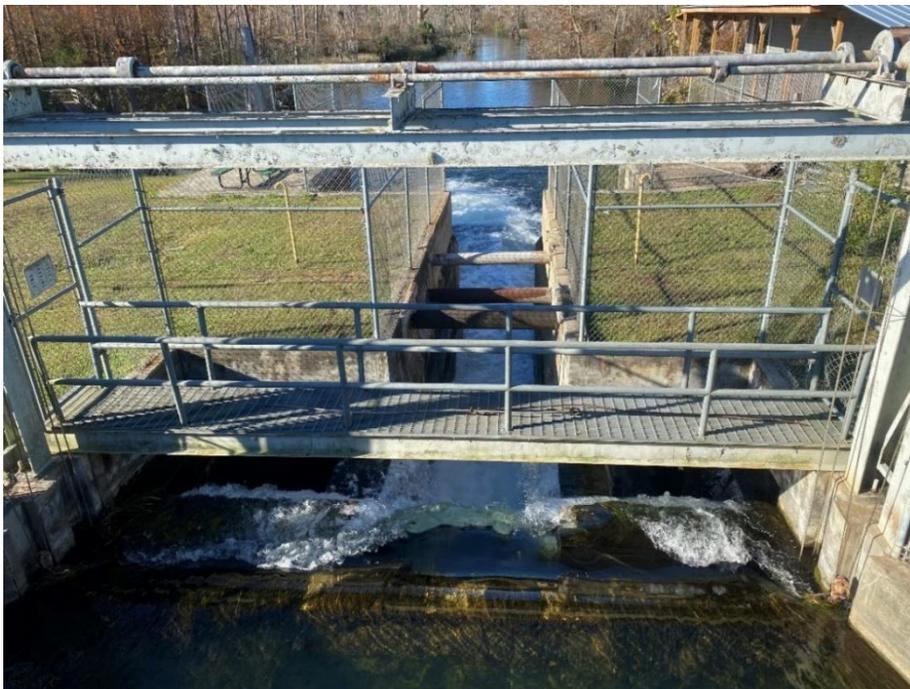
**Figure 9: View of Merritts Mill Pond Control Structure from US 90 (Date of Photo: December 6, 2023)**

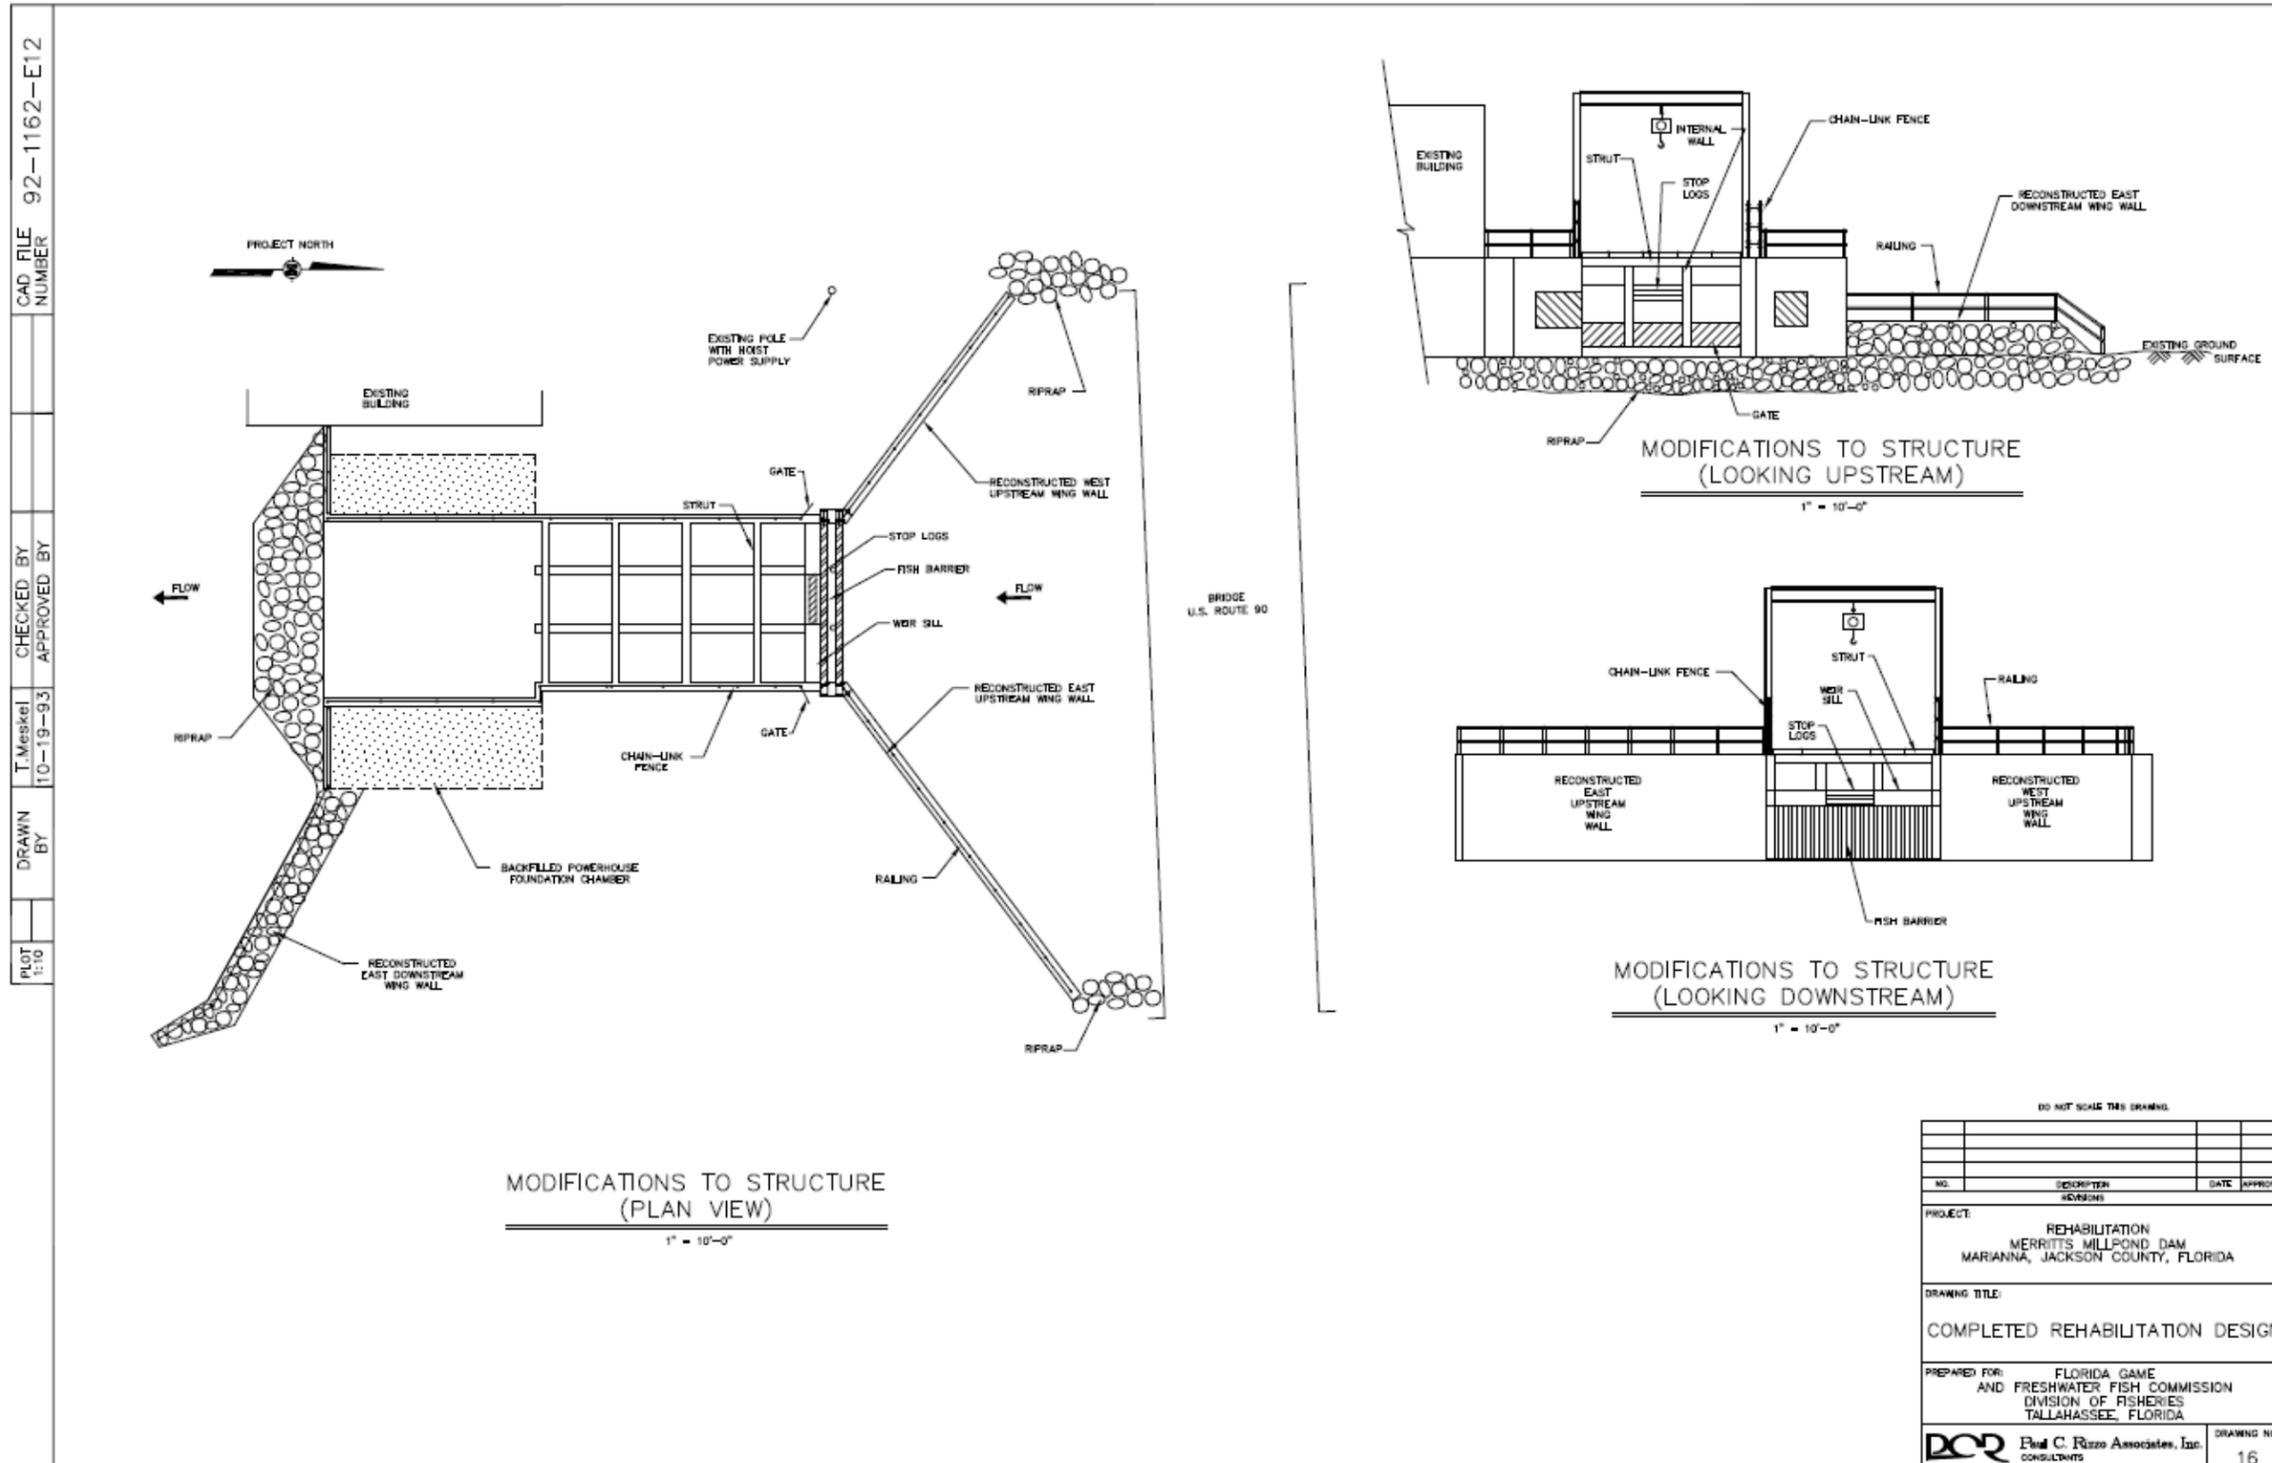
Figure 10: As-Built Drawing of Merritts Mill Pond Control Structure

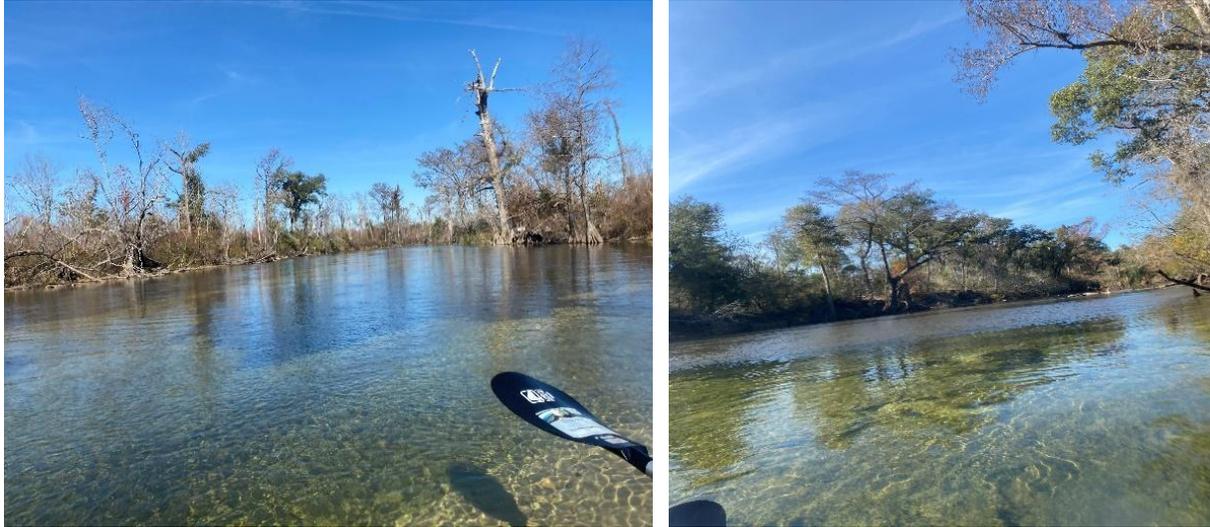
**Figure 12: Spring Creek during the December 6, 2023, Field Reconnaissance**

Water levels in Spring Creek were not high during the December 6, 2023, field reconnaissance, with observed depths ranging from 1 to 3 ft for most of the creek. The general conditions were that the creek channel seemed to be wider and shallower than historical observations of District staff and Mr. Daniels. The goal of the kayak trip was to observe the general characteristics of the channel geometry and its representation in the HEC-RAS model, occurrences of very shallow locations, noted locations of inflows, and flow characteristics of Spring Creek. Photos taken during the course of the trip are contained in the companion .kmz file previously submitted to the District, and photo locations are shown in Figure 11. Figure 12 and Figure 13 illustrate the general character of Spring Creek. Observations of note were as follows.

- The Spring Creek channel is generally shallow, with some locations shallow enough that the kayakers ran aground due to the shallow depths, making navigation more challenging.
- There was one small surface water inflow into Spring Creek, north of the railroad bridge. It appeared to be a small tributary inflow, with a flow rate estimated to be about 0.5 cfs.

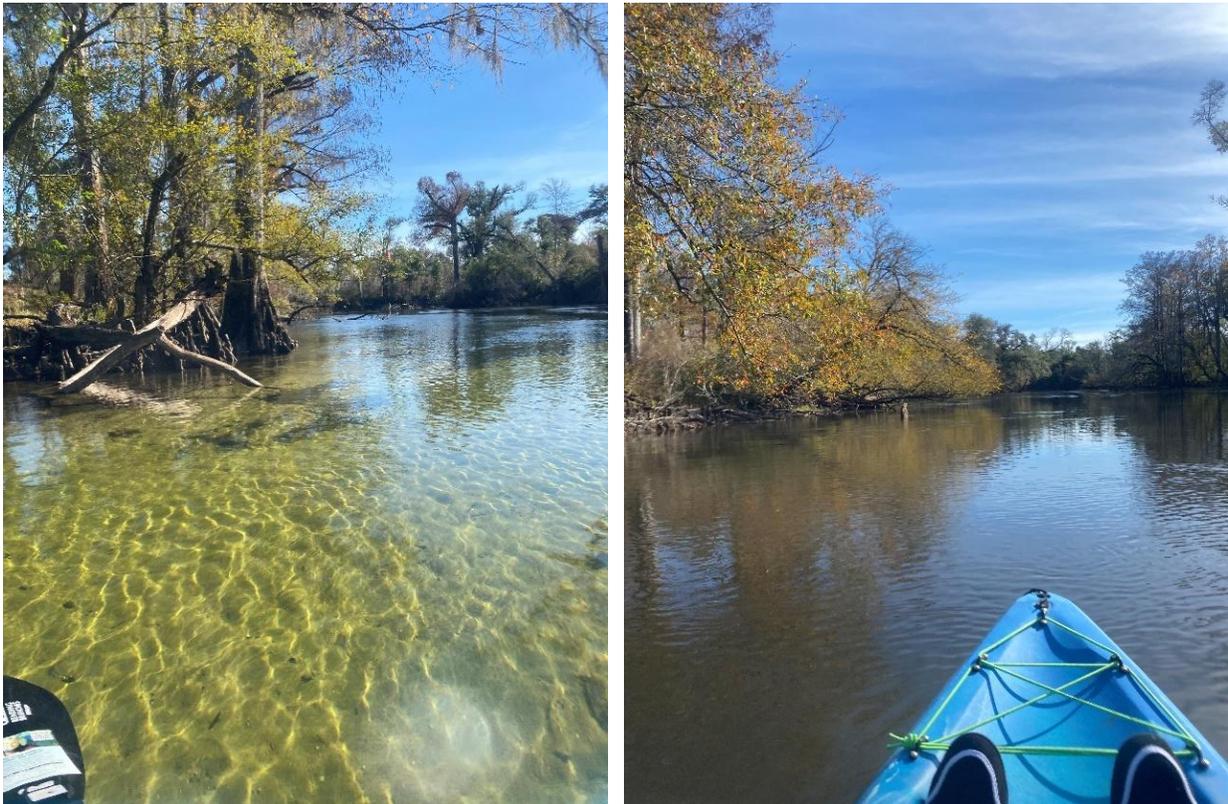
**Figure 13: Spring Creek Approaching Chipola River**

- Changes in the flow characteristics (reduced velocities and greater water depths) in Spring Creek were noted approaching the railroad bridge due to the backwater influence of the Chipola River.
- There were locations in the Spring Creek channel where velocity noticeably increased, indicating the possibility of sub-critical/super-critical flow conditions, depending on water levels in Spring Creek and the Chipola River. These were typical in locations where a sill or lime rock was near surface.

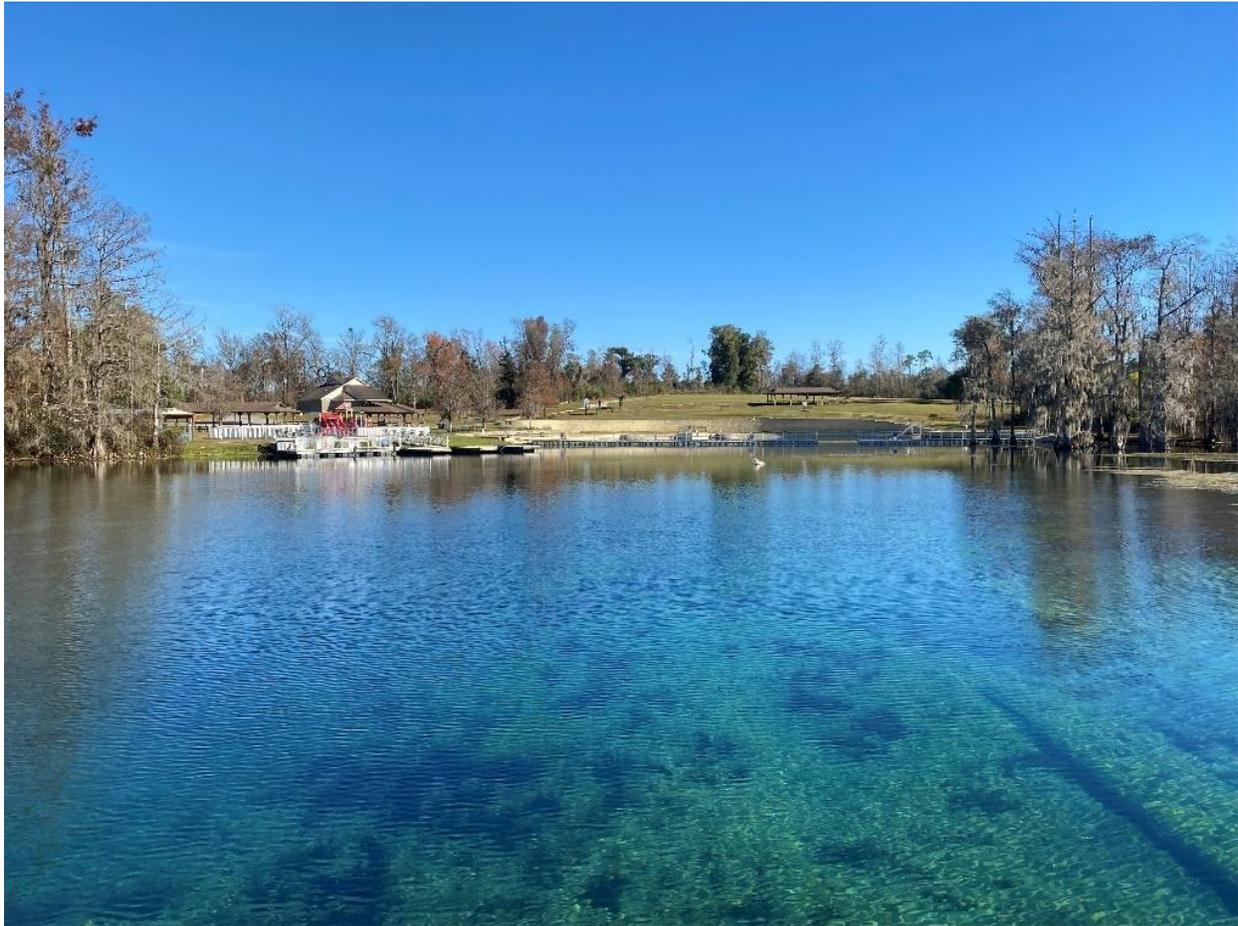
**Figure 14: Merritts Mill Pond Approaching Jackson Blue Spring**

The goal of the reconnaissance was to get general observations of Jackson Blue Spring (Figure 14) and Merritts Mill Pond and to confirm that the model reflects the physical system observed with respect to channel geometry, inflow characteristics, and bottom and bank vegetation communities and includes important flow control points such as shallow areas and control structures. A number of known springs were located (Figure 15).

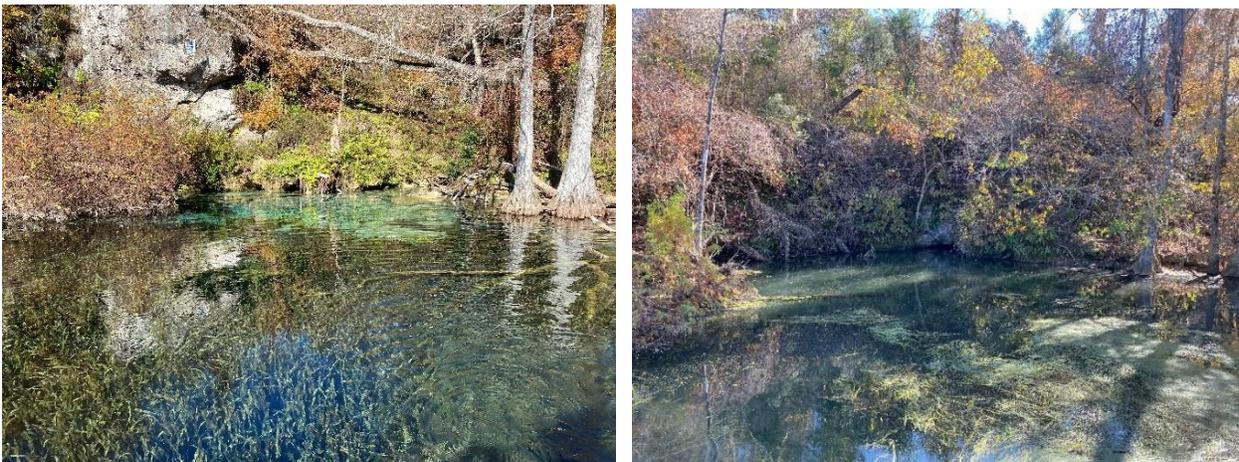
**Figure 15: Minor Springs in Merritts Mill Pond**
