# **HYDROLOGIC ENGINEERING CENTERS RIVER ANALYSIS SYSTEM (HEC-RAS) MODEL**

## **JACKSON BLUE SPRING SYSTEM**

### **FINAL REPORT**

**Northwest Florida Water Management District**

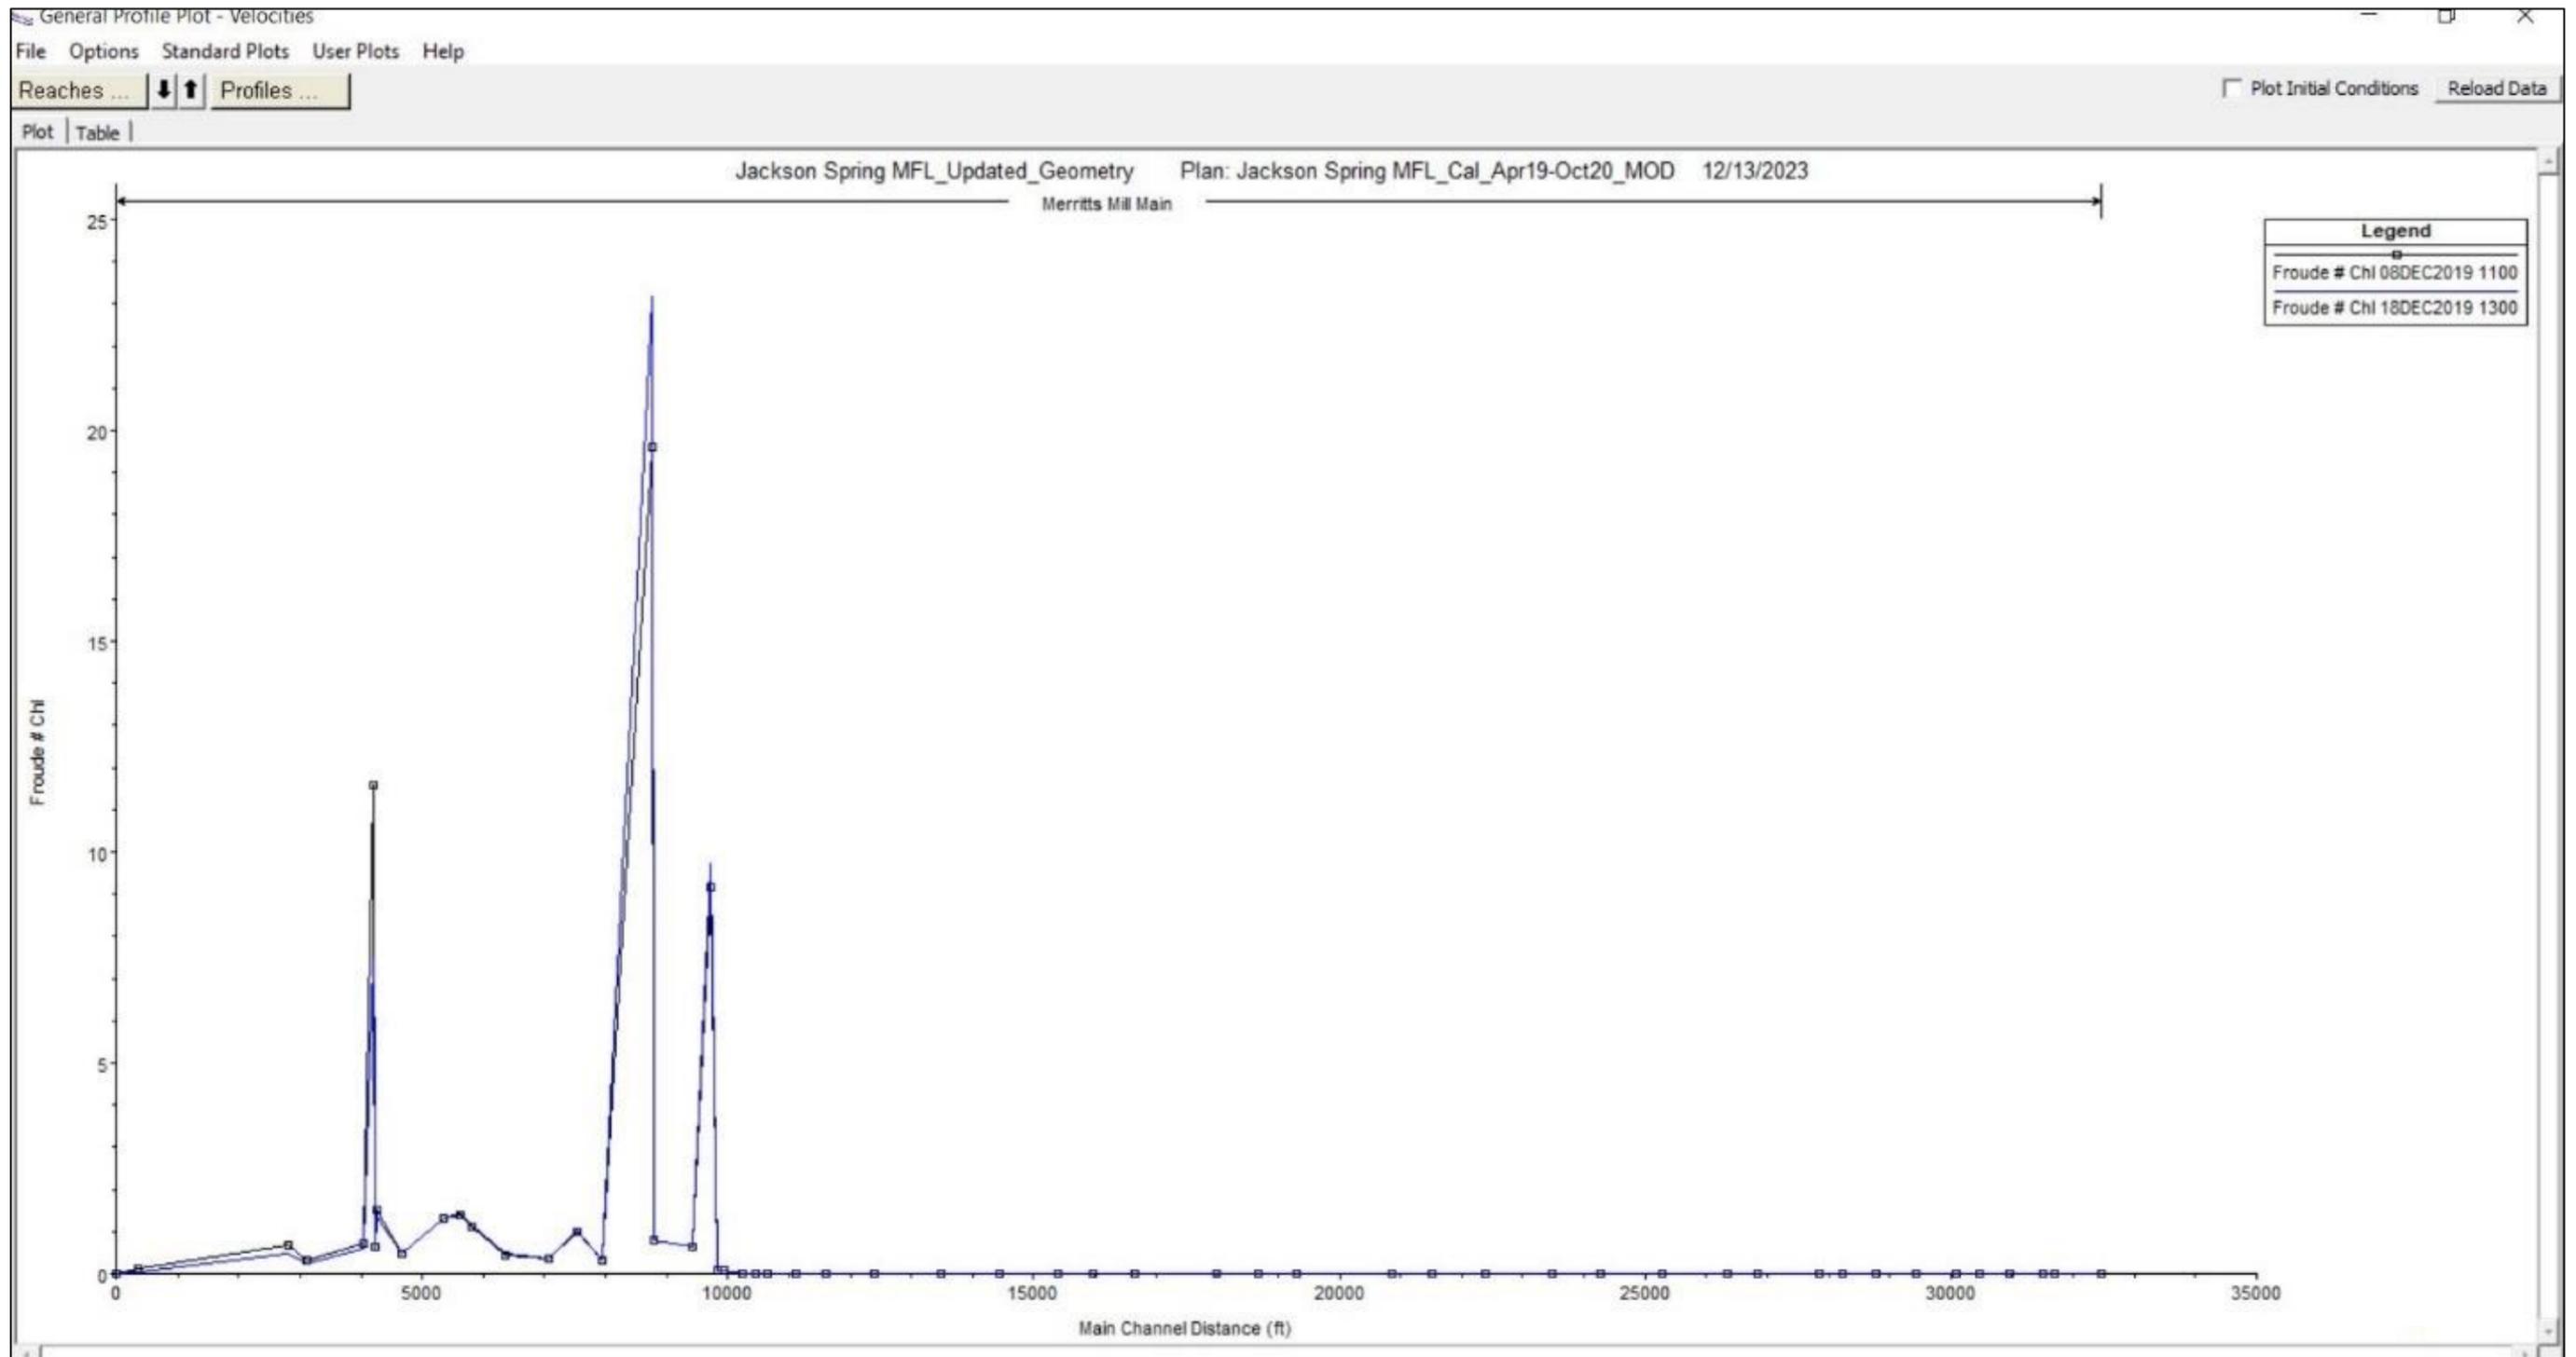
Figure 16: Plot of Froude Number vs Channel Distance For Simulation Time December 8, 2019 at 1100 and 1300 hrs

The reconnaissance supported the conclusion that the shallowness of Spring Creek was the primary cause of the model instability. Evaluation of the computed energy grade line over time in Spring Creek confirmed that at certain locations, particularly around the railroad bridge, flow was varying between sub-critical and supercritical state, as evidenced by the Froude number ( $Fr$ ). The Froude number is the dimensionless ratio of the inertial and gravitational forces and is used to determine what flow state is present (Critical:  $Fr=1$ , Sub-critical:  $FR<1$ , Super critical:  $Fr>1$ ). Figure 16 presents an example of the longitudinal plot of Froude number versus channel length at one point during the simulation. Running HEC-RAS model in “mixed flow mode,” which is useful when flow can vary rapidly between sub-critical and super-critical, was employed and resulted in stabilizing the model. Further investigation indicated that the shallowest cross section at the railroad bridge was neither a surveyed cross section nor part of a previous HEC-RAS model. This cross section was modified so that the minimum elevation was approximately equal to the adjacent cross sections, which were surveyed sections. After this change and some further testing, the model could be run in sub-critical mode, as well as in mixed-flow mode. This allowed for a more complete evaluation of model performance after these modifications were made to the model.

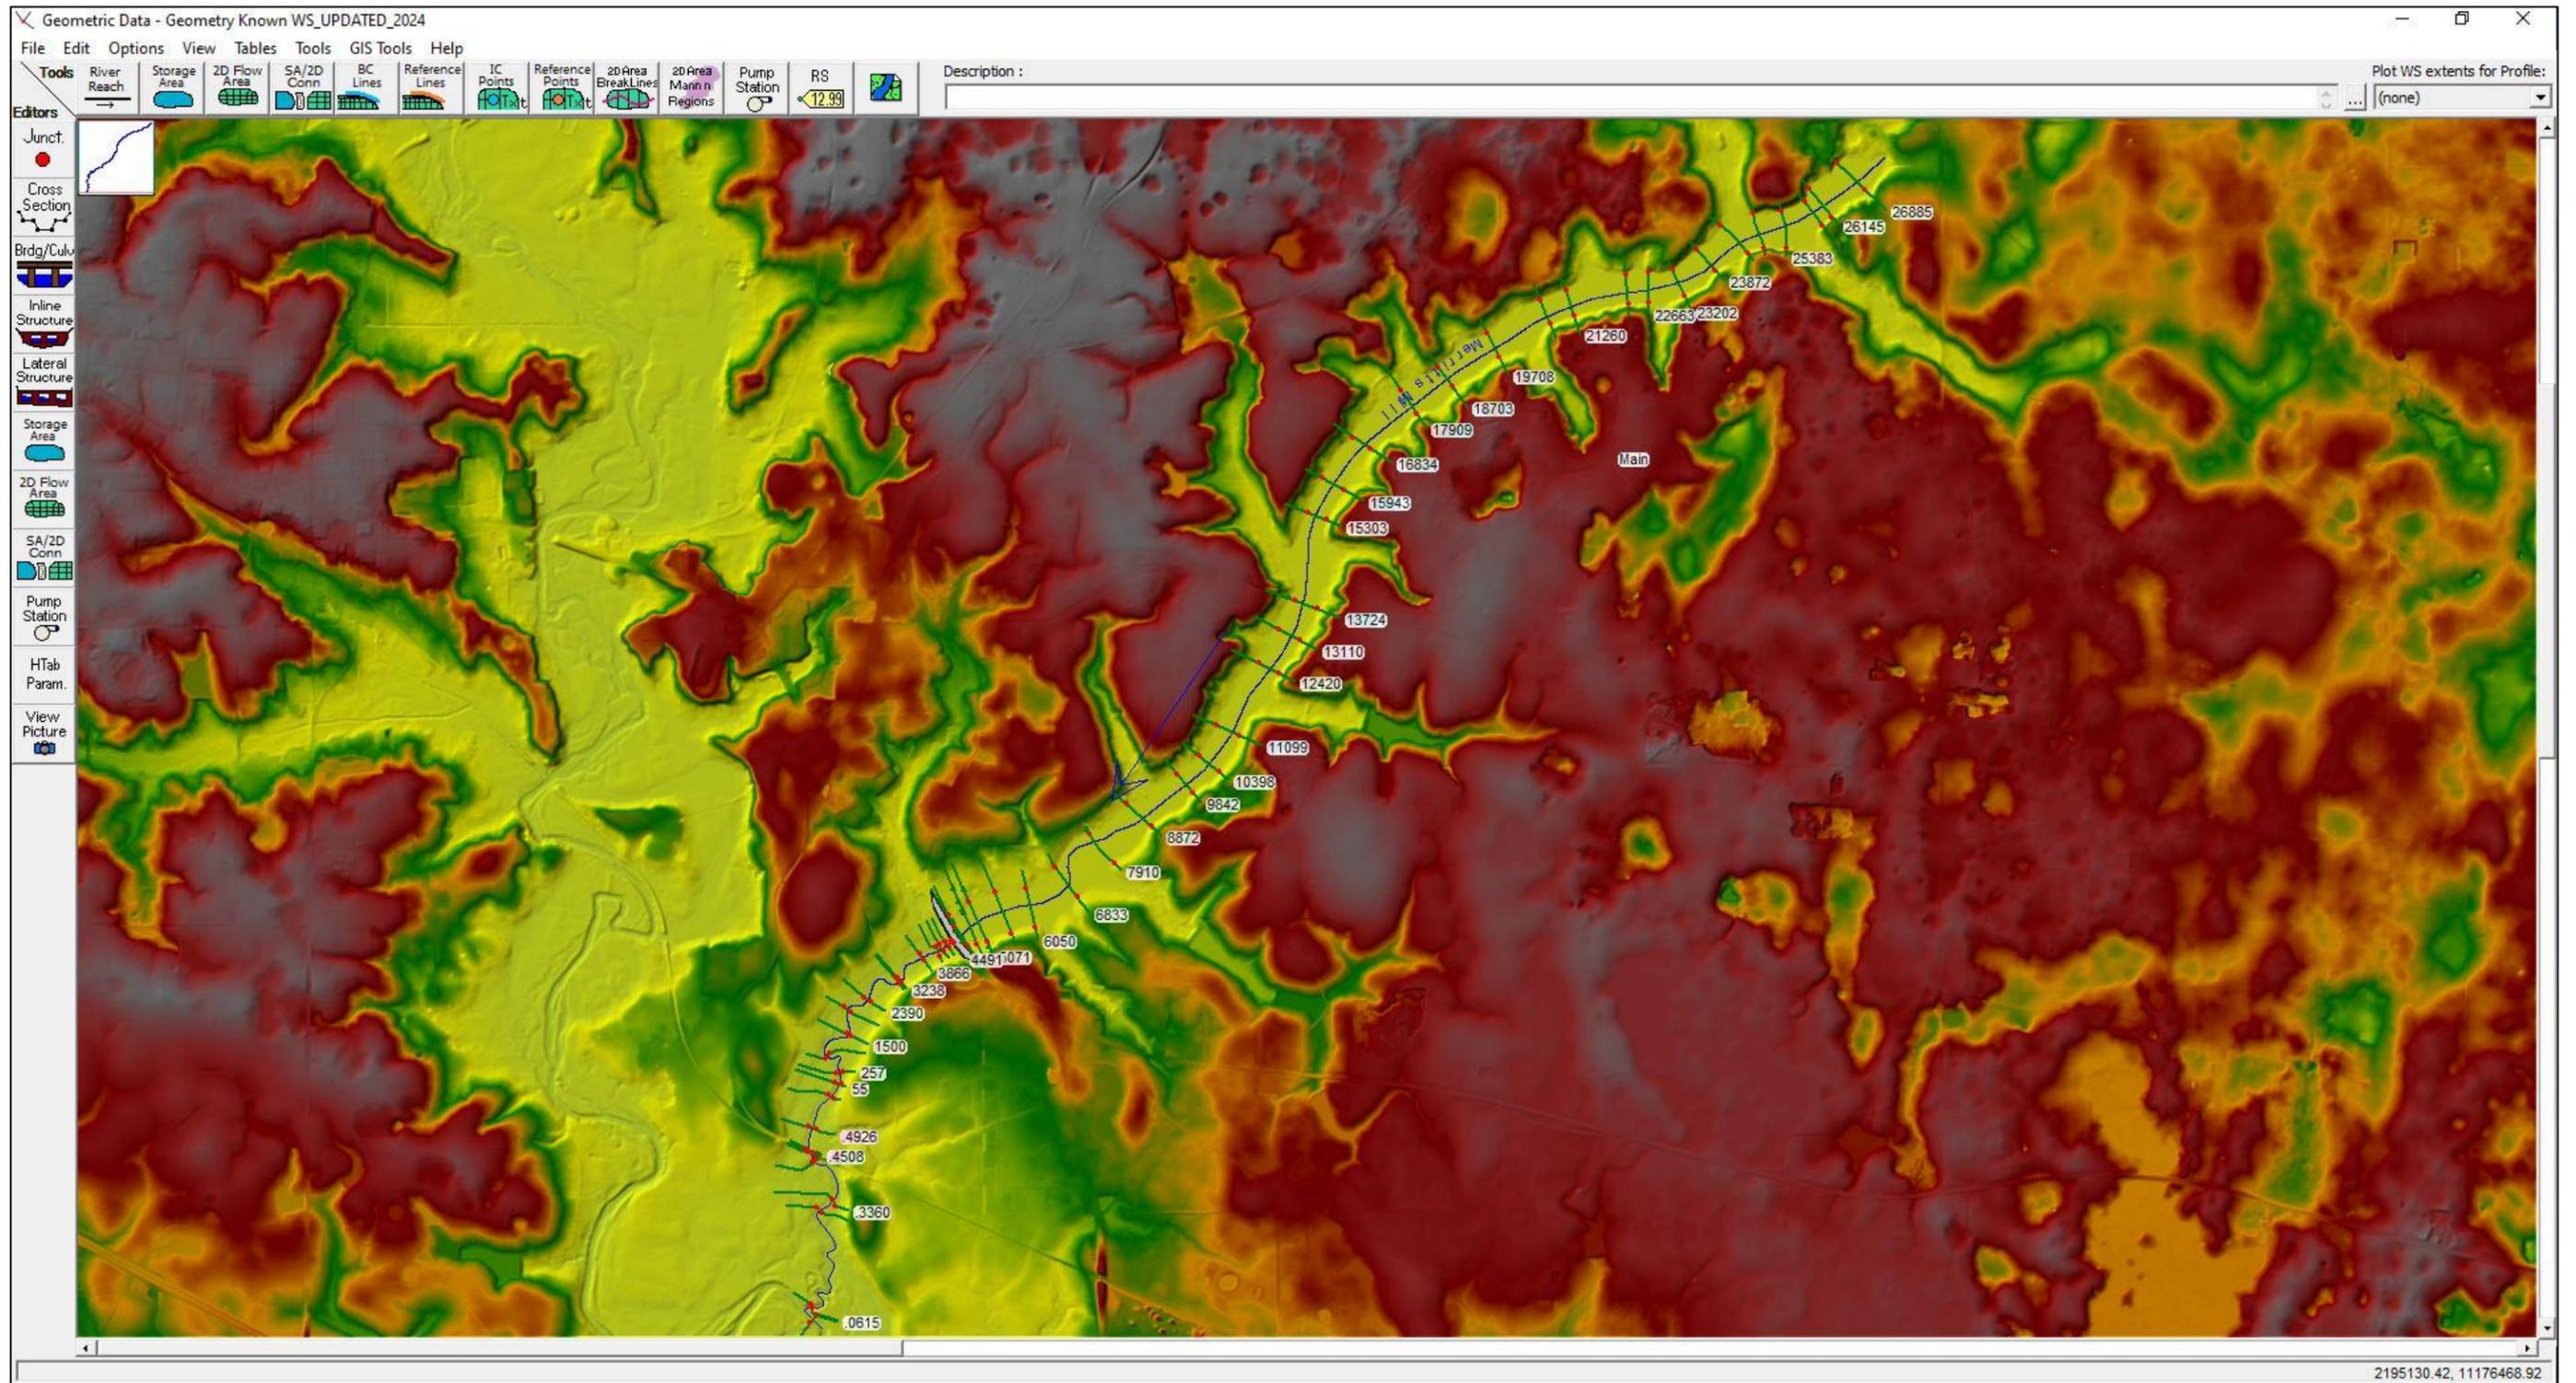
Figure 17: Jackson Blue Springs System HEC-RAS Model Schematic

Figure 17 presents the overall model schematic. The model contains 57 cross sections, one bridge (US 90 bridge), one inline structure (US 90 Control Structure), and four boundary conditions (three flow, one stage, described further in the text below). Figure 18 presents a zoomed-in view of the model schematic around the US 90 bridge (shown in gray) and water control structure (black line immediately downstream of US 90).

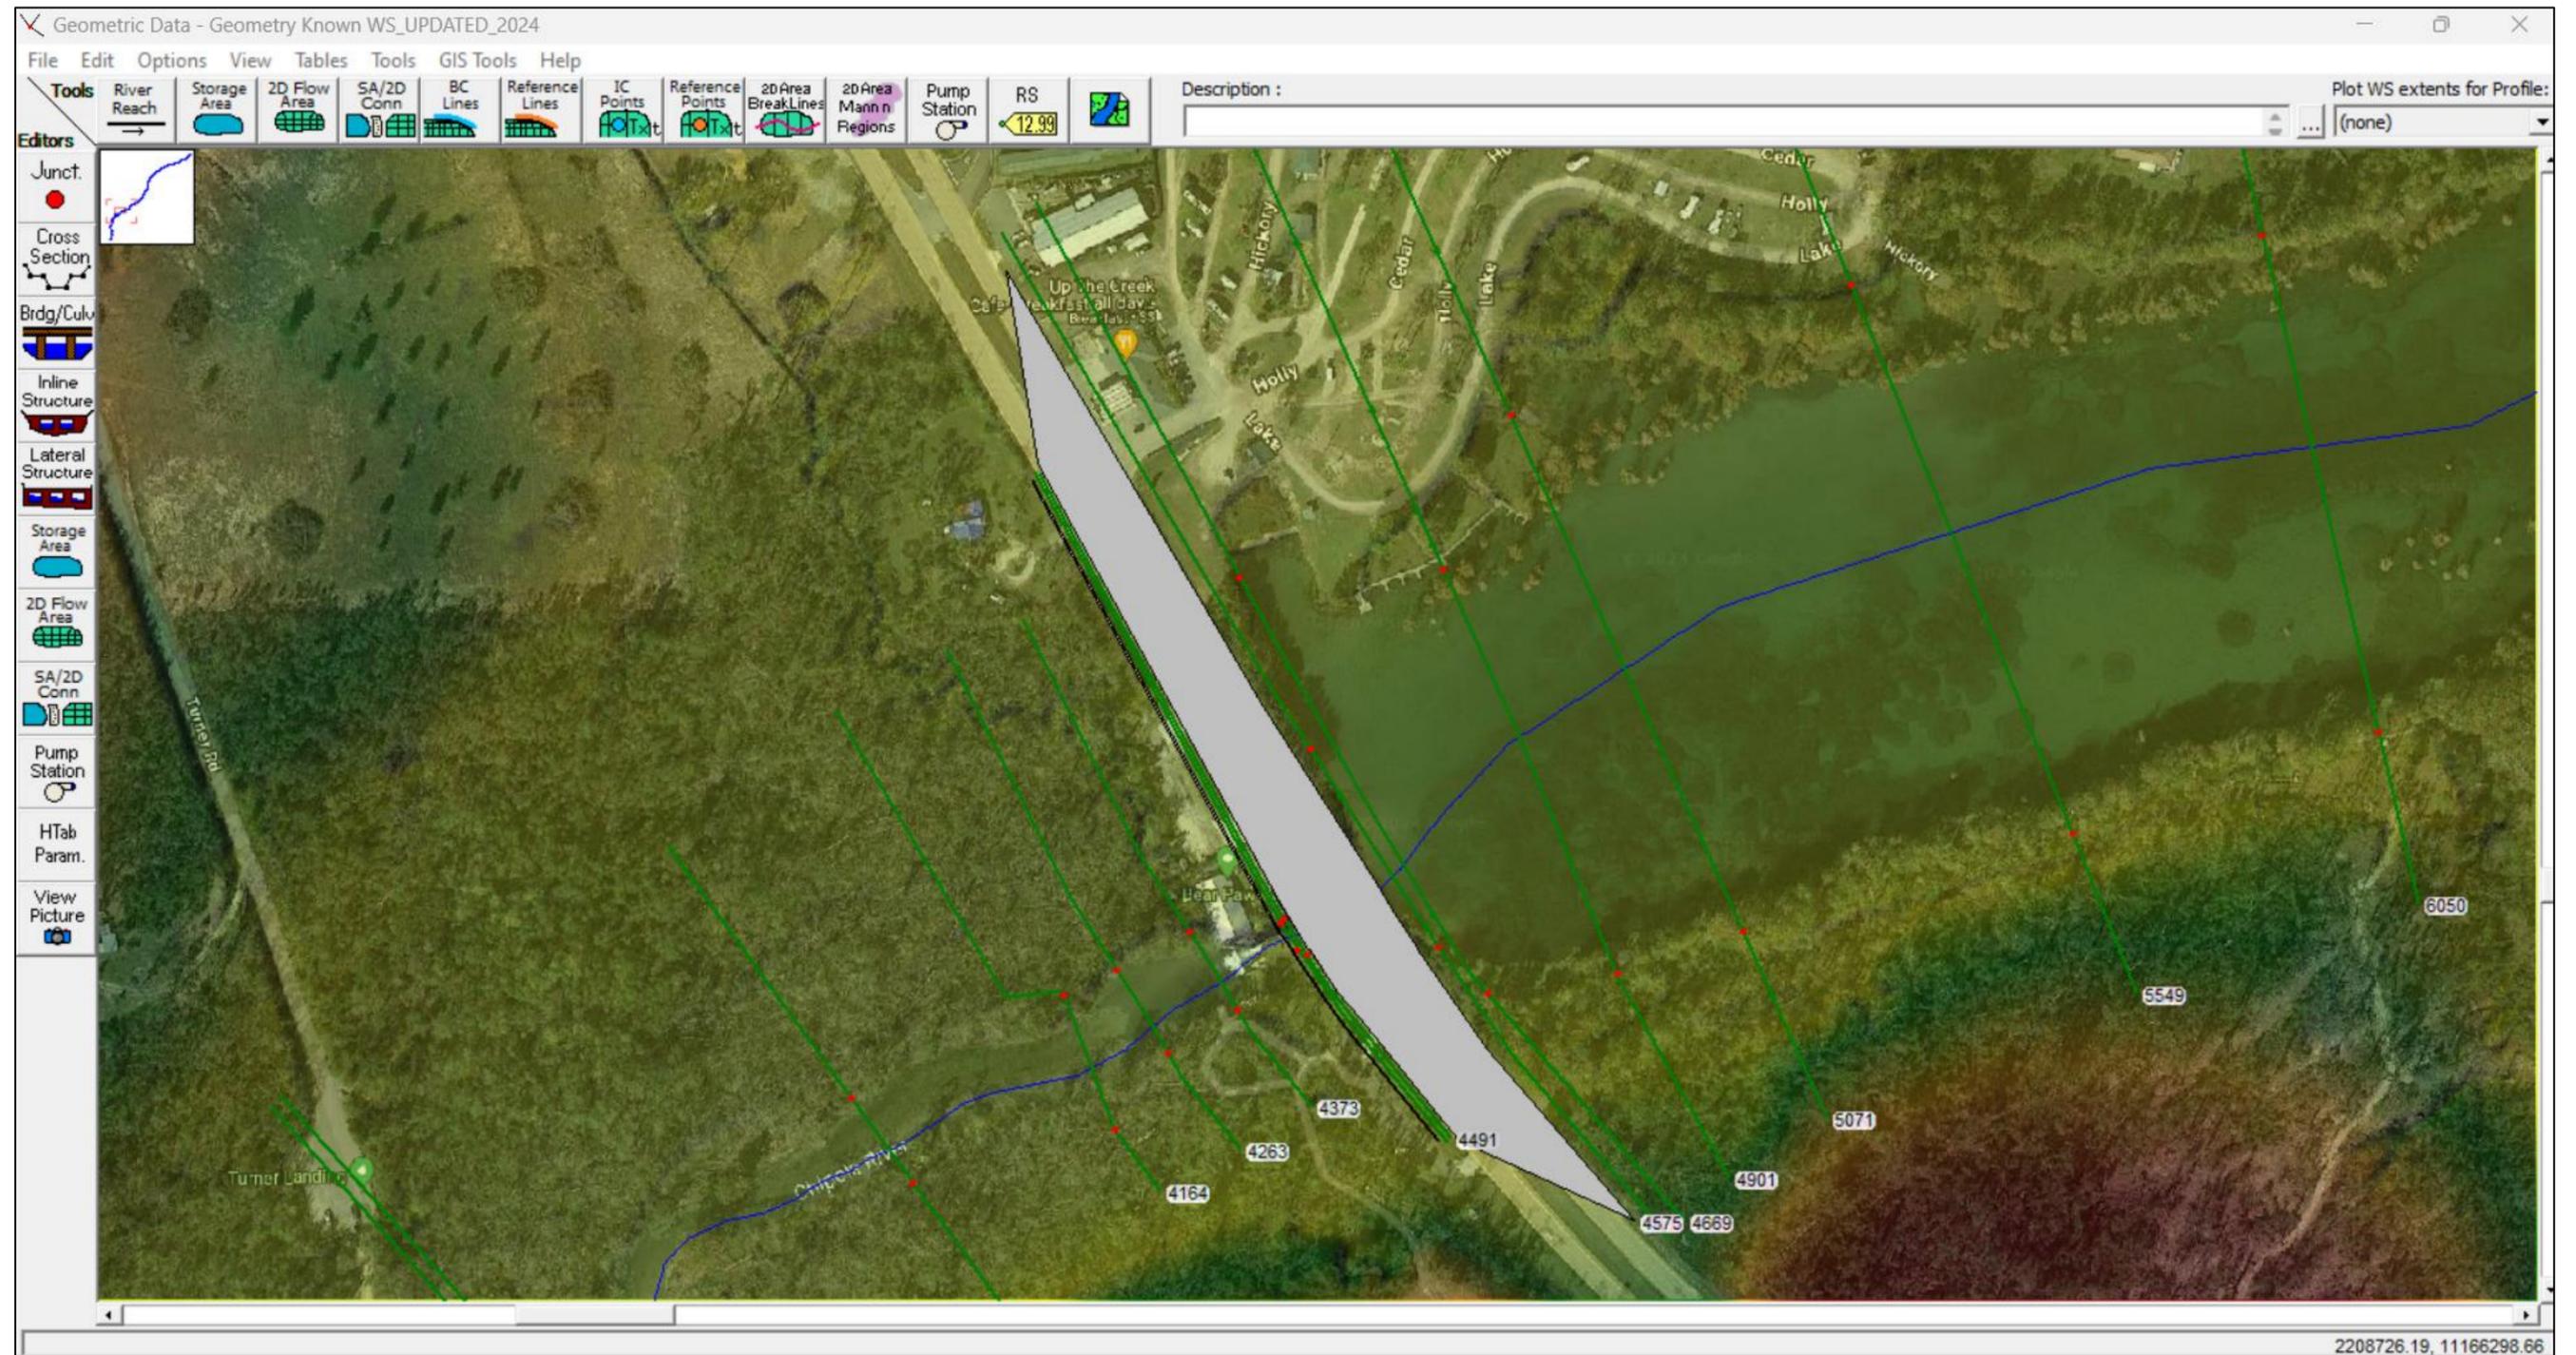
Figure 18: Jackson Blue Springs System HEC-RAS Model Schematic showing the US 90 Bridge and Merritts Mill Pond Control Structure

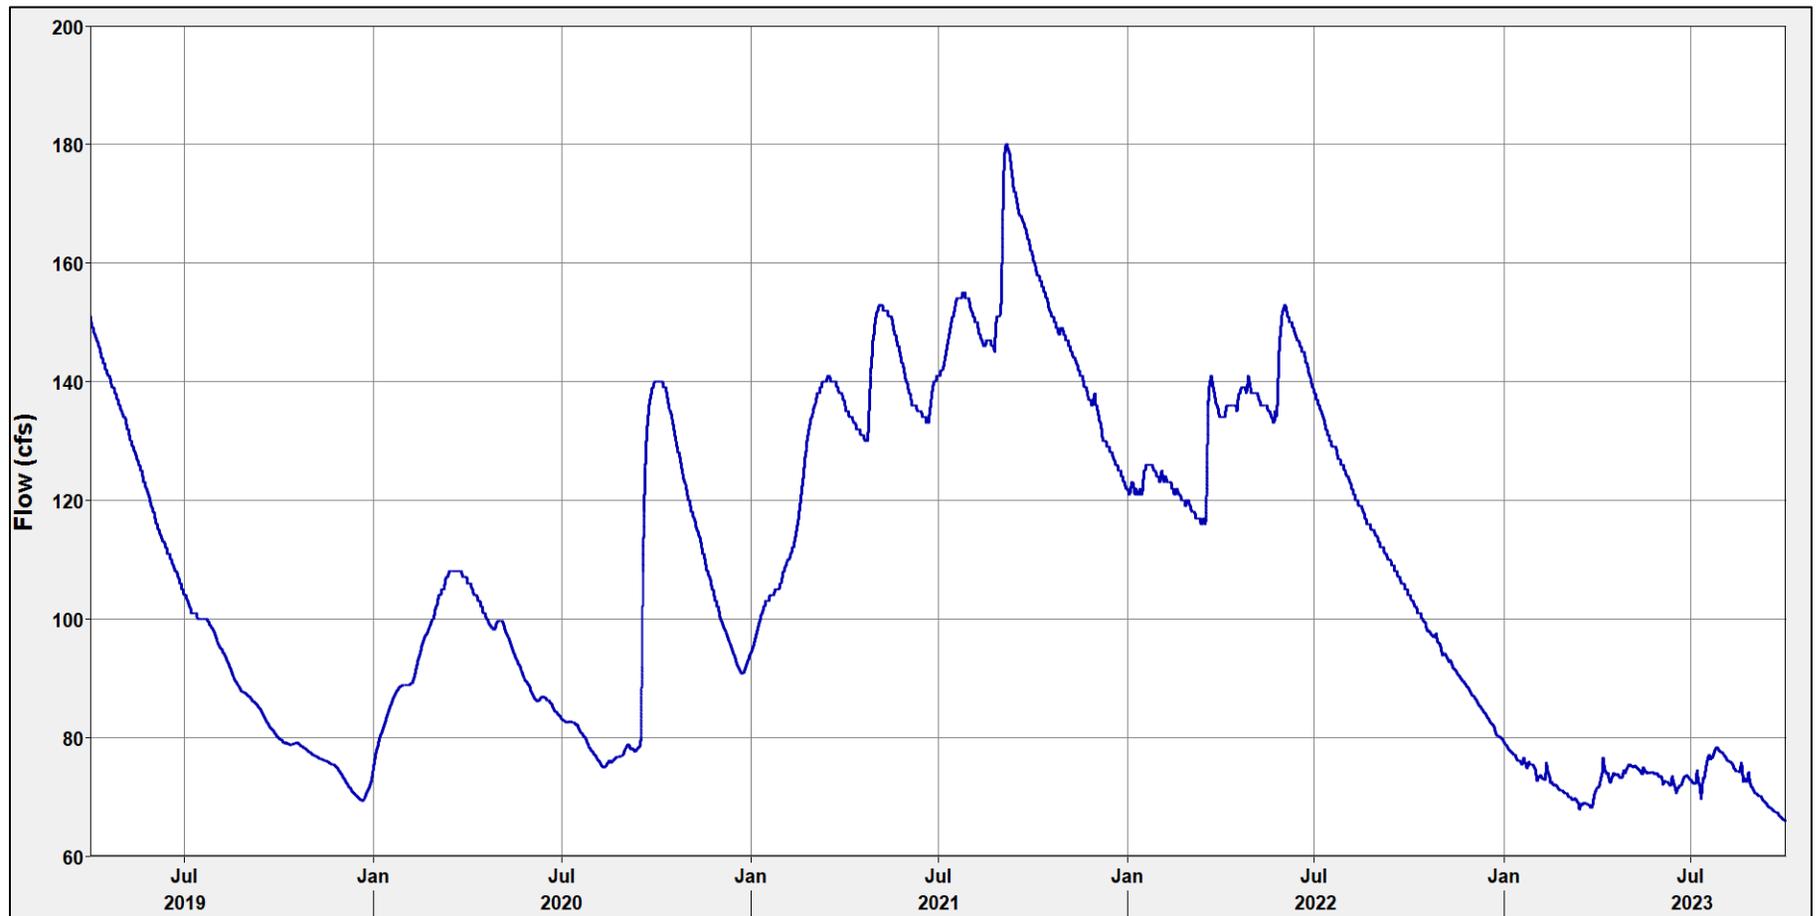
**Figure 19: Jackson Blue Spring Discharge, April 1, 2019 – September 30, 2023**

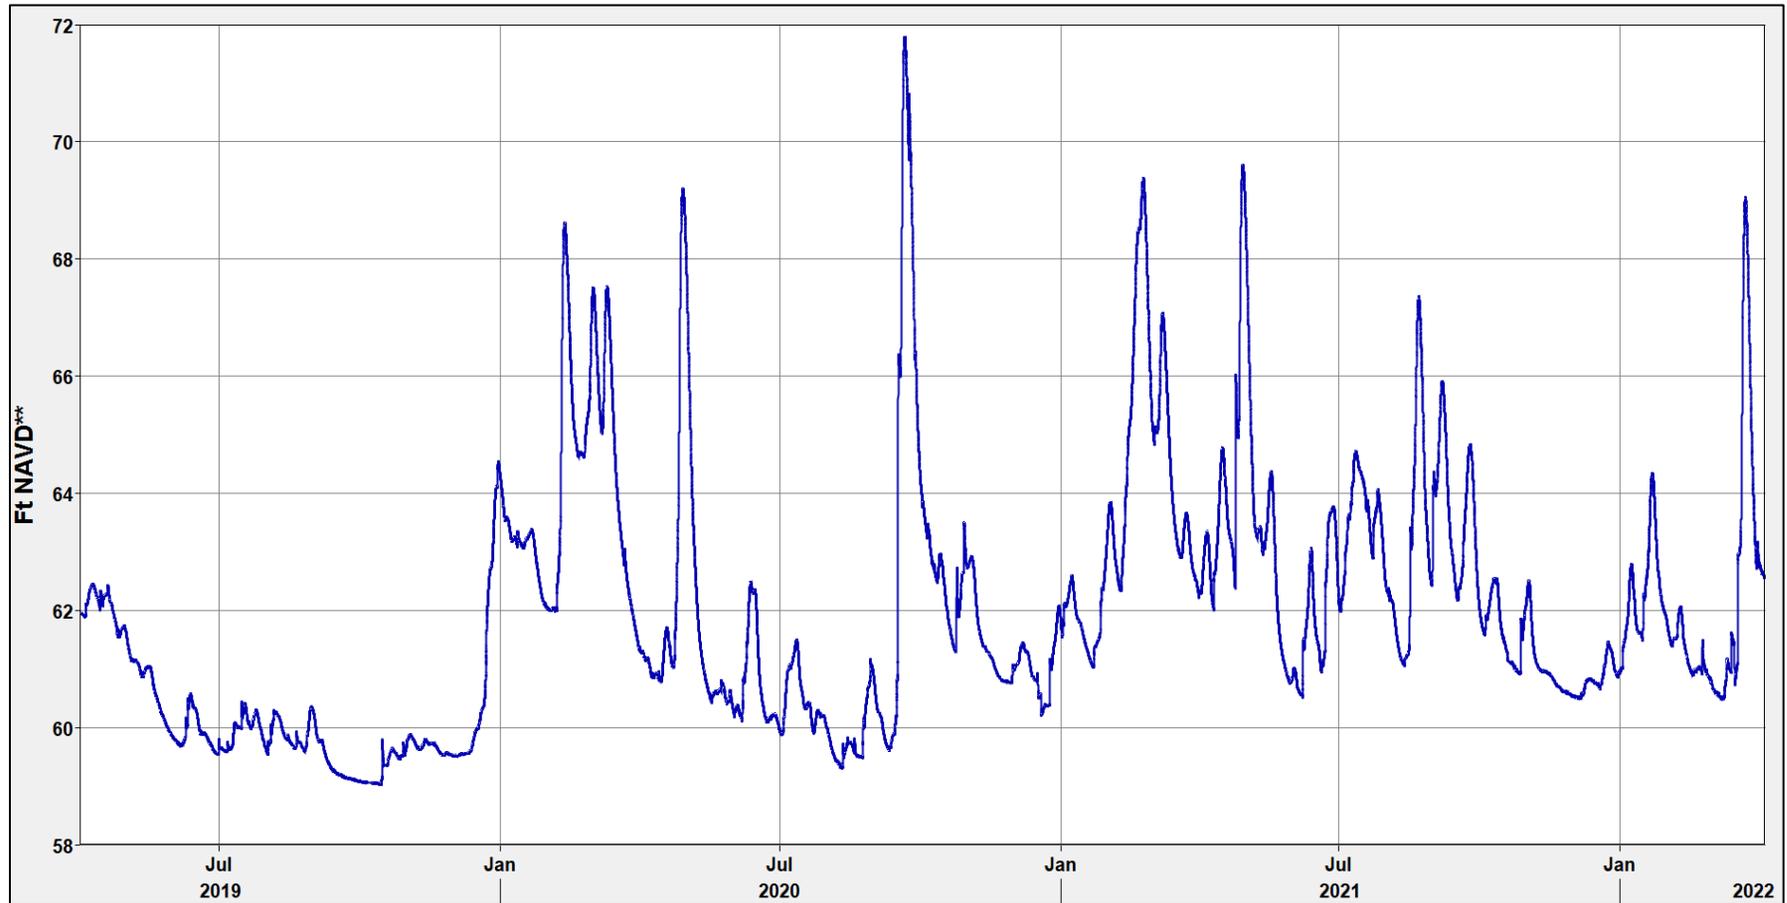
**Figure 20: Chipola River Stage at the Confluence with Spring Creek (April 1, 2019 – April 5, 2022)**

The Chipola River stage at the Spring Creek confluence serves as the downstream boundary condition for the HEC-RAS model. The District established a stage gage at this location called the “above Spring Creek” gage. The period of available data extends from 16:45 on September 23, 2020, to April 5, 2022. These data included one short period (less than 1 hour) of missing data on January 20, 2022, which was filled in using linear interpolation. These data also included a long period of missing data between March 3, 2021 at 19:00 and July 1, 2021 at 19:50. A method was developed to estimate missing data on the basis of measured water surface elevations at the USGS gage 02358789 Chipola River at Marianna, which is about 5 miles upstream from the District’s above Spring Creek gage (Verdantas, 2022). The resultant time series is presented in Figure 20.

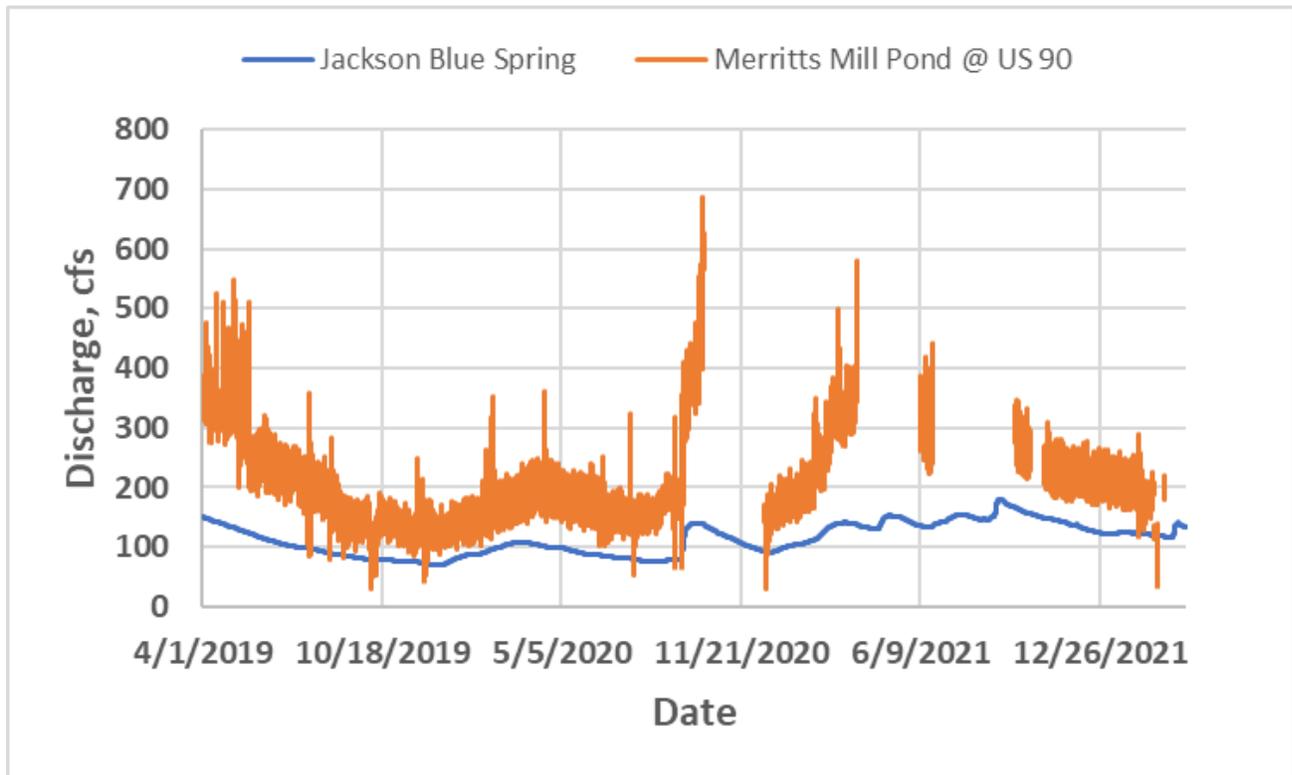
**Figure 21: Measured Discharge at the Jackson Blue Spring and Merritts Mill Pond @ US 90 Gages from April 1, 2019, to April 1, 2022**

The measured discharge at the Merritts Mill Pond @ US 90 gage comprises inflows from groundwater discharge/seepage and surface runoff during normal gate operations when Merritts Mill Pond stages are not changing rapidly. The measured discharge is also affected by the gate operations and the height of the gate openings, as well as turbulence as water approaches the control structure. During periods when the gate is opened dramatically, measured flow can suddenly increase substantially, causing more rapid declines in Merritts Mill Pond water levels. It is during such times when water storage changes in Merritts Mill Pond contribute more to the discharge measured at the Merritts Mill Pond @ US 90 gage.

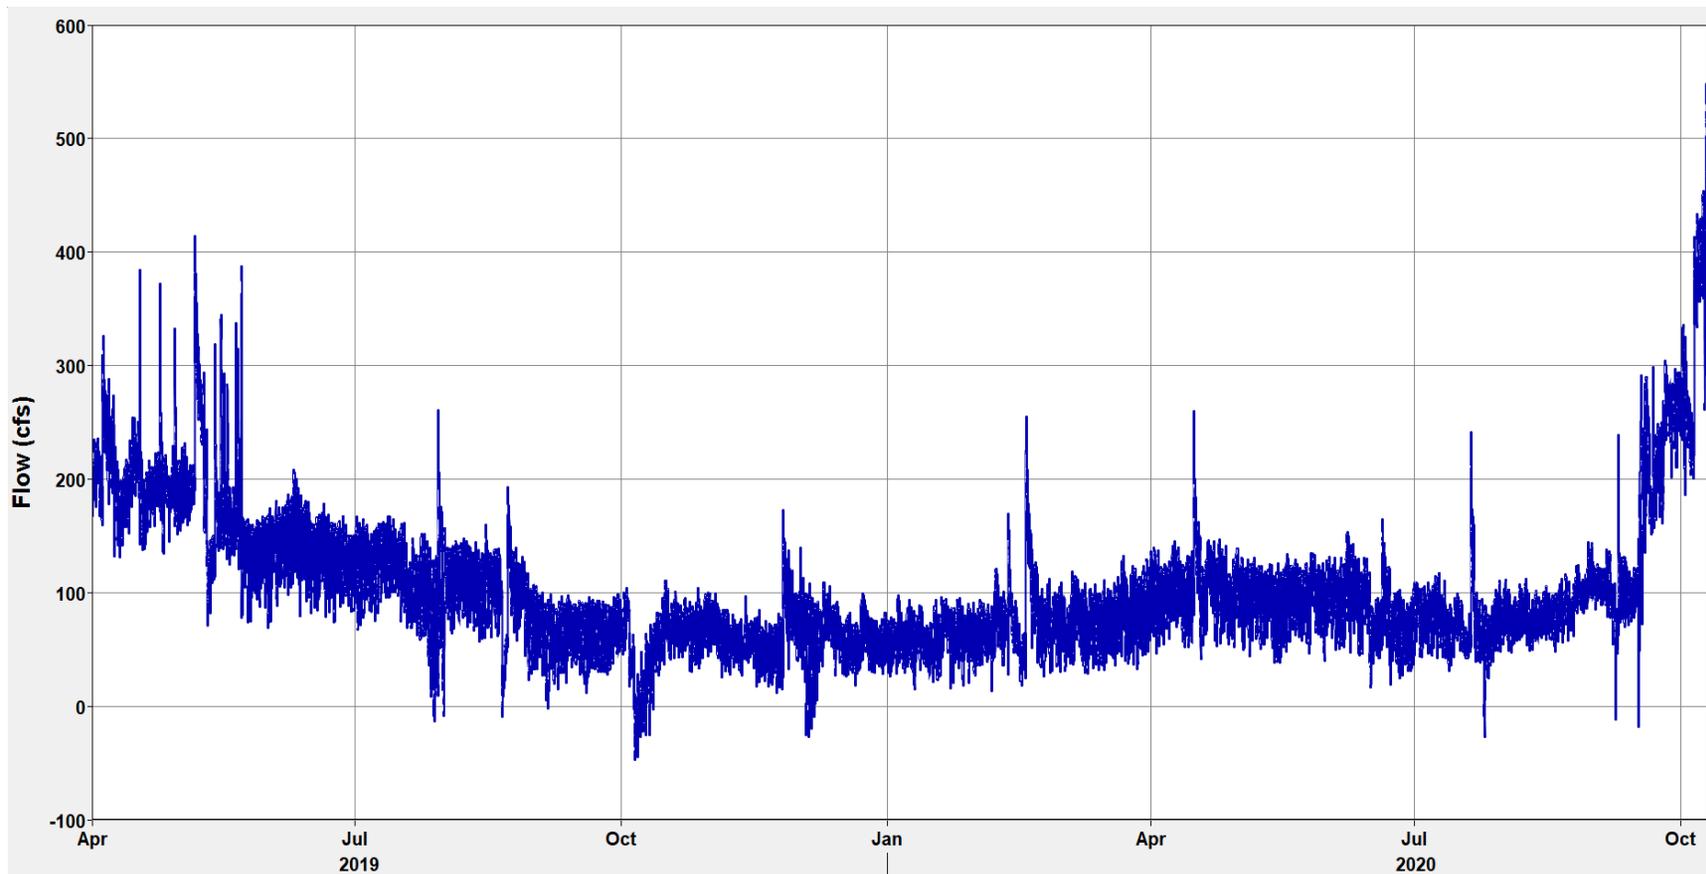
**Figure 22: Uniform Lateral Inflow Hydrograph Internal Boundary Condition for Merritts Mill Pond (April 1, 2019 – October 10, 2020)**

Given the complexities of the various flow components, the difference in discharge measurements was incorporated as an internal boundary condition as a uniform lateral inflow hydrograph. The difference in measured discharges at the Merritts Mill Pond @ US 90 gage and Jackson Blue Spring was input as a uniform lateral inflow hydrograph between the edge of the Jackson Blue Springs pool (RS 25929) and the US 90 bridge (RS 4901), covering 21,028 ft. During consistent and non-extreme gate operations, this approach is a reasonable approximation of the flow contributions between the Jackson Blue Spring and the US 90 bridge and still allows for the measured stage at the Merritts Mill Pond @ US 90 gage to be used as a calibration target. It should be noted that during rapidly changing conditions in which the gate is opened dramatically, the rapid flow change can result in some flow imbalances and possible model instability. Figure 22 presents the resulting flow time series that was input as a uniform lateral inflow hydrograph internal boundary condition. The spikiness/noisiness of the time series is

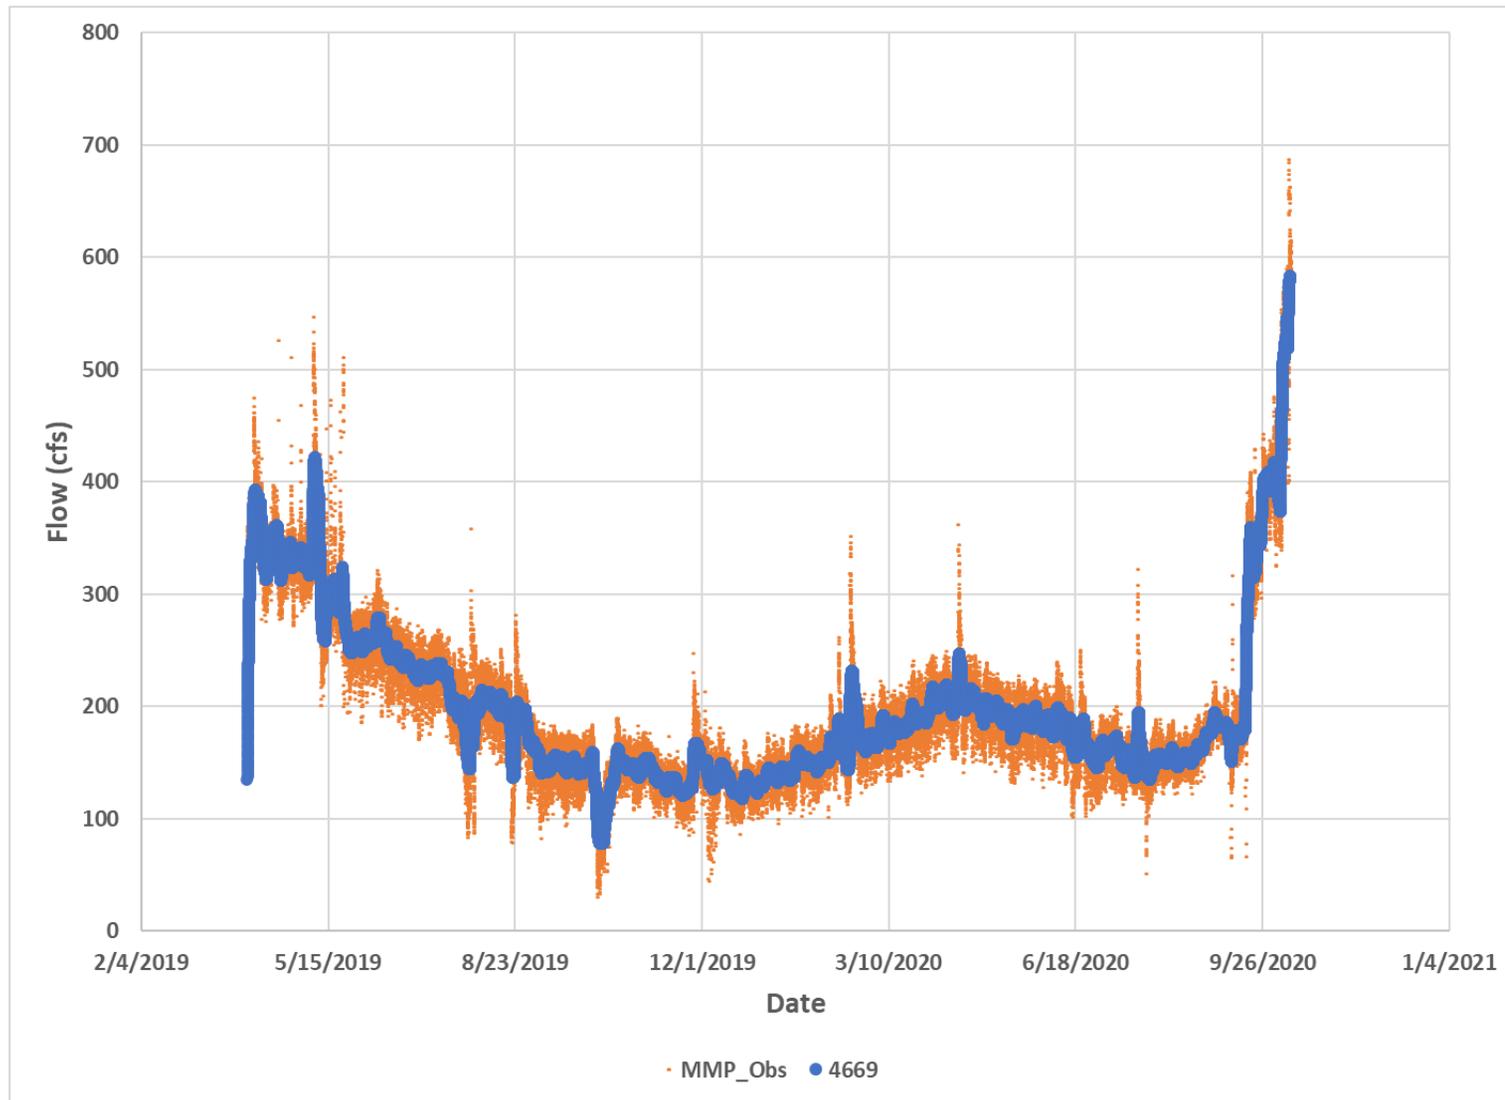
**Figure 23: Comparison of Measured and Simulated Flow at the Merritts Mill Pond @ US 90 Gage (River Station 4669)**

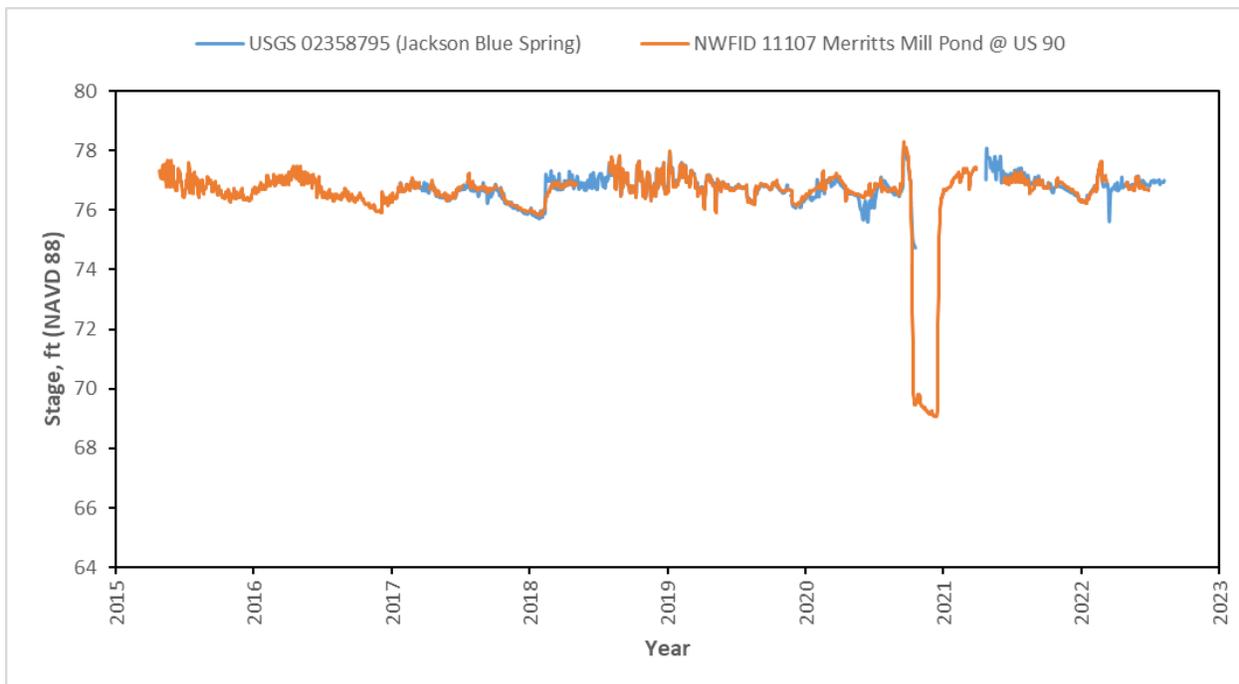
**Figure 25: Comparison of Stage at USGS 2358795 Jackson Blue Spring Near Marianna with Stage at NWFID 11107 Merritts Mill Pond @ US 90**
