# **HYDROLOGIC ENGINEERING CENTERS RIVER ANALYSIS SYSTEM (HEC-RAS) MODEL**

## **JACKSON BLUE SPRING SYSTEM**

### **FINAL REPORT**

**Northwest Florida Water Management District**

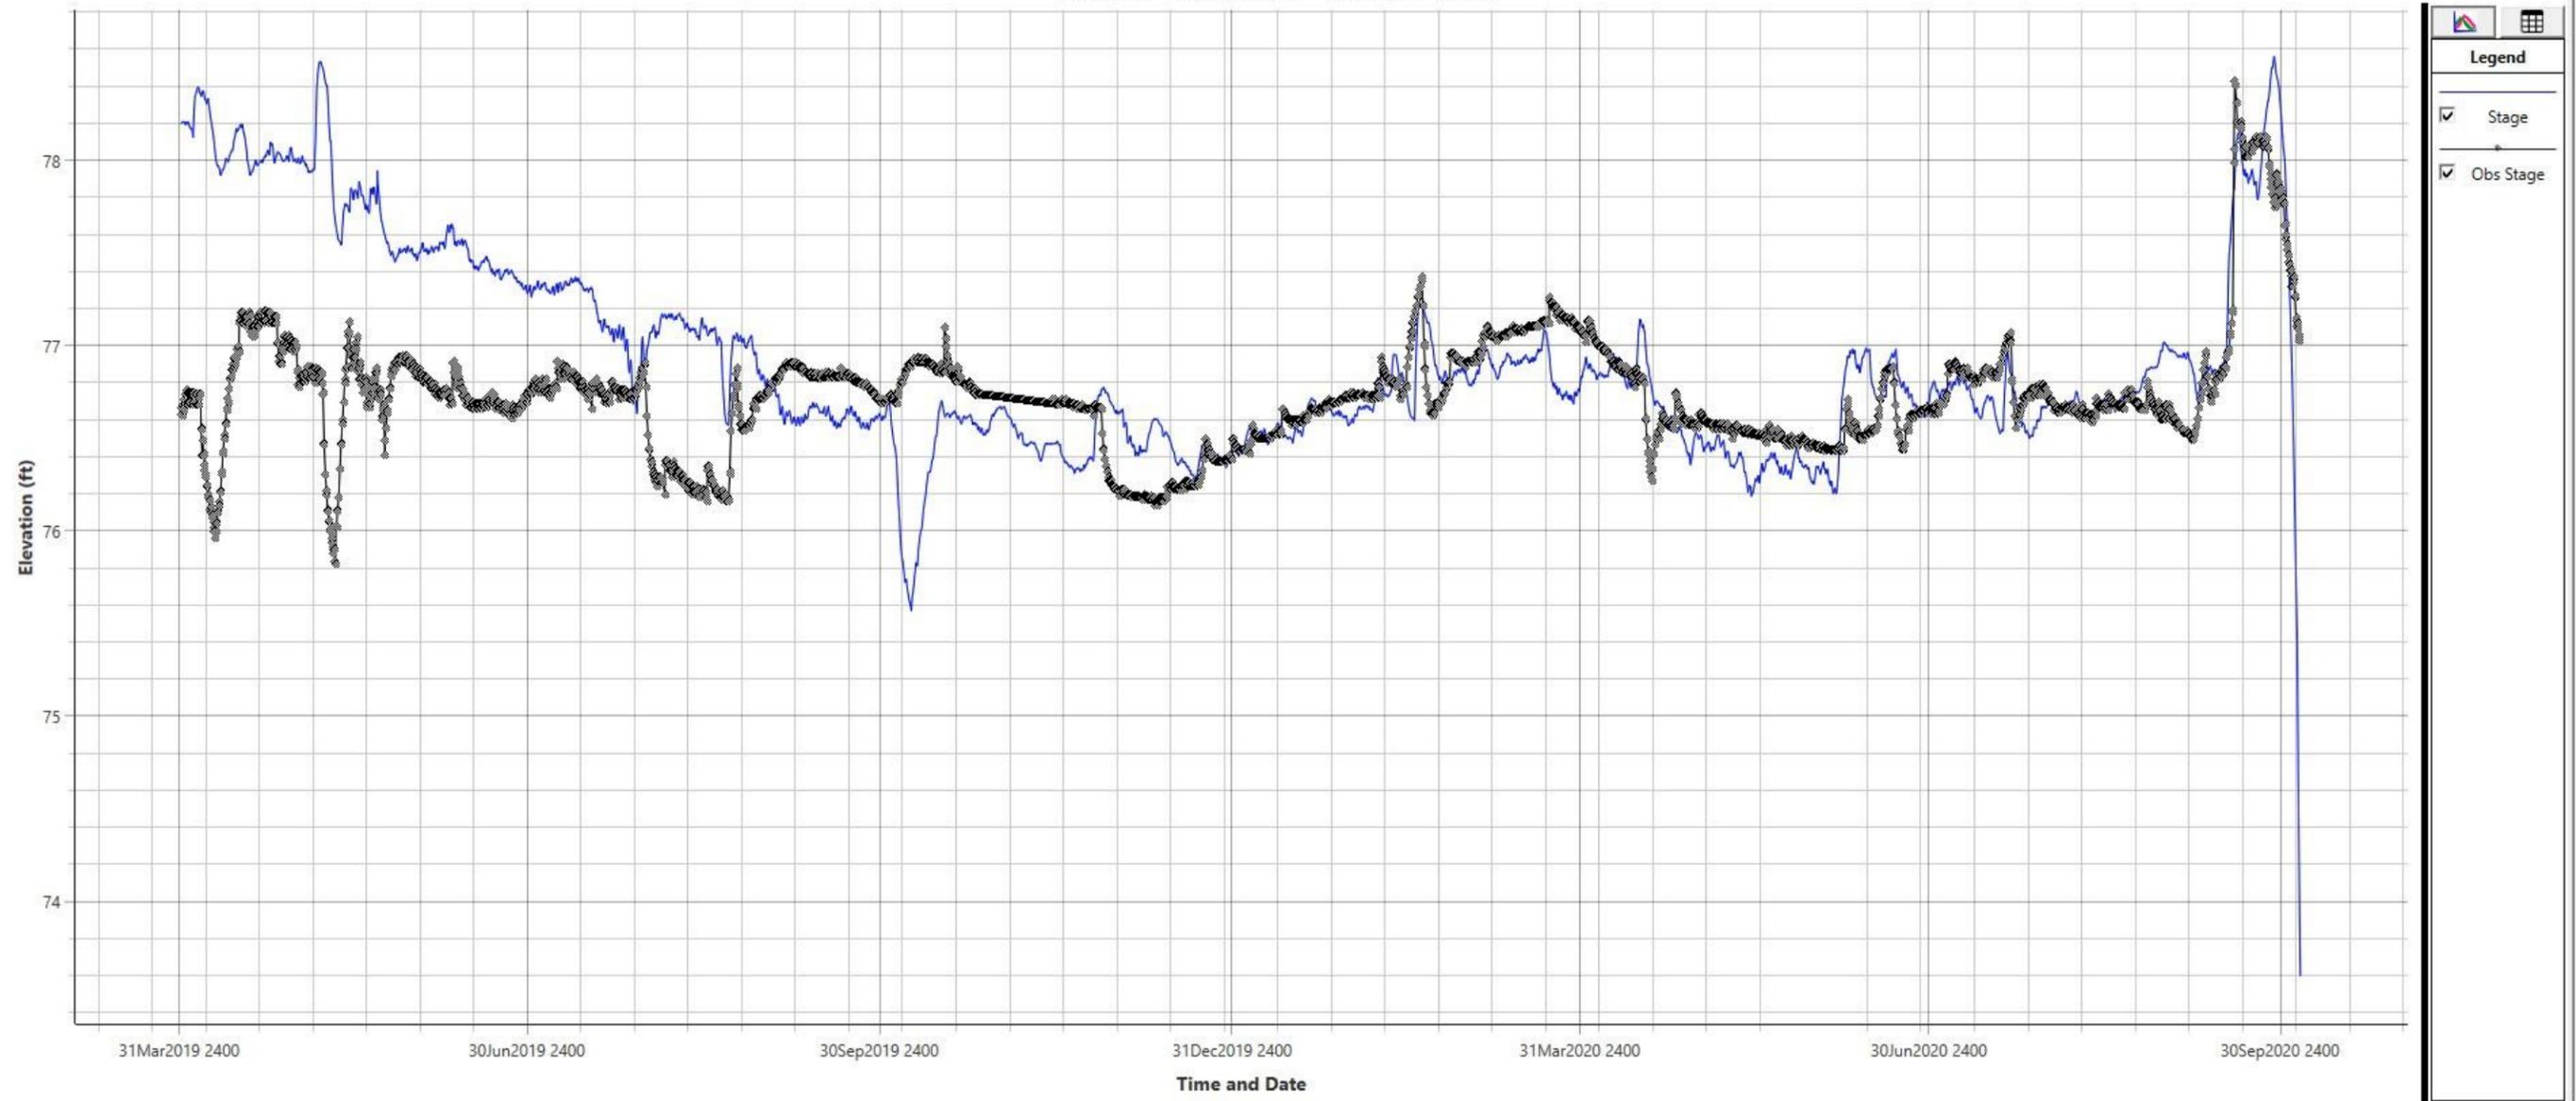
Plan: Plan 19 River: Merritts Mill Reach: Main RS: 4669

**Figure 26: Measured Water Surface Elevations at the Merritts Mill Pond @ US 90 Gage (Station Number NFWMD 11107) Compared with Model-Simulated Elevations from Plan 19 Test.**

4. Plan 19 – This plan used a modified Geometry file in which ineffective flow areas were defined, particularly around the US 90 bridge and the control structure. Also, modifications were made in the Spring Creek portion of the model in which the location of in-channel and overbank areas of some cross sections were modified. Following this, Manning’s n coefficients were updated at all cross sections for all channel and floodplain areas to reflect conditions observed during the field reconnaissance. The Unsteady Flow file was modified to include the recorded Gate Operations Record by importing the record into the DSS and modifying the unsteady flow file to reflect that boundary condition in the DSS file. Figure 26 presents the simulation results from Plan 19 at the location of the Merritts Mill Pond @ US 90 gage.

It should be noted that the model eventually became unstable during rapidly changing conditions that occurred near the end of the simulation period in which the gate was opened dramatically, dropping stage in the pond more than 5 ft, so that a major rehabilitation project could be completed (known as The Drawdown Event).

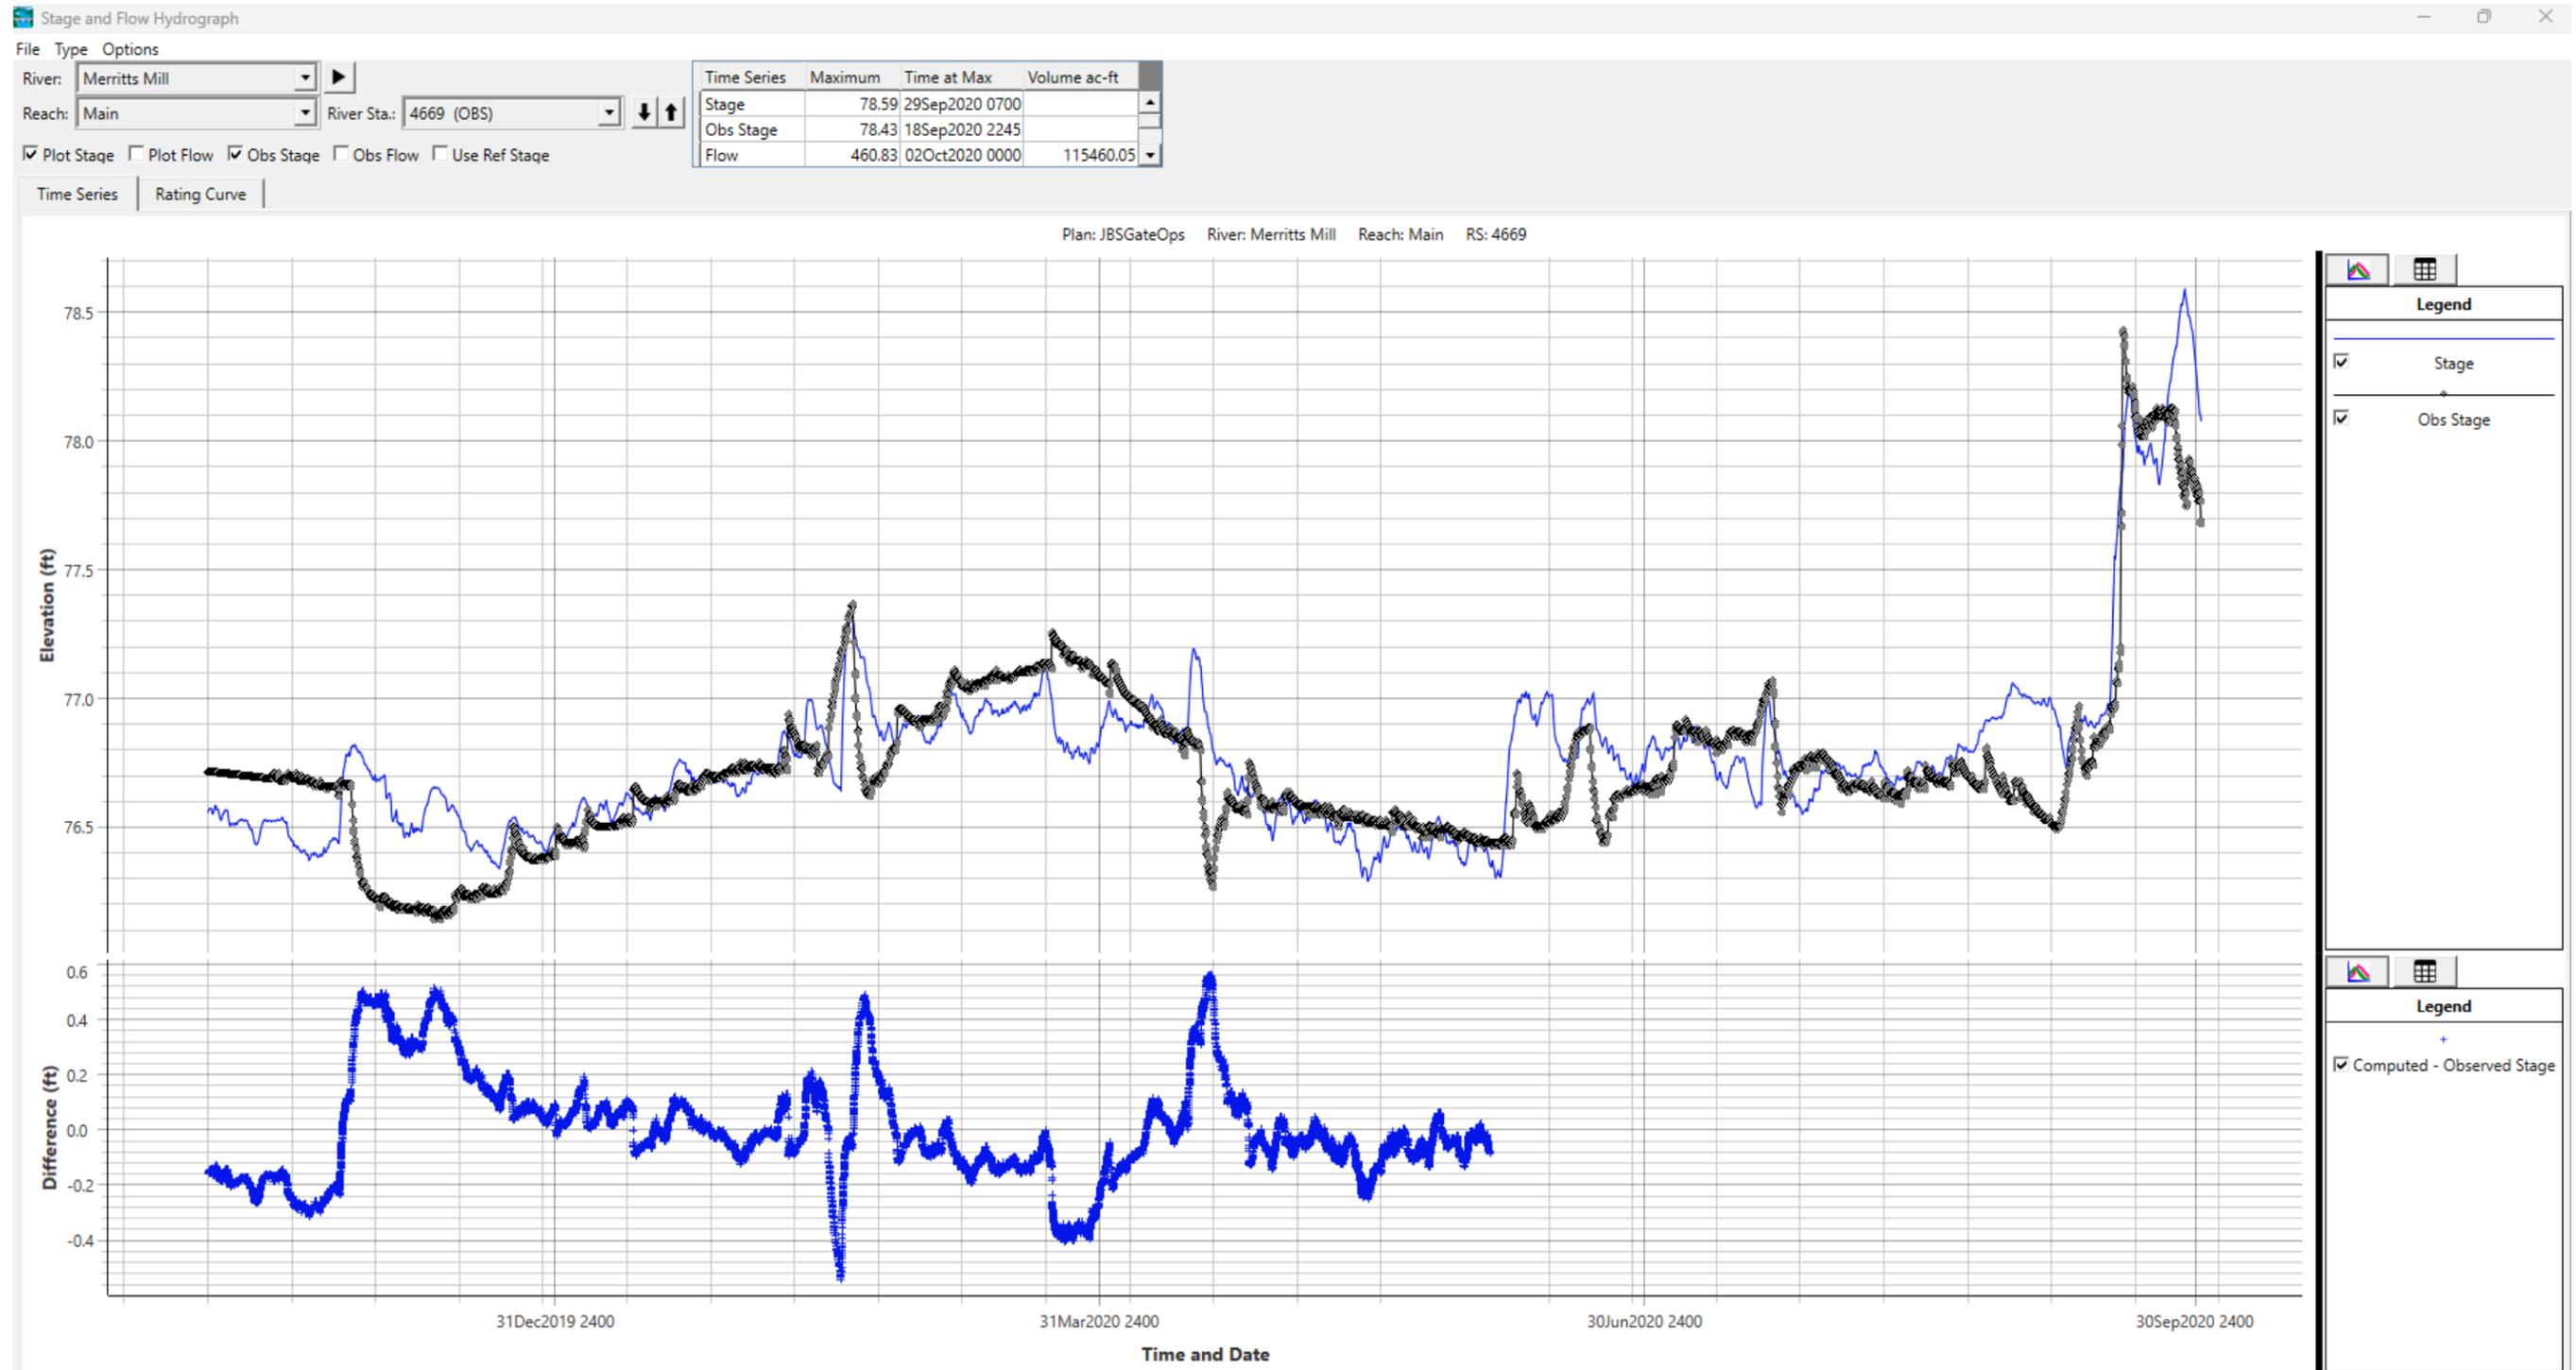
Figure 27: Jackson Blue Springs System HEC-RAS Model Calibration Showing Simulated vs. Observed Stage Time Series at the US 90 Bridge on Merritts Mill Pond

0.7, per HEC-RAS guidance). The sluice discharge coefficient was adjusted, and simulations were performed, after which graphical comparisons with simulated and observed stage time series were done. After a number of iterations, a sluice discharge coefficient of 0.57 was determined to provide the best fit. This value is in the lower range for this coefficient, which possibly reflects the additional flow resistance through the fish barrier. Figure 27 presents the result of the Model Calibration (HEC-RAS model plan “JBS\_GateOps”) at Merritts Mill Pond @ US 90 (Station ID 011107). Of note at the beginning of the calibration simulation (November 25-28, 2019) is where the model is showing a sudden increase in stage in Merritts Mill Pond, while the observed data shows a sudden decrease of approximately 0.5 ft. The gate operations records had no entries during these two months. Figure 28 presents the simulated and measured flows at Merritts Mill Pond @ US 90 (Station ID 011107).

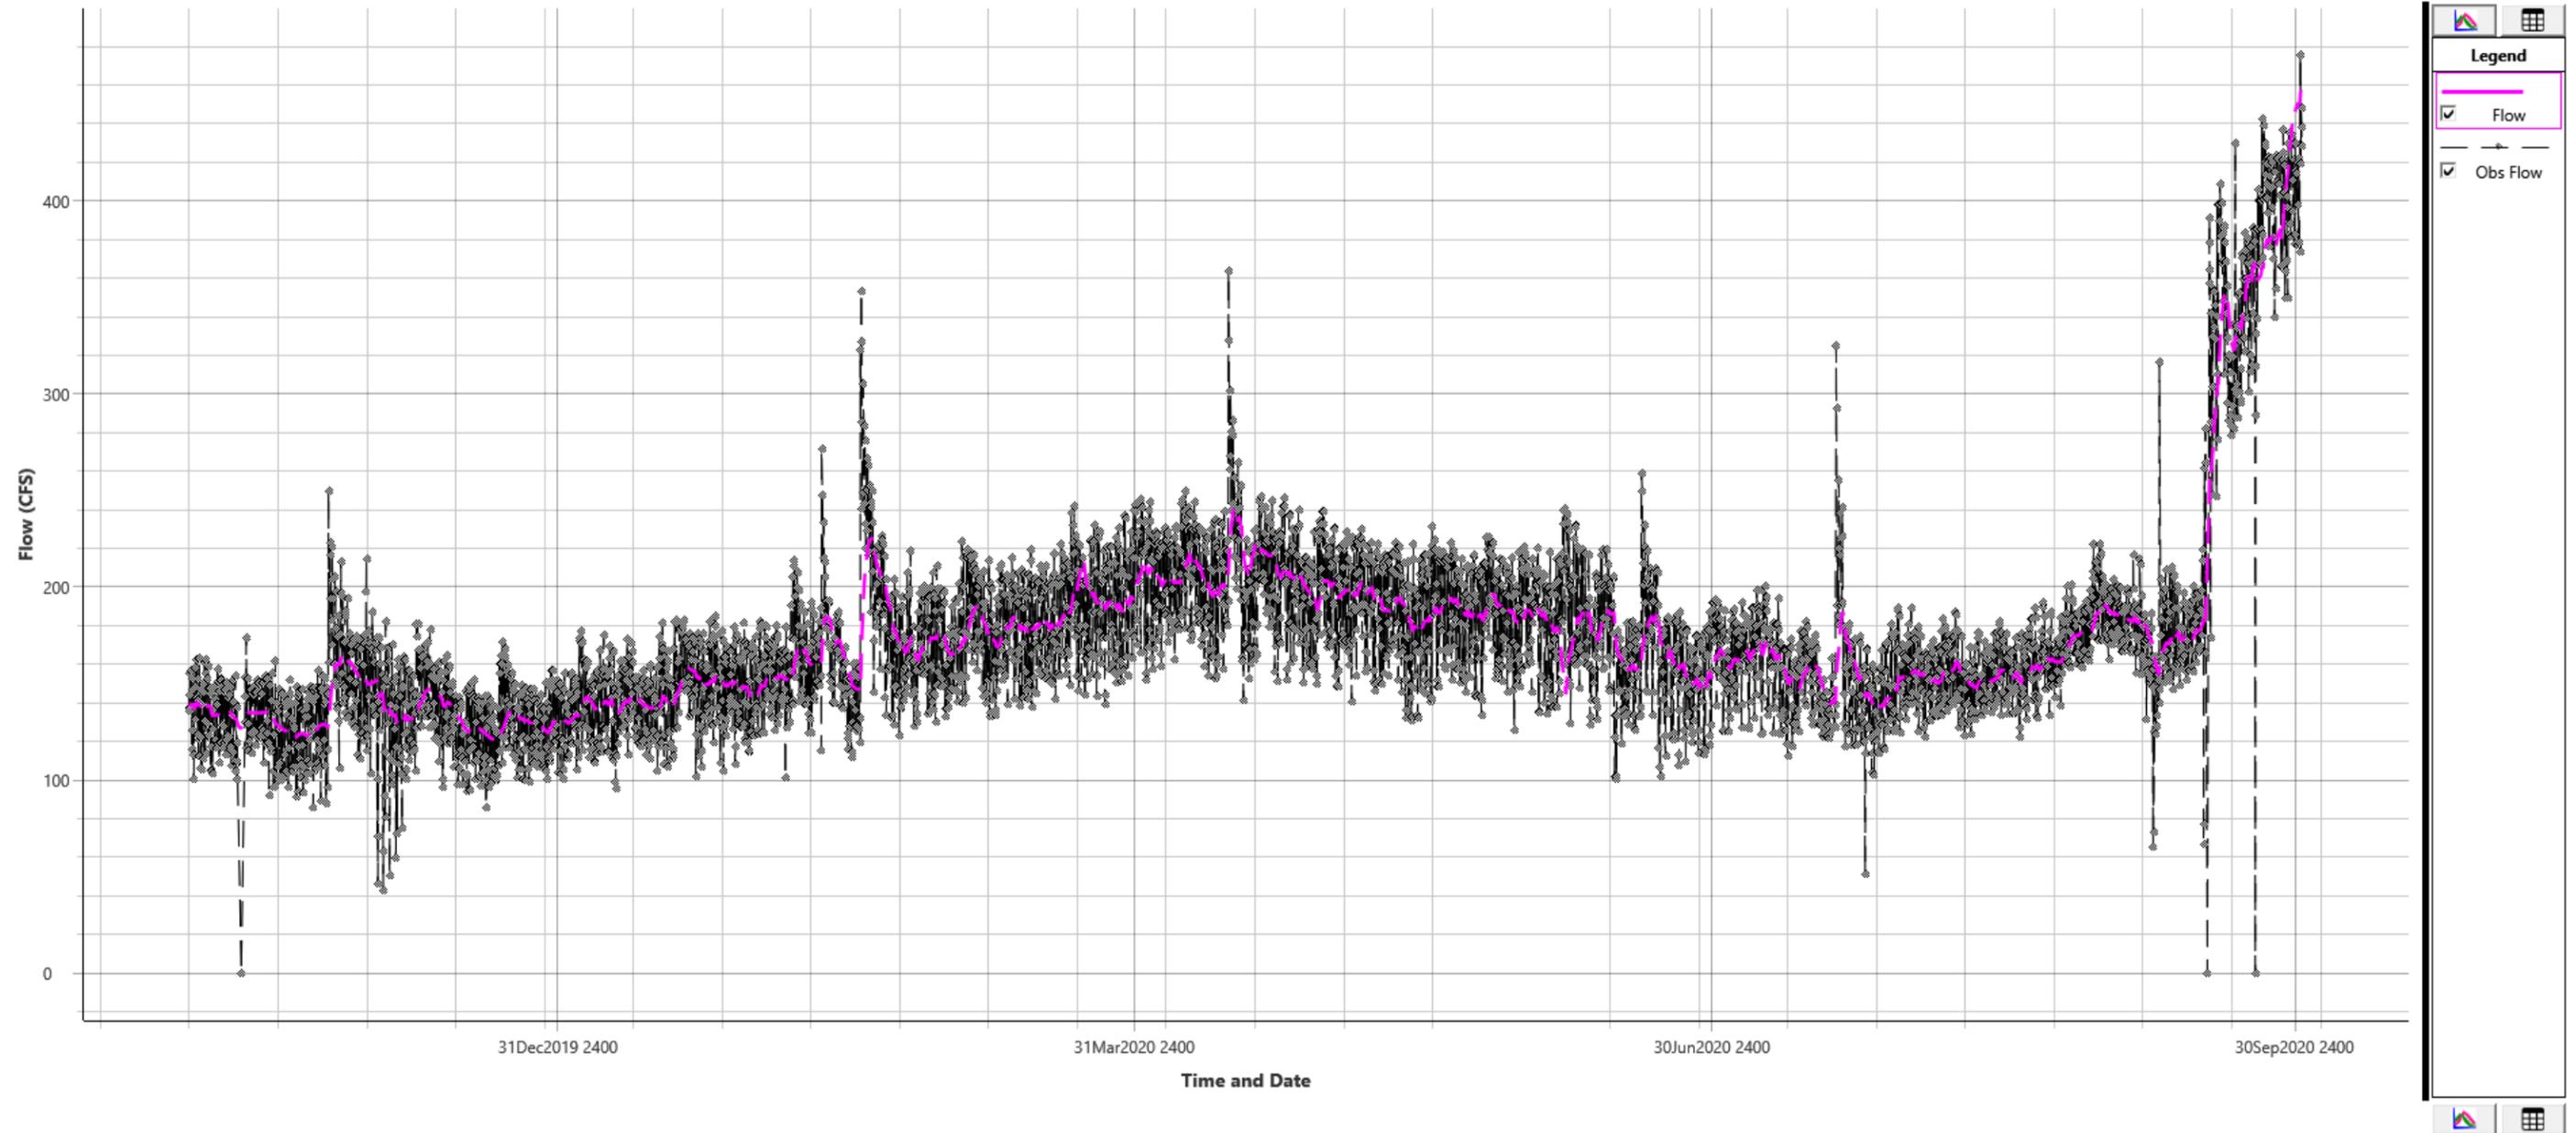
Plan: JBSGateOps River: Merritts Mill Reach: Main RS: 4669

Figure 28: Jackson Blue Springs System HEC-RAS Model Calibration Showing Simulated vs. Observed Flow Time Series at the US 90 Bridge on Merritts Mill Pond

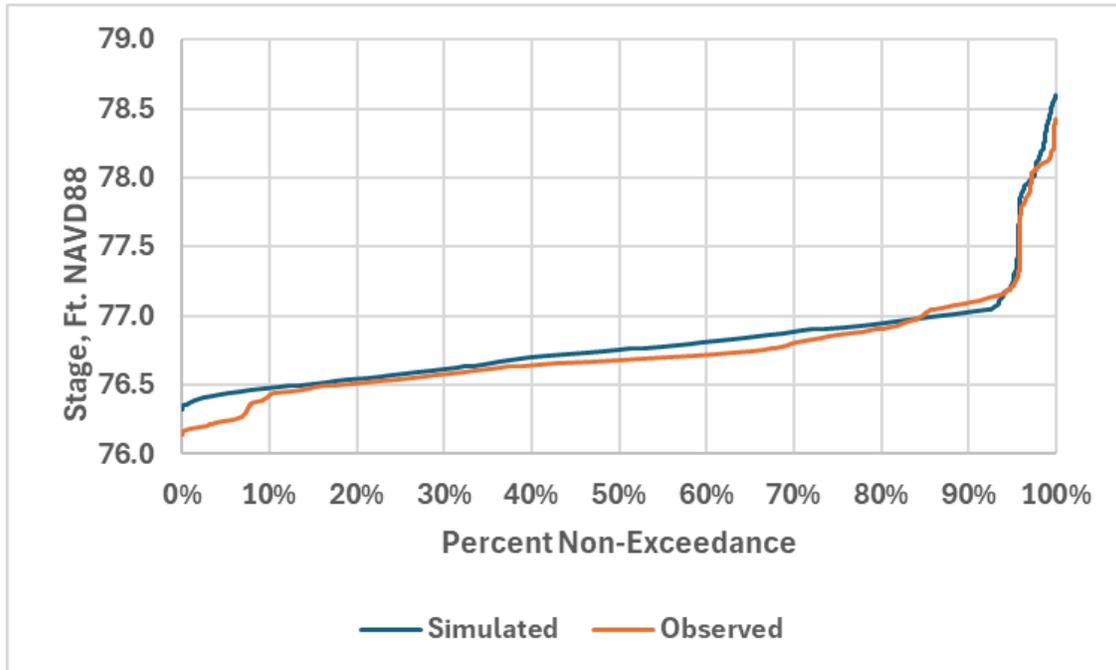
**Figure 29: Stage Frequency Curves for the Calibration Simulation Comparing Observed and Simulated Stages at the US 90 Bridge on Merritts Mill Pond**

Figure 29 compares the stage frequency curves for the observed and simulated Merritts Mill Pond stages at the US 90 bridge. The curves match very well for the calibration time period. This supports the conclusion that the model is responding to the boundary forcings appropriately.

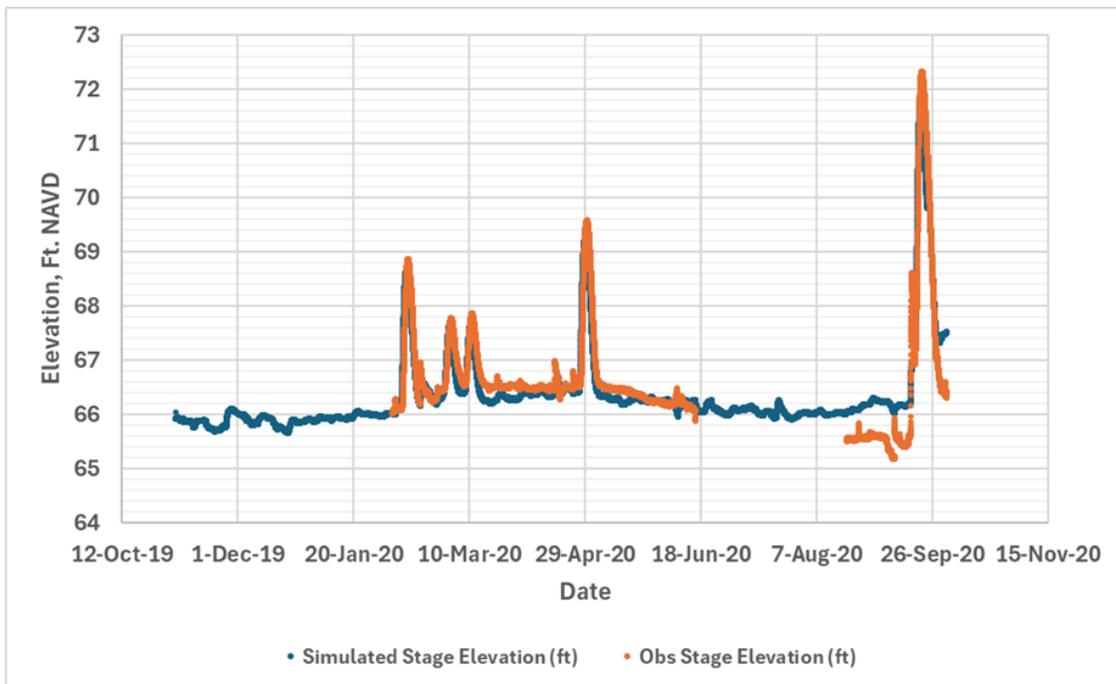
**Figure 30: Stage Time Series for the Calibration Simulation Comparing Observed and Simulated Stages at the Spring Creek @ Spring Creek Park Gage**

Calibration of the model in the Spring Creek reach involved adjustments to in-channel and floodplain Manning’s n values. Initially in-channel and floodplain Manning’s n values were 0.03 and 0.08, respectively. The final in-channel values along Spring Creek ranged from 0.055 near the control structure to 0.045 in the lower third of Spring Creek, values which are representative of main stream channels which are clean, winding, with some pools, shoals, weeds and stones (USACE, 2020). Floodplain values were set at 0.22, which is representative of a floodplain that is densely covered in trees (USACE, 2020) and reflects the large amount of debris observed along the reach. The final Manning’s n values were similar to those used for the Middle Econfina Creek HEC-RAS model (Northwest Florida Water Management District, 2025). Figure 30 compares the simulated and observed stages in Spring Creek @ Spring Creek Park (Station ID 012744). Figure 31 compares simulated and observed flows at the same location. Figure 30 and Figure 31 demonstrate that the model is performing well up to June 18, 2020. When the station came back online approximately 2 months later, the modeled water surface elevations were approximately 0.5 ft higher than the observed elevations. A comparison of the measured flow at the Spring Creek Park station on August 19, 2020 with the concurrent discharge from the rating at the Merritts Mill Pond @ US 90 gage indicated a difference of approximately 33 cfs with the rating at the Merritts Mill Pond gage, indicating a flow of approximately 152 as compared to a measured flow at Spring Creek Park just downstream of the station of 119 cfs. These flows should be similar given their proximity and that no flow additions or reductions occur between these two locations. This would indicate the modeled residuals seen during the latter calibration period are largely due to measurement uncertainties and not model parameterization.

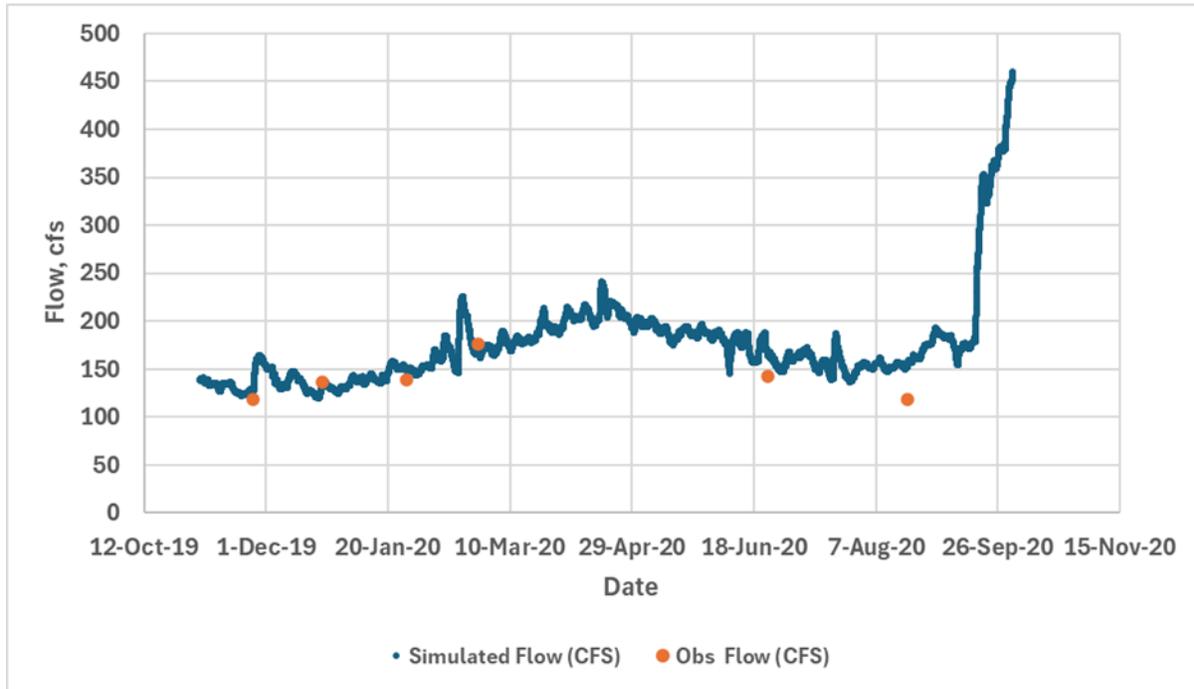
**Figure 31: Flow Time Series for the Calibration Simulation Comparing Observed and Simulated Flows at the Spring Creek @ Spring Creek Park Gage**

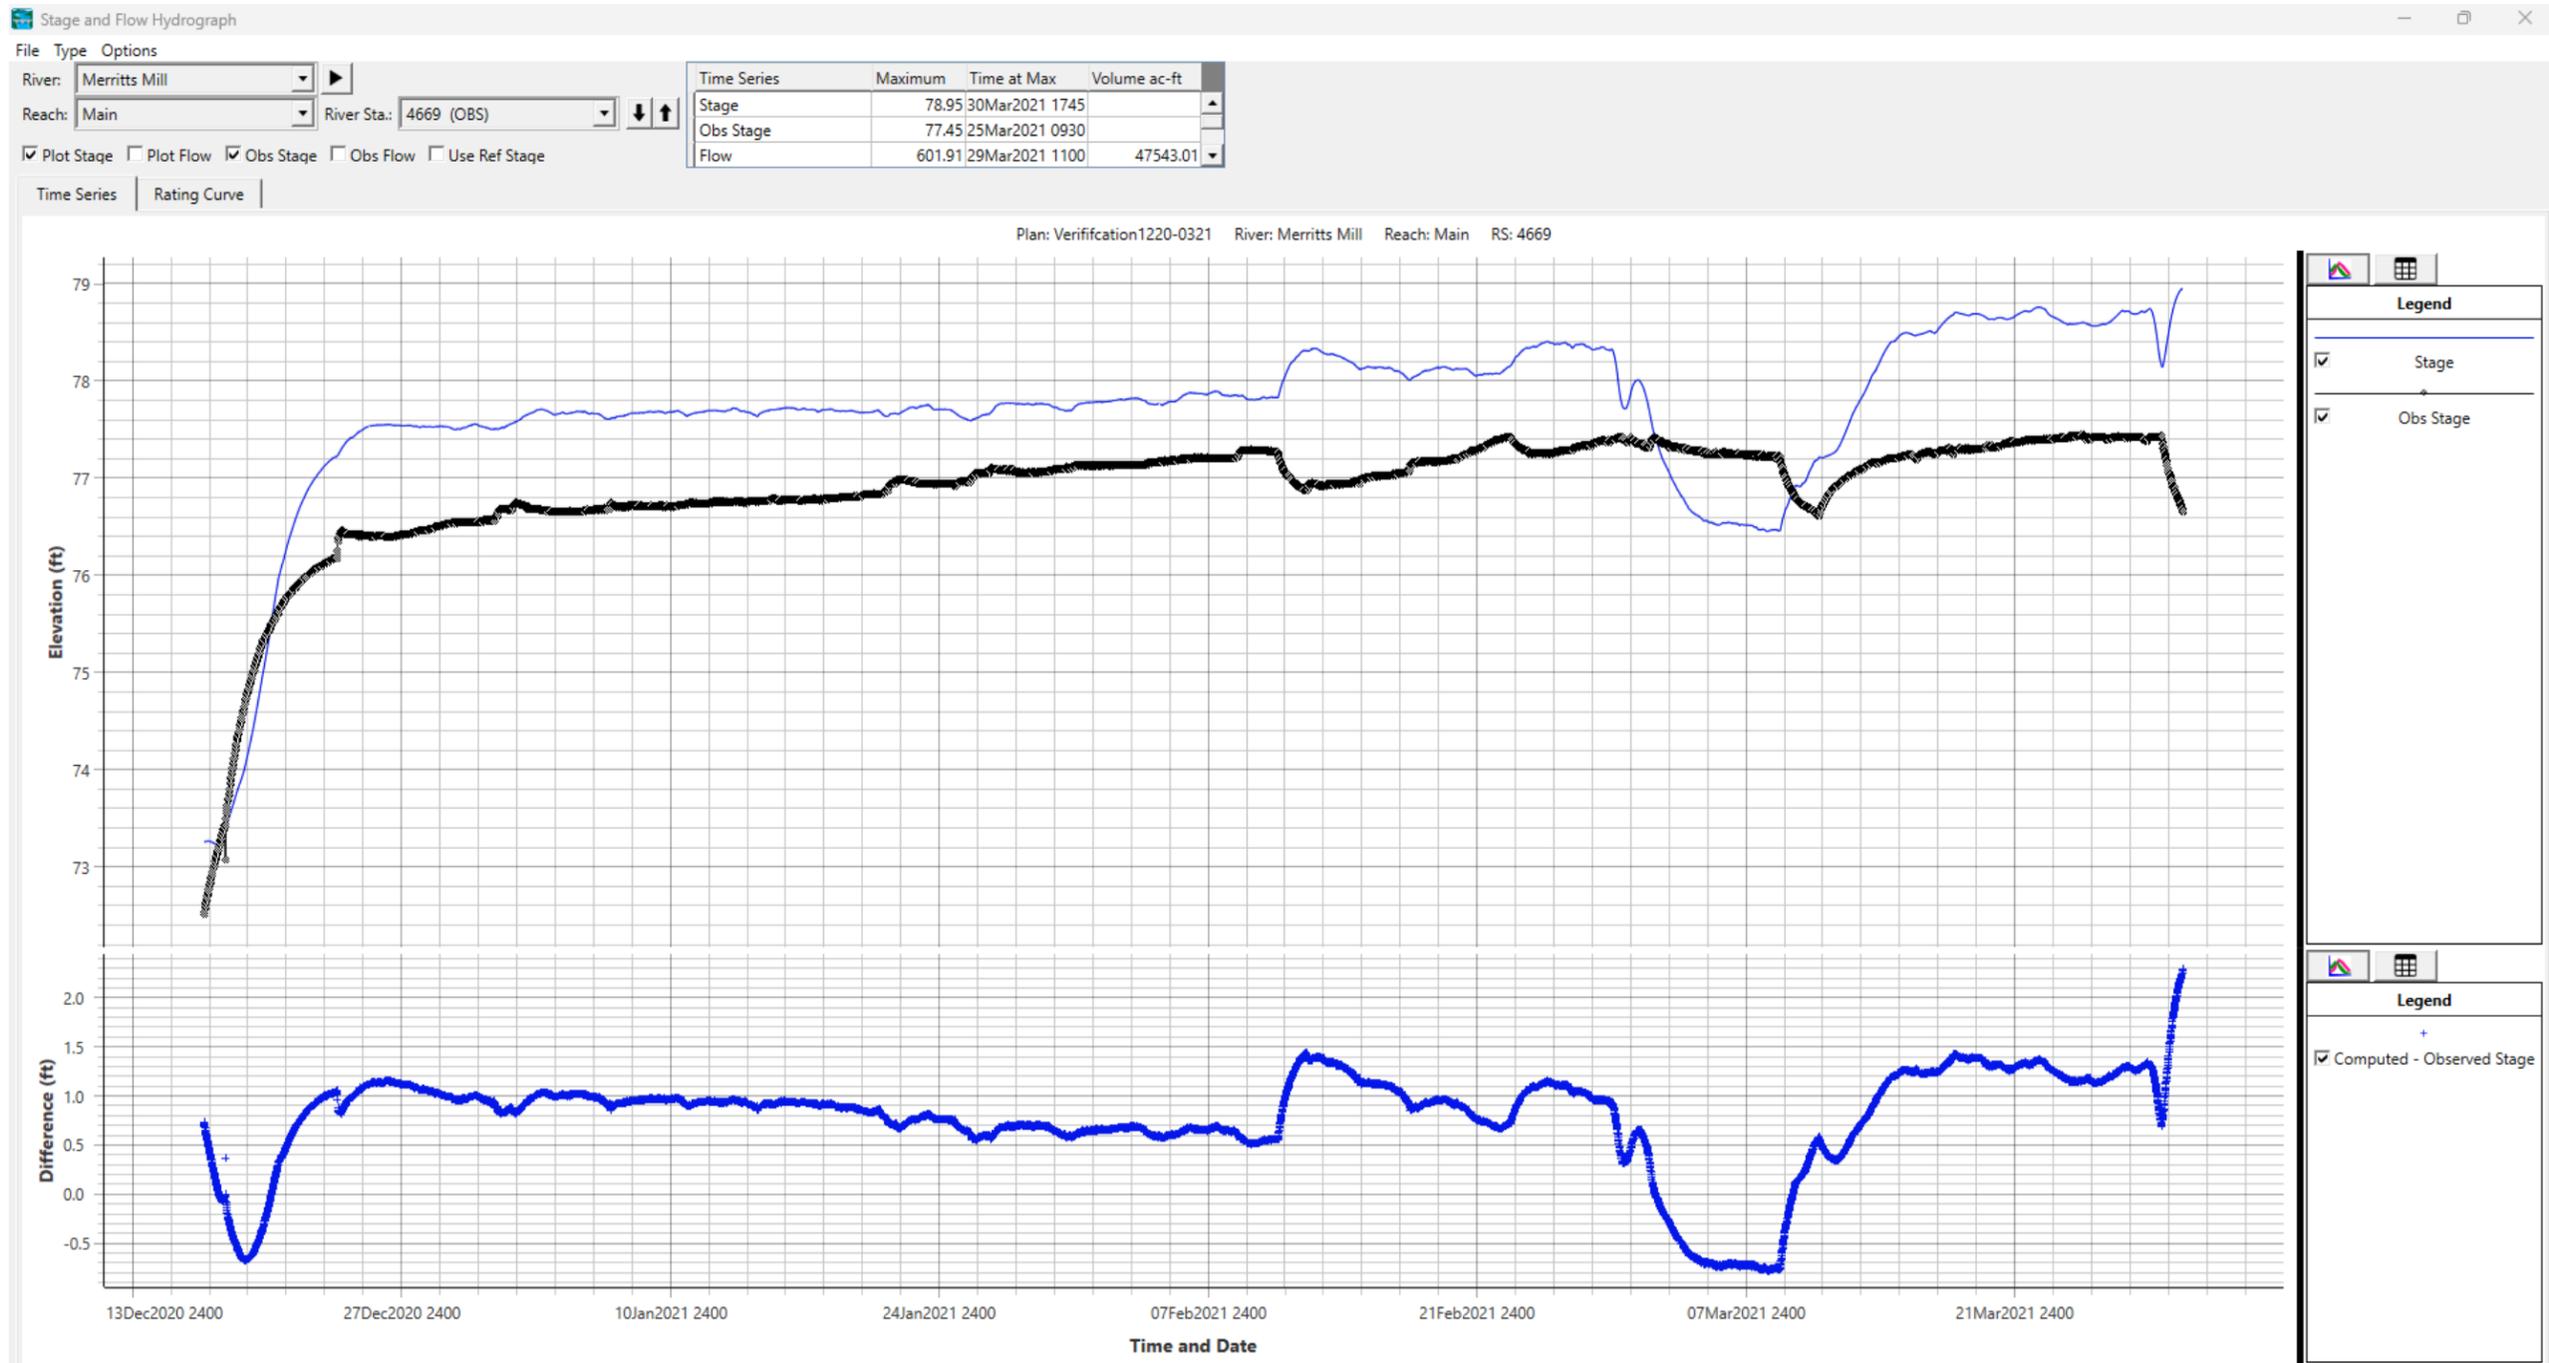
Figure 32: Jackson Blue Springs System HEC-RAS Model Verification (12/20-03/21) Showing Simulated vs. Observed Stages at the US 90 Bridge on Merritts Mill Pond

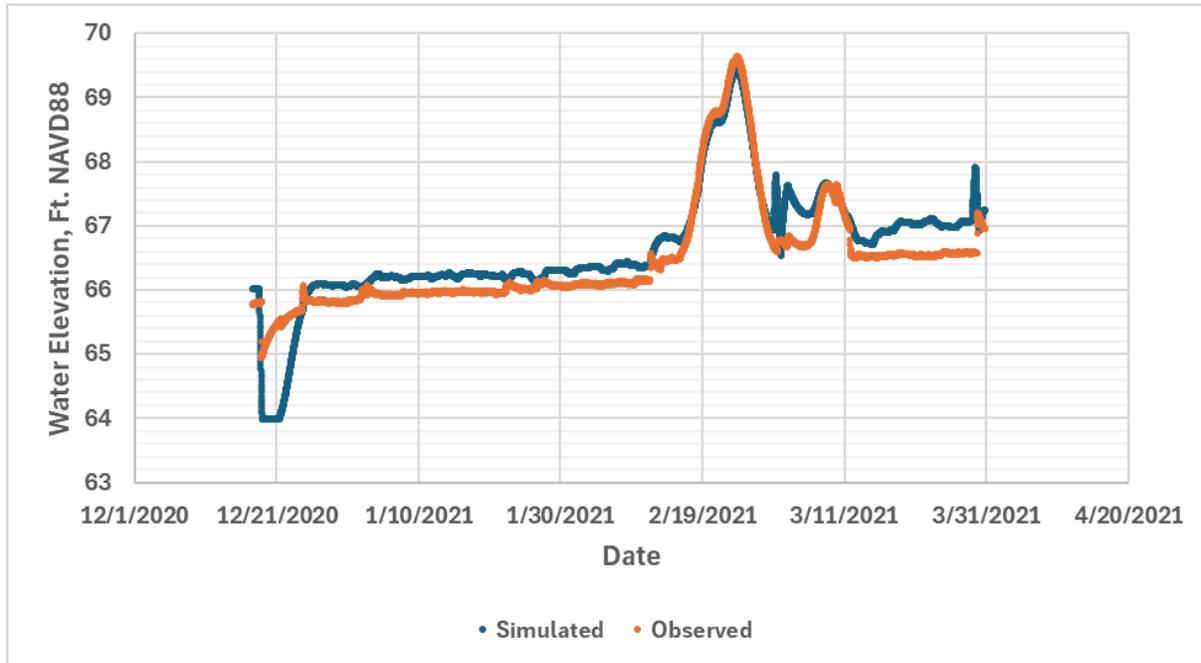
**Figure 33: Jackson Blue Springs System HEC-RAS Model Verification (12/20-03/21) Showing Simulated vs. Observed Stages in Spring Creek @ Spring Creek Park**

generally overpredicted stage based on the measured stage 0.2 to 0.4 ft. Figure 34 compares simulated and observed flows at the same location and show good agreement.

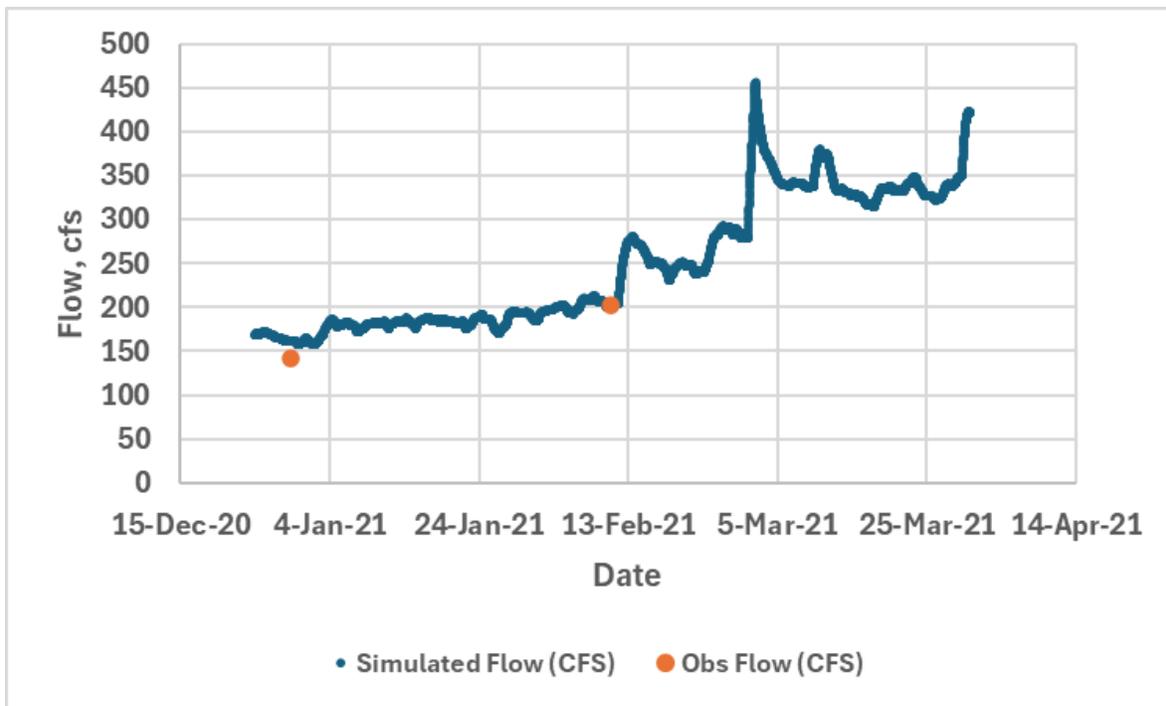
**Figure 34: Jackson Blue Springs System HEC-RAS Model Verification (12/20-03/21) Showing Simulated vs. Observed Flows in Spring Creek @ Spring Creek Park**

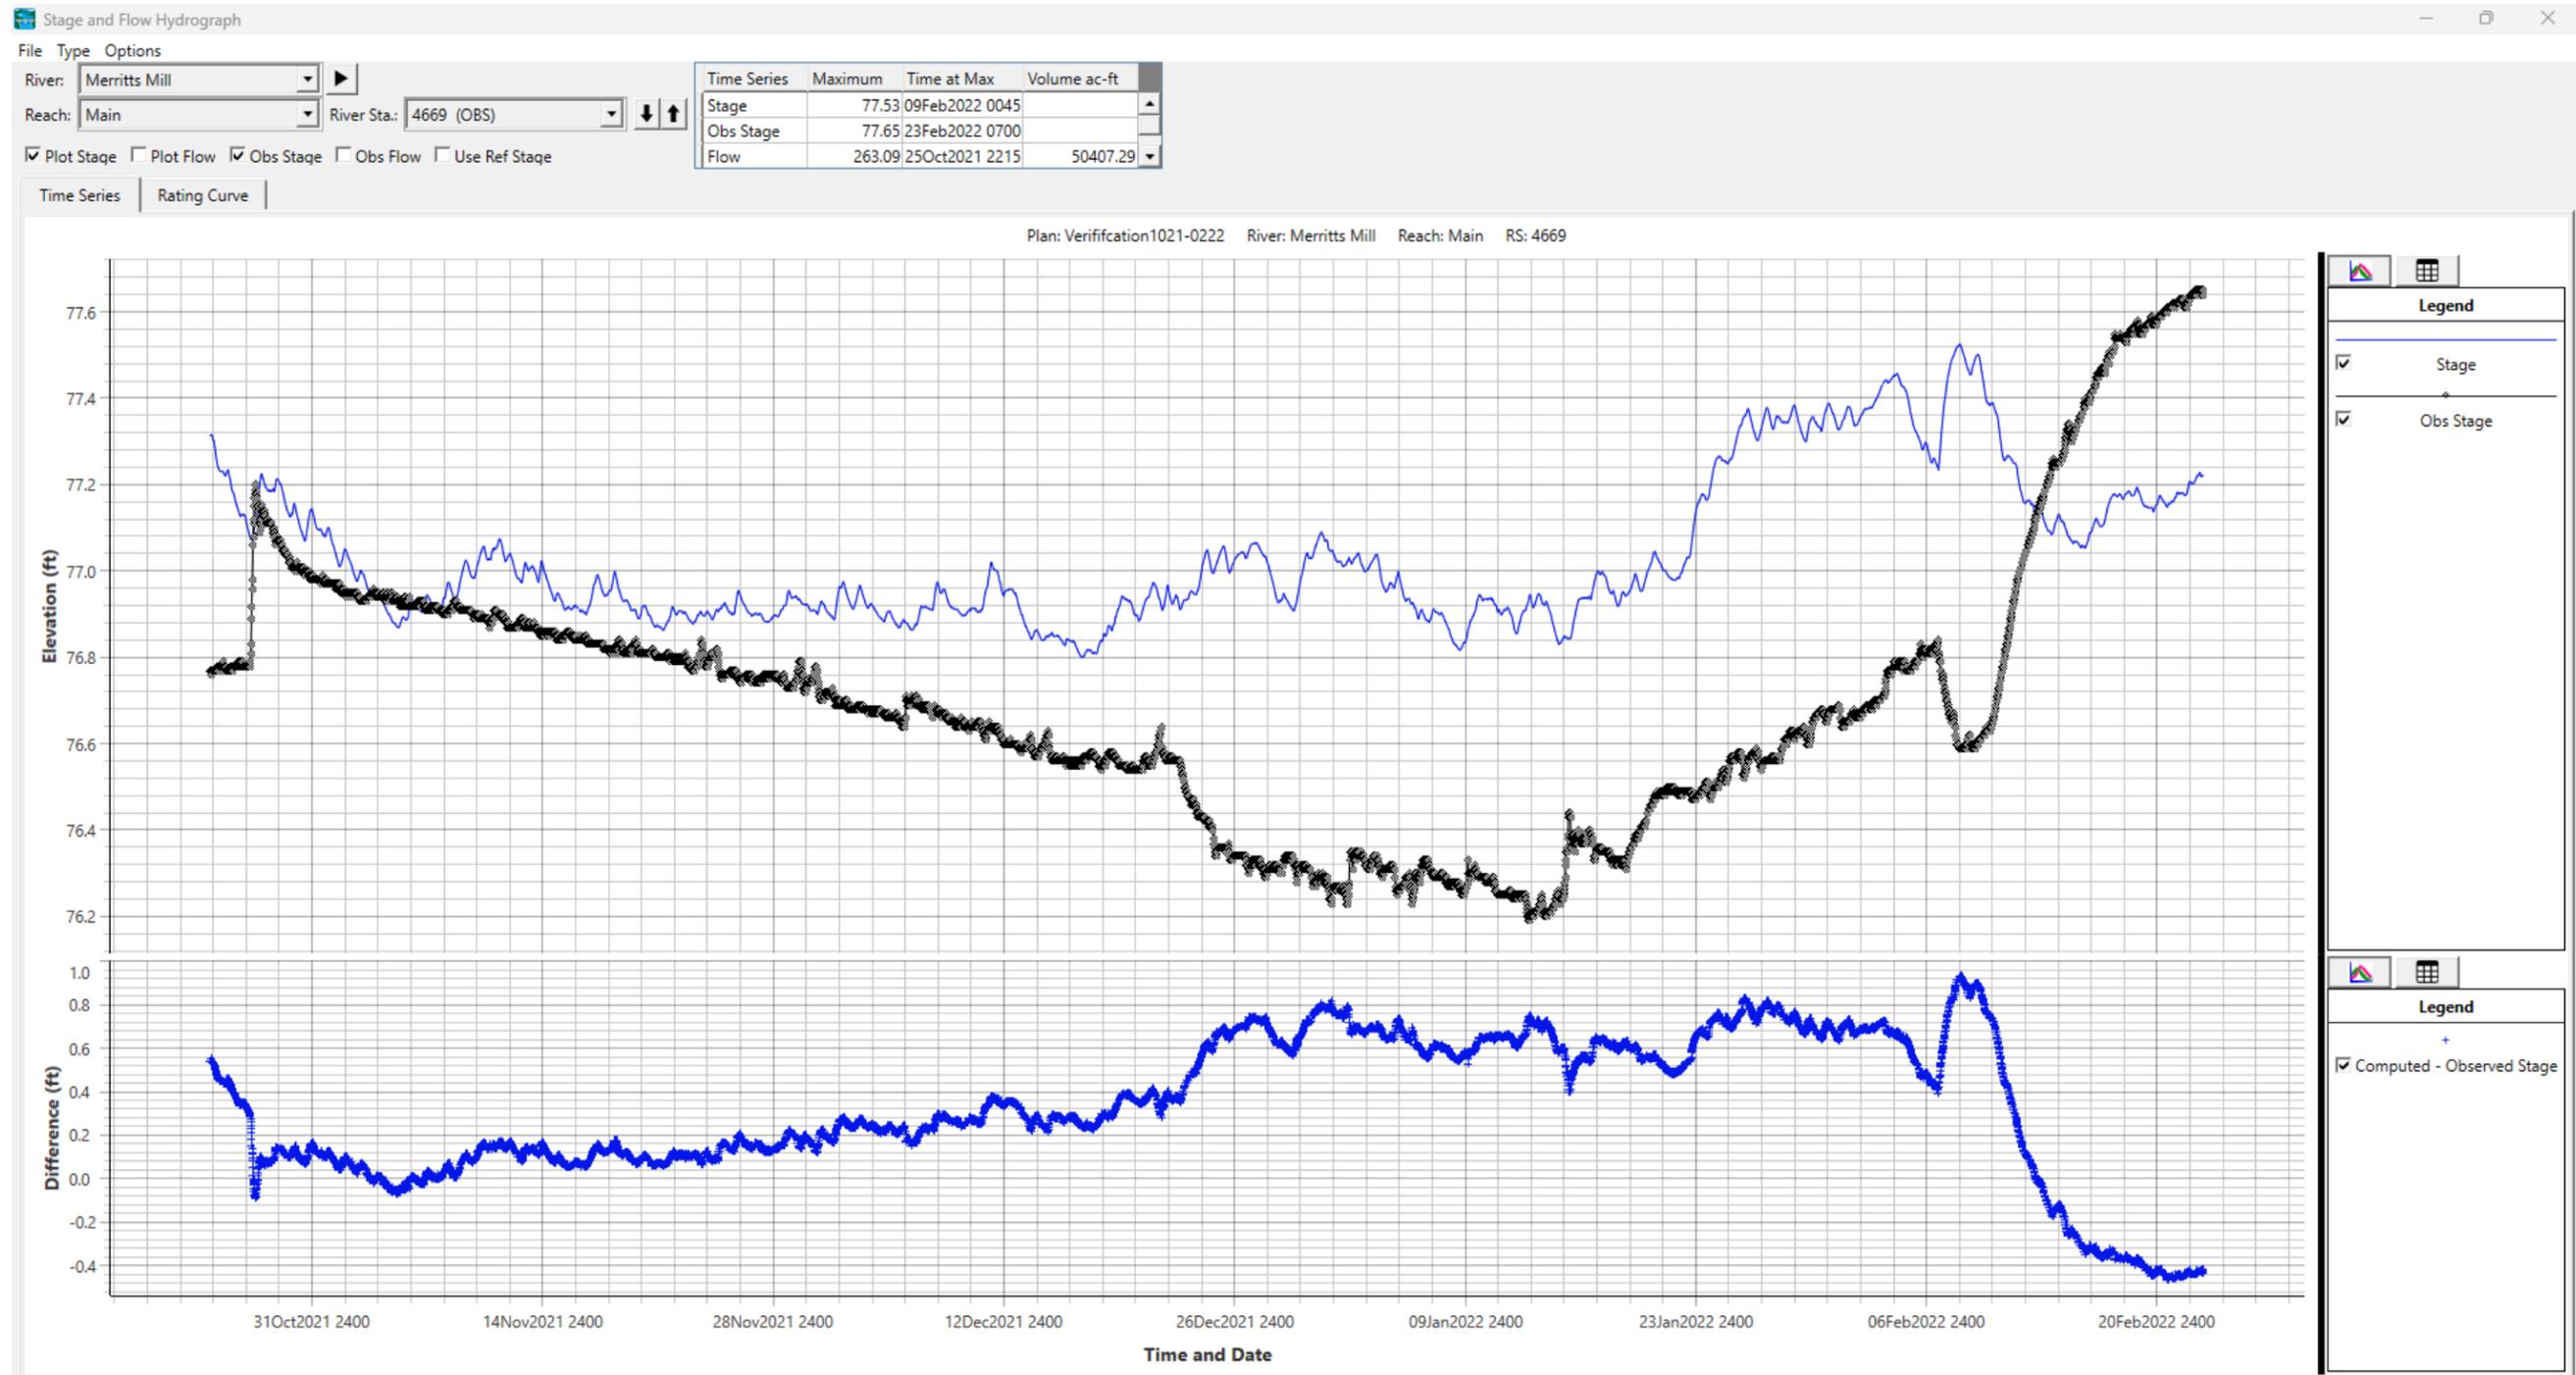
Figure 35: Jackson Blue Springs System HEC-RAS Model Verification (10/21-02/22) Showing Simulated vs. Observed Stages at the US 90 Bridge on Merritts Mill Pond.

Figure 35 presents the results of the second verification simulation, which spanned the time period from October 2021 to February 2022 (HEC-RAS model plan “Verification\_1021-0222”), showing simulated versus observed stages at the US 90 Bridge on Merritts Mill Pond. Gate operations records data were missing in November and December 2021. Based on the pattern of the stage hydrograph (sudden decrease in observed water levels but for which no record was available), adjustments to the gate opening were made to the November 2021 gate operations record in the DSS in which the main gate opening was increased slightly to better match the observed record.
