# **HYDROLOGIC ENGINEERING CENTERS RIVER ANALYSIS SYSTEM (HEC-RAS) MODEL**

## **JACKSON BLUE SPRING SYSTEM**

### **FINAL REPORT**

**Northwest Florida Water Management District**

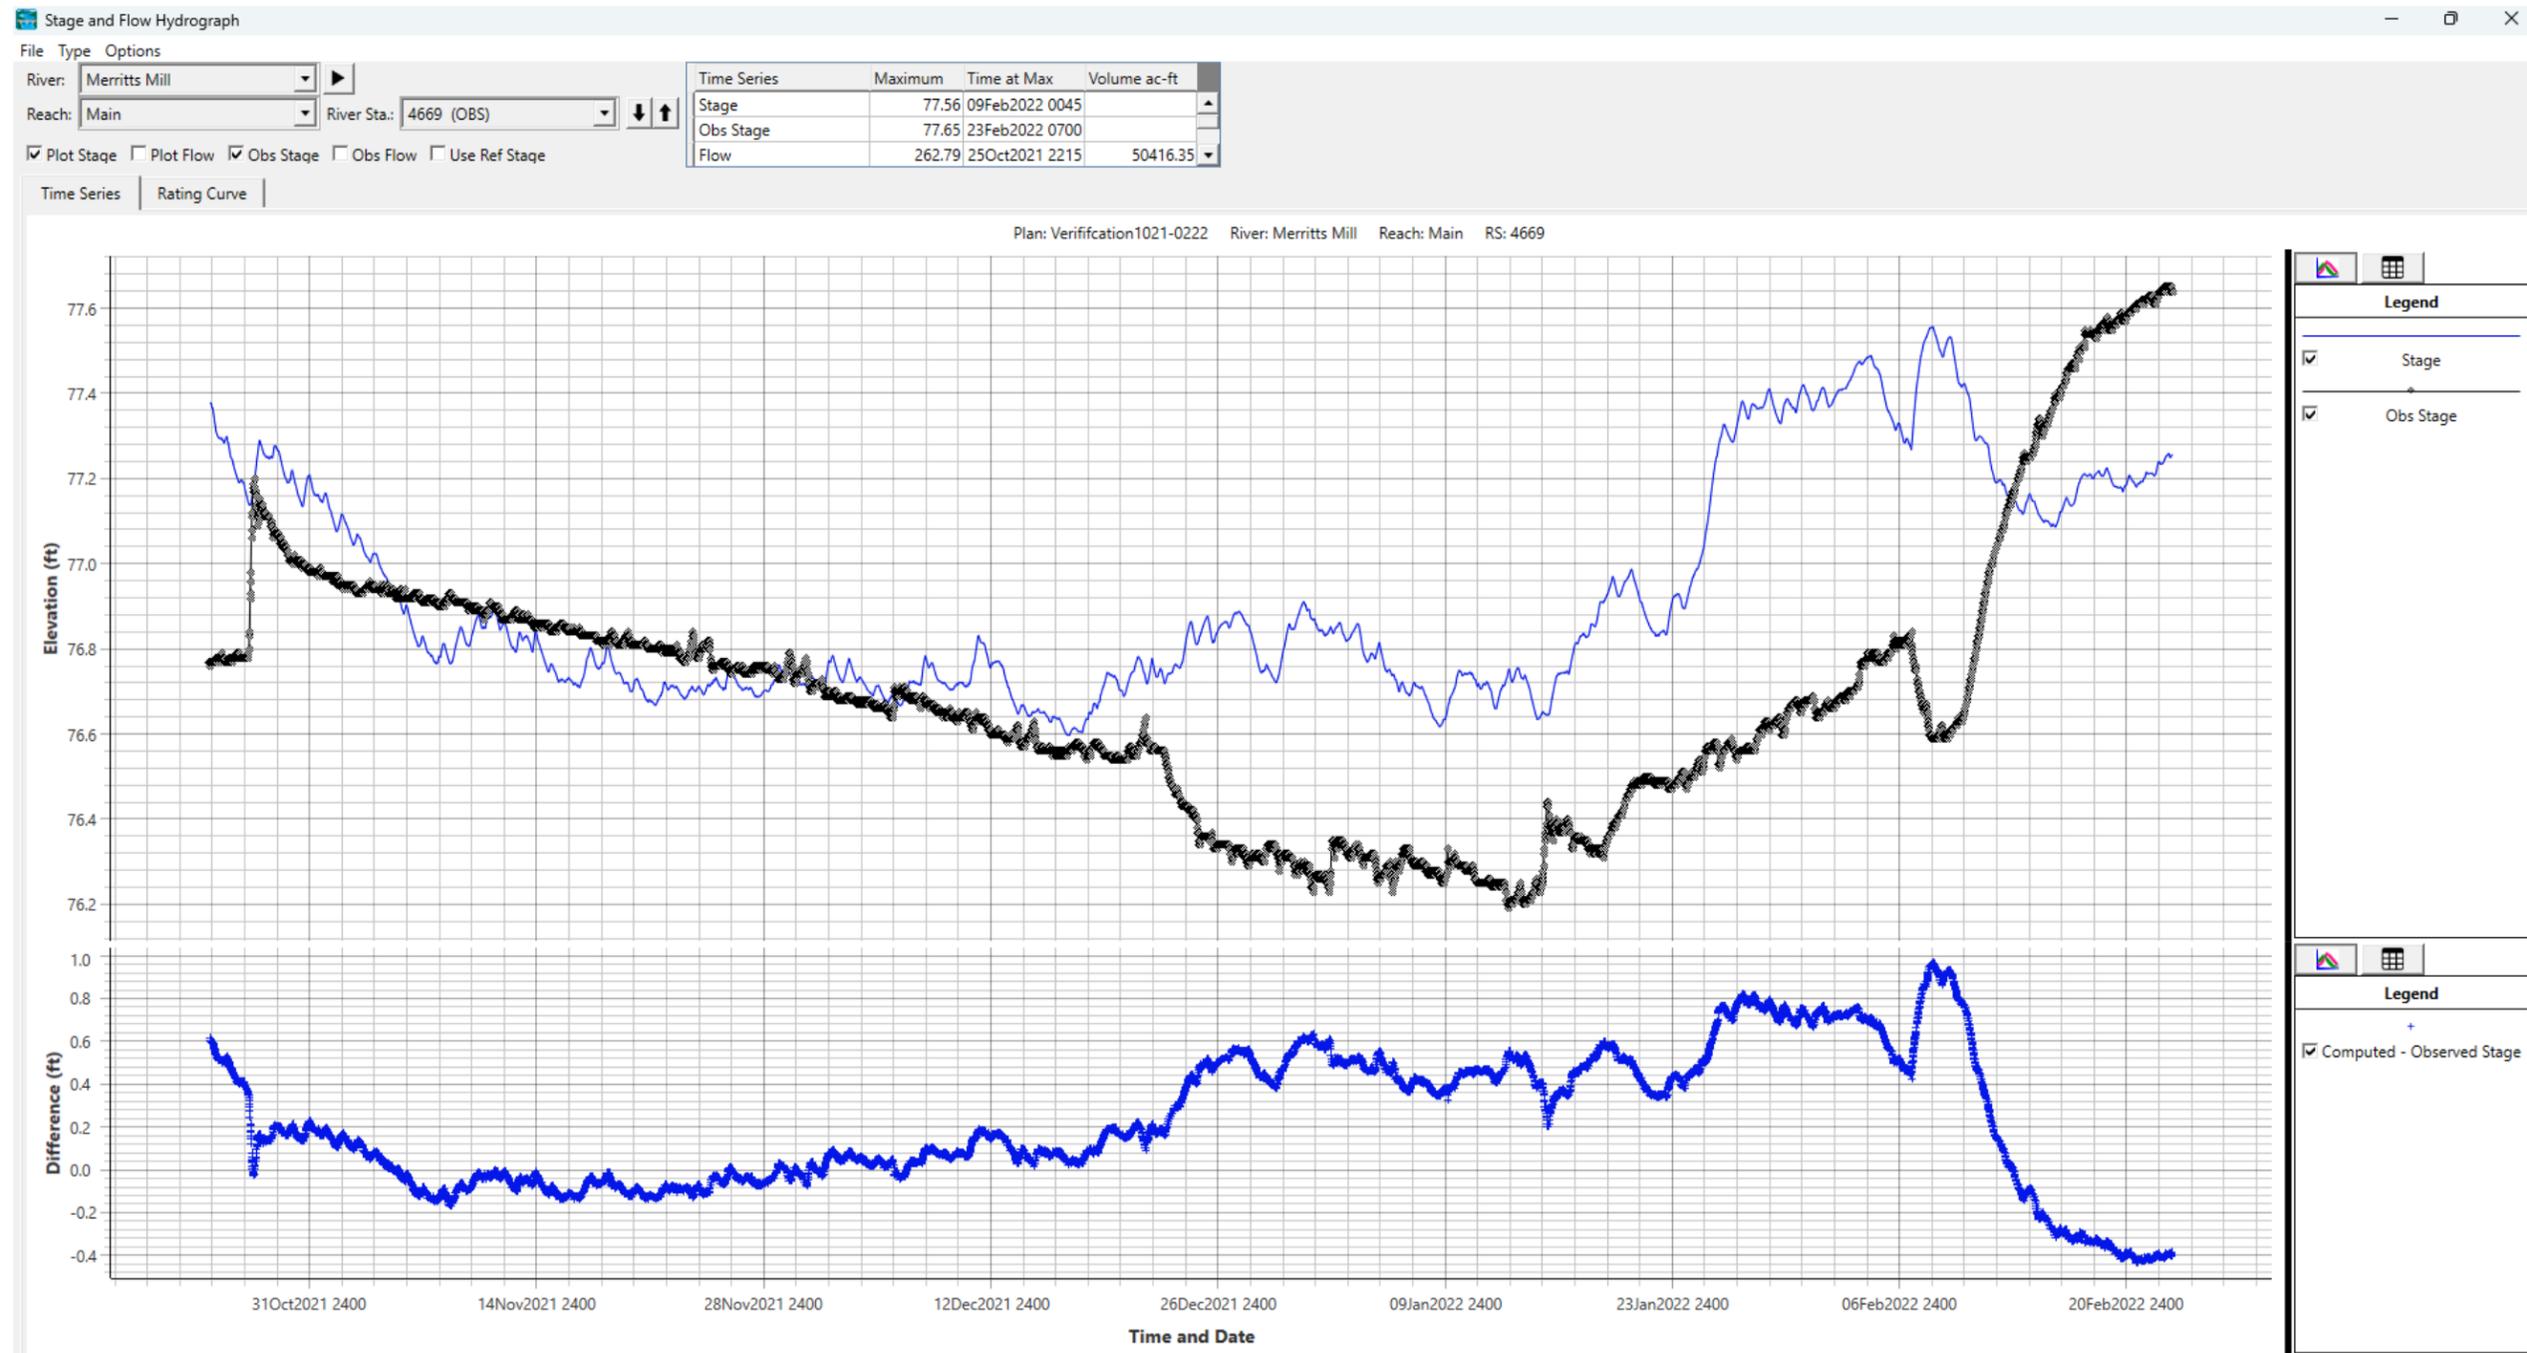
Figure 36: Jackson Blue Springs System HEC-RAS Model Verification (10/21-02/22) Showing Simulated vs. Observed Stages at the US 90 Bridge on Merritts Mill Pond Following Adjustments to the Gate Opening.

Figure 35 presents the results of the second verification simulation, which spanned the time period from October 2021 to February 2022 (HEC-RAS model plan “Verification\_1021-0222”), showing simulated versus observed stages at the US 90 Bridge on Merritts Mill Pond. Gate operations records data were missing in November and December 2021. Based on the pattern of the stage hydrograph (sudden decrease in observed water levels but for which no record was available), adjustments to the gate opening were made to the November 2021 gate operations record in the DSS in which the main gate opening was increased slightly to better match the observed record.

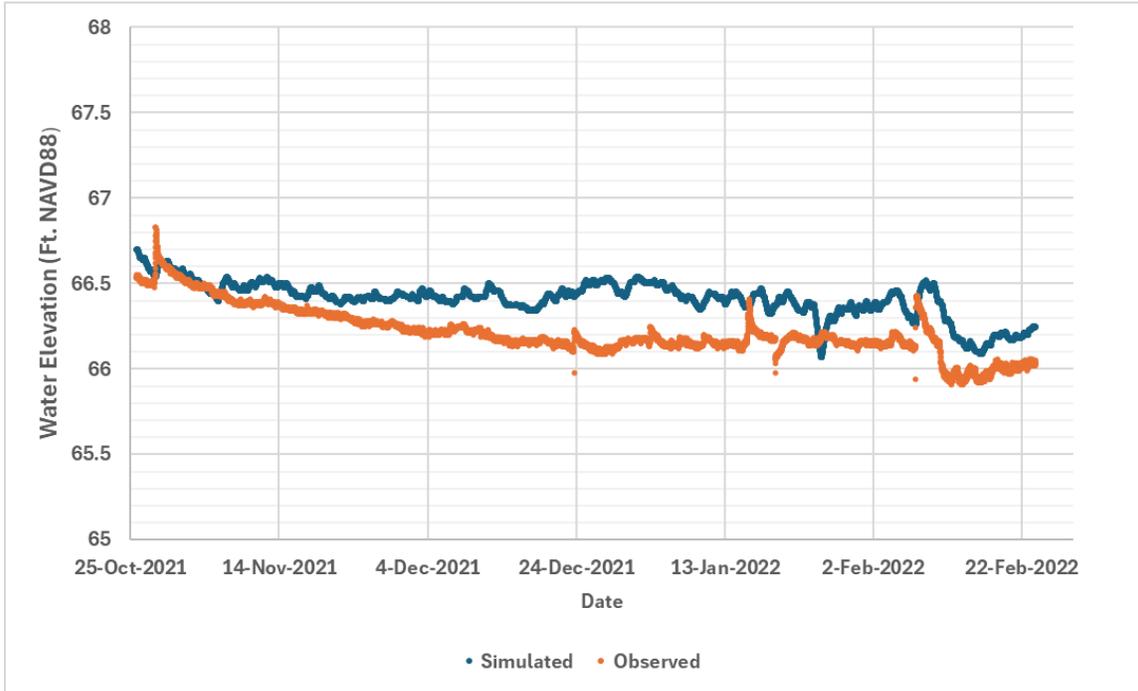
**Figure 37: Jackson Blue Springs System HEC-RAS Model Verification (10/21-02/22) Showing Simulated vs. Observed Stages at Spring Creek @ Spring Park**

Figure 37 compares the simulated and observed stages in Spring Creek @ Spring Creek Park (Station ID 12744) for the verification simulation for October 2021 to February 2022 and shows that the model is overpredicting stage by 0.2 to 0.4 ft. Figure 38 compares simulated and observed flows at the same location.

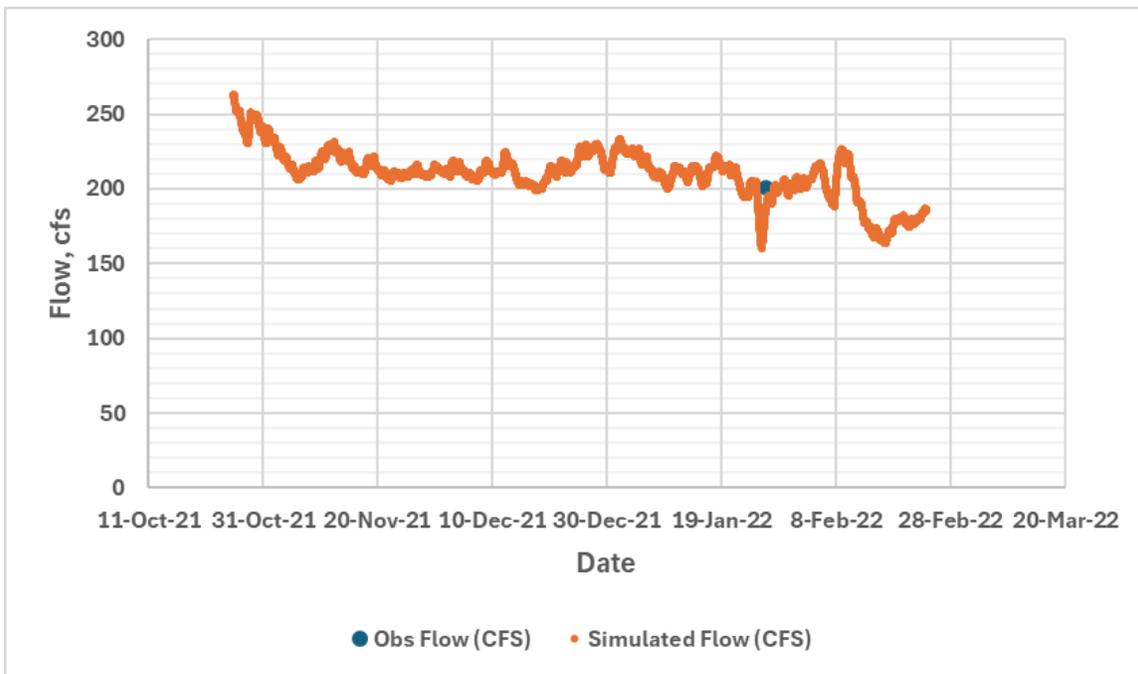
**Figure 38: Jackson Blue Springs System HEC-RAS Model Verification (10/21-02/22) Showing Simulated vs. Observed Flows at Spring Creek @ Spring Park**
