Womack Creek/Tates Hell Wetlands Restoration Annual Monitoring Report (2008)
Nationwide Permits – 200200233 (NW-JWS), 200205045 (NW-JWS) &
200205047 (NW-JWS) issued 2/6/2003, and 200205672 (NW-JWS) issued 5/2/2003

Mitigation: Womack Creek/Tates Hell

Monitoring Date: 11/11/08

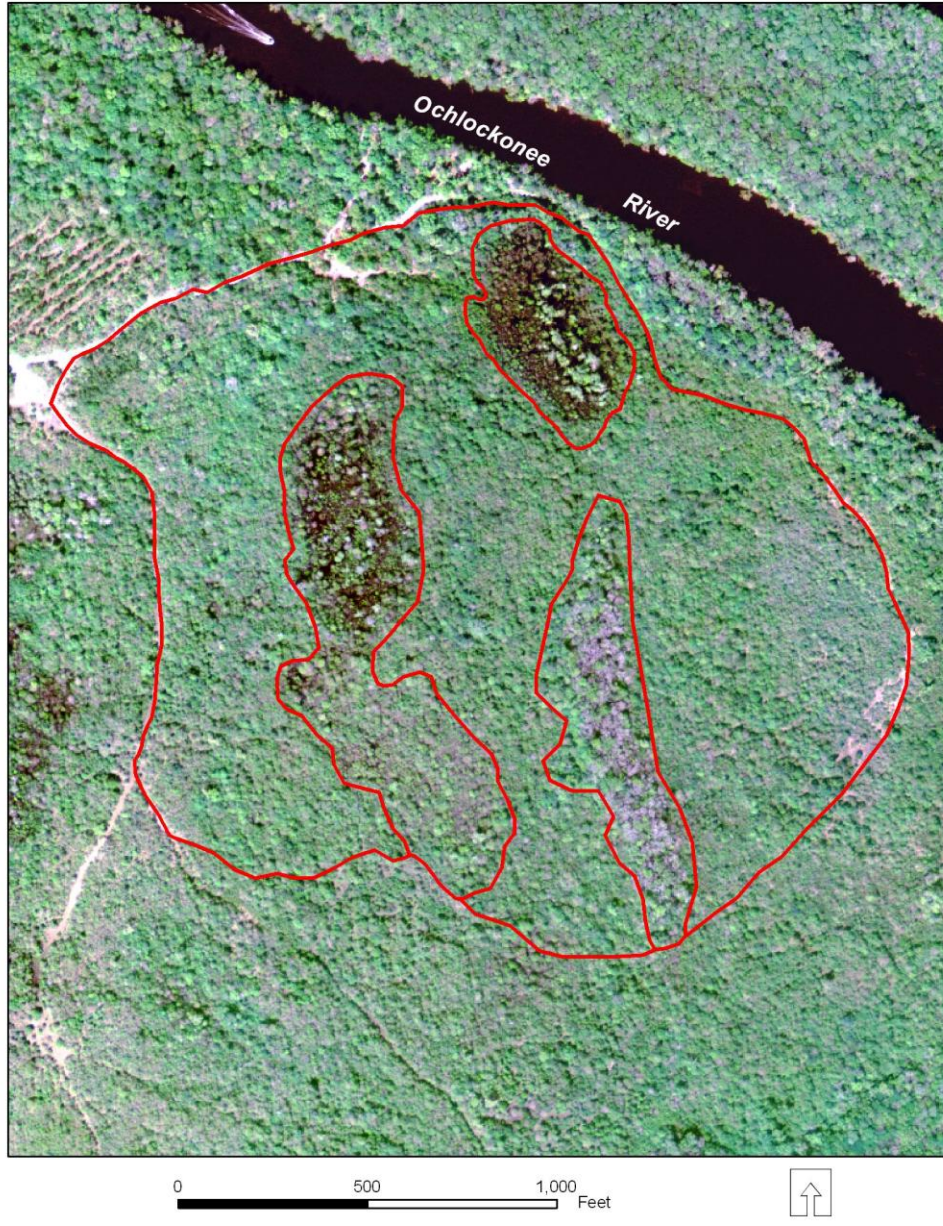
Womack Creek Mitigation Area

Figure 3. Aerial photograph of the site indicating locations of wetlands (darker, elongated patches in central and northern portions of site).

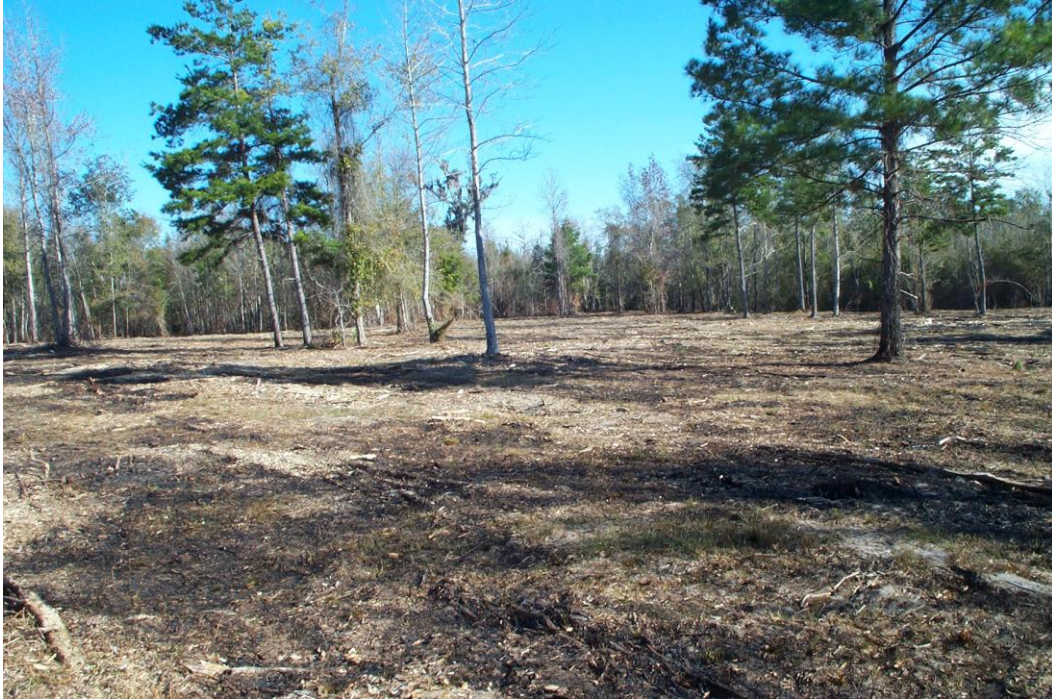
Figure 4. Typical appearance of site after gyrotrack clearing of vegetation and second burn (December 2007). Photo was taken on western side of tract prior to planting.

The project was divided into two phases with all site preparation activities (mechanical reduction and burning) included in phase one and vegetation planting in phase two. Mechanical reduction was initiated in May 2005 with a walk down of the woody shrubs on about 50 acres of the site; care was taken to avoid the low lying wetlands located through the central portion of the site. All vegetation less than about 6-8 inches in diameter was pushed over with a D-6 tractor; larger hardwoods and scattered pines were left standing. Walkdown was followed by roller chopping most of the site after 2-3 months. Due to the vagaries of the weather no burning was carried out in the area until fall 2007 when an unsuccessful partial burn was attempted. Additional mechanical reduction was completed with a gyrotrack in December 2007 in preparation for planting. A second burn was carried out at the end of December 2007 just prior to planting (Figure 4). Only partial success was noted with both burns because of the limited amount of fuel on site. A dormant season burn is scheduled for later this year (winter 2009). A total of 96,075 wiregrass tubelings was planted on 3-ft centers on 18 January 2008 over approximately 20 acres of the site (Figure 5).

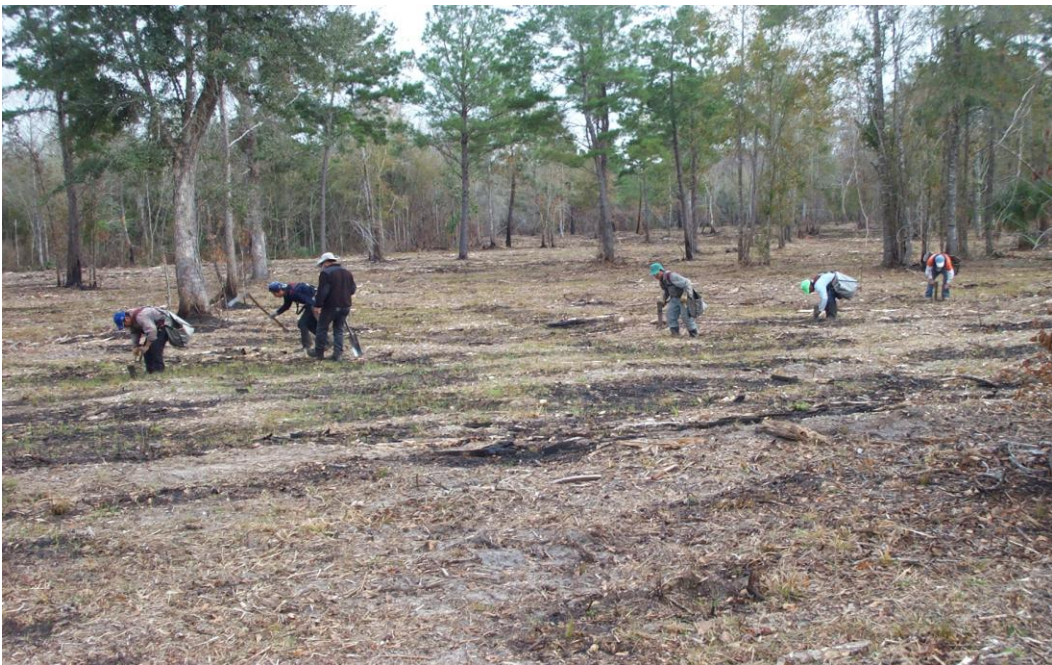
Figure 5. Wiregrass planting on western side of tract (January 2008). A total of 96,075 wiregrass tubelings was planted over approximately 20 acres of the site.

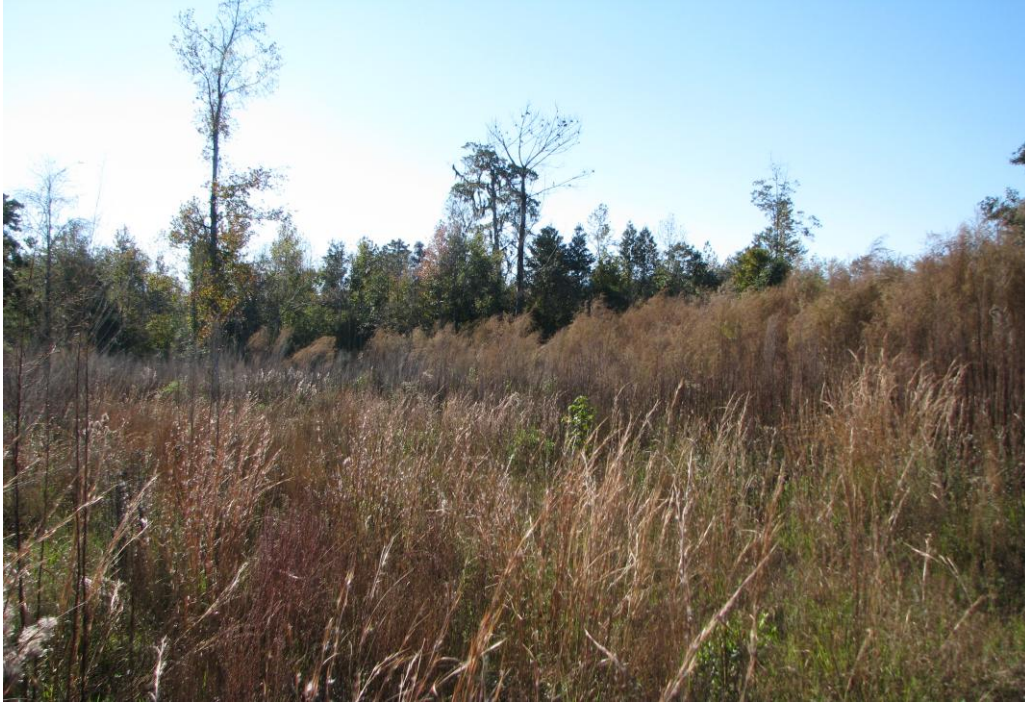
Annual monitoring of the restoration site was carried out on 11 November 2008 (Figures 6 and 7). A series of transects was walked over the site noting vegetation present. Fifty-five groundcover and shrub species were observed (Table 1). Vegetation coverage of jurisdictional wetland species ranged from 60 to 75% depending on location at the site. Survival of wiregrass was estimated to be 40-45% with less than 5% exotic species. A small patch (approximately 250 square feet) of cogongrass (*Imperata cylindrica*) was noted on the eastern side of the tract. An

Figure 6. Typical vegetation cover on eastern side of tract observed during annual monitoring (11/11/08). Wiregrass cover is 40-45%.

- Survival of the planted wiregrass shall be 85%: annual monitoring indicated that wiregrass survival was 40-45%; a second planting to insure proper survival will be done in Fall 2009.

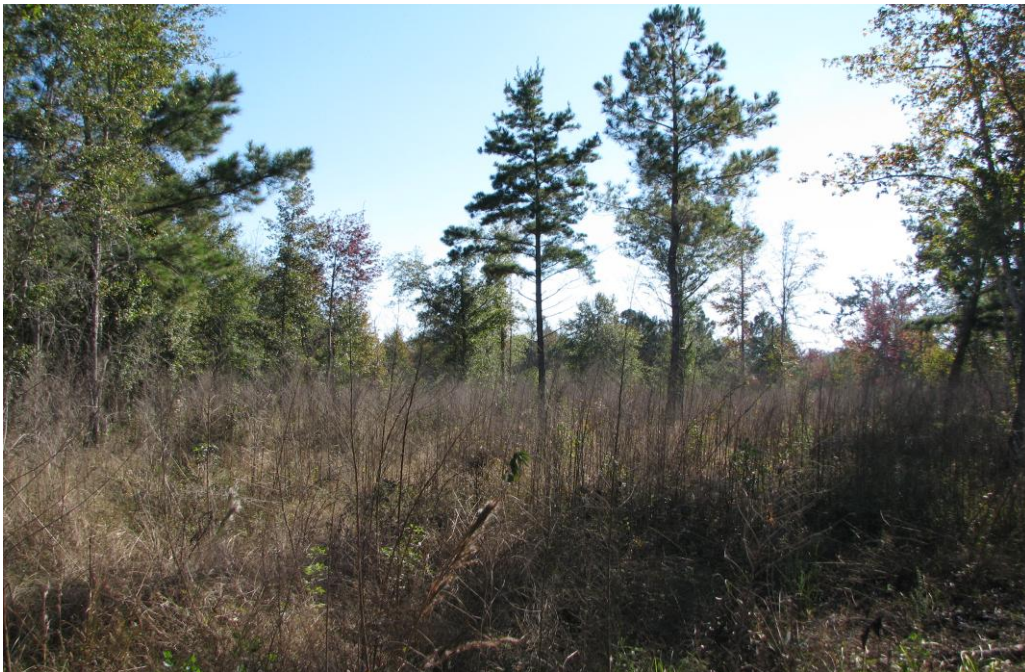
Figure 7. Typical vegetation cover on western side of tract observed during annual monitoring (11/11/08). Wiregrass cover is 40-45%.
