## Meginnis Arm Shoreline Restoration Fifth Annual Monitoring Report Fall (2011)

SAJ – 20051406 IP – SEG Issued: 4/7/06; Impact: I-10 (Ochlockonee-CR 361) in Leon Co, 1.90 acres; FM 2225902; NW24

Monitoring Date: January 19, 2011

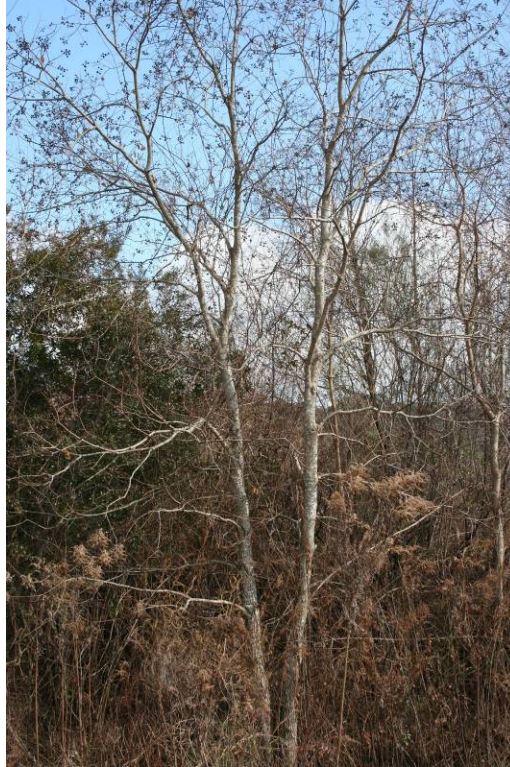
Figure 3. Reproductive popcorn tree (*Sapium sebiferum*) on edge of restoration area.

The herbicide treatment for the eradication of exotic species was initiated in 2006-2007. Treatments targeted popcorn tree, purple sesban, and wild taro. Trunks of the popcorn trees were hand cut and the stems painted with a systemic herbicide. Hand application with backpack sprayers was used to treat the purple sesban and wild taro. During 2008, NFWFMD contracted with Entrix to conduct popcorn tree, wild taro, and purple sesban eradication as a follow up to the initial treatments. The limits of the mitigation area were identified using sub-meter GPS and permanently marked. A total of five monthly treatments were conducted in May-September of 2008 and the site was treated again in 2009. All herbicides were labeled for aquatic systems and administered by licensed pesticide applicators. In January of 2011 the site was inspected for invasive exotic and nuisance species survival. A single reproductive popcorn tree was observed. At the time of the survey wild taro was dormant and no stalks of last season's purple sesban were observed. One mature, reproductive *Sapium sebiferum* was present along the perimeter of the restoration area (Figure 3). Nuisance species such as *Sesbania herbacea*, *Andropogon virginicus*, *Verbena brasiliensis*, and *Eupatorium capillifolium* were common throughout. An additional treatment of invasive exotic and nuisance species is scheduled for March/April of 2011.

- Additional exotic / invasive species eradication and planting of shoreline vegetation if success criteria are not met. **Shoreline vegetation survival appears to meet the criteria as of January 2011, invasive species eradication also appears to meet the criteria and further treatment of exotic invasive species is scheduled for March/April of 2011.**

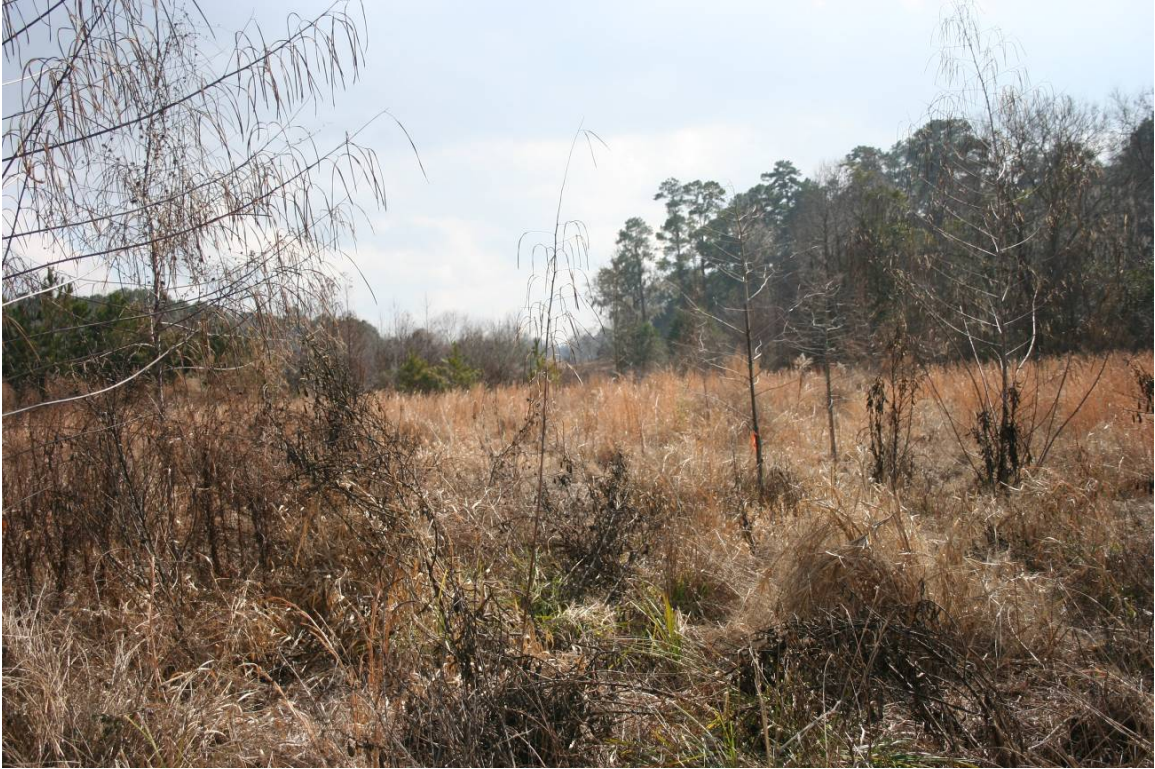
On April 4-6, 2009 NFWFMD planted the restoration area with button bush (*Cephalanthus occidentalis*), pickerel weed (*Pontederia cordata*), arrowhead (*Saggitaria lancifolia*), and soft rush (*Juncus effusus*). On November 7-9, 2009 ATS Partners, Inc. installed climbing aster (*Symphyotrichum carolinianum*), marsh mallow (*Hibiscus moscheutos*), and cypress (*Taxodium ascendens*) throughout the Meginnis Arm restoration area (see Tables 1 and 2). Site visits during 2009 confirmed survival of the majority of the plant material. The Meginnis Arm marsh supports a mixture of species that result from disturbance as well as desirable wetland species. The planted material that was seen during the 2011 monitoring event includes soft rush, pond cypress, and marsh mallow (Figures 4 and 5). Although these species appeared to exhibit good survival, only the marsh

Figure 4. Meginnis Arm restoration site, *Taxodium ascendens* in photo with orange flag, January 2011, in center of site facing southeast.

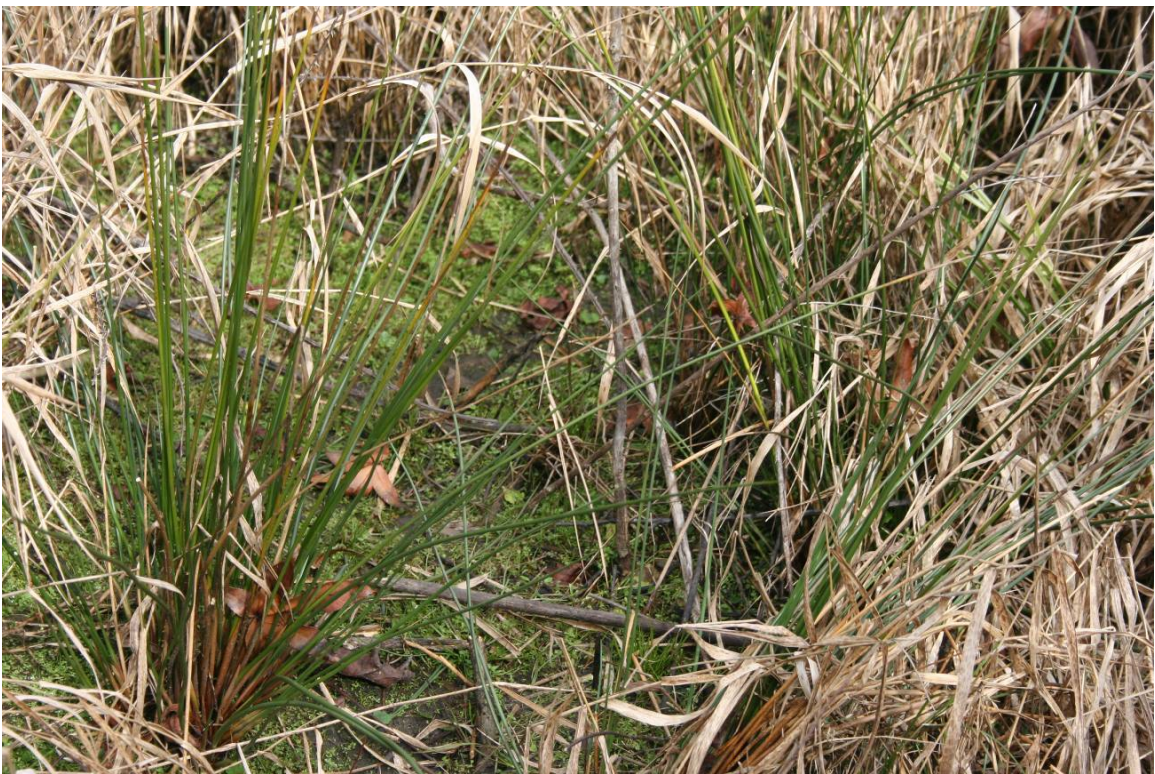
mallow had been reproductive during the previous growing season. The planted soft rush was more robust as it approached the edge of the lake while closer to the upland it was smaller and less vigorous. Loblolly pine (*Pinus taeda*) has invaded the marsh as a result of a lowered water table, but as the lake level has rebounded, this species is exhibiting high mortality close to the shoreline. This increase in the lake level has also led to mortality in blackberry (*Rubus argutus*) and will have a positive effect on the overall species composition over time. The site is currently dominated by wetland herb, shrub, and tree species (see Table 3; Figures 6 and 7).

Figure 5. Survival of soft rush (*Juncus effusus*) in marsh restoration area.

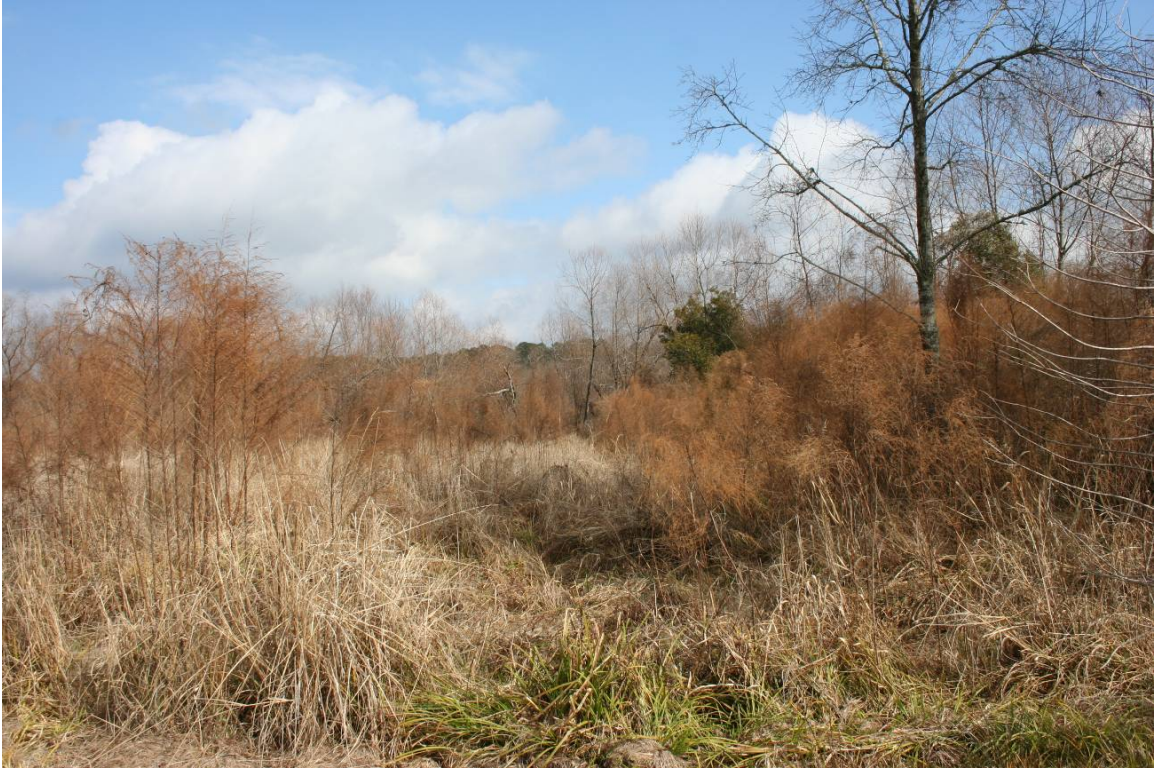
Figure 6. Meginnis Arm restoration site, January 2011 in northern portion facing east.

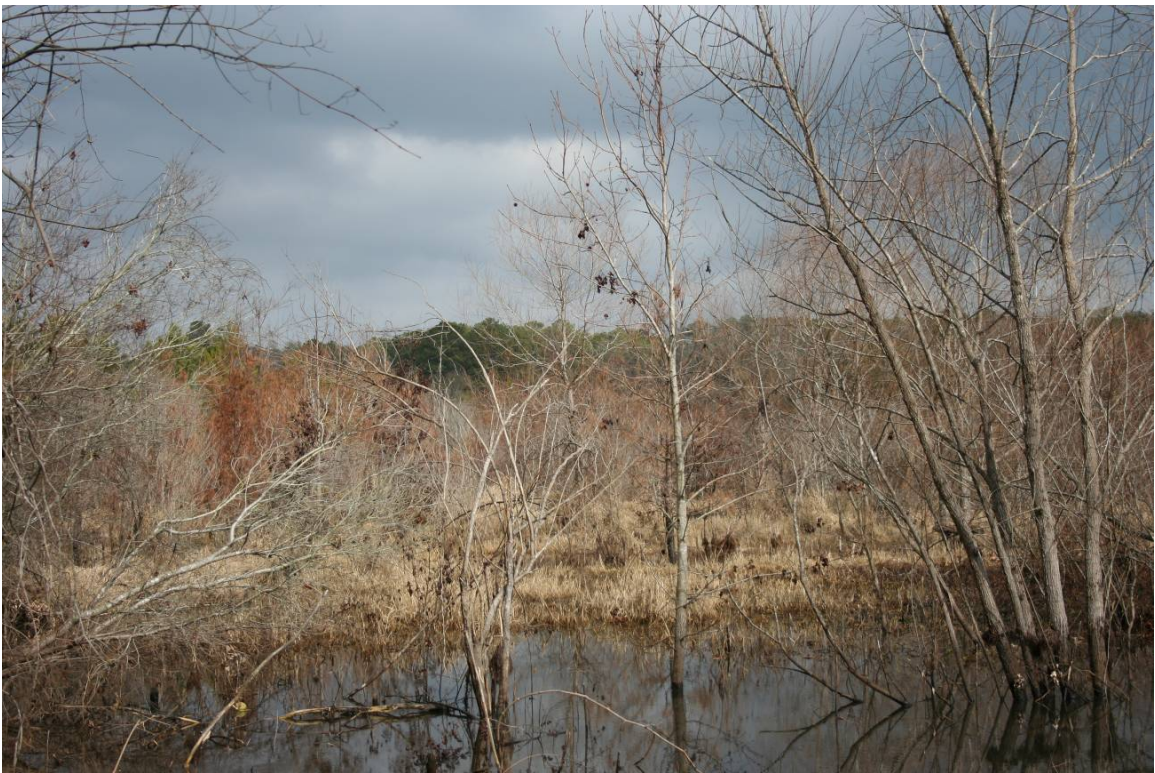
Figure 7. Meginnis Arm restoration site, January 2011, in southern portion of property facing northeast.
