# 2012 Monitoring Report

## YELLOW RIVER RANCH SITE

Santa Rosa County, Florida

December 2012

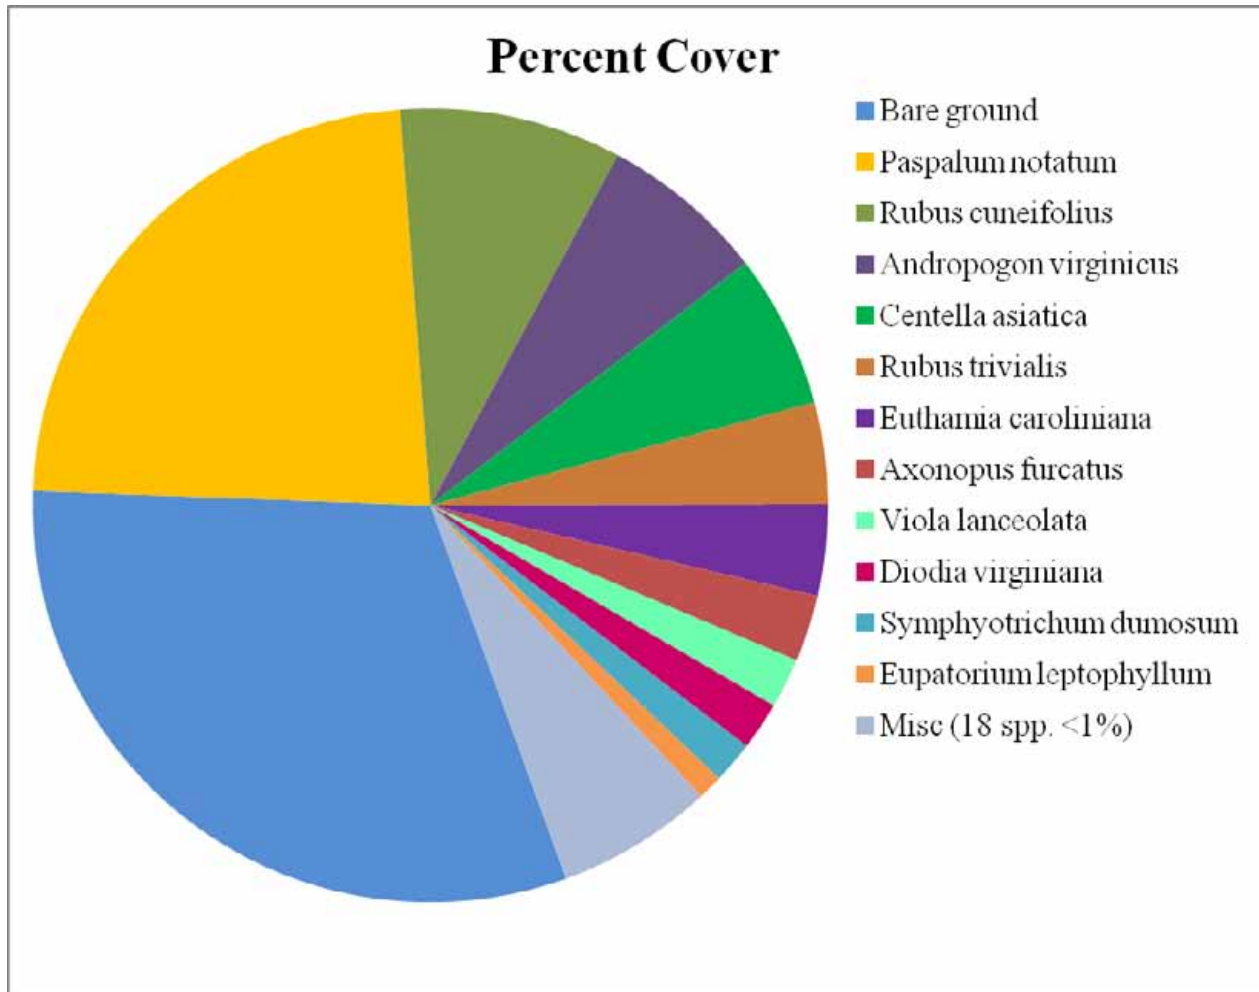
**Transect YRRT1-625 Hydric Pine Flatwoods**

Four standard calculations of the relative abundance of each species are given for each quantitative transect: Importance Value, Relative Cover, Relative Density, and Relative Frequency (See Tables 5a and 6a). Quantitative summary data is reported for each transect and broken down by plant community (See Tables 5b and 6b). Summary data for the Belt transects is provided in Tables 7, 8, 9, and 10.
