COTTON CREEK MITIGATION SITE

2018 Annual Monitoring Report

USACE Permit No.: SAJ-2013-00295 (NW-AWP), issued 5/31/2013

Date of Inspection: 11/16/2018

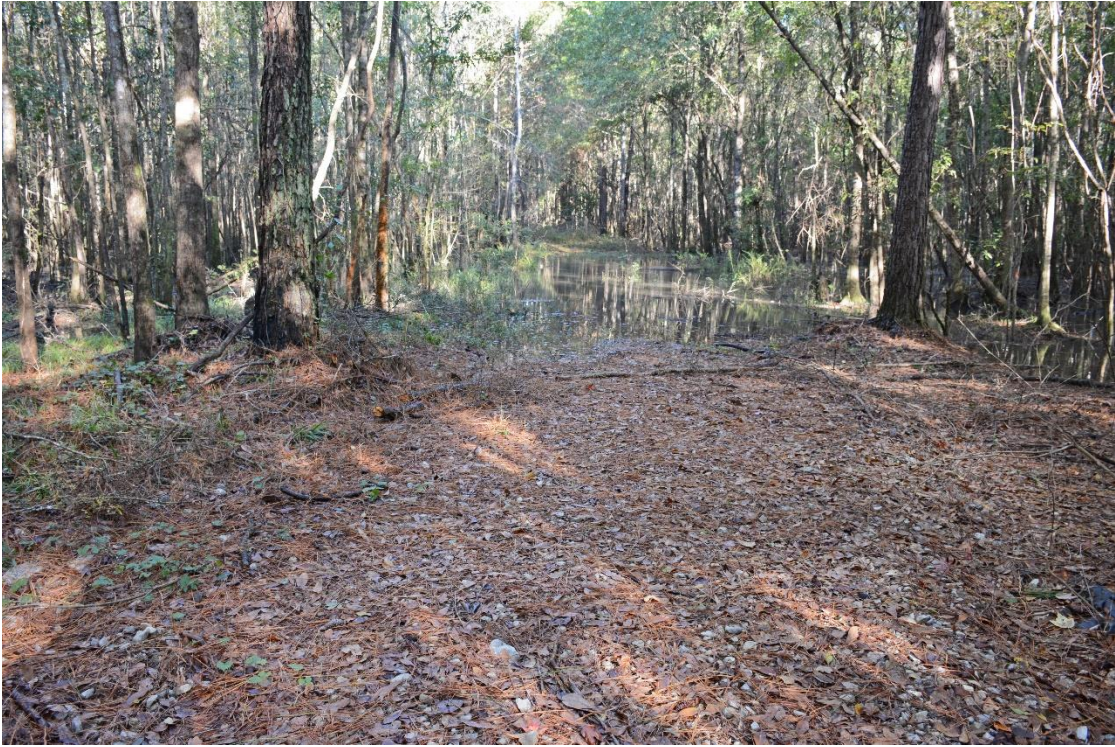
Raised above natural grade, Cotton Creek Road bisected a palustrine forested slough and disrupted natural hydrologic flows and moisture regimes. The low-water-crossing designed to enhance the hydrology of adjacent wetlands was installed in July 2015. An inspection by NFWFMD staff on November 16, 2018 concluded that the low-water-crossing was functioning as designed, and that natural hydrologic flows had been reestablished. During the inspection, water in the slough was observed gently flowing east to west and was approximately one foot deep at the crossing low

point. There has been no erosion or downstream movement of rock used in construction of the low-water-crossing. The forested slough appears ecologically healthy; no exotic or nuisance vegetation was noted. Annuals monitoring inspections will continue through 2020 or as directed by the USACE. In the event of failure of the low-water-crossing, remedial action will be taken.

Cotton Creek Road LWC (Looking North; 11/16/2018)

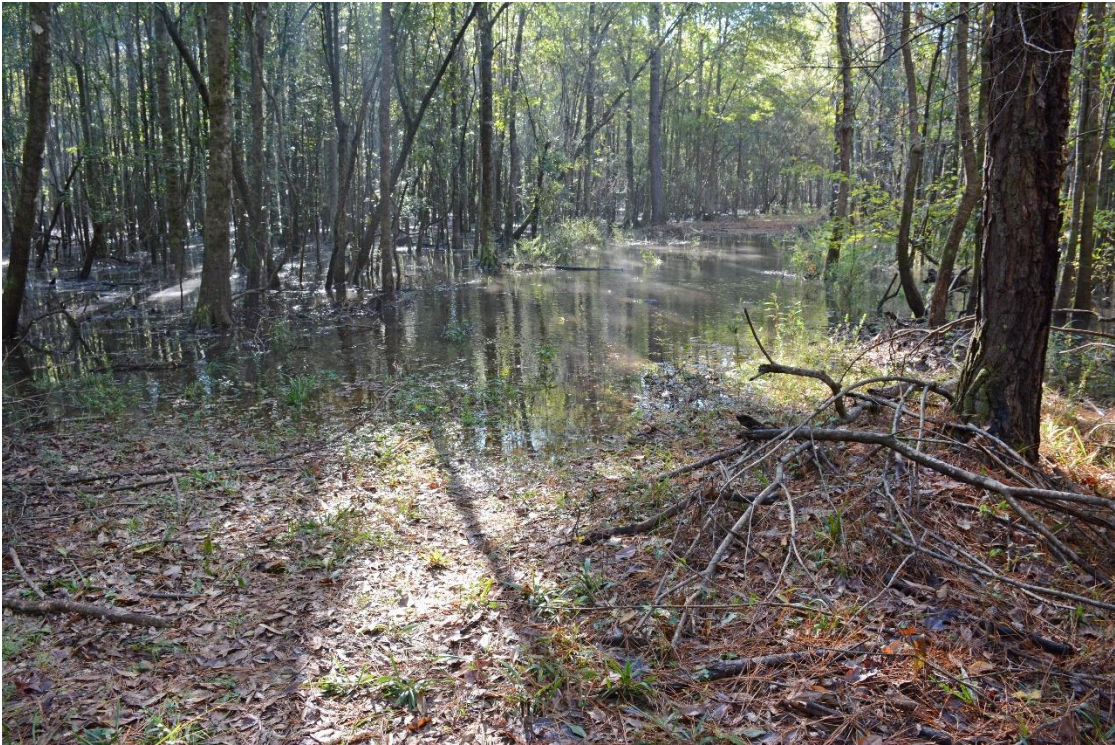
Cotton Creek Road LWC (Looking South; 11/16/2018)
