Dutex (NFWFMD ILF Program Mitigation Project Site)

Northwest Florida Water Management District
In-Lieu Fee Program

Dutex Mitigation Area

22 September 2014

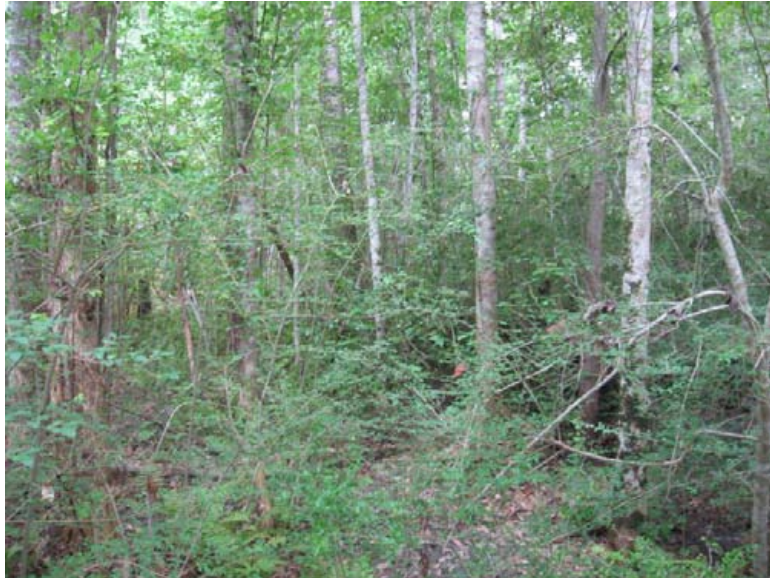
Bay Swamp with Privet (FLUCCS 611)

This community designation is dominated by sweetbay. Additional canopy species observed include tulip popular (*Liriodendron tulipifera*), swamp bay (*Persea palustris*) and red maple (*Acer rubrum*). Slash pines were occasionally present as canopy trees. Although no cypress species were observed within this community, several small cypress stumps were present. Herbaceous groundcover was dominated by sensitive fern. Additional species observed included poison ivy, evergreen bayberry (*Myrica carolinensis*), Virginia chain fern, and littlehead nutrush (*Scleria oligantha*), common boneset (*Eupatorium perfoliatum*), water cowbane (*Oxypolis filiformis*), mild waterpepper (*Polygonum* cf. *hydropiperoides*), possumhaw (*Viburnum nudum*), fringed yelloweyed grass (*Xyris fimbriata*), hairy maiden fern (*Thelypteris hispidula*), lax hornpod (*Mitreola petiolata*), irisleaf yelloweyed grass (*Xyris laxifolia* var. *iridifolia*) and marsh fern (*Thelypteris palustris*). A large amount of Chinese privet (*Ligustrum sinense*) is present throughout the northern half of this community.

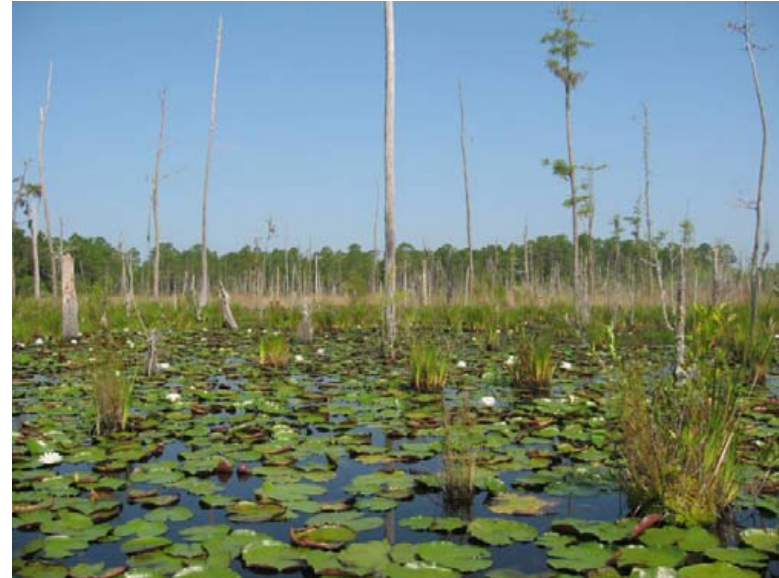
Beaver Pond (FLUCCS 534)

No significant changes in vegetative assemblages or structure are anticipated to occur within existing gum swamps. Following removal of the beaver dam, currently inundated lands are anticipated to revegetate naturally and succeed back to historic vegetative conditions.

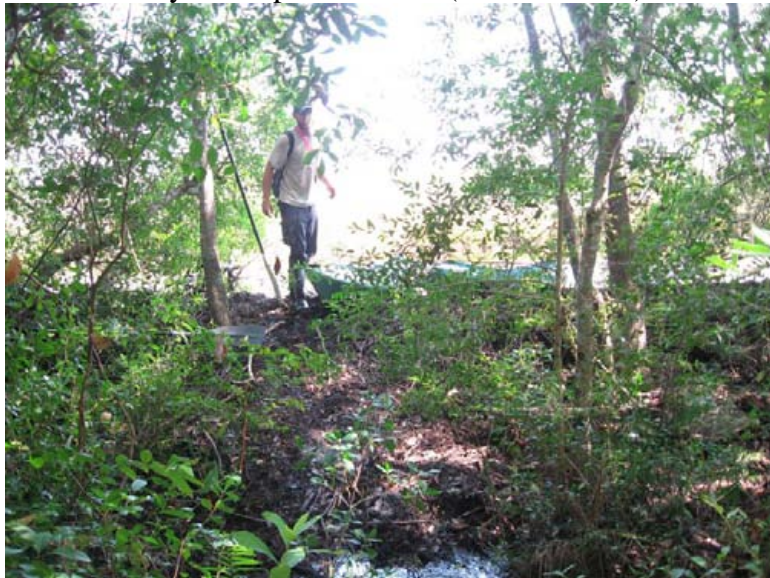
Beaver Dam (FLUCCS 747)

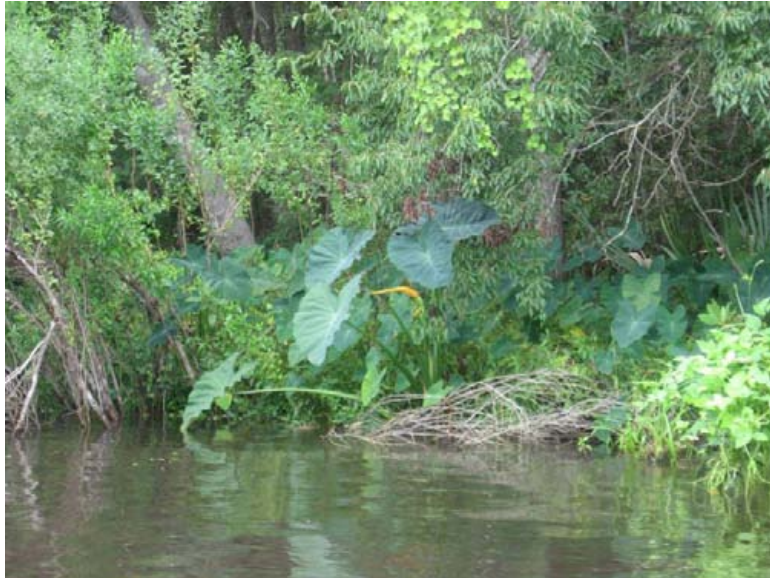
Stream and Waterways (FLUCCS 510) with Wild Taro (*Colocasia esculenta*)

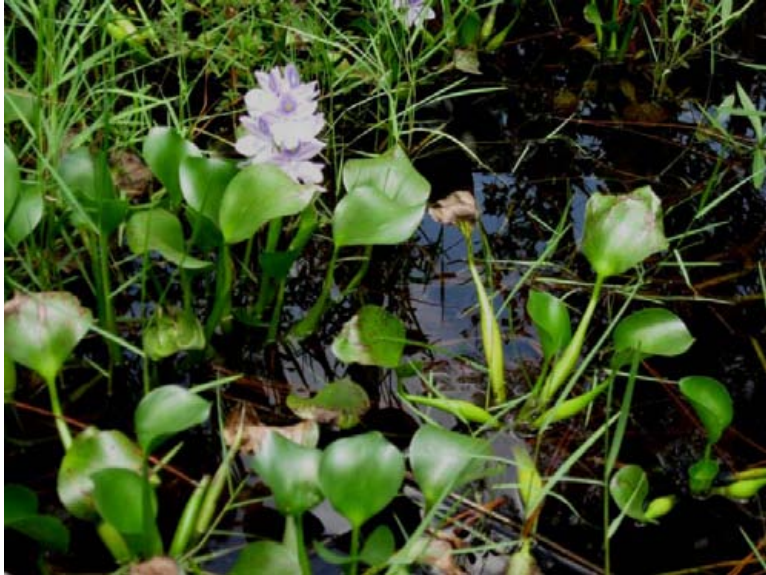
Common water hyacinth (*Eichhornia crassipes*)

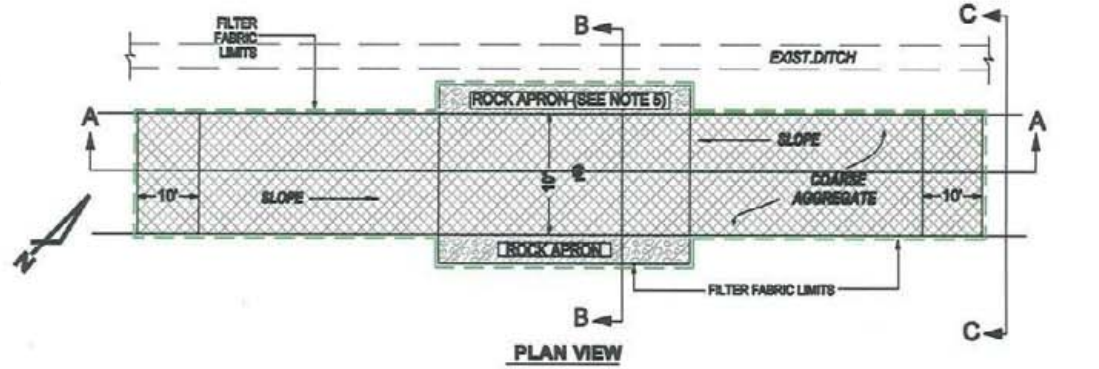
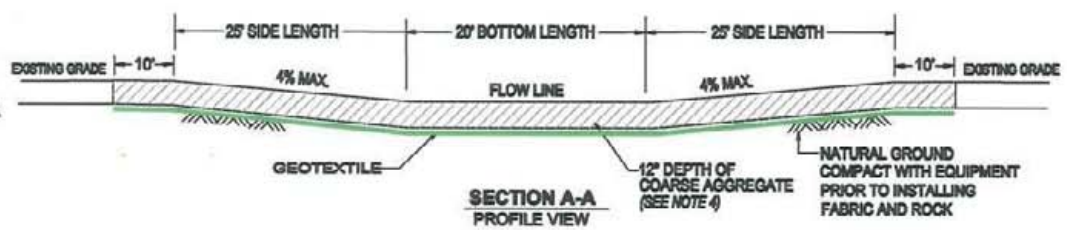
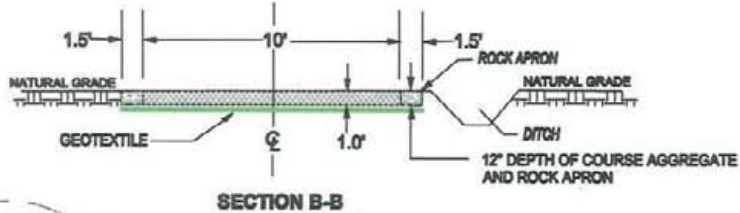
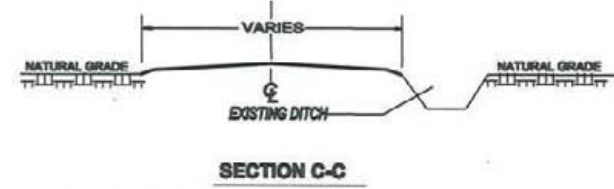
HARDENED LOW WATER CROSSING #1 DETAIL

1. GEOTEXTILE SHALL BE A WOVEN FABRIC FOR STABILIZATION THAT CONFORMS TO FDOT DESIGN STANDARDS, INDEX 199, CLASS D-1 OR D-2.
2. MINIMUM FABRIC OVERLAP SHALL BE 2 FT. ON EACH EDGE. ROCK SHALL BE PLACED ON LAP PRIOR TO PLACING ROCK ON SINGLE LAYERS OF FABRIC TO PREVENT LATERAL MOVEMENT.
3. LIMEROCK SHALL BE TRUCK DUMPED AND MACHINE SPREAD OVER THE FABRIC FOLLOWING PLACEMENT OF FABRIC.
4. COARSE AGGREGATE BASE SHALL BE 12" THICK AND CONSIST OF LIMESTONE OR GRANITE, 2 TO 6 INCHES IN DIAMETER, ($D_{50} = 4$ INCHES), WITH A MAXIMUM L. A. ABRASION LOSS OF 35%.
5. ROCK APRON SHALL CONSIST OF BEDDING STONE, RUBBLE OR COBBLES IN THE RANGE OF 6"-10" WITH A D_{50} OF 8 INCHES AND MAXIMUM L.A. ABRASION LOSS OF 35%. THE THICKNESS OF THE ROCK APRON SHALL BE A MINIMUM OF 12 INCHES.
6. ALL MATERIALS TO BE PROVIDED BY THE CONTRACTOR.

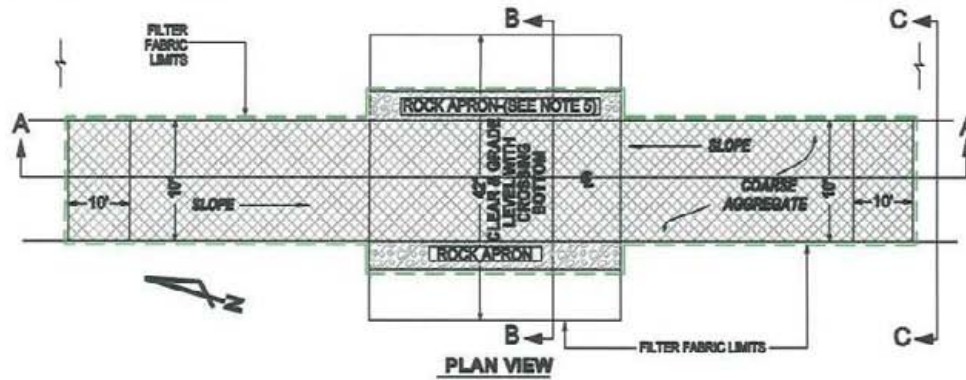
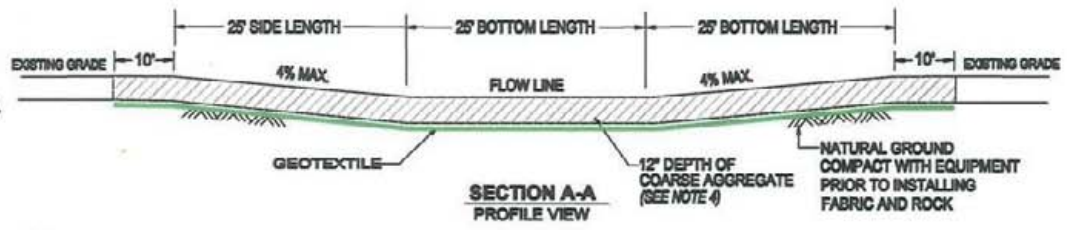
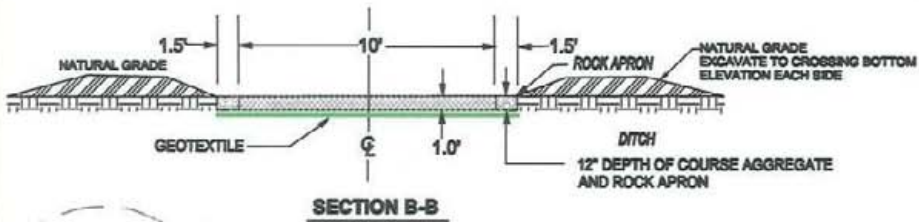
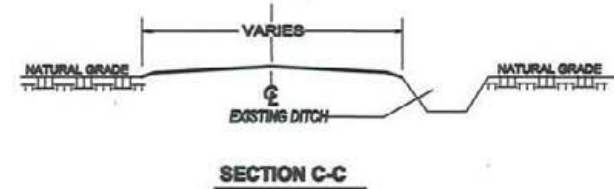
HARDENED LOW WATER CROSSINGS #2 & #3 DETAIL

1. GEOTEXTILE SHALL BE A WOVEN FABRIC FOR STABILIZATION THAT CONFORMS TO FDOT DESIGN STANDARDS, INDEX 199, CLASS D-1 OR D-2.
2. MINIMUM FABRIC OVERLAP SHALL BE 2 FT. ON EACH EDGE. ROCK SHALL BE PLACED ON LAP PRIOR TO PLACING ROCK ON SINGLE LAYERS OF FABRIC TO PREVENT LATERAL MOVEMENT.
3. LIMEROCK SHALL BE TRUCK DUMPED AND MACHINE SPREAD OVER THE FABRIC FOLLOWING PLACEMENT OF FABRIC.
4. COARSE AGGREGATE BASE SHALL BE 12" THICK AND CONSIST OF LIMESTONE OR GRANITE, 2 to 8 INCHES IN DIAMETER, ($D_{50} = 4$ INCHES), WITH A MAXIMUM L. A. ABRASION LOSS OF 35%.
5. ROCK APRON SHALL CONSIST OF BEDDING STONE, RUBBLE OR COBBLES IN THE RANGE OF 6"-10" WITH A D_{50} OF 8 INCHES AND MAXIMUM L.A. ABRASION LOSS OF 35%. THE THICKNESS OF THE ROCK APRON SHALL BE A MINIMUM OF 12 INCHES.
6. ALL MATERIALS TO BE PROVIDED BY THE CONTRACTOR.

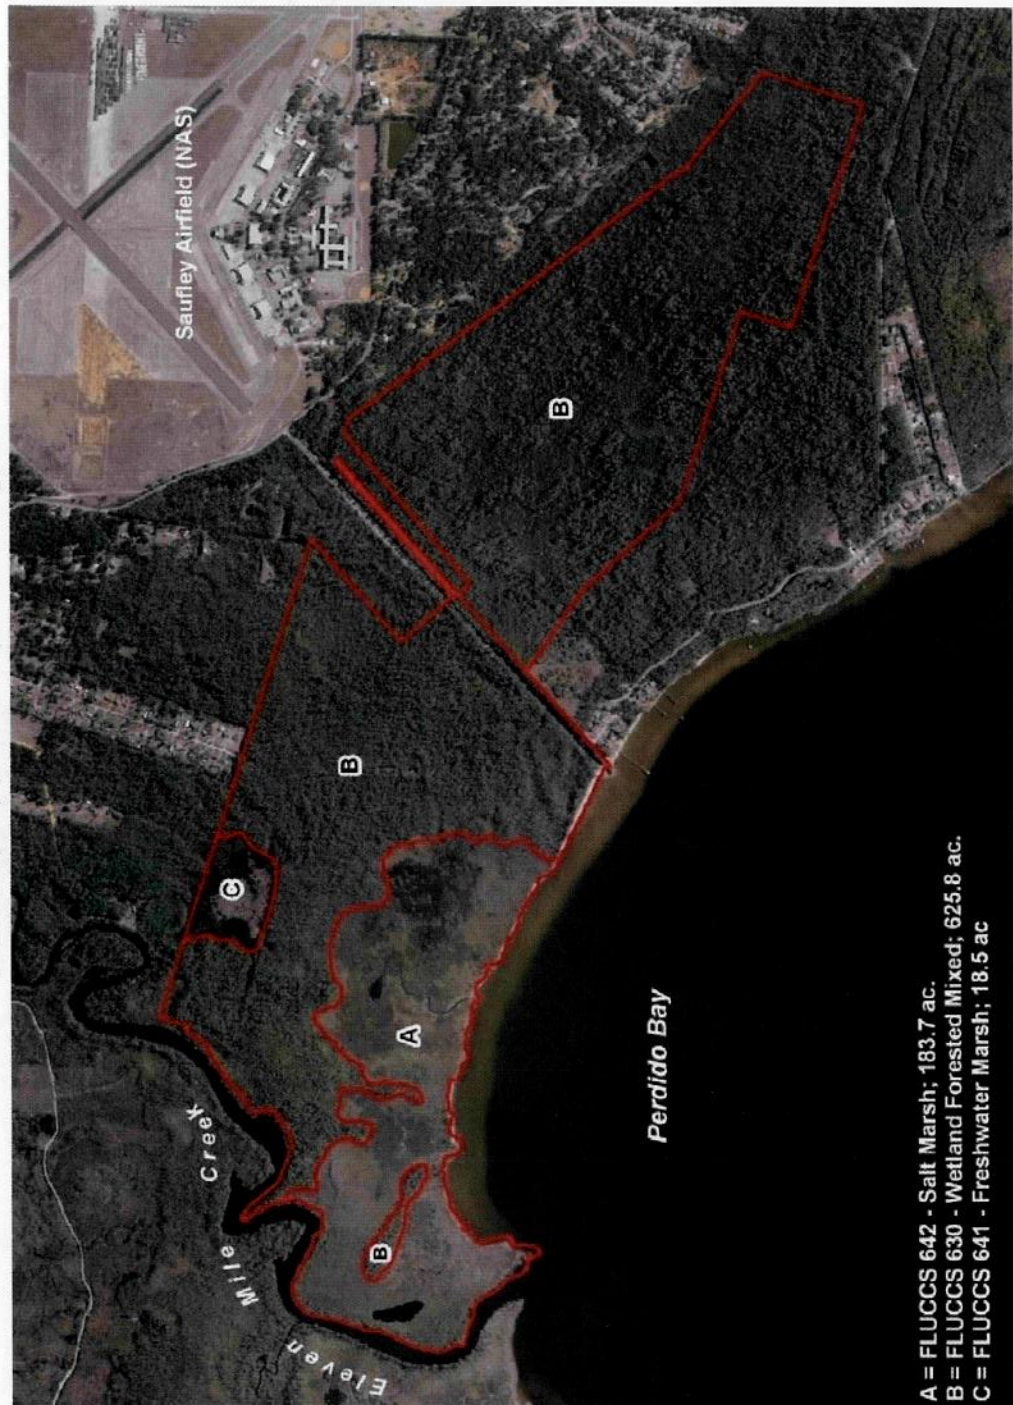
Dutex Property (828 Acres) - Wetland Types

A = FLUCCS 642 - Salt Marsh; 183.7 ac.
B = FLUCCS 630 - Wetland Forested Mixed; 625.8 ac.
C = FLUCCS 641 - Freshwater Marsh; 18.5 ac
