CAT POINT MITIGATION SITE
Annual Monitoring Report, Year 5 of 5
January 11, 2012

Impact: SR 300 St. George Island Bridge, Franklin County
USACE Permit No.: SAJ-2003-05450 NW-JWS, issued 6/6/2003
Mitigation: Cat Point, Franklin County
Permittee/Consultant: Northwest Florida Water Management District (NFWFMD)
Responsible Party for Monitoring: NFWFMD
81 Water Management Dr.
Havana, FL 32333
Date of Inspection: November 9, 2011
Inspectors: Leigh Brooks, Graham Lewis

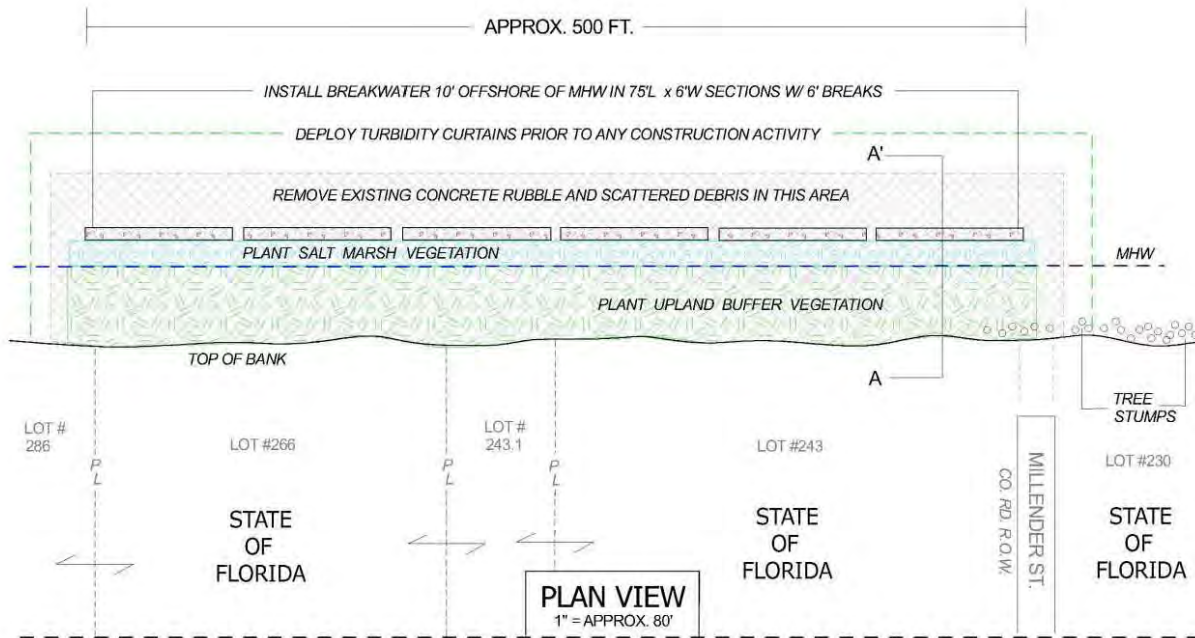
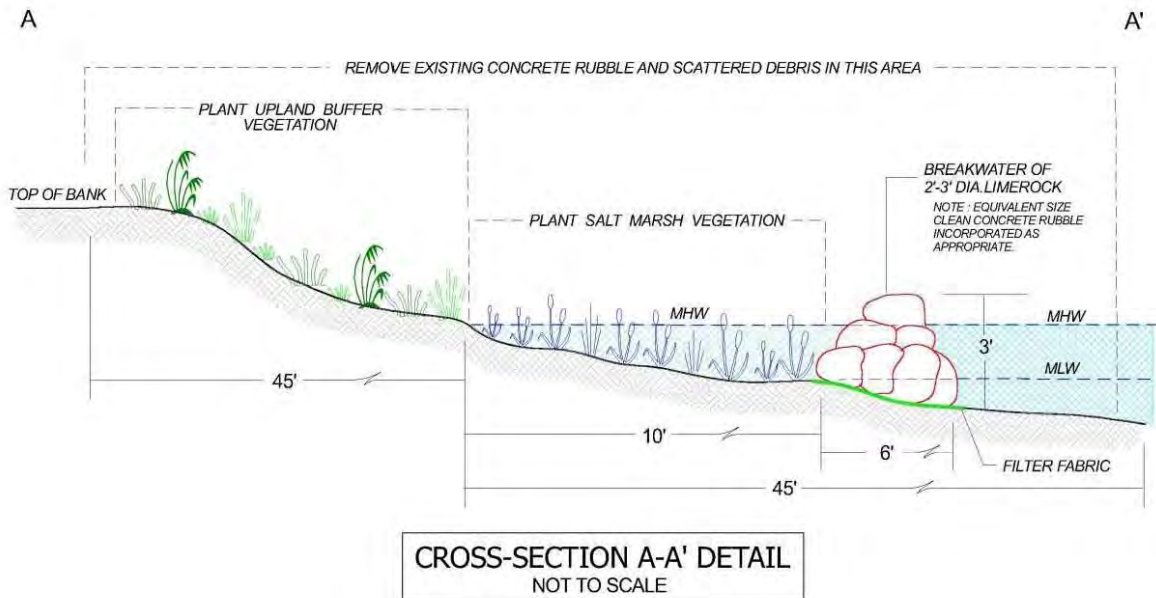
FIGURE 3
APALACHICOLA BAY
BREAKWATER CONSTRUCTION PROJECT
EASTPOINT, FLORIDA
 SEC. 31 - T8S - R6W

The general project design was based on the specifications of a demonstration project implemented by ANERR in 1994. A breakwater of 2-3 foot diameter rock was placed approximately 10-25 feet offshore, roughly parallel to the shore with a 1:1 slope (6-foot base and 3 feet high; [Figure 3](#)). The base of the breakwater was located such that at Mean Low Water (MLW) it will be covered with several inches of water and at Mean High Water (MHW) approximately 0.5 to 1 foot of the breakwater will remain above the water surface. This placement was based on a 2-foot tidal range typical of Apalachicola Bay. Six foot wide breaks were located at 75-foot intervals along the breakwater.

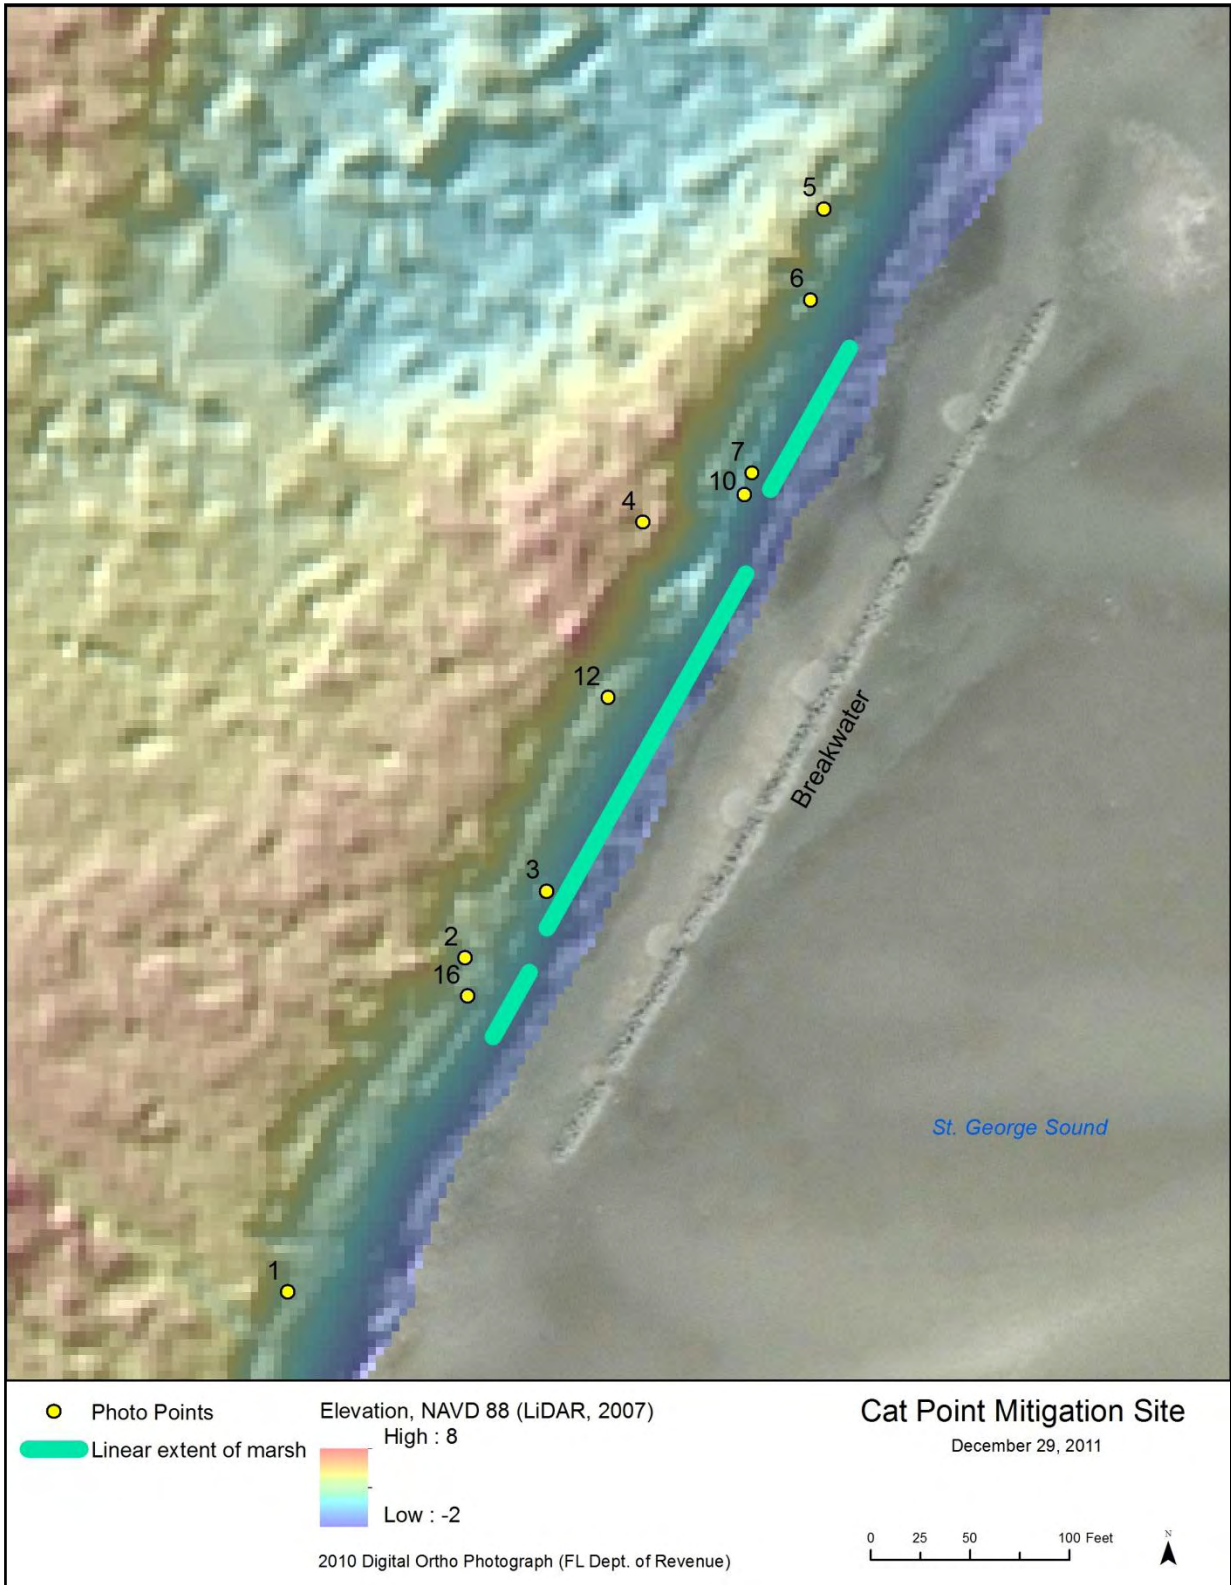
Figure 5. Topography of mitigation site with photo points indicated.

The current monitoring was carried out on November 9, 2011, and consisted of a meandering pedestrian survey of both the intertidal marsh and transitional buffer zones. Photographs were taken; photo points are shown in [Figures 4](#) and [5](#). Field sheets are attached documenting [site conditions](#) and listing [observed species](#); several new floral species were found during the 2011 inspection and are discussed below.
