Northwest Florida Water Management District

Re: Progress Report 8

Please accept this submittal as the **semi-annual progress report** for the SHLMB.

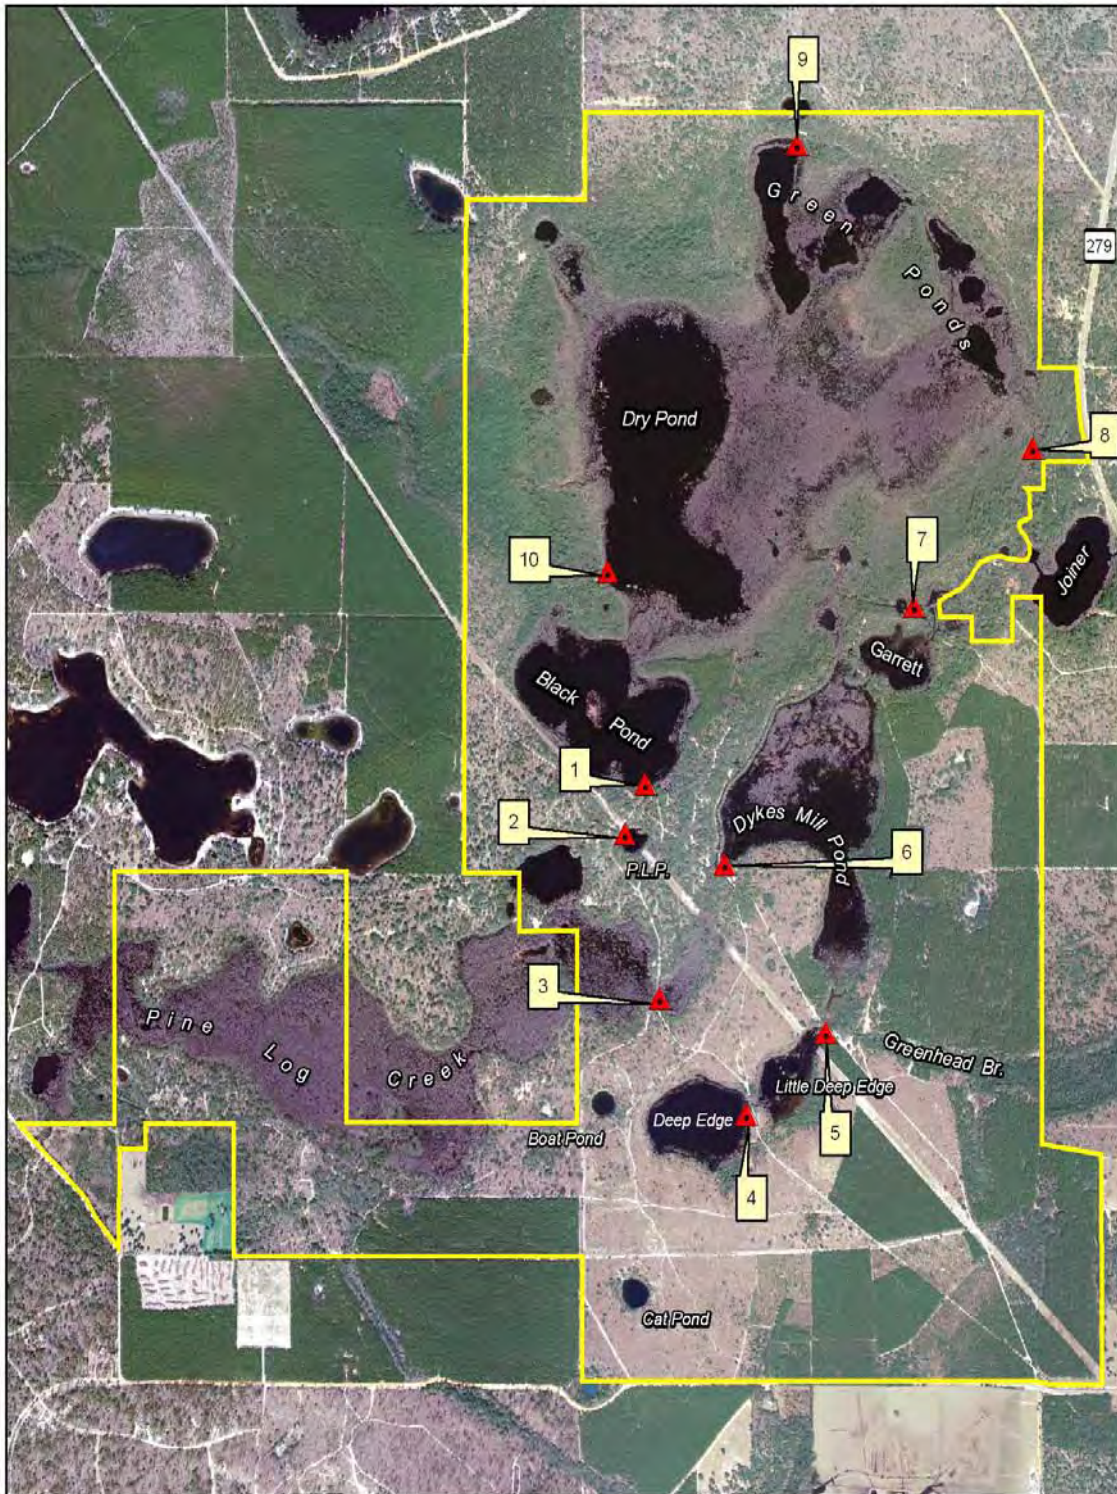
Figure 9 - Water Level Staff Gage Locations

6. Water Level gauges will continue to be measured over the summer.
7. Site prep burns for the areas, where offsite sand pine were harvested (Management Unit 11).
