Doyle Creek – 2007 Monitoring
CORPS Permit No. SAJ-2004-706 (NW-TLZ)
[SR 65 Mitigation]

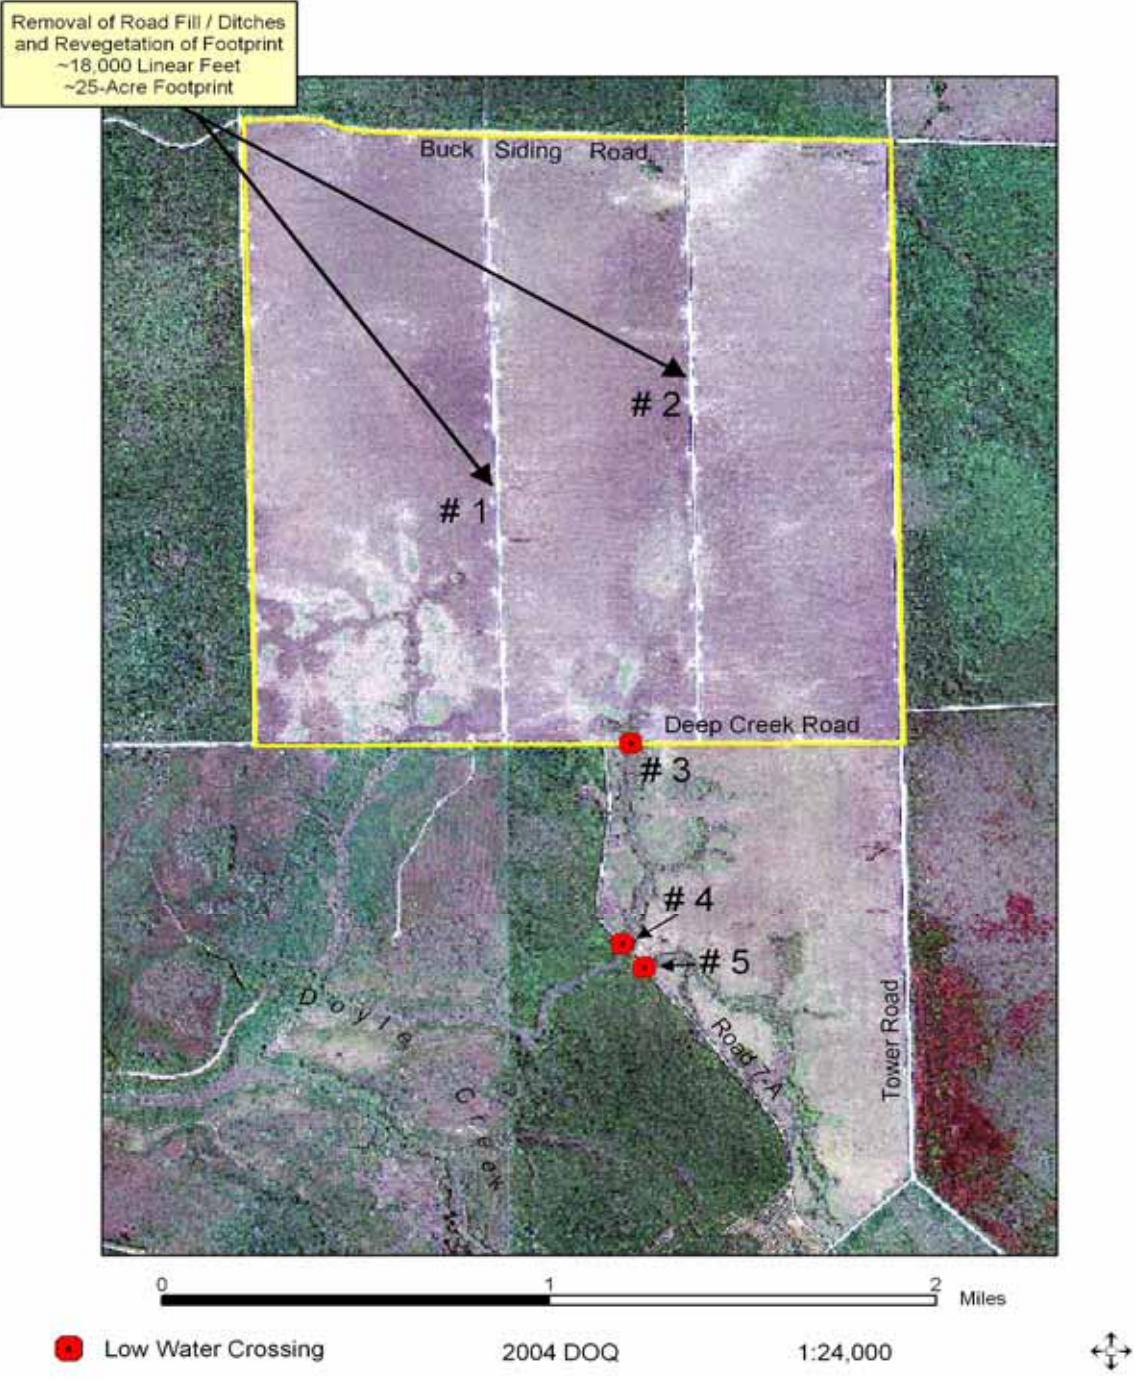
Figure 2. Doyle Creek mitigation site with location of each construction activity. Sites #1-2 are road removals; sites #3-5 are hardened low-water crossings.
