TATE’S HELL - DOYLE CREEK MITIGATION SITE
Annual Monitoring Report, 2011
February 8, 2012

PROJECT OVERVIEW

Impacts: SR 65, Franklin County
USACE Permit No.: SAJ-2004-706 (NW-TLZ), issued 4/26/2004
Mitigation: Tate’s Hell – Doyle Creek, Franklin County
Permittee/Consultant: FDOT
Responsible Party for Monitoring: Northwest Florida Water Management District (NFWFMD)
81 Water Management Dr.
Havana, FL 32333
Date of Inspection: November 16, 2011
Inspectors: Leigh Brooks, Graham Lewis

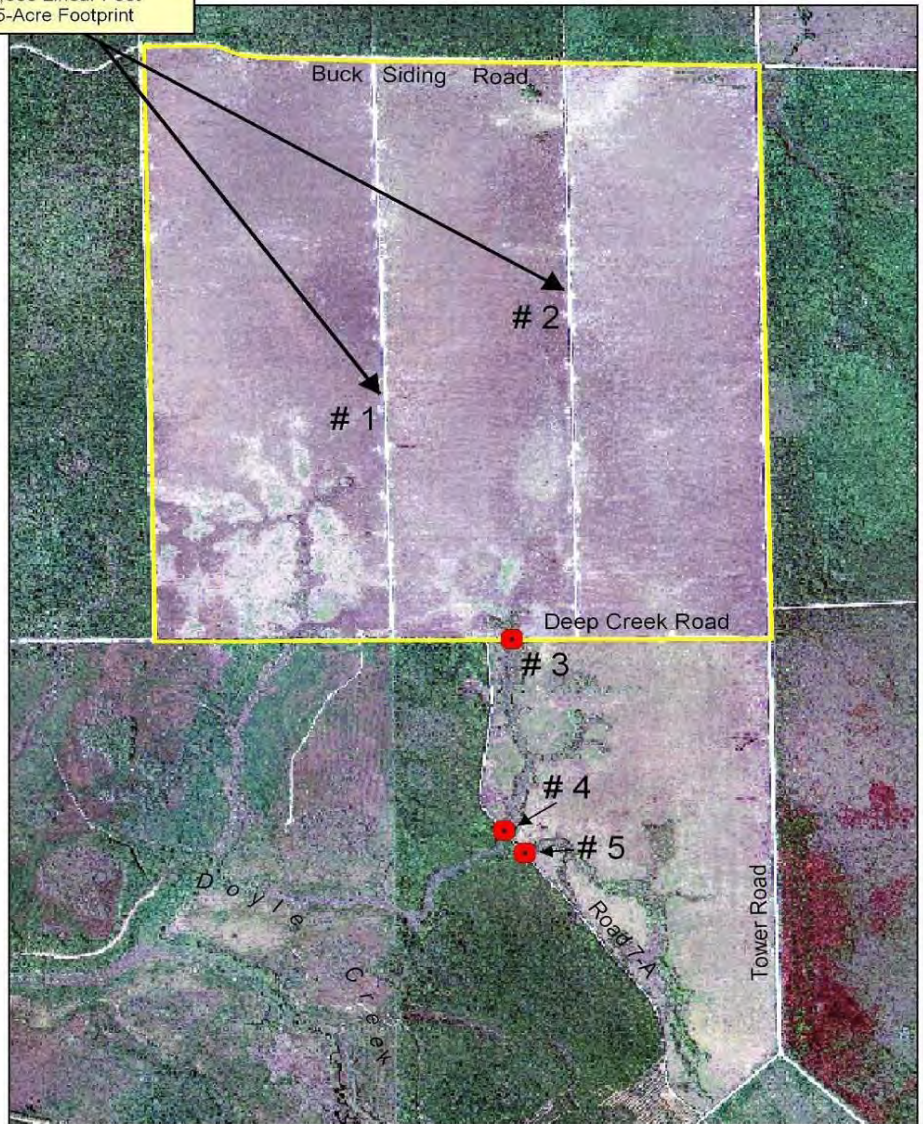
Doyle Creek Mitigation Area

Removal of Road Fill / Ditches
and Revegetation of Footprint
~18,000 Linear Feet
~25-Acre Footprint
