Cat Point – 2007 Monitoring
CORPS Permit No. 200305450 (NW-JWS)

Project Description: The objective of this project is to mitigate for a 0.3-acre impact to seagrass beds in Apalachicola Bay associated with the replacement and realignment of the St. George Island Bridge (SR 300 – Bryant Patton Bridge). The approved mitigation plan included the restoration of approximately 0.8 acre of degraded shoreline. This involved removing old debris from 0.5 acres of shoreline, establishing a minimum marsh/breakwater area of 0.3 acre within the debris removal area, and restoring 0.3 acres of upland native habitat and vegetation on a strip landward of the created marsh. The marsh habitat includes the breakwater footprint, gaps in the breakwater, and areas of planted emergent vegetation. Planted marsh vegetation will enhance the amount of habitat along this section of shoreline. Gaps in the breakwater will allow flushing and ingress/egress of aquatic organisms utilizing the marsh area. The breakwater itself will provide valuable hard substrate for various forms of estuarine epifauna. This project is being carried out in accordance with U.S. Army Corps of Engineers Nationwide Permit 27, #200305450

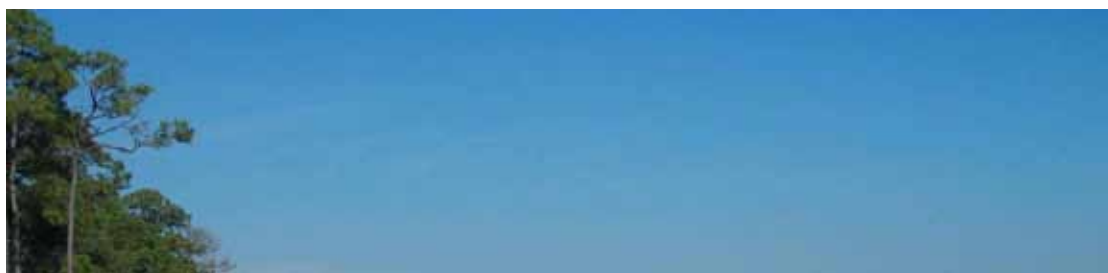
Figure 7. Cleanup of debris underway with old tires piled in foreground (later removed) and stone for breakwater just behind. The first section of breakwater is shown under construction in center right.

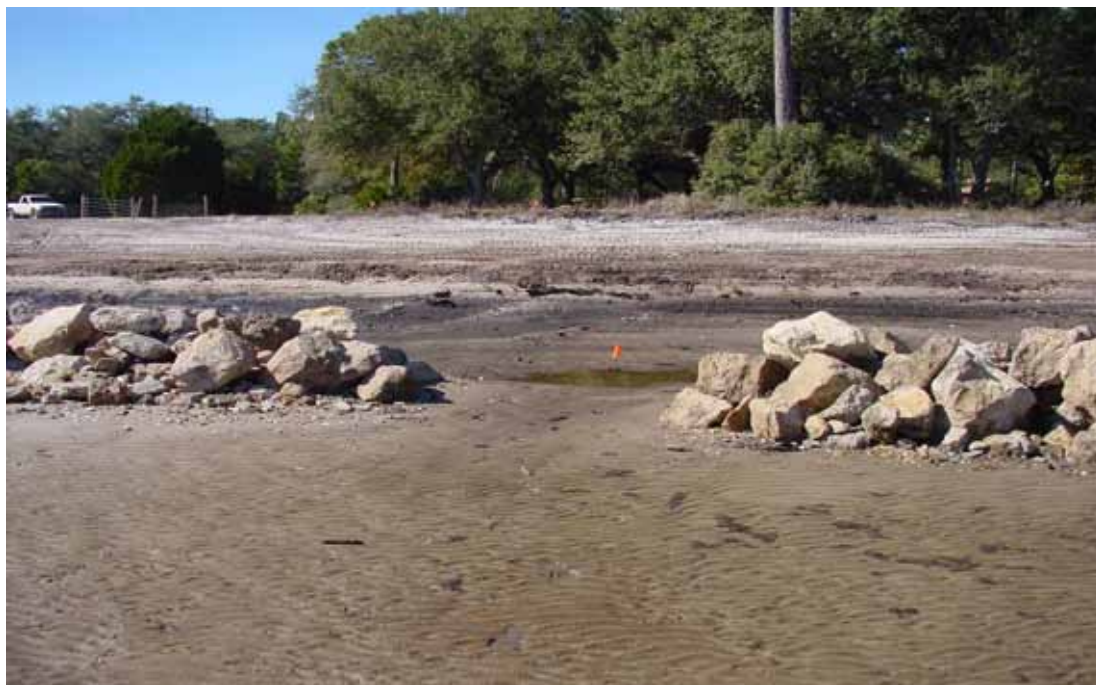
Figure 8. Construction of breakwater nearing completion with piles of old tires shown at center left (later removed from site).

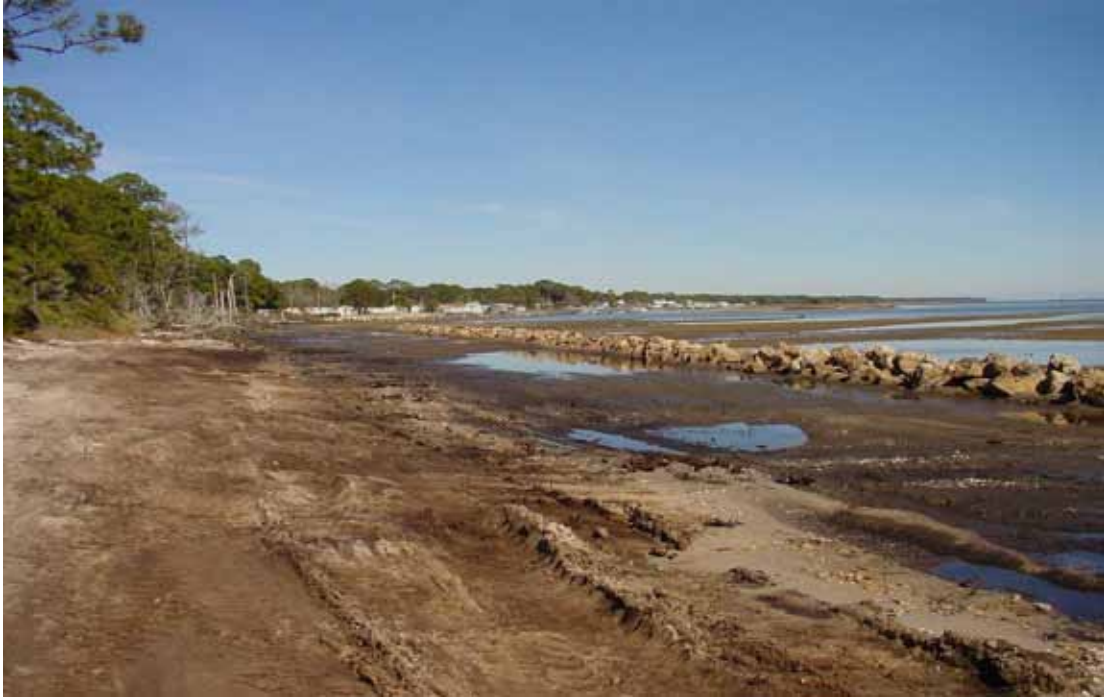
Figure 9. Close-up view of gap in breakwater (shown in center) to allow movement of water and organisms. Contoured shoreline with rubble removed seen in background.

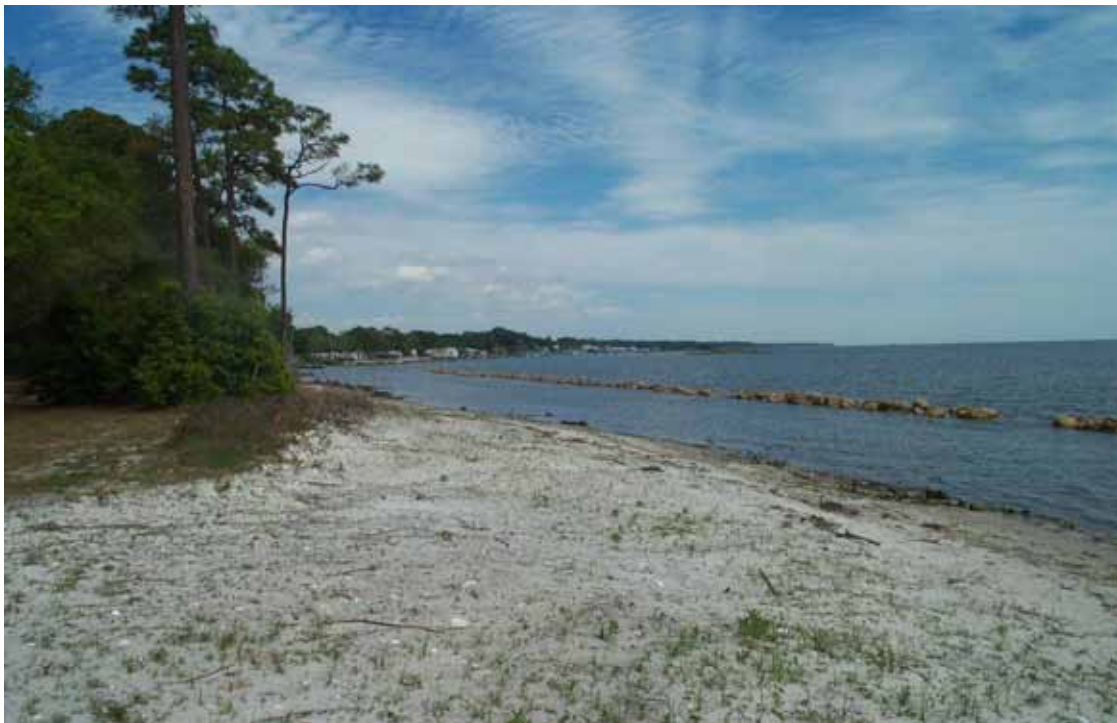
Figure 10. Construction of breakwater complete along with rubble removed and shoreline sloped to match adjacent beach profile.

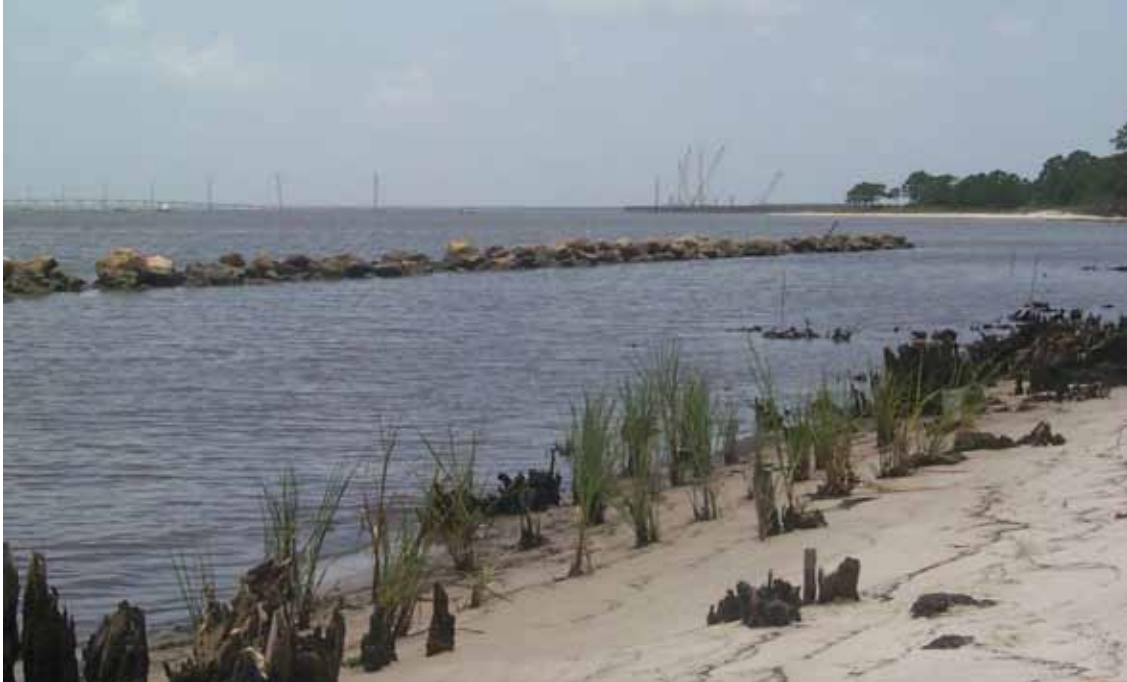
Figure 11. Post-construction view of breakwater showing rubble removed, shoreline contoured and initial recovery of beach vegetation.

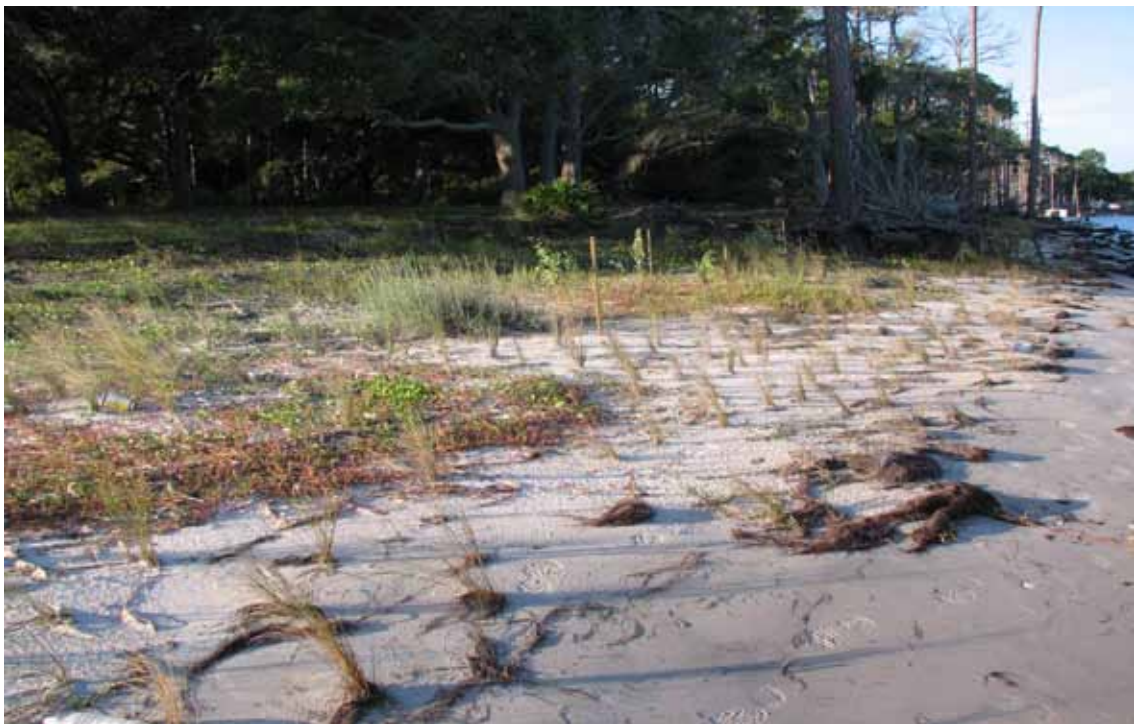
Figure 16. Supplemental planting of marsh during January 2007. Approximately 1500 plants were added after relatively high mortality was experienced.

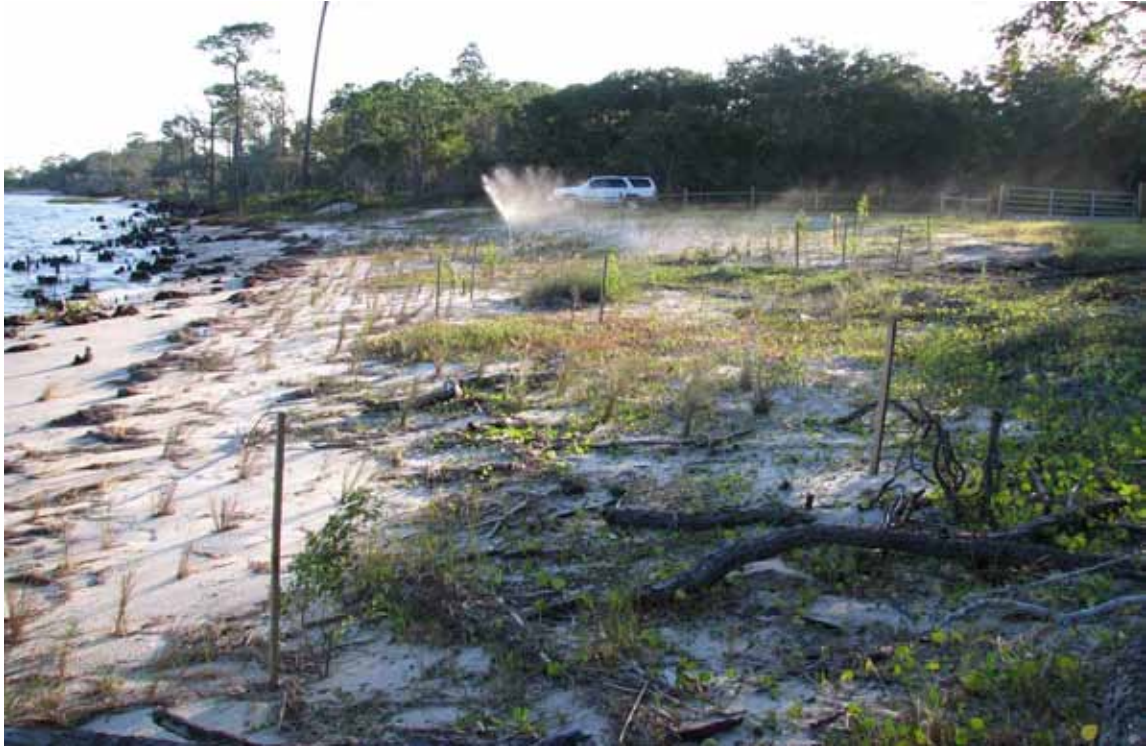
Figure 17. Vegetation planted in the transition zone between the beach and uplands (fall 2007). See text for list of planted species.
