TATE'S HELL – WHISKEY GEORGE/SUMATRA MITIGATION SITES
Annual Monitoring Report, 2011, Year 2 of 5
December 15, 2011

USACE Permit No.: SAJ-2008-04457 (NW-RLT), issued 3/10/2010

Mitigation: Tate's Hell – Whiskey George and Sumatra Savannas
Hydrologic Restoration Project, Franklin County

Date of Inspection: November 16 & 17, 2011

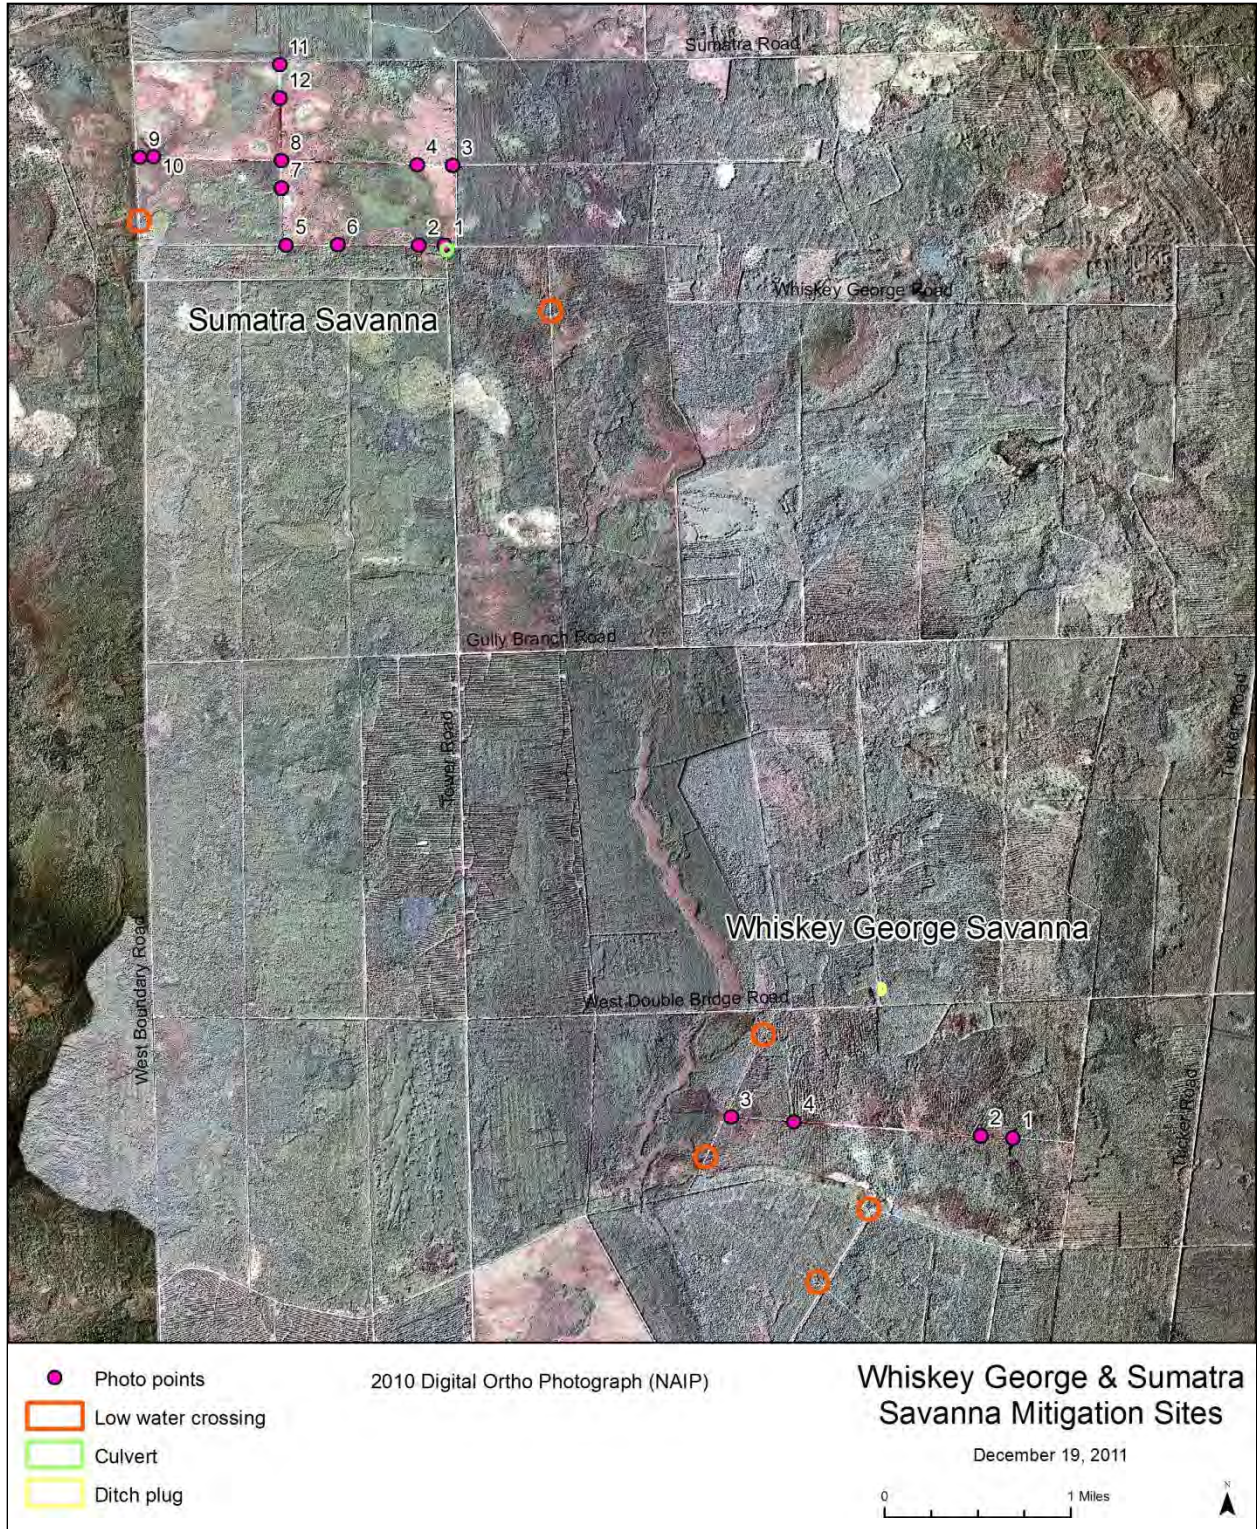
Figure 5. Aerial photograph of the mitigation site after construction of hydrologic improvements. Areas of mostly bare ground appear white; areas of standing water appear dark. Photo points are indicated as Whiskey George 1-4 and Sumatra Savannas 1-12. [RTN](#)
