Cat Point Breakwater (Apalachicola Bay Breakwater and Salt Marsh Restoration) Fourth Annual Monitoring Report (2011)

Nationwide Permit – 200305450 (NW-JWS) issued 6/6/2003; Impact: SR 300 St. George Island Bridge, Franklin County; Impact: 0.3 acre of seagrass in Apalachicola Bay

Monitoring Date: January 1, 2011

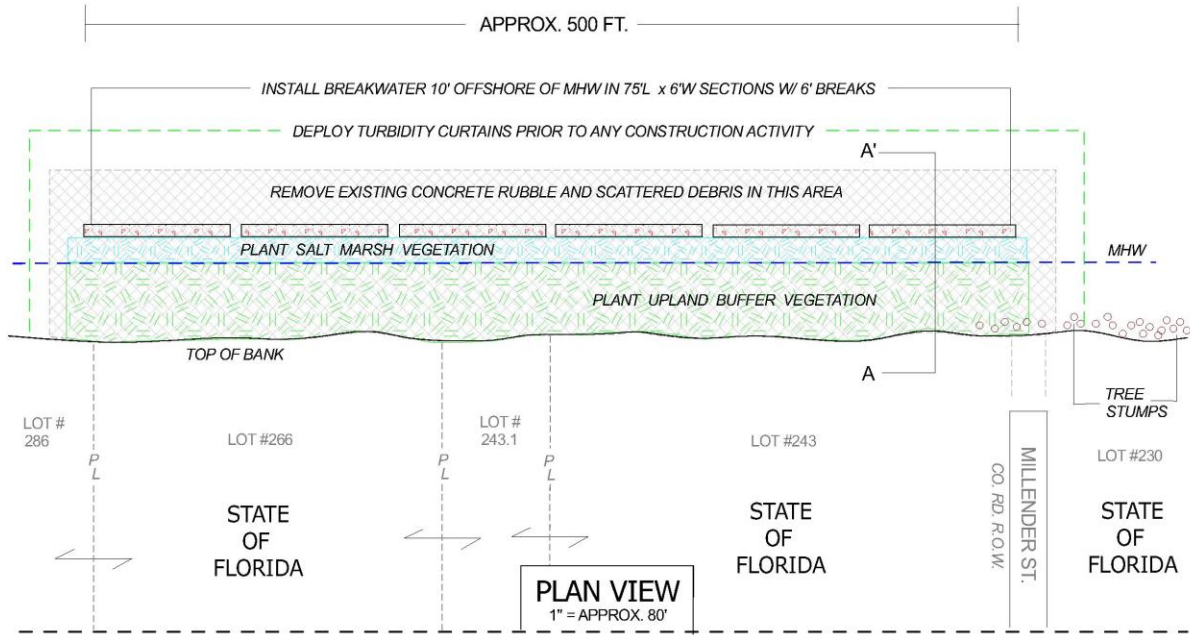
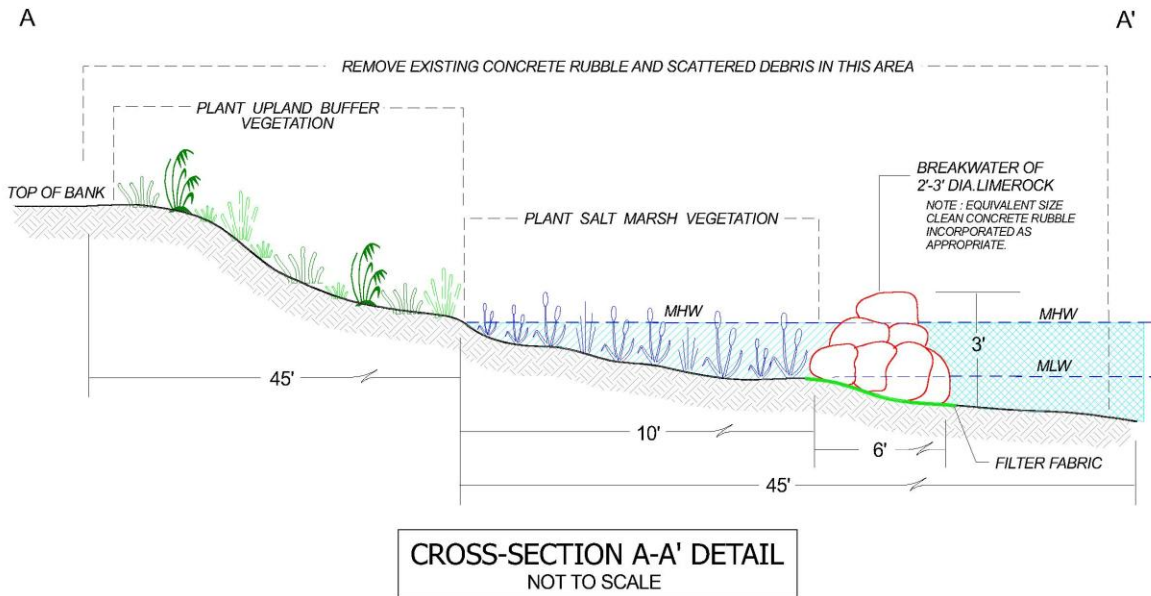
Figure 4. Post-construction view of breakwater showing rubble removed, shoreline contoured, and initial recovery of beach vegetation (June 2004).
