Impact: SR 300 Bryant Patton Bridge in Franklin County, 0.3 acre of seagrass in Apalachicola Bay

Mitigation: Cat Point/Apalachicola Bay breakwater and salt marsh

Monitoring Date: 11/25/08

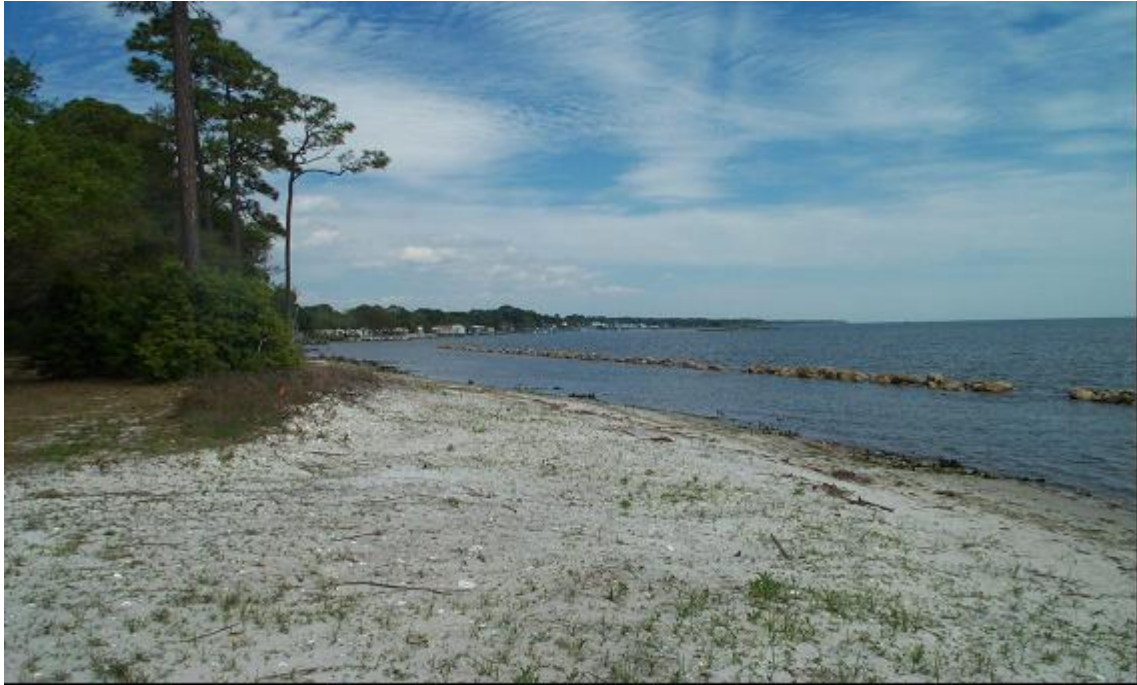
Figure 4. Post-construction view of breakwater showing rubble removed, shoreline contoured and initial recovery of beach vegetation (June 2004).
