**NORTHWEST
FLORIDA
WATER
MANAGEMENT
DISTRICT**

EASTPOINT REGIONAL STORMWATER MANAGEMENT SYSTEMS FRANKLIN COUNTY, FLORIDA

FINAL REPORT – TFR 08-01

Florida Department of Environmental Protection Contract Number G0160

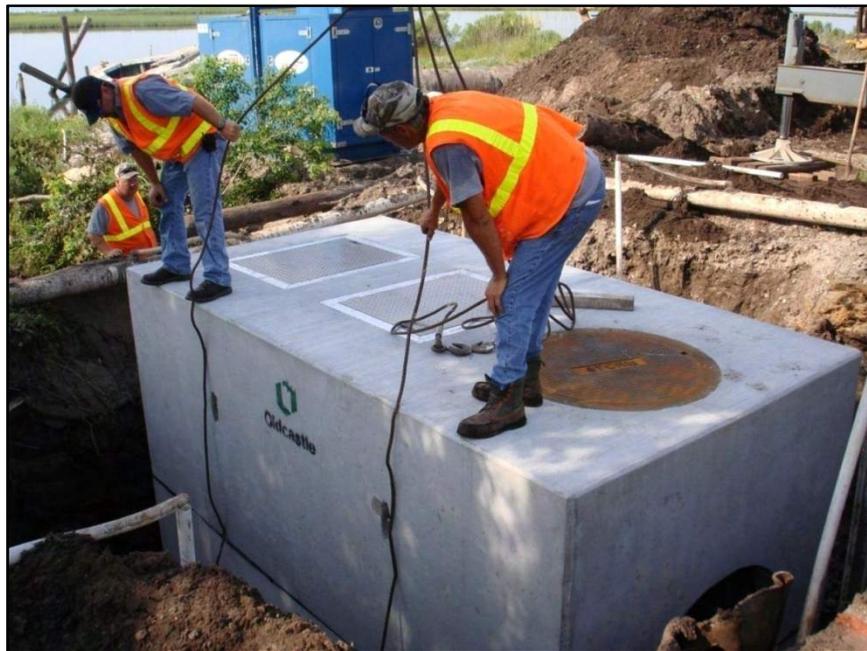
Figure 8: Site 1 – Baffle Box Installation

damaged and required replacement. The contractor did not encounter any problems during excavation and placement of the box (Figure 8). When the box was in place, the headwall was formed and poured in place (Figure 9). After the headwall replacement, the site was

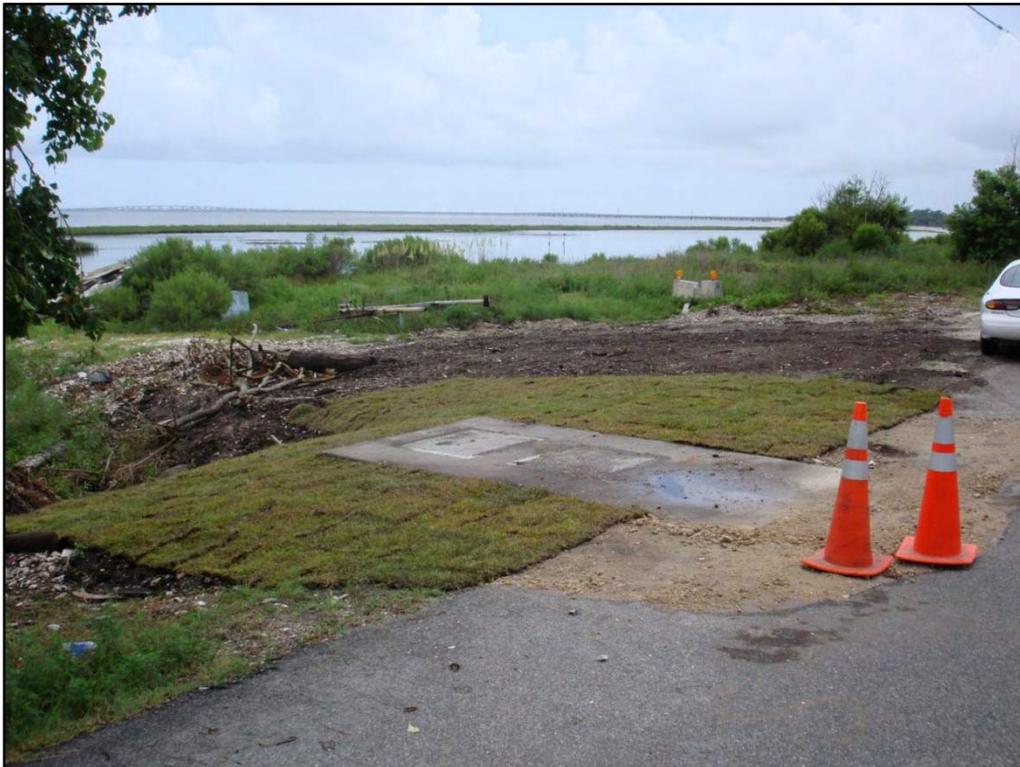
Figure 10: Site 1 – Sod Replacement

dressed with sod, seeded and mulched (Figures 10 and 11). New object markers were placed along the sides of the baffle box to keep cars from driving or parking on top of the non-load bearing aluminum access hatches.

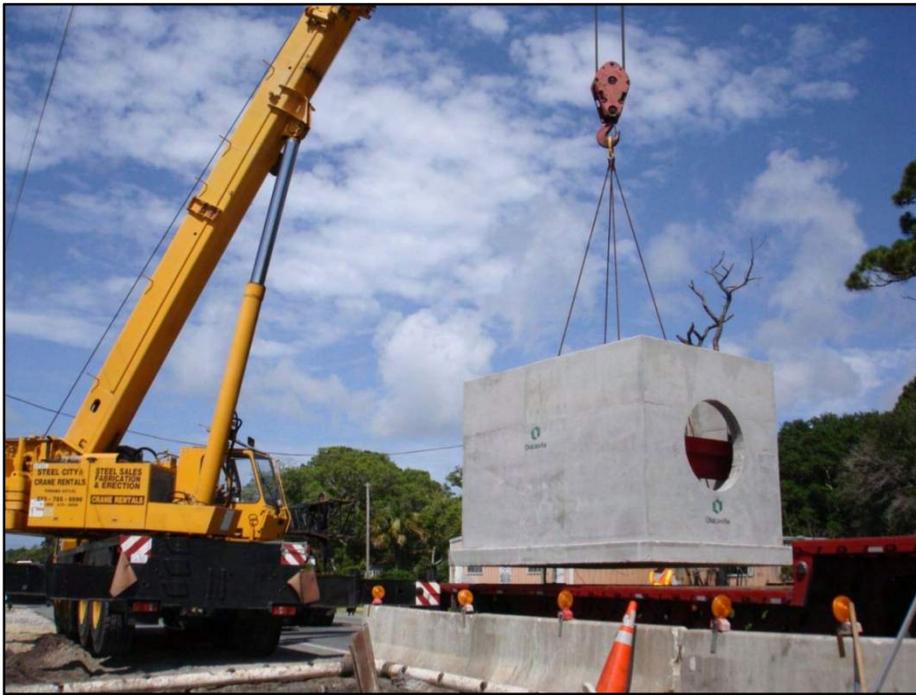
Figure 13: Site 2 – Box Installation

This structure was larger than most used on the project and was constructed as a single unit with a top slab. The added weight and size of the box required a larger 100 ton crane to set the structure (Figure 13). The overhead power lines were temporarily shut off by the local electric utility, Progress Energy, due to safety considerations when the crane set the box. Only one business, Lynn’s Quality Oysters, was affected for about an hour. Eastpoint has a breakwater that parallels the shoreline for the majority of the community and provides an energy break from coastal storms. Structure 2 is located in an area of the shoreline where there is a gap in the breakwater for boat traffic. Additional measures, including an anti-flotation footer and concrete reinforcement were added to the box at this location to provide more protection from potential storm surge and wave action (Figure 14). Before installation of the treatment box, the shoreline area at site 2 was covered with concrete rubble and debris from Hurricane Dennis storm surge damage in 2005 that had not been cleaned up. During the installation of the treatment boxes the debris was removed and the sites were graded, seeded and mulched (Figure 15). After the box was set, the drain pipes were connected then grouted and the hole was backfilled and compacted. The site was dressed with sod, seeded and mulched. Asphalt

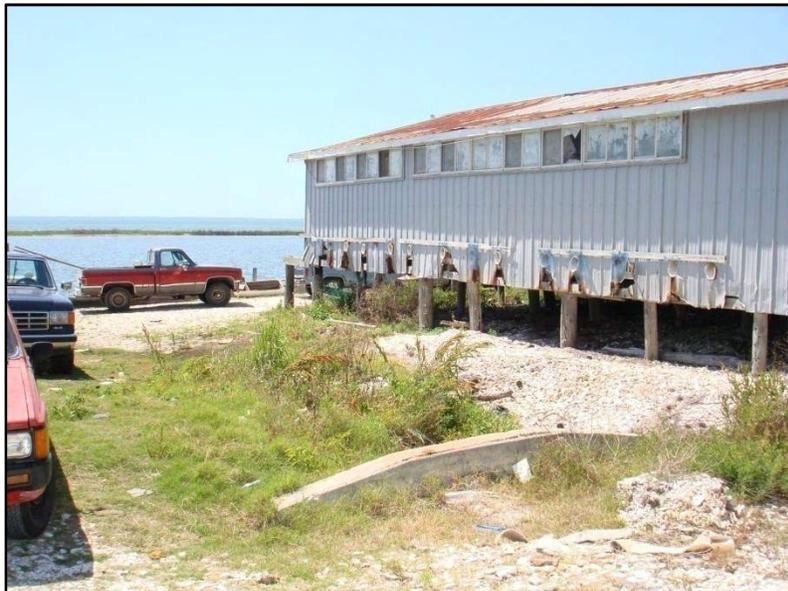
Figure 17: Site 3 – Pre-construction, Looking South.

Site 3: This site is located in the middle of the project area across from Flowers Street in Eastpoint (Figure 1). This structure was planned for installation on the north side of US 98, but was moved to the south side of the highway due to a conflict with a forced sewer main line that

runs underground along the north side of the road. This location has a wide section of land between the treatment box and the shoreline, a headwall and a breakwater that provides protection from coastal storm damage (Figure 17). This structure is an 8' x 12' nutrient separating baffle box. The shop drawing is provided in Appendix

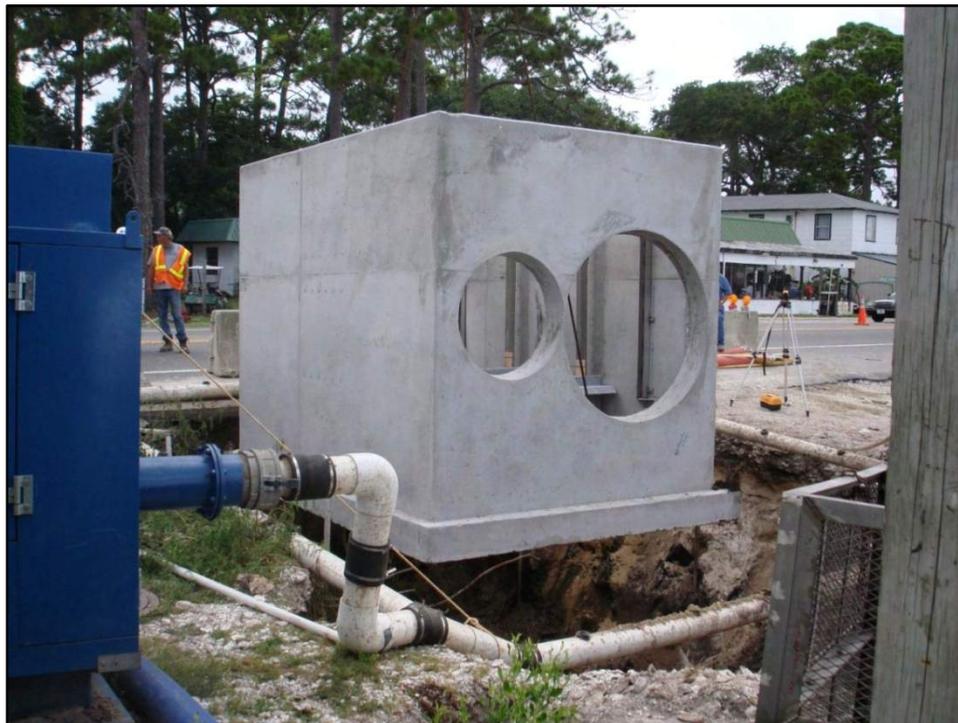
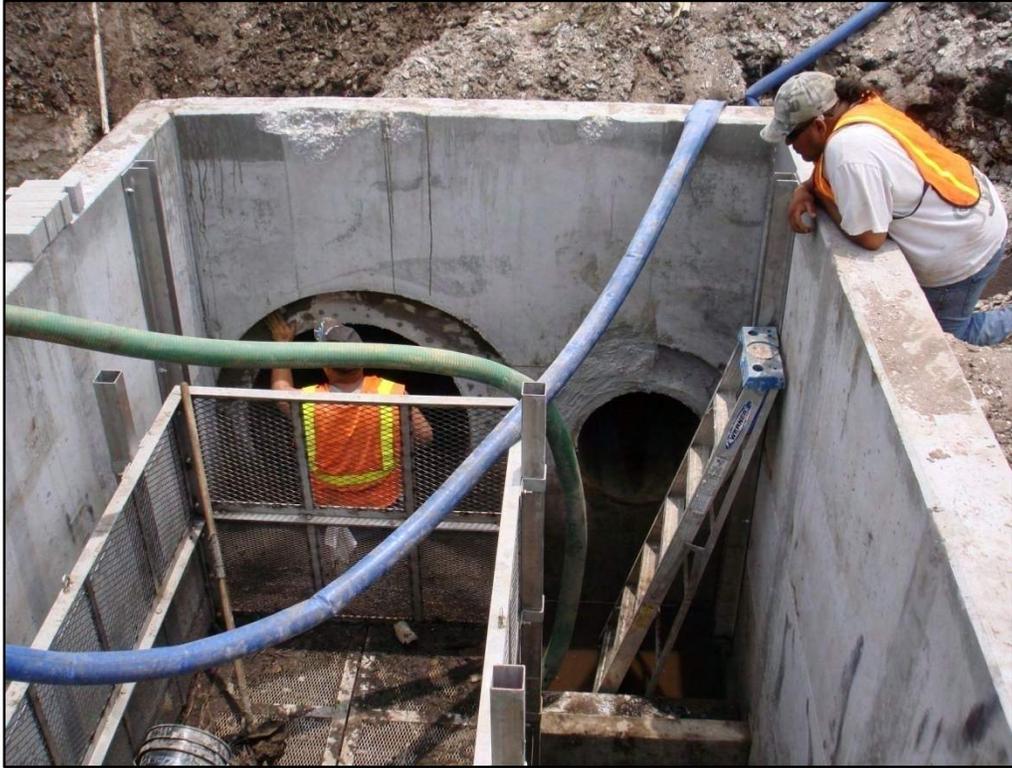
A. Construction on this site started on 07/08/08 with the installation of the well point system and turbidity barriers in the outfall channel. The baffle box was set in place on 07/11/08 and final site grading and sod replacement were completed on 07/15/08. This structure was one of the larger boxes installed on the project and was constructed as a single unit with a top slab; the added weight and size of the box required a larger 100 ton crane to set the structure (Figure 18). This structure was constructed with two inflow and outflow pipes (42-inch and 24-inch) to accommodate the two existing drainage pipes. The box and pipe sizes were designed to prevent any constriction or backflow through the structure during storm events (Figure 19 and 20).

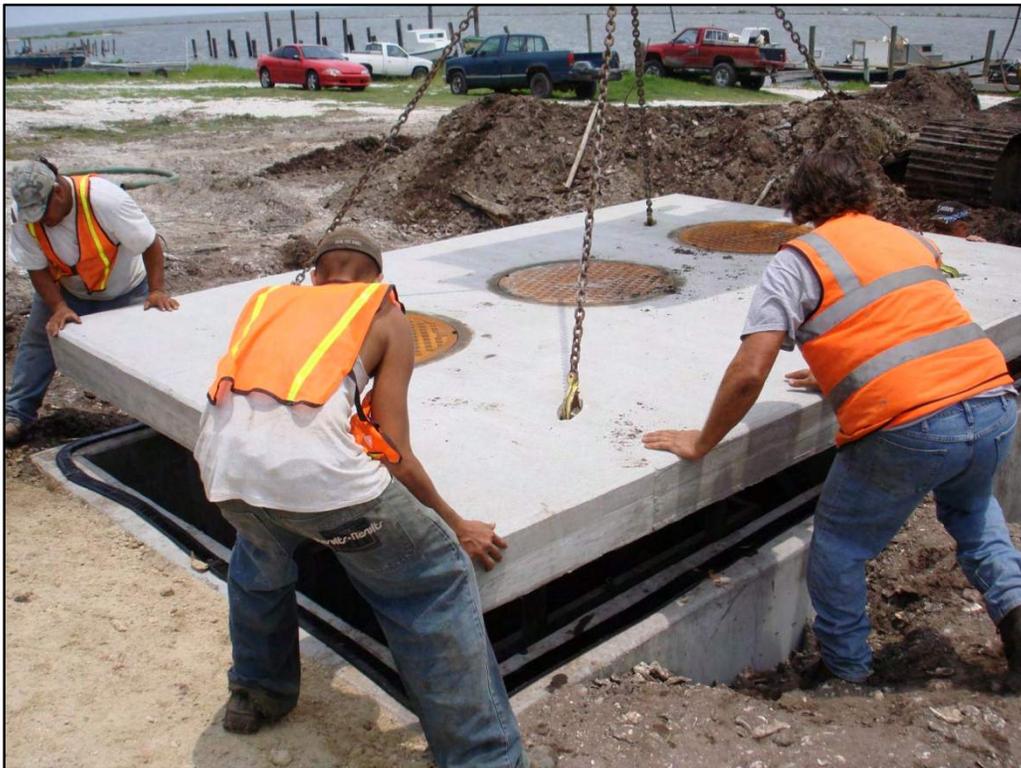
Figure 21: Site 3 – Top With Load Bearing Manholes

The location of structure 3 is in a high traffic area used by local oystermen for parking their vehicles and boat trailers. The lid on this structure was constructed with three load bearing manhole covers in place of non-load bearing aluminum hatches to prevent damage to the boxes or vehicles (Figure 21). After completion, the site was dressed with oyster shell (which was the existing cover before construction) to stabilize the site and prevent erosion (Figure 22).

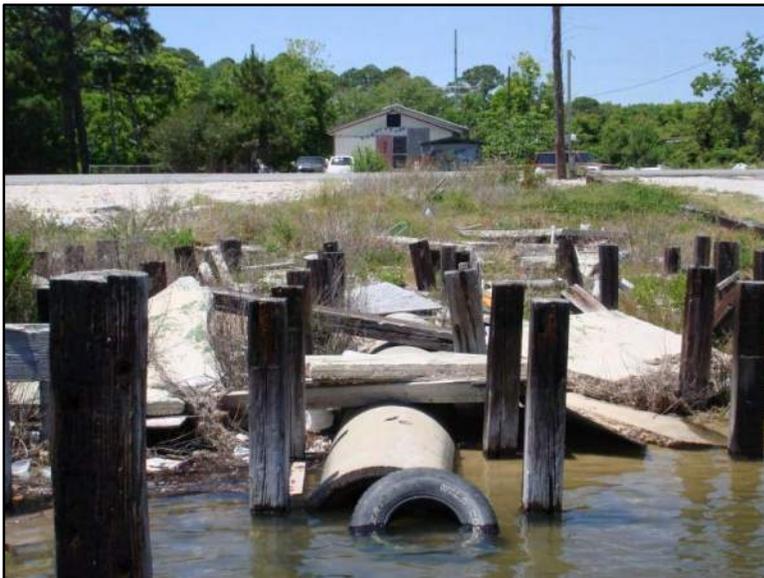
Figure 23: Site 4 - Before Construction, Looking North

installation on the north side of US 98 but was moved to the south side of the roadway due to underground utility conflicts (Figure 23). The structure at this site is a 6' x 12' nutrient separating baffle box with two aluminum hatches and a load bearing manhole cover located on the shoulder of the road. The

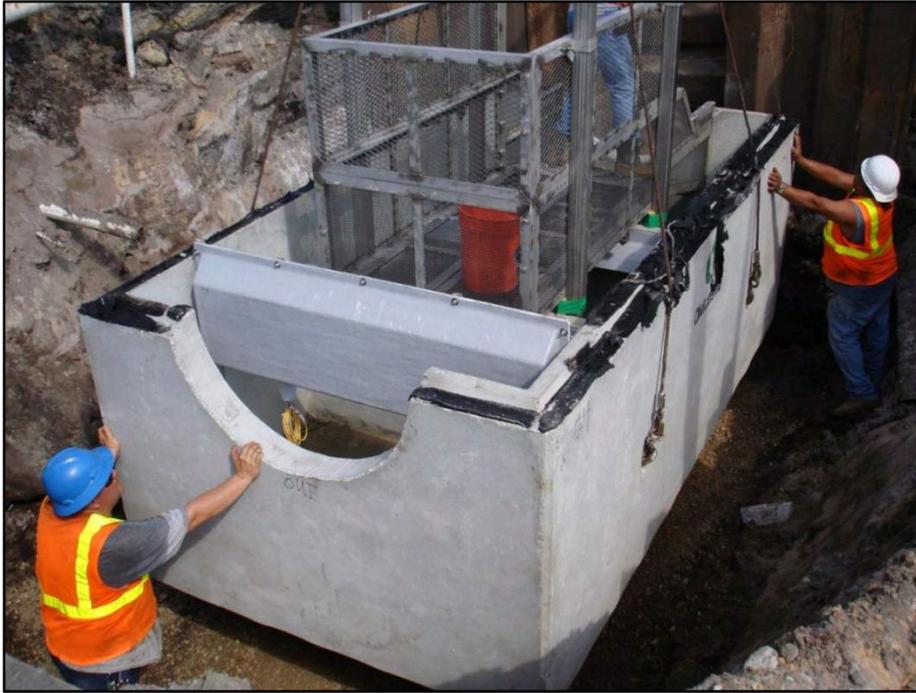
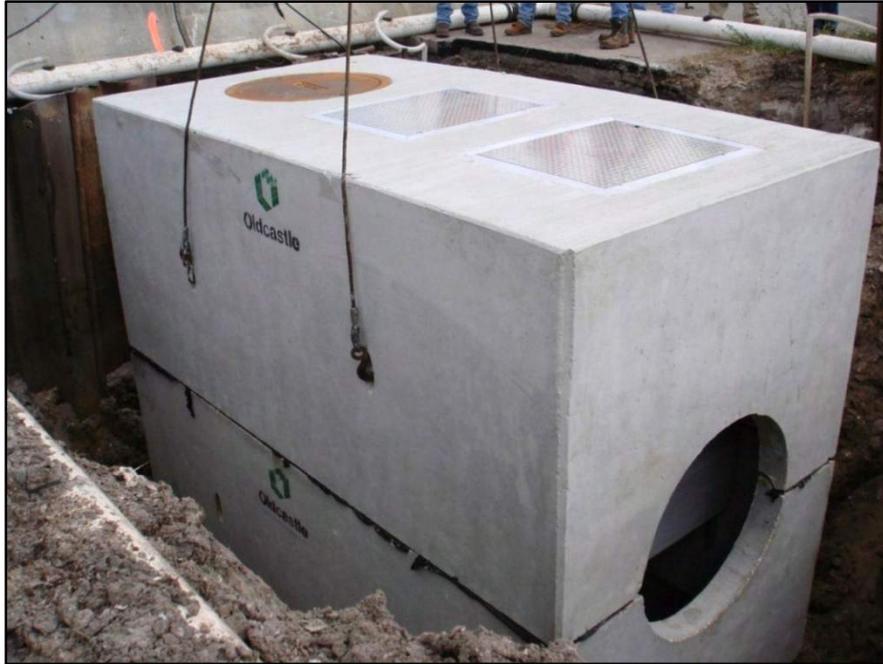
turbidity barriers on the outfall pipe. The baffle box was set in place on 06/06/08 and final site grading and sod replacement were completed on 06/10/08. The baffle box used at this site was made in two halves, which required a smaller crane and made placement and adjustments easier during installation (Figures 24 and 25). The drainage pipe at this site between the

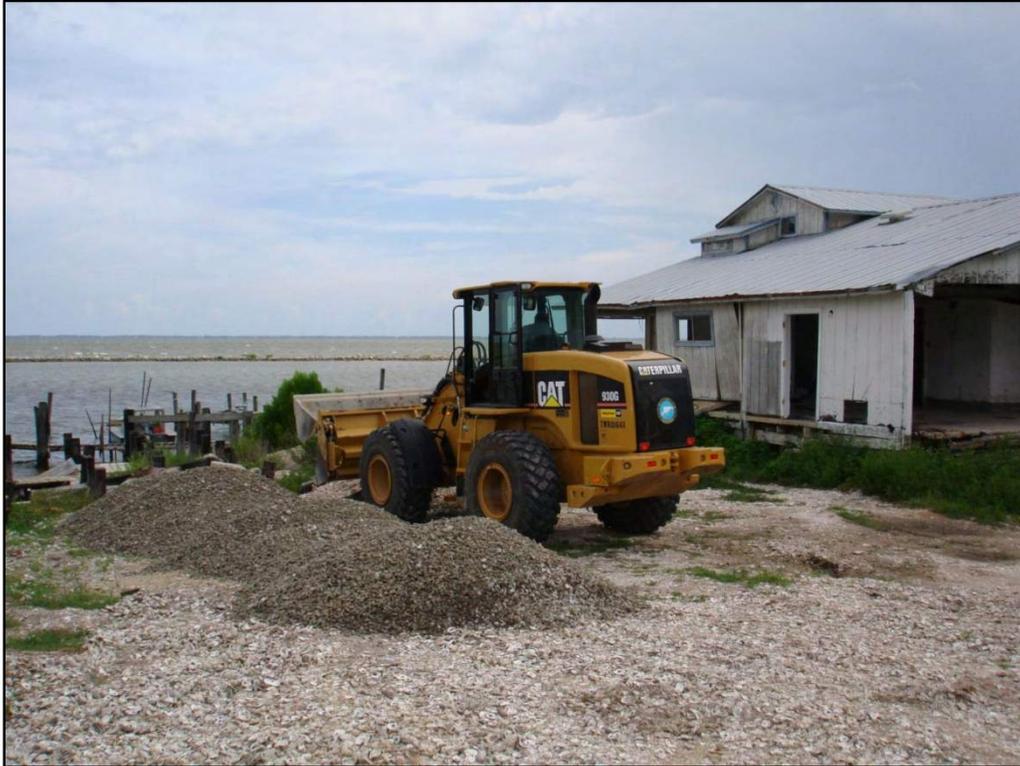
Figure 29: Site 4 – Oyster Shell Cover

final site grading (Figure 29). Object markers were placed along the sides of the box to keep cars off the aluminum access hatches (Figure 30).

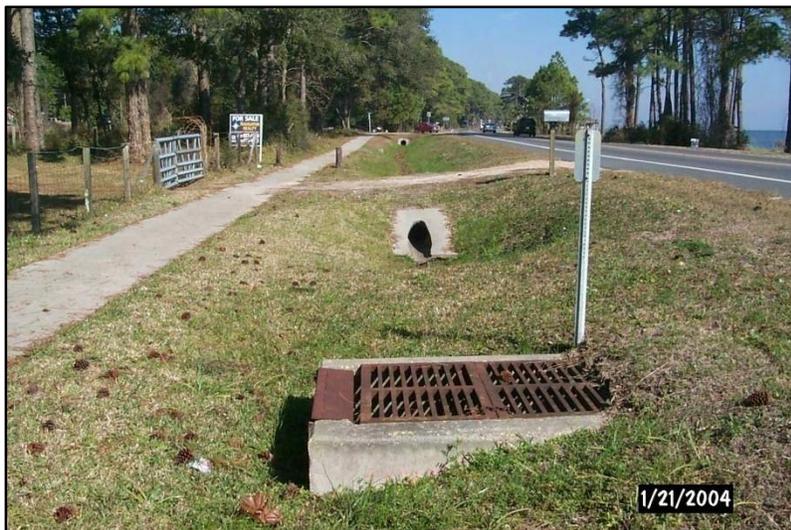
Figure 31: Site 5 – Pre-construction, Looking East.

box that was installed at the location of a drop inlet box that had two 24-inch diameter inflow pipes, one from the west and one from the east, and one 30-inch outfall pipe running south under US 98 (Figure 31). The stainless steel trash rack in this baffle box was modified to accommodate the inflow pipes on the sides of the box (shop drawing provided in Appendix A). The installation began on 06/11/08 with the installation of the well point system for de-watering the site. The baffle box was set in place on 06/13/08 and final site grading and sod replacement were completed on 06/16/08. A vacuum sewer line underground running east to west along the north side of US 98 required relocating during the installation of this structure. The contractor and the District worked with the local utility, Eastpoint Water and Sewer District, to temporarily close and reposition the vacuum line around the north end of the baffle box pit (Figure 32). The vacuum pipe was cut, temporarily capped and relocated around the site in a few hours with no disruption to service. Once the relocation was complete, the structure was set in place (Figures 33 and 34). After the baffle box was installed, the inflow and outflow pipes were connected and grouted and the site was backfilled and compacted. Sod was replaced so that only the top of the box is visible (Figure 35). Object markers were placed along the sides of the box to prevent cars from driving or parking on top of the aluminum hatches.

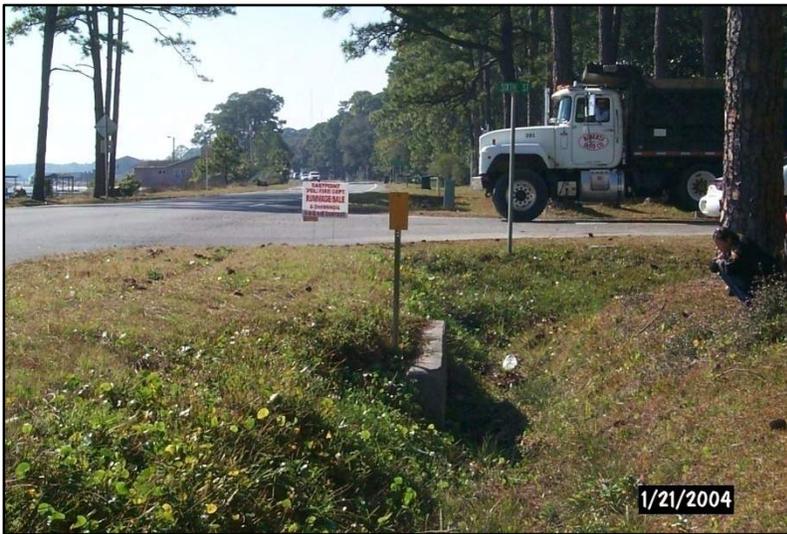
Figure 36: Site 6 – Pre-construction, Looking West.

that runs under US 98 and discharges to the sound (Figure 36). A 6' x 12' nutrient separating baffle box was installed at this site with an inflow opening on the north end to capture and treat runoff from the swale ditch (shop drawing in Appendix A). There were no underground utility conflicts at

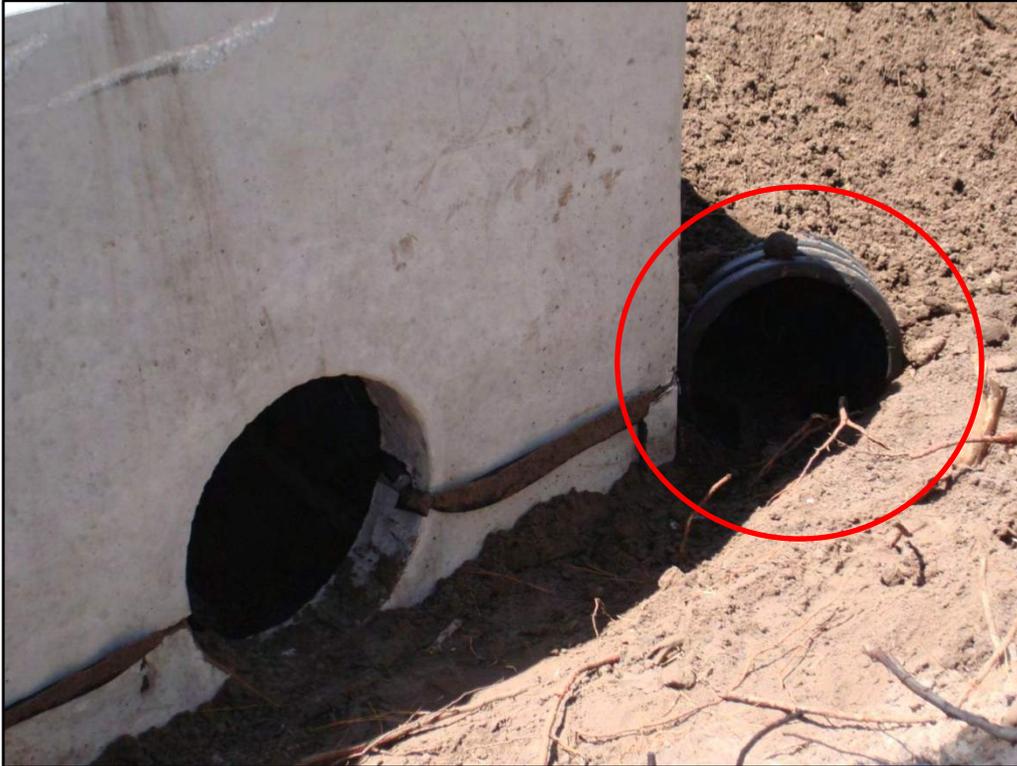
Figure 37: Site 6 - Culvert Re-route

this site. The well point system was setup on 05/27/08, the baffle box was set in place on 05/29/08 and final site grading and sod replacement were completed on 06/02/08. A buried box culvert was uncovered during excavation of the site that was not located during the survey or included on the site plan. The drainage pipe to this box culvert was re-routed to discharge into the ditch on the west side of the structure (Figure 37). During excavation, a large concrete collar around the outfall pipe was removed. This collar extended under the north shoulder of US 98 and required additional fill and compaction to stabilize the shoulder of the road (Figure 38). After the excavation was completed, a gravel base was laid and the upper and lower halves of the box were set (Figure 39). The site was graded and dressed with sod on the road shoulder and swale embankments (Figure 40). This baffle box is open on the north end and the 24-inch opening created a potential safety hazard for children and animals that could enter the structure from this opening. Stainless steel safety bars were installed horizontally over the end of the box with a 5-inch opening between the bars which will provide protection and not obstruct flow into the structure. Object markers were placed along the sides of the baffle box to keep cars from driving or parking on top of the aluminum hatches (Figure 41).

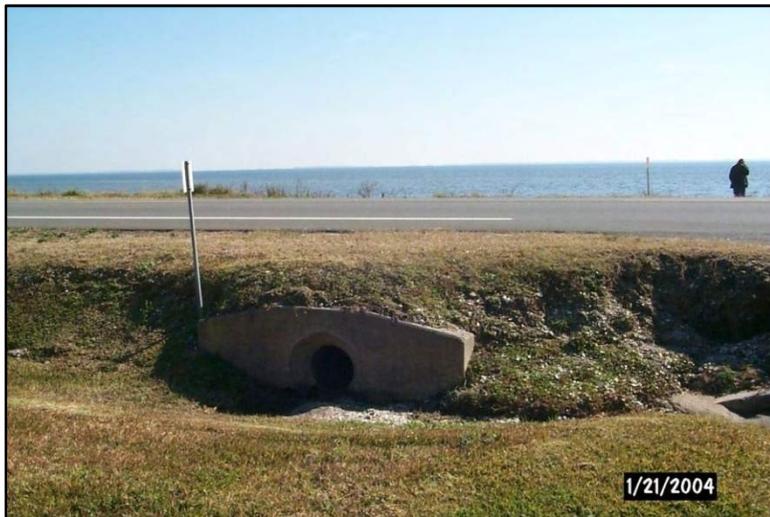
Figure 42: Site 7 – Pre-construction, Looking South.

storm drain pipe crosses under US 98 and discharges into the sound (Figure 42). A 6' x 12' nutrient separating baffle box was installed at this site and is open on the north end as the inlet from the swale ditch (shop drawing in Appendix A). There were no underground utility conflicts at this site. The

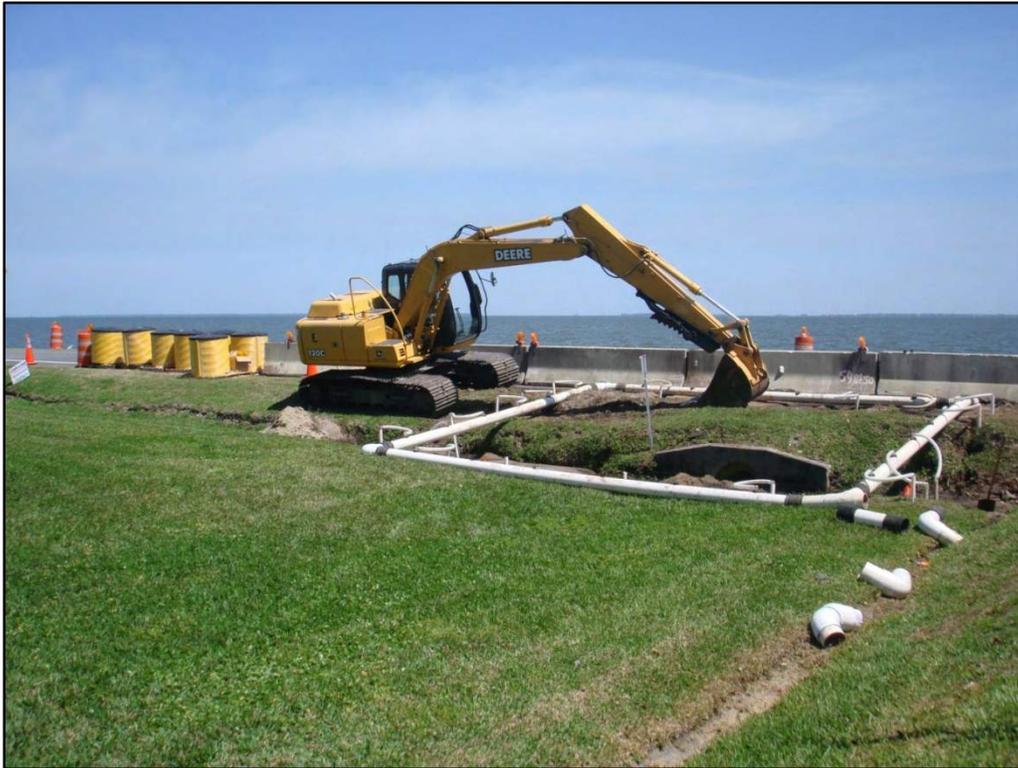
Figure 43: Site 7 De-watering Setup

The well point system and concrete barricades were set up on site on 05/06/08 (Figure 43) and excavation started the next day. The structure is located in the front yard of a well landscaped

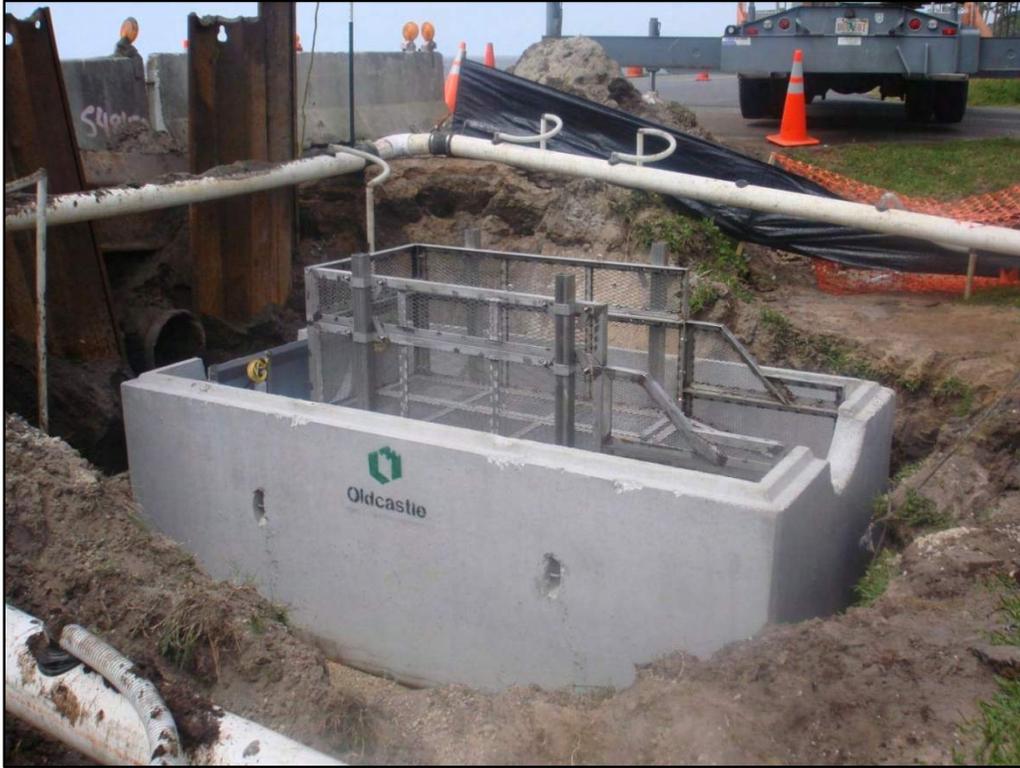
Figure 44: Site 7 – Lower Box Installation

smaller crane to set than the larger boxes. It was placed on 05/08/08 (Figures 44 and 45). Final grading and sod replacement were completed on 05/09/08. The south bank of the swale ditch west of the baffle box had a very steep slope and significant erosion prior to the start of construction. In addition, there is a cross drain pipe flowing into the ditch from the west under 7th Street. Due to these conditions, limestone riprap rock was used to dress the slope on the ditch west of the structure. The riprap will provide long term stability for the bank and allow the cross drain to function properly without scouring the bank or channel bottom. The property owners are pleased with the completed installation and feel it is a significant improvement over the previous condition (Figure 46).

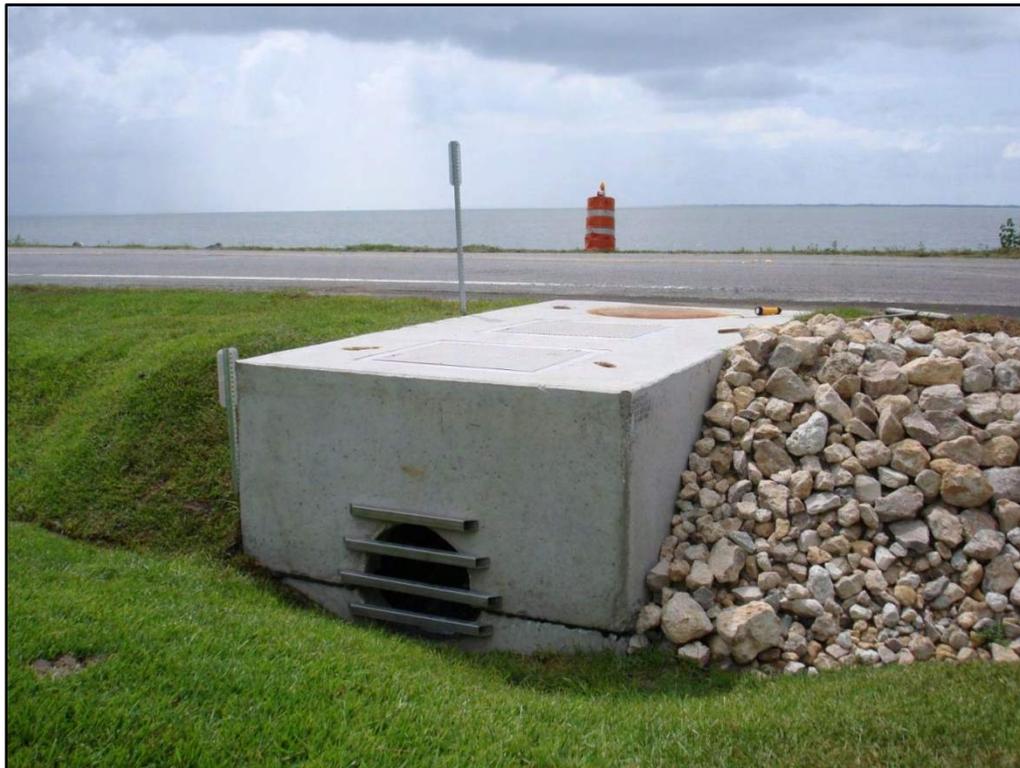
Figure 47: Site 7 – Completed Installation

This baffle box is open on the north end and stainless steel safety bars were installed horizontally over the end of the box with a 5-inch opening between the bars which will keep children and animals from entering structure and not obstruct flow. Object markers were placed along the sides of the baffle box to keep cars from driving or parking on top of the aluminum hatches (Figure 47).

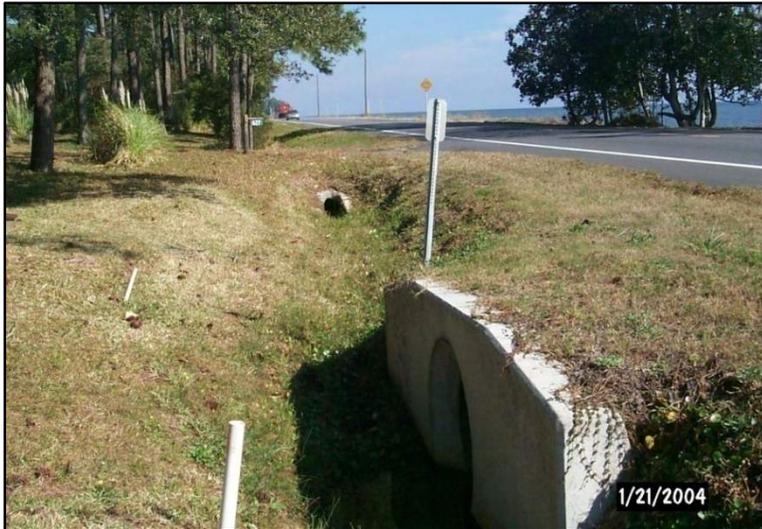
Figure 48: Site 8 – Pre-construction, Looking East

medium density residential land-use area that drains through a 30-inch pipe under US 98 to the sound (Figure 48). A 6' x 12' nutrient separating baffle box was installed at this location that is open on the north end providing the inflow orifice for the structure. The shop drawing is provided in

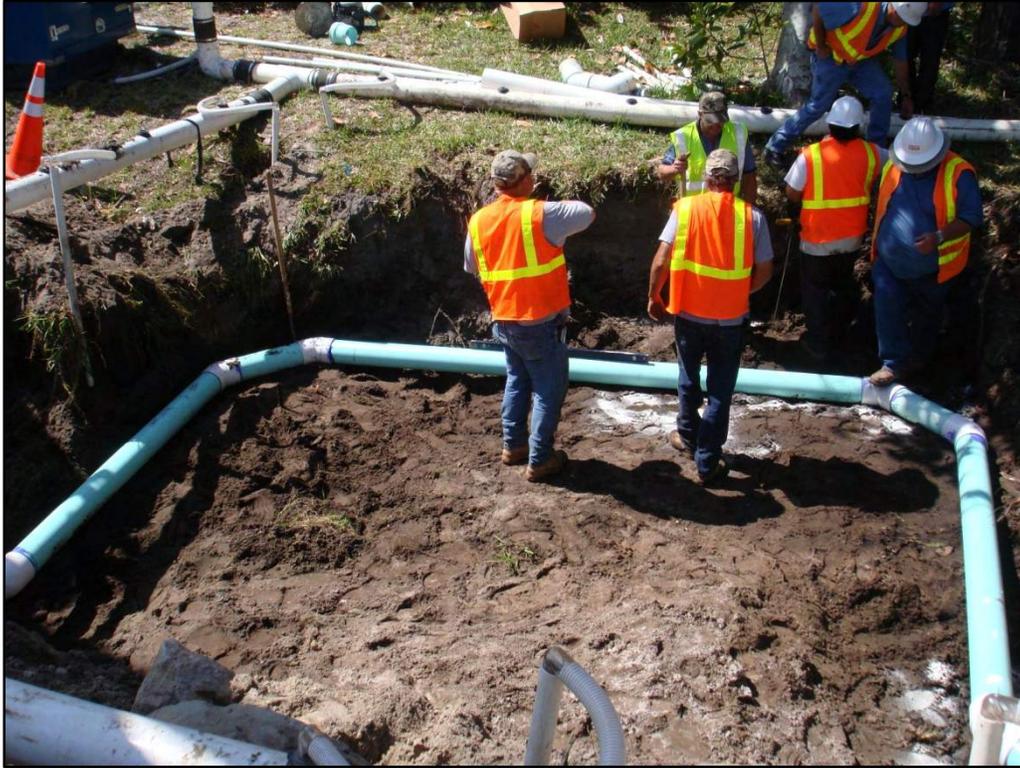
Figure 49: Site 8 - Sewer Line Relocation

the first structure installed on the project. The well point system was set up on 04/28/08 and excavation of the site started the next day. The culvert headwall at the ditch was excavated and removed. A second headwall was found near the road shoulder that had been left in place from a previous road widening. FDOT confirmed that it is standard practice to leave existing headwalls and bury them in place when widening roads. There was a vacuum sewer line conflict at this site that required relocating the sewer line around the north end of the structure (Figure 49). Eastpoint Water and Sewer District, the local utility that provides water and sewer service to the Eastpoint area, provided on site assistance and inspection for relocation of the sewer line. No waste was spilled or discharged from the pipe when the line was re-located. Once the vacuum sewer relocation was complete, the structure was set in place on 05/02/08 (Figure 50). After the drain pipe was connected and grouted, the site was backfilled, compacted and graded. The site was dressed with sod on 05/06/08. This baffle box is open on the north end to function as the drainage inlet to the structure. Stainless steel bars were installed horizontally over the end of the box with a 5-inch opening between the bars which will keep children and animals from entering structure and not obstruct flow.

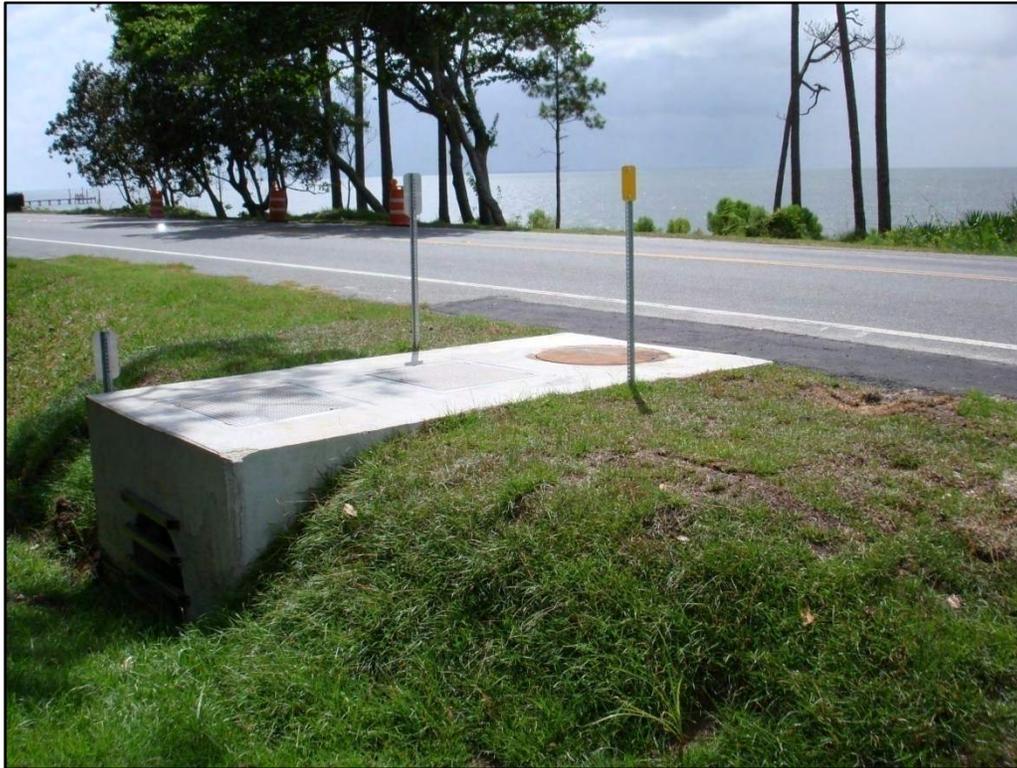
Figure 51: Site 8 – Completed Installation

The structure has a load bearing manhole that is located near the shoulder of the road that is designed for vehicular traffic. Object markers were placed along the sides of the baffle box to keep vehicles from driving or parking on top of the aluminum hatches (Figure 51).
