LIVE OAK POINT LIVING SHORELINES

2022 (Fall) Reference Site Monitoring Report

USACE Permit No.: SAJ-2011-00287

Project Location: Live Oak Point Salt Marsh Reference Site
30.42° North, -86.27° West
Approximately 2 ½ Miles NW of Santa Rosa Beach
Walton County, Florida

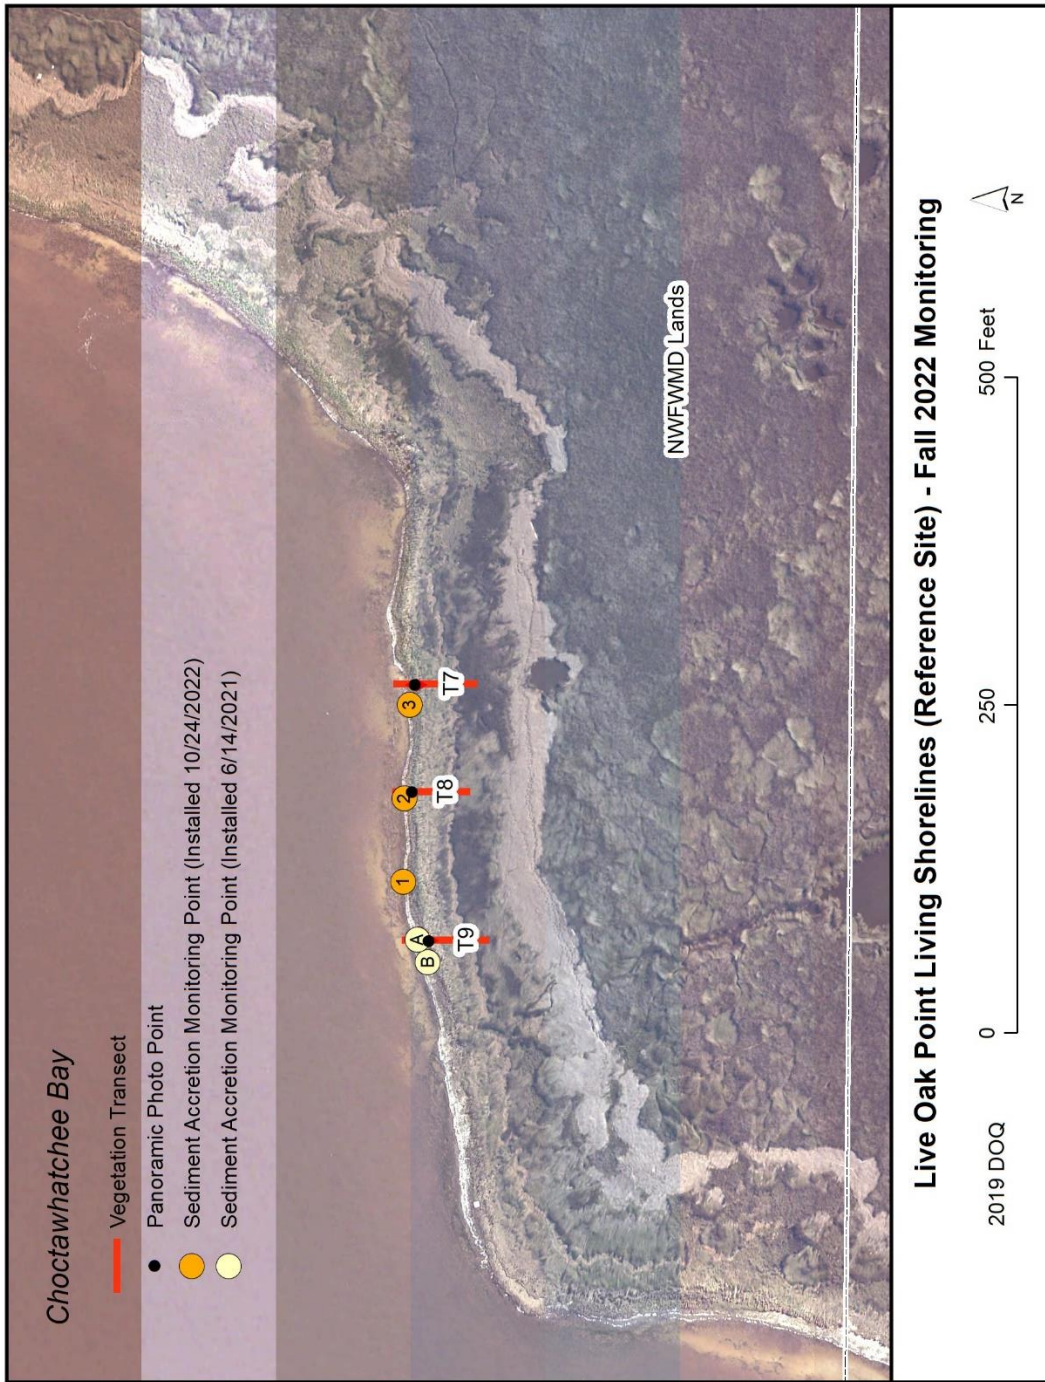
Figure 2. Fall 2022 Reference Site Monitoring Closeup

⁶ Point "A" is a circular (4" DIA) stainless steel drain plate installed 6/14/2021 at 2.5 cm below the surface. Point "B" was (missing and presumed washed away) a circular (4" DIA) PVC drain plate installed 6/14/2021 at 5.1 cm below the surface. Points SB1 – SB3 are 4" x 7" concrete paving stones installed 10/24/2022 at depths of 21.9 cm, 16.9 cm, and 21.3 cm, respectively, beneath the surface (identified on Figure 2 map as Points 1 – 3).
