**TATE’S HELL - PINE LOG CREEK MITIGATION SITE**  
Annual Monitoring Report, Year 1 of 5  
February 21, 2012

**PROJECT OVERVIEW**

Mitigation: Tate’s Hell – Pine Log Creek  
Hydrologic Restoration Project, Franklin County

Date of Inspection: January 18, 2012

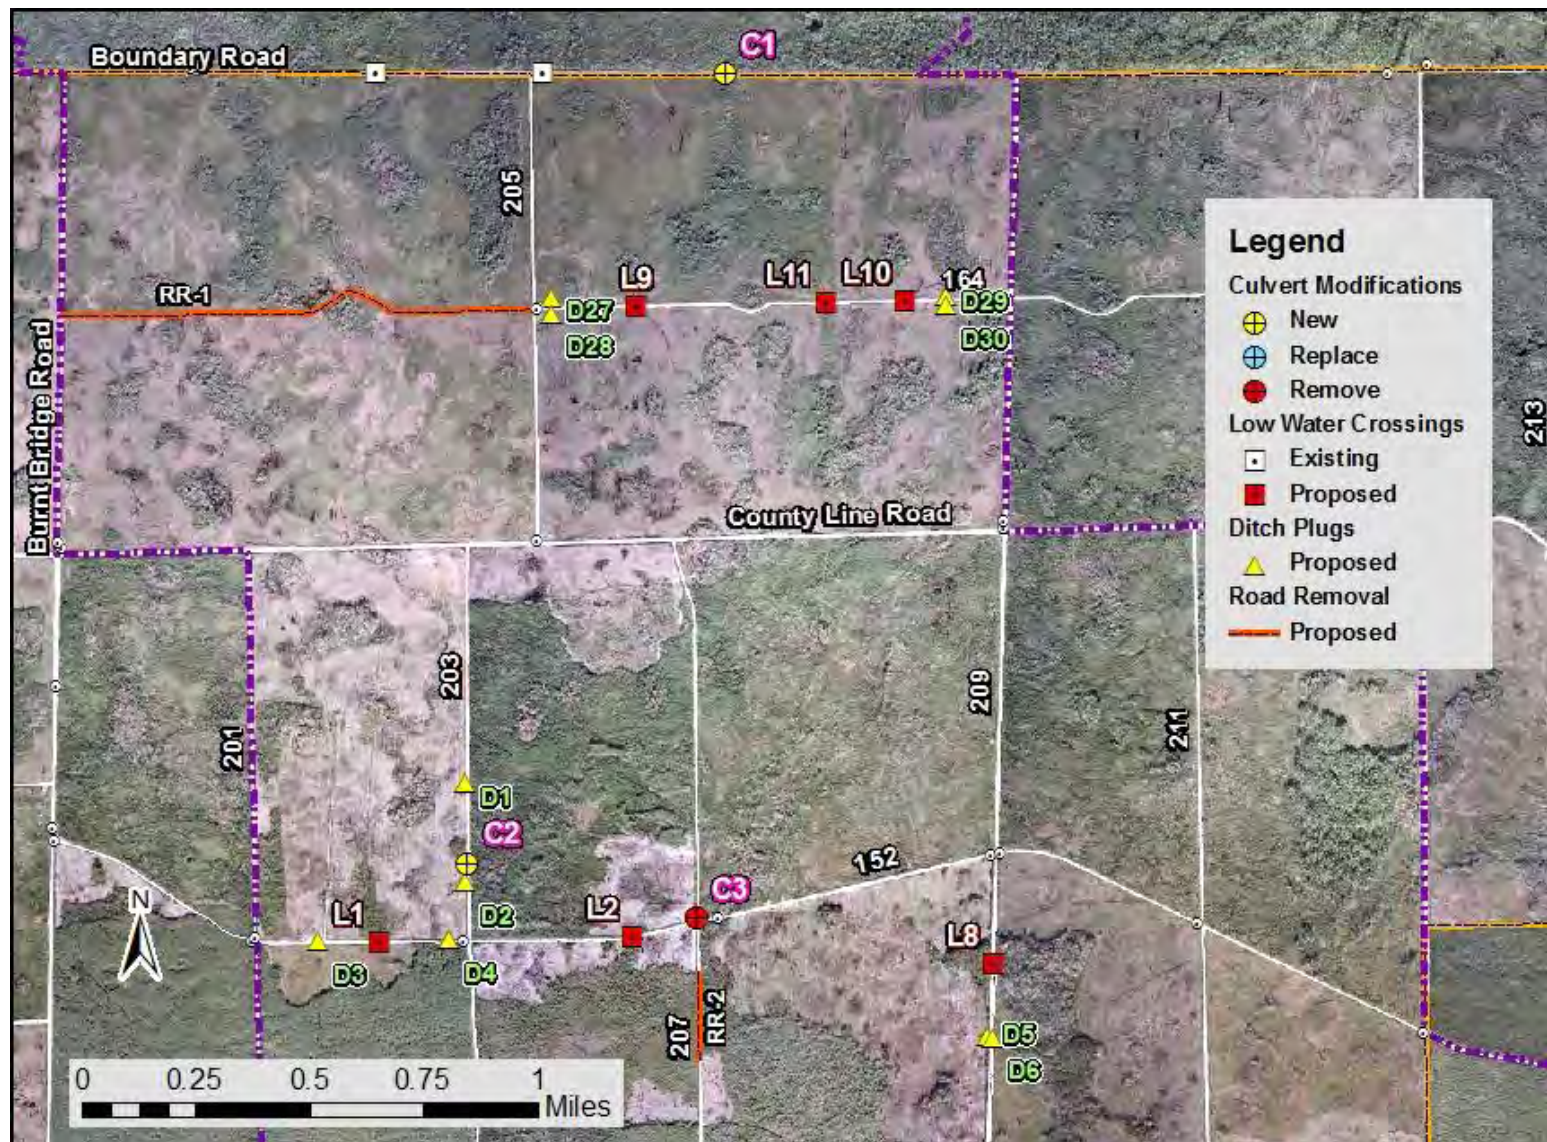
Figure 3. Hydrological restoration activities in the northern portion of the Pine Log Creek basin. Improvements are labeled as road removal (RR), low-water crossing (L), ditch plug (D), culvert (C), flashboard riser (F) and numbered for reference in text. [RTN](#)

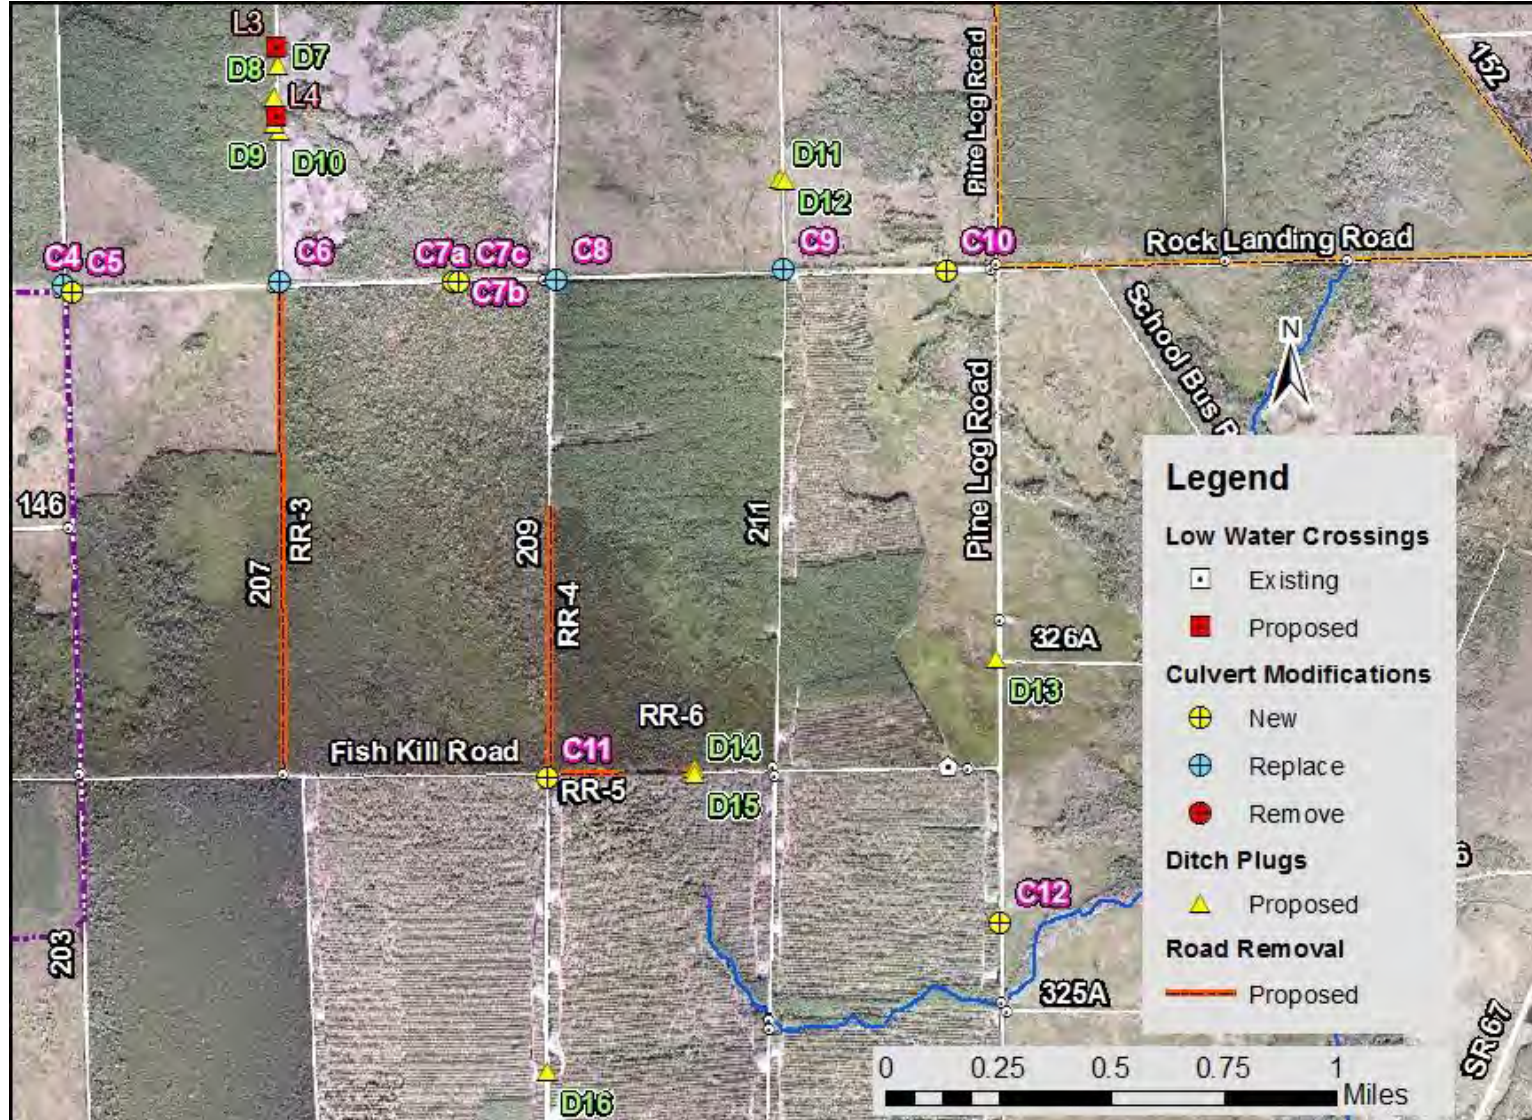
Figure 4. Hydrological restoration activities in the central portion of the Pine Log Creek basin. Improvements are labeled as road removal (RR), low-water crossing (L), ditch plug (D), culvert (C), flashboard riser (F) and numbered for reference in text. [RTN](#)

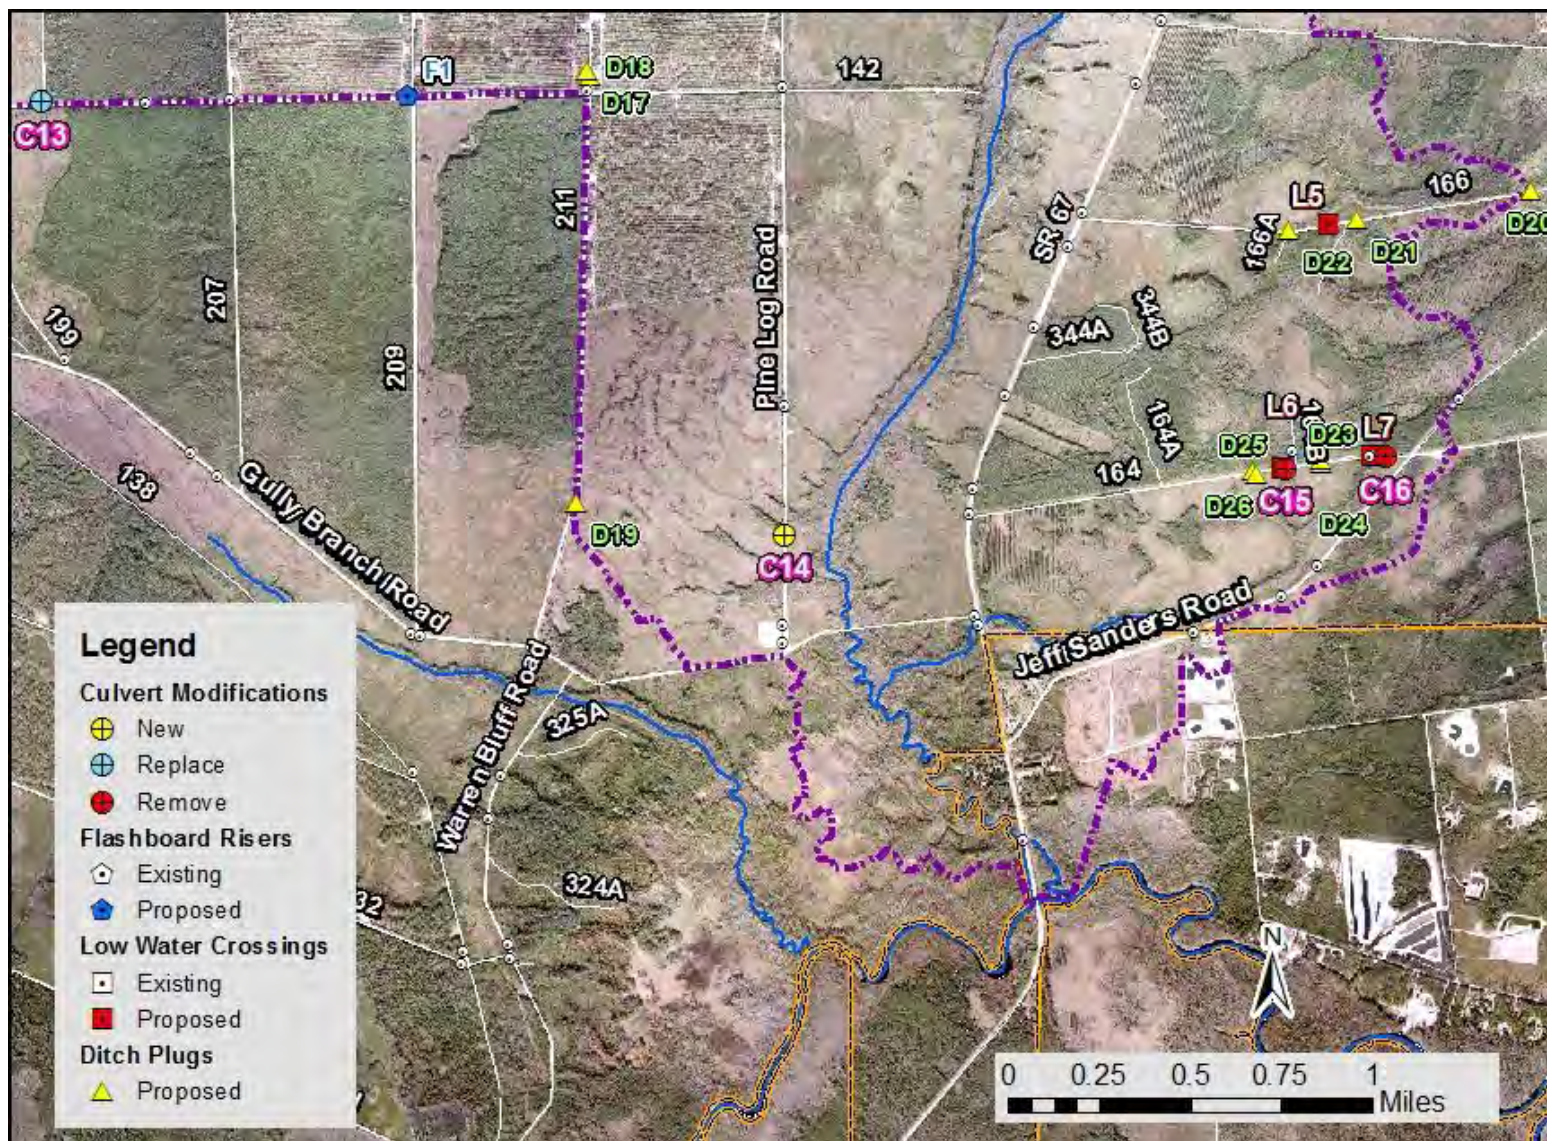
Figure 5. Hydrological restoration activities in the southern portion of the Pine Log Creek basin. Improvements are labeled as road removal (RR), low-water crossing (L), ditch plug (D), culvert (C), flashboard riser (F) and numbered for reference in text. [RTN](#)

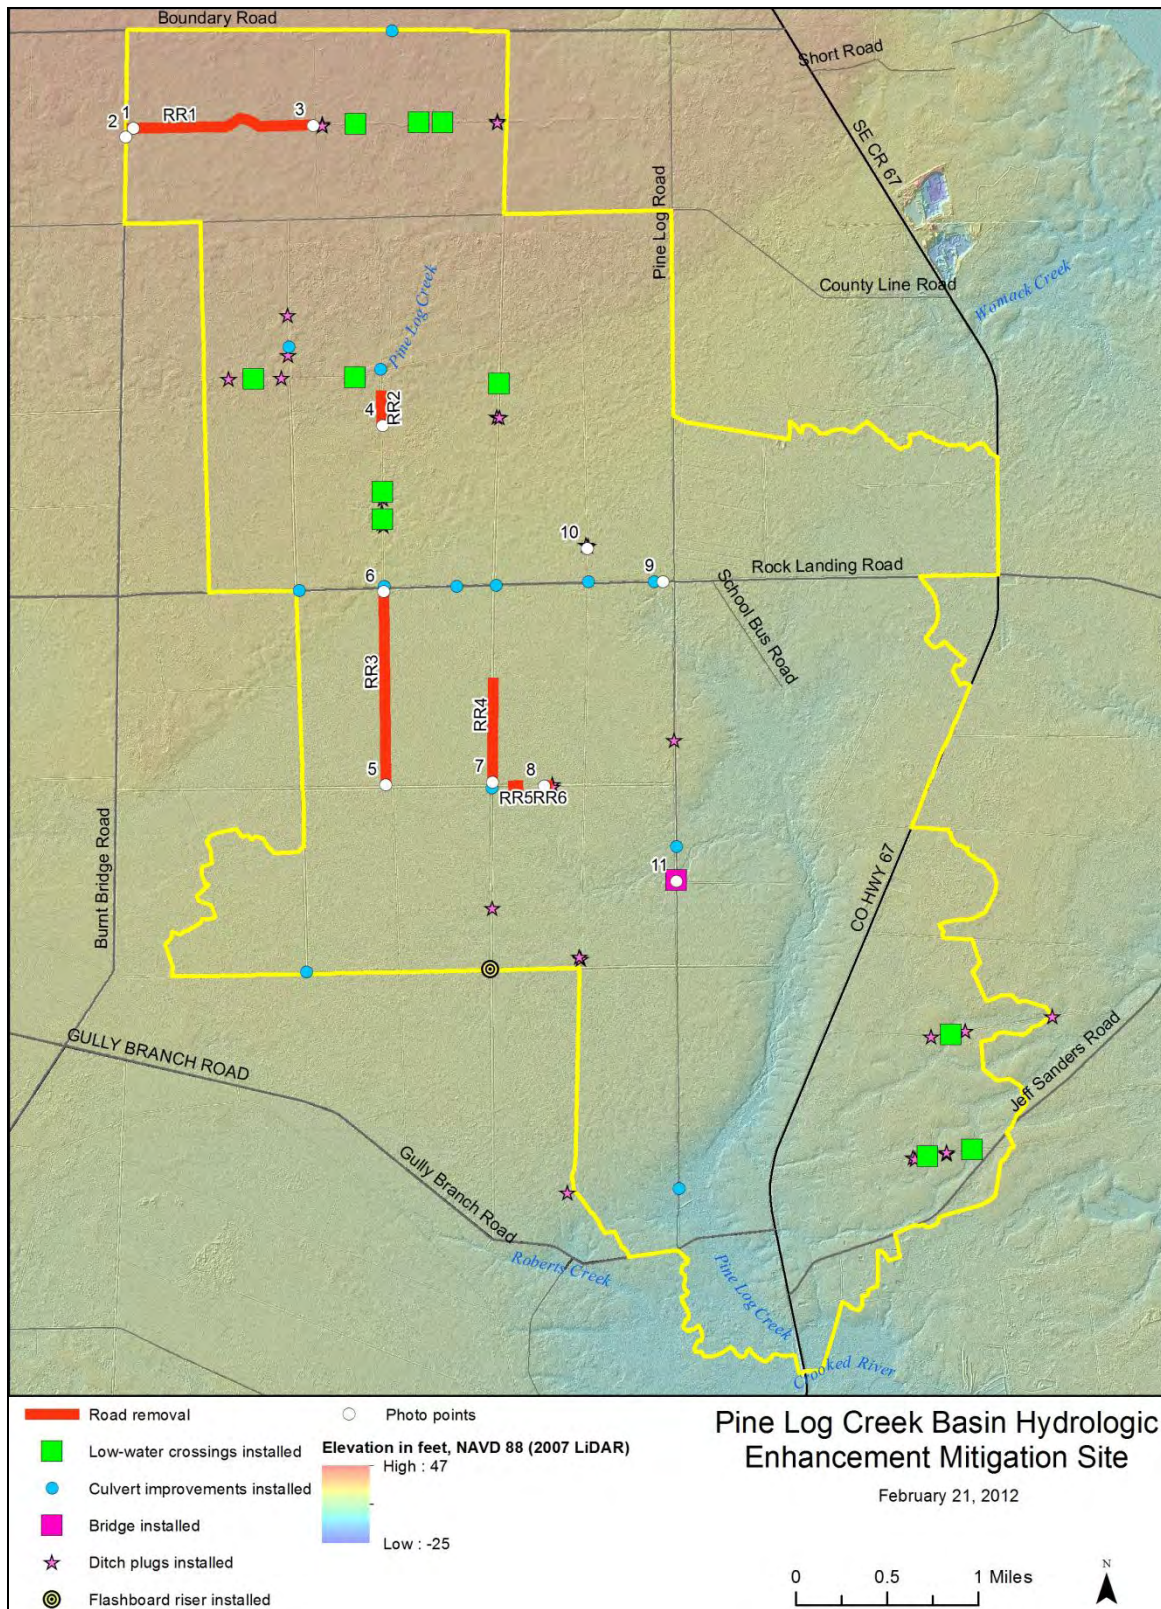
Figure 6. Topography of the Pine Log Creek mitigation site taken from LiDAR imagery (2006). Photo points are indicated as 1-11. [RTN](#)
