Tate's Hell State Forest Hydrologic Restoration Plan

Volume II: Basin Restoration Plans 2010 - 2020

Northwest Florida Water Management District
81 Water Management Drive, Havana, Florida 32333-4712

Florida Division of Forestry
290 Airport Road, Carrabelle, FL 32322

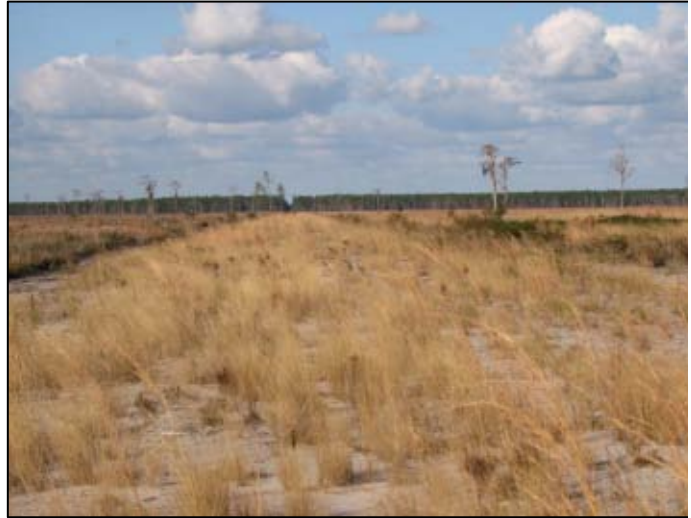
Figure 1. Road removal footprint following one year of vegetation regrowth.

Road removals involve using bulldozers or other heavy equipment to excavate and recontour a segment of a dirt logging road to match the adjacent natural grade. The excavated road material is used to fill in adjacent drainage ditches. Road removals have been proposed in selected areas where existing roads bisect existing or former wetlands and streams and where roads have altered natural surface water drainage patterns. Road removals were generally limited to areas where both sides of the road are unsuitable for long-term timber management and where pines are currently absent or

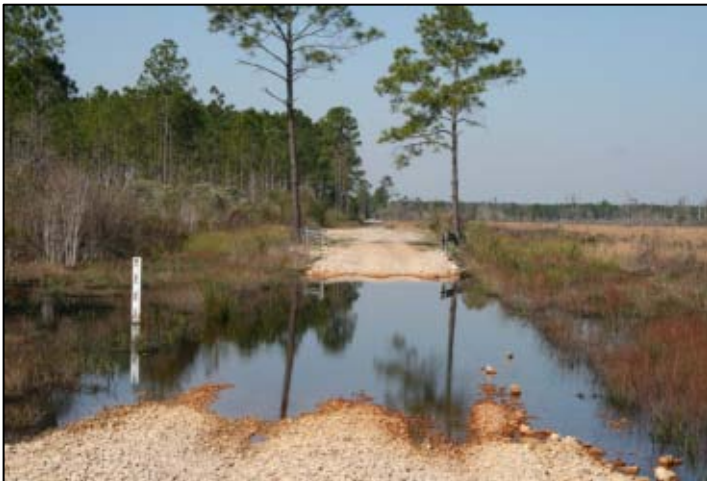
Figure 2. Low water crossing

Road attributes and LiDAR land surface elevations were also reviewed. In some instances, existing culverts are proposed to be replaced with low water crossings to increase conveyance capacity and restore channel morphometry. Due to the need to maintain year-round vehicle access, low water crossings have generally not been proposed on primary roads or roads leading directly to campsites.

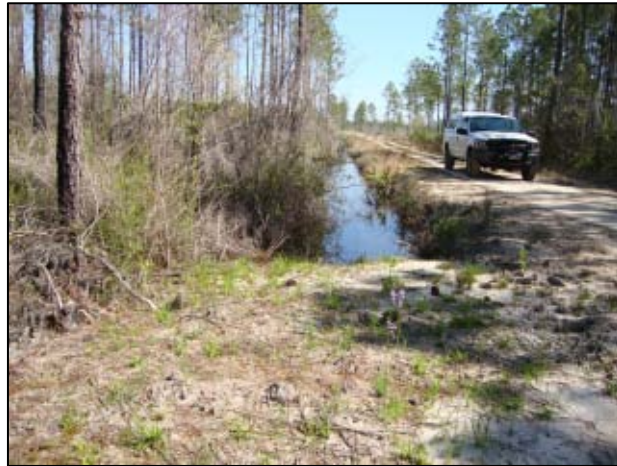
Figure 3. Earthen ditch block

Ditch blocks and flashboard risers are proposed where it is desirable to reduce, redirect, or prevent surface water flow in roadside ditches. Ditch blocks also may be used to restore local topographic features or to prevent ditch flow across hydrologic basins. The construction of a ditch block involves placing fill material in a ditch, compacting the material, and seeding and mulching the ditch block top surface and side slopes with native grasses to prevent erosion. Ditch blocks are generally constructed using onsite soil materials such as road fill excavated during the construction of low water crossings.

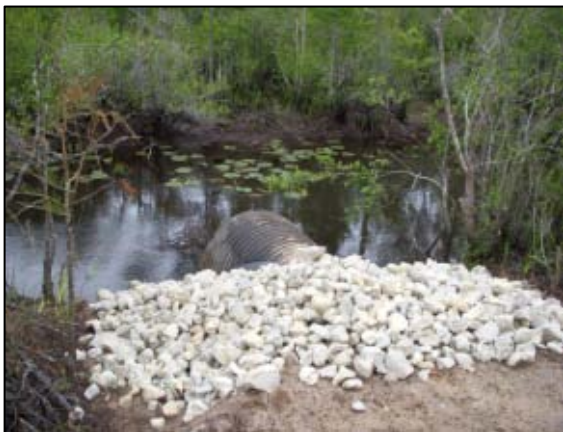
Figure 4. Recently installed culvert

Culverts modifications include the installation of new culverts and the replacement or removal of existing culverts. The evaluation of recommended culvert modifications focused on adding culverts to re-connect contributing drainage areas and removing culverts that transfer water across historical basin

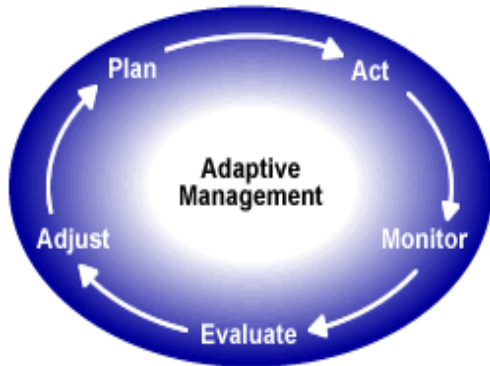
Figure 102. Adaptive management (NOAA 2008)

Post-construction monitoring of environmental conditions and hydrologic structures should be performed at Tate’s Hell State Forest to ensure that desired ecosystem conditions are achieved and restoration goals are met. There are many uncertainties inherent in the restoration process and many reasons why actual ecosystem conditions may differ from those set forth as restoration goals. An adaptive management approach recognizes that uncertainties exist and provides the flexibility to take corrective actions to address them (Figure 102). An adaptive management approach to wetland
