# DUTEX PROPERTY UMBRELLA REGIONAL MITIGATION PLANS FOR FLORIDA DEPARTMENT OF TRANSPORTATION PROJECTS CONCEPTUAL MITIGATION PLAN ESCAMBIA COUNTY, FLORIDA

June 24, 2010

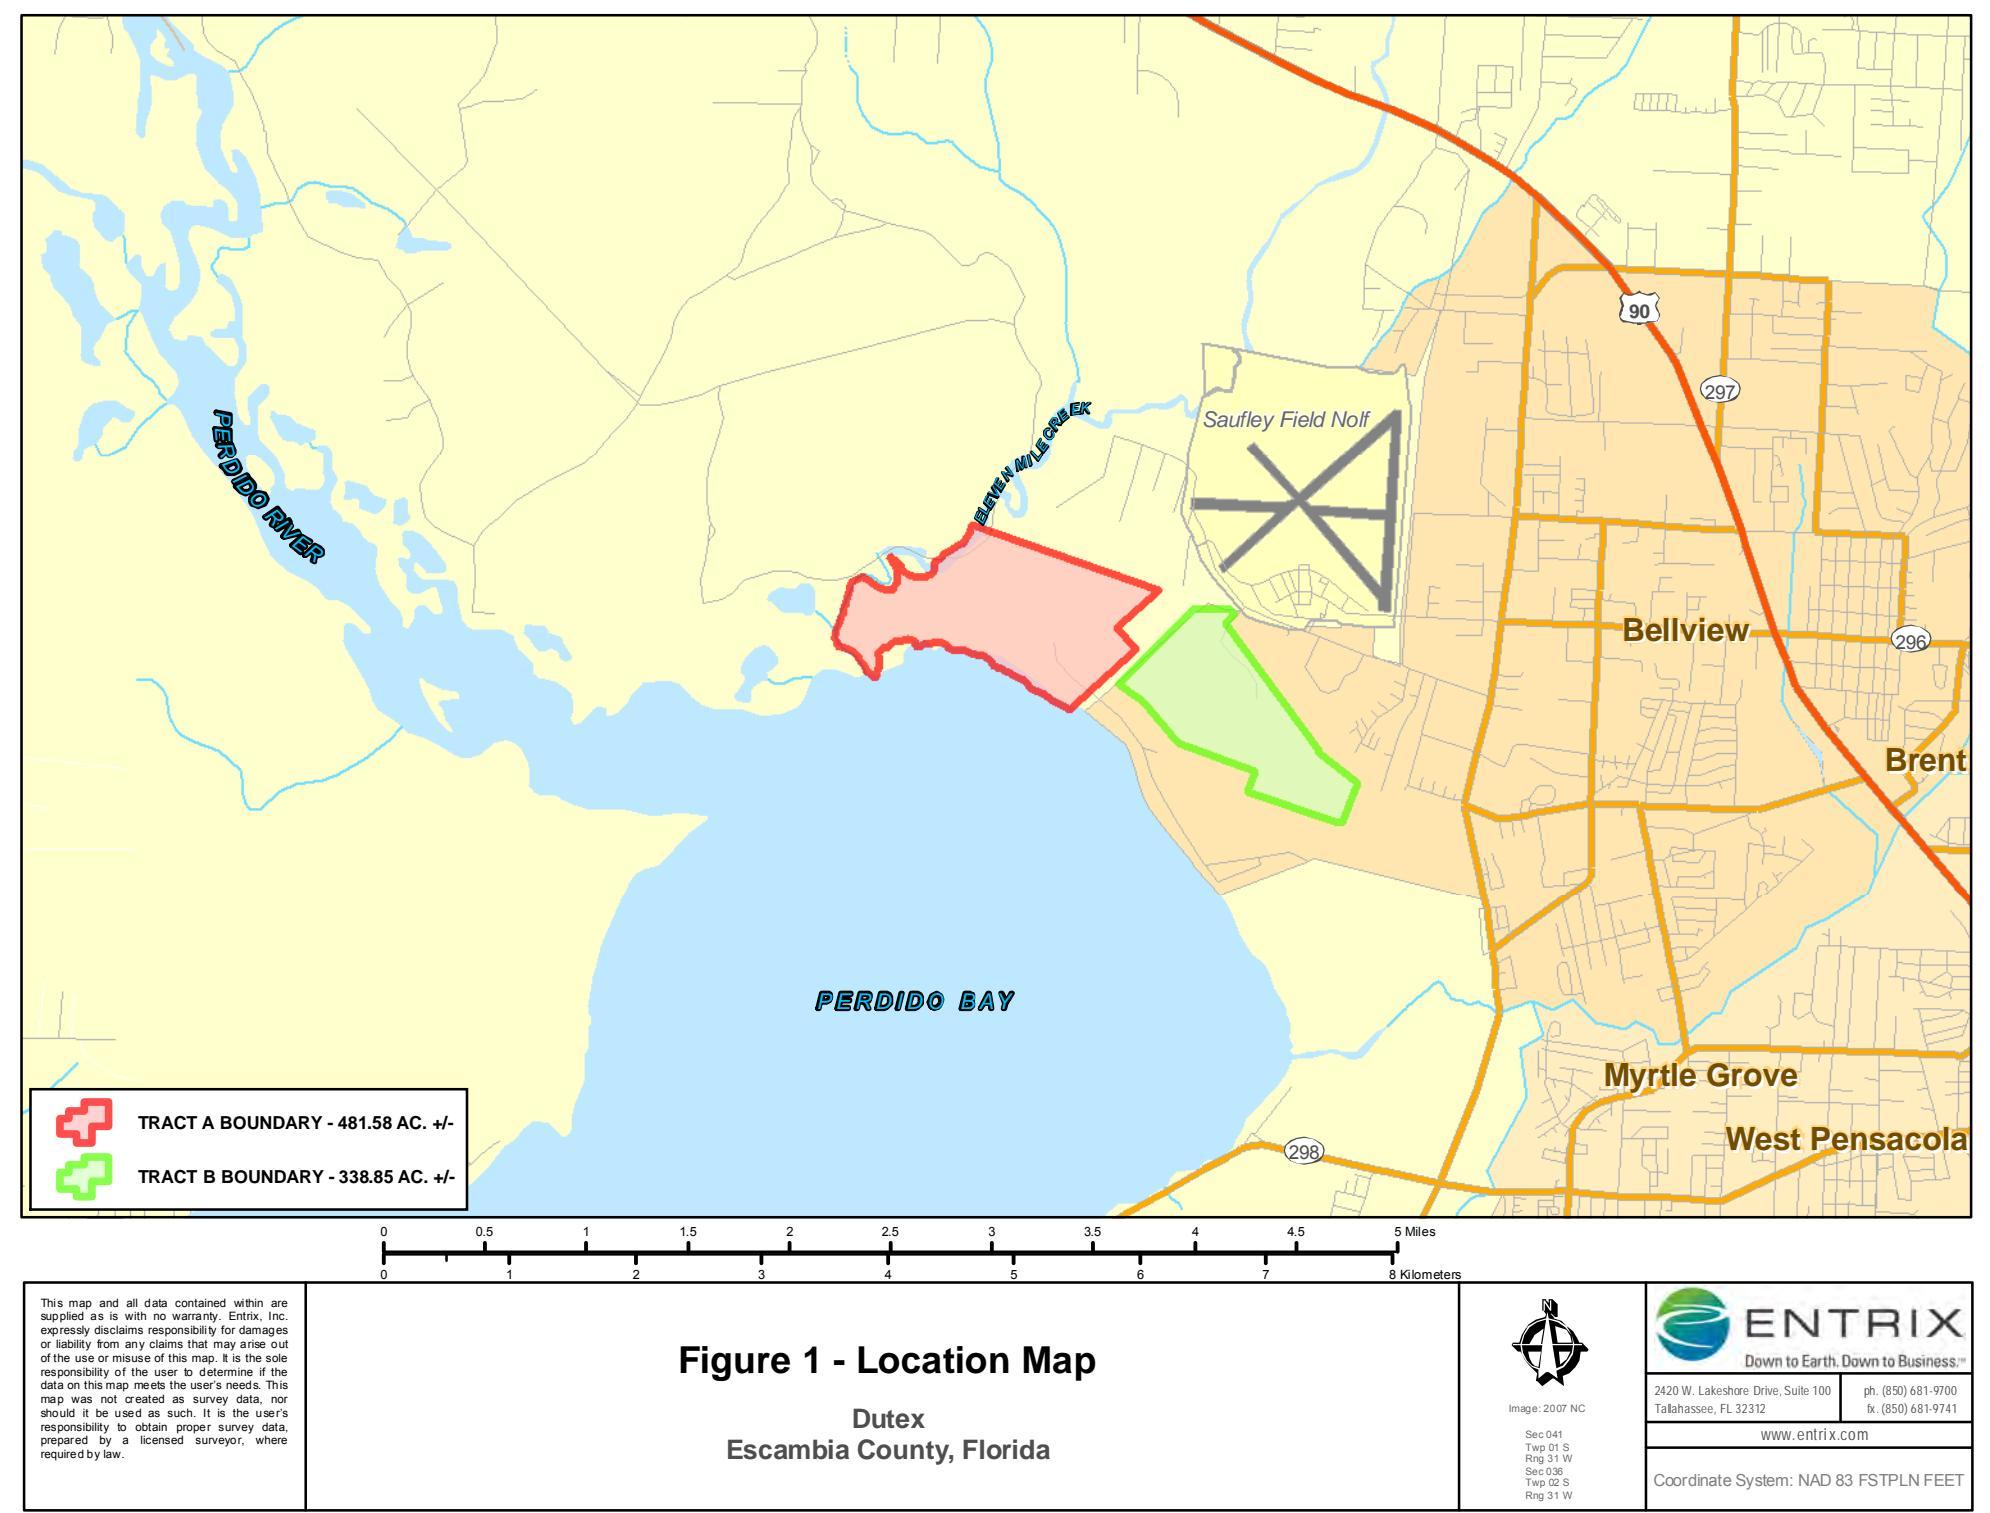
Dutex (Section 36, Township 2S, Range 31W) is approximately 820 acres located in the Perdido watershed between Perdido Bay and Saufley Field (part of the Pensacola Naval Air Station facilities), Escambia County, Florida; see **Figure 1**. The property lies north of Perdido Bay (a Class III water body), bordered by Eleven Mile Creek to the west and Saufley Field, a naval training facility, to the north. Topographic changes within Dutex are detailed on a United States Geological Survey (USGS) Quadrangle map as **Figure 2**.

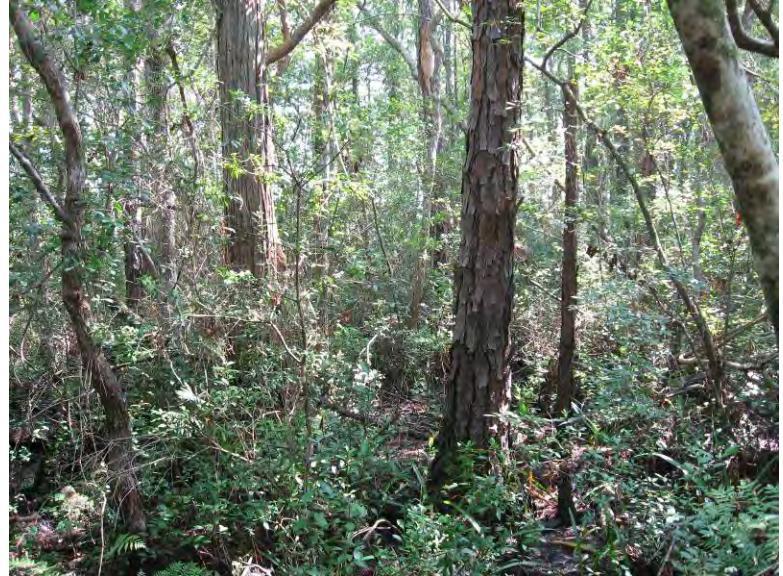
South of beaver pond (Gum Swamp; FLUCCS 613)

This system occurs immediately south of the beaver dam and grades into the freshwater marsh. Very few large tree specimens were observed within this community, and were primarily limited to a few pond cypress and slash pine. Shrub growth was primarily limited to rooting on hummocks. Some cypress cut stumps were observed. Pond cypress recruitment was also present.

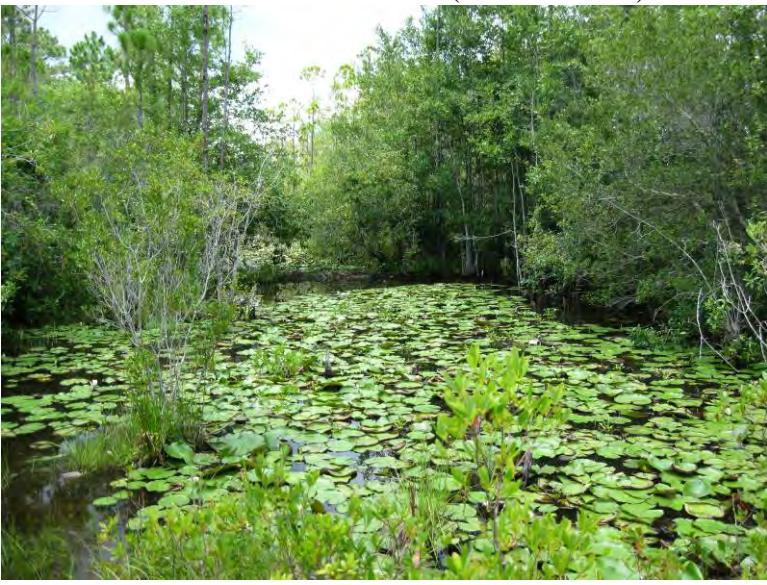
Ditch (FLUCCS 510)

A system of primarily wetland cut ditches and associated roads occur across Tract A. These ditches are associated with either an existing or historic fill road. These ditches were likely created as a result of fill road construction and not for the sole purpose of wetland drainage. Commonly observed ditch vegetation includes southern umbrellasedge (*Fuirena sciroides*), manyhead rush (*Juncus polycephalus*), fringed beaksedge (*Rhynchospora ciliaris*), needlepod rush (*Juncus scirpoides*), fascicled beaksedge (*Rhynchospora fascicularis*), torpedograss (*Panicum repens*), and common water-hyacinth (*Eichhornia*)

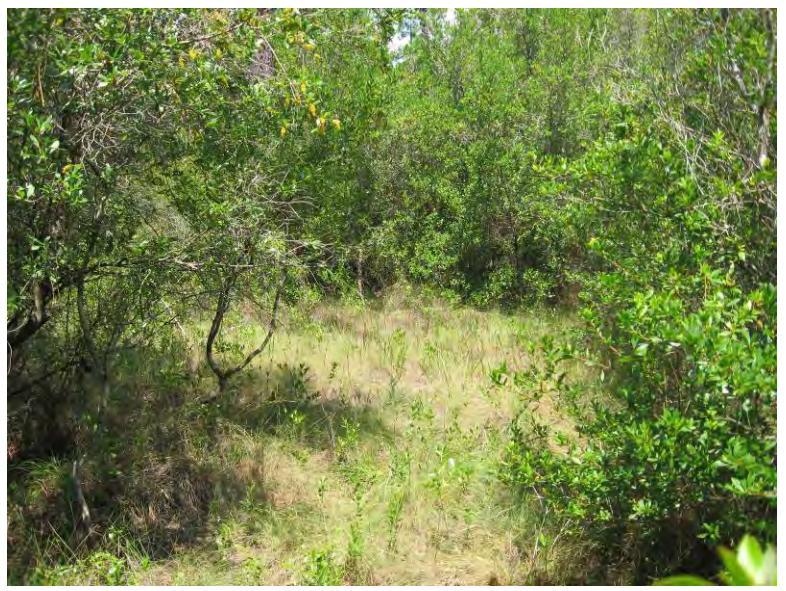
Canopy opening in Pine Flatwoods (FLUCCS 411)

The duff layer throughout this designation was typically deep and ground cover minimal. Occasional canopy openings often contained relict flatwoods herbaceous species including wiregrass (*Aristida stricta*), downy milkpea (*Galactia volubilis*), Carolina yelloweyed grass (*Xyris caroliniana*), and pale meadowbeauty (*Rhexia mariana*).

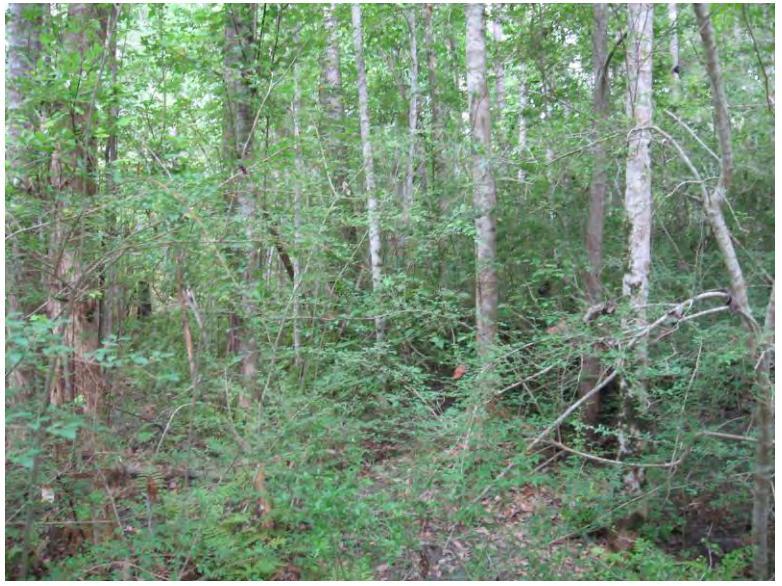
Bay Swamp with Privet (FLUCCS 611)

This community designation is dominated by sweetbay. Additional canopy species observed include tulip popular (Liriodendron tulipifera), swamp bay (Persea palustris) and red maple (Acer rubrum). Slash pines were occasionally present as canopy trees. Although no cypress species were observed within this community, several small cypress stumps were present. Herbaceous groundcover was dominated by Additional species observed included poison ivy, evergreen bayberry (Myrica sensitive fern. caroliniensis), Virginia chain fern, and littlehead nutrush (Scleria oligantha), common boneset (Eupatorium perfoliatum), water cowbane (Oxypolis filiformis), mild waterpepper (Polygonum cf. hydropiperoides), possumhaw (Viburnum nudum), fringed velloweved grass (Xyris fimbriata), hairy maiden fern (Thelypteris hispidula), lax hornpod (Mitreola petiolata), irisleaf yelloweyed grass (Xyris laxifolia var. iridifolia) and marsh fern (Thelypteris palustris). A large amount of Chinese privet (Ligustrum sinense) is present throughout the northern half of this community.

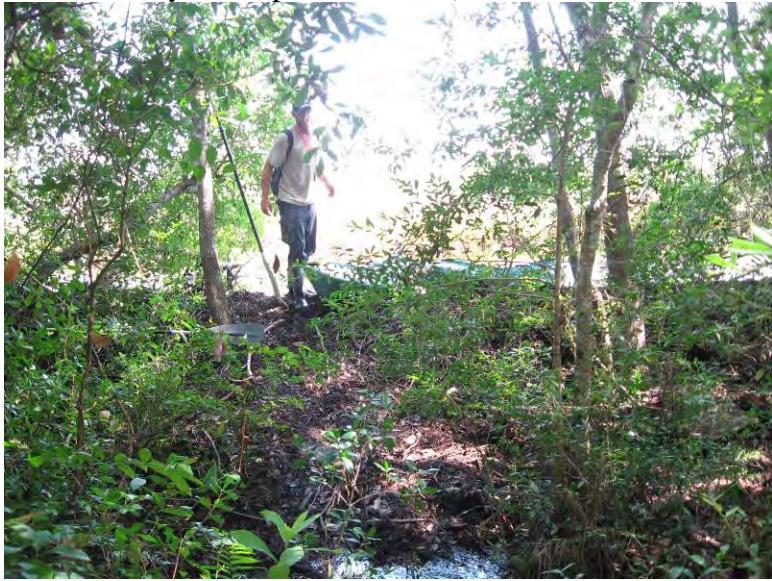
Beaver Dam (FLUCCS 747)

No significant changes in vegetative assemblages or structure are anticipated to occur within existing gum swamps. Following removal of the beaver dam, currently inundated lands are anticipated to revegetate naturally and succeed back to historic vegetative conditions.

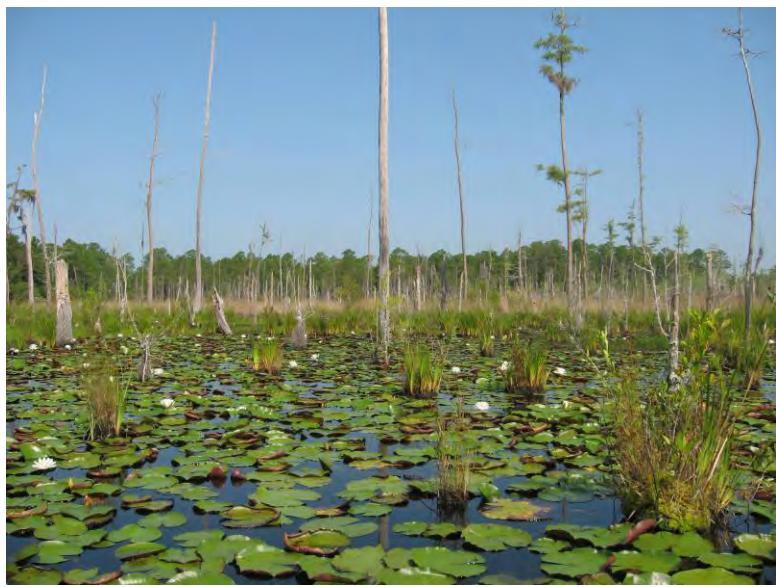
Beaver Pond (FLUCCS 534)

This feature was created through the flooding of a gum swamp. Downstream wetlands appear sufficiently hydrated and vegetative structure appropriate. Remnant tree stumps and standing dead cypress trees are present throughout this community. The center of this community designation contains a large area of floating and emergent herbaceous vegetation. Herbaceous vegetation is also rooted on persisting hummocks and cypress buttresses. Deeper inundated lands are dominated by fragrant water lily (Nymphaea odorata). Vegetation observed included white-topped pitcherplant (Sarracenia leucophylla). southern umbrellasedge (Fuirena scirpoidea), saltmarsh umbrellasedge (F. breviseta), wooly witchgrass (Dichanthelium scabriusculum), acid swamp yelloweyed grass (Xyris serotina), purple love grass (Eragrostis refracta), hairy primrosewillow (Ludwigia pilosa), slender beaksedge (Rhynchospora gracilenta), bunched beaksedge (Rhynchospora cephalantha), and switch grass (Panicum virgatum).

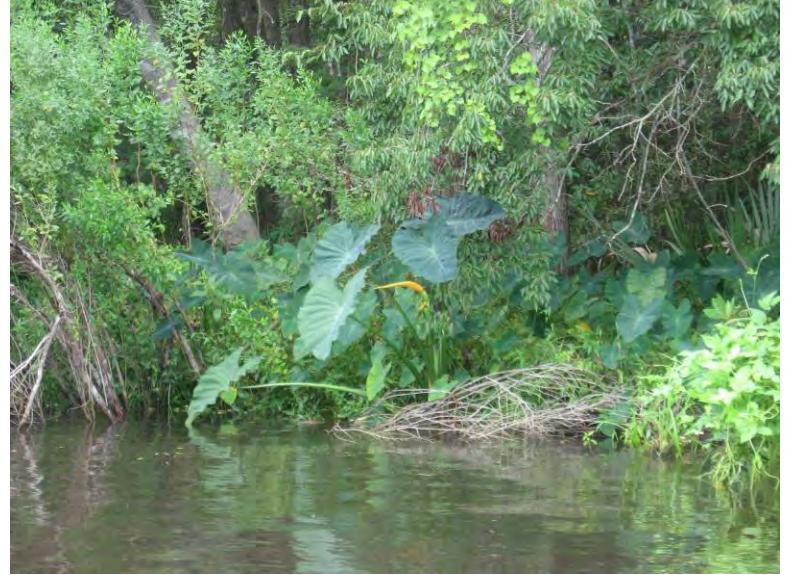
Stream and Waterways (FLUCCS 510) with Wild Taro (Colocasia esculenta)

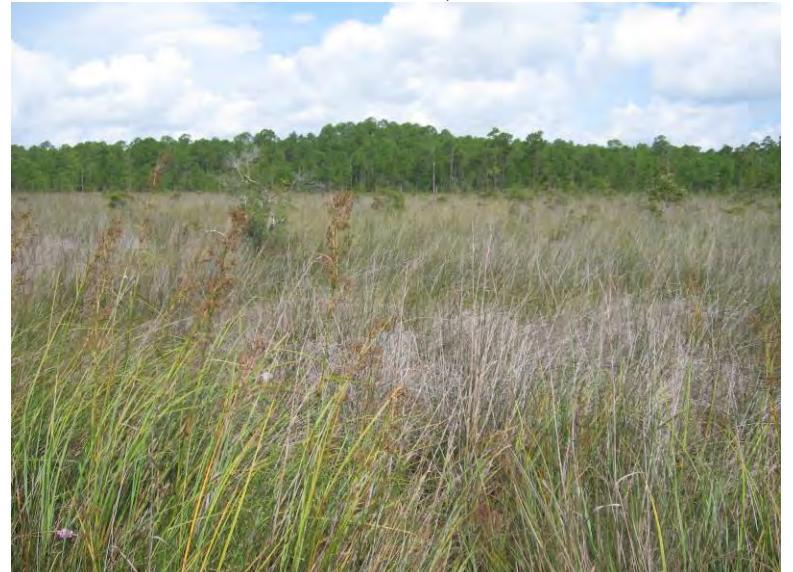
Freshwater Marsh (FLUCCS 641)

A freshwater marsh dominates the southeastern half of Tract A. Additionally, two small disjunct freshwater marshes occur within the northwestern corner of Tract A. The northernmost of these marshes is an oxbow of Eleven Mile Creek. Tree species were occasionally observed and with the exception of slash pine, typically small in stature. Herbaceous vegetation occurs as a mosaic of nearly pure stands of saw grass (Cladium jamaicense) to areas containing combinations of saw grass, wool-grass bulrush (Scirpus cyperinus), Leconte's flatsedge (Cyperus lecontei), wand loosestrife (Lythrum lineare), bighead rush (Juncus megacephalus), fragrant flatsedge (Cyperus odoratus), herb-of-grace (Bacopa monnieri), torpedograss (Panicum repens), switchgrass (Panicum virgatum), rough barnyard grass (Echinochloa muricata), conecup spikerush (Eleocharis tuberculosa), comfort root (Hibiscus aculeatus), water cowbane (Oxypolis filiformis), and dotted smartweed (Polygonum punctatum).

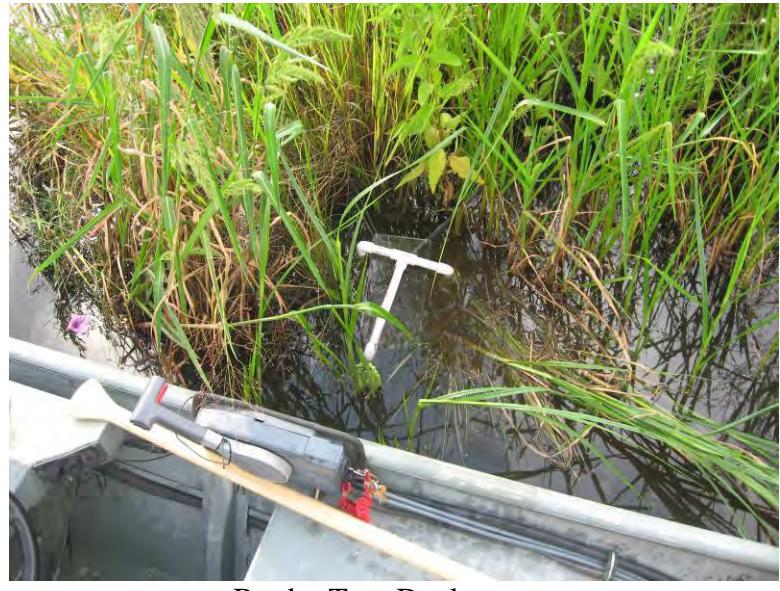
Breder Trap Deployment

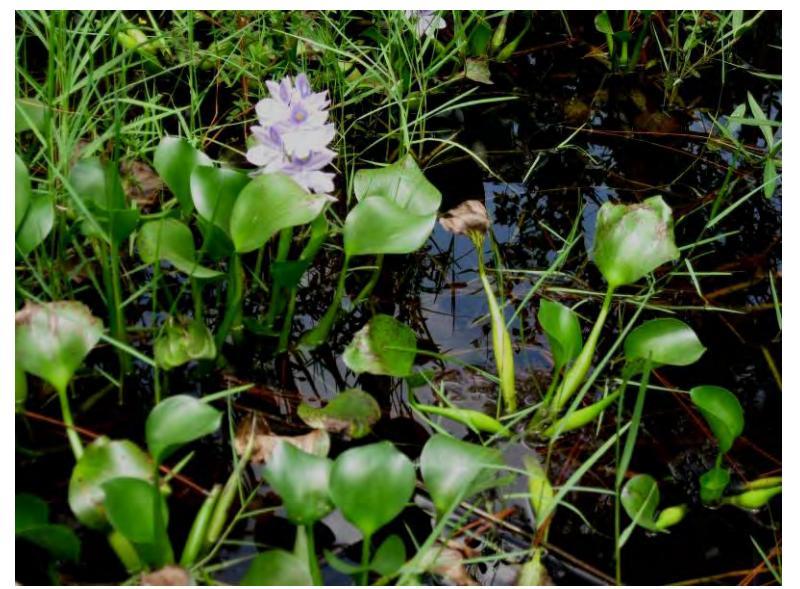
Common water hyacinth (*Eichhornia crassipes*)
