ISLAND ROAD MITIGATION SITE

2020 Annual Monitoring Report

USACE Permit No.: SAJ-2014-00624 (NW-JML), issued 3/9/2015

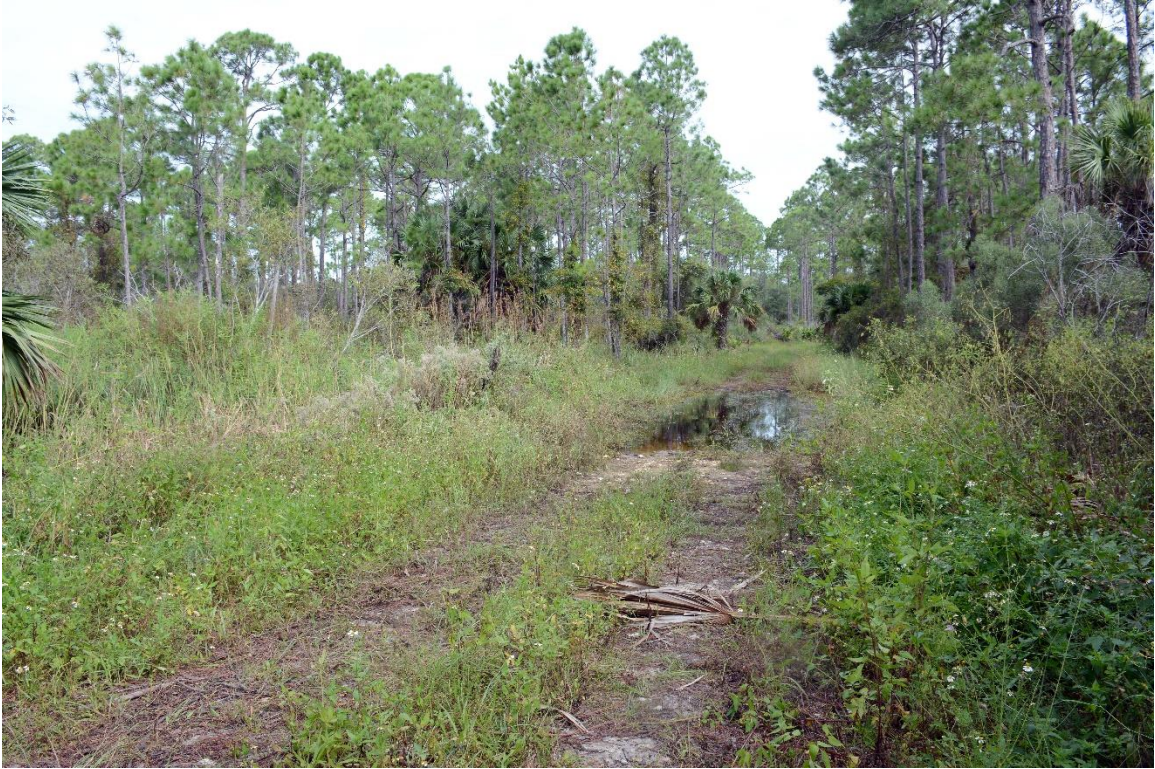
Figure 1: Island Road LWC (9/22/2020; Looking North)

An annual inspection by NFWMD staff on 9/22/2020 concluded that the low-water-crossing is in excellent condition, is functioning as designed, and that natural hydrologic flows have been reestablished. Although storm surge associated with Hurricane Michael overflowed the site in 2018, the low-water-crossing suffered no apparent damage, and the adjacent marsh and pine flatwoods appear healthy. The site continues to be being managed for ecological integrity by Buffer Preserve staff in accordance with an ARC-approved (Acquisitions and Restoration Council) St. Joseph Bay State Buffer Preserve management plan (available at
