**Sand Hill Lakes Mitigation Bank
Combined DEP/ACOE Ninth Annual Report
December 2014**

FDEP Permit # 0227351-001 Issued 9/6/2005, Washington County

**Submitted by David Clayton on behalf of the Northwest Florida Water Management District
In support of specific conditions 26 and 28**

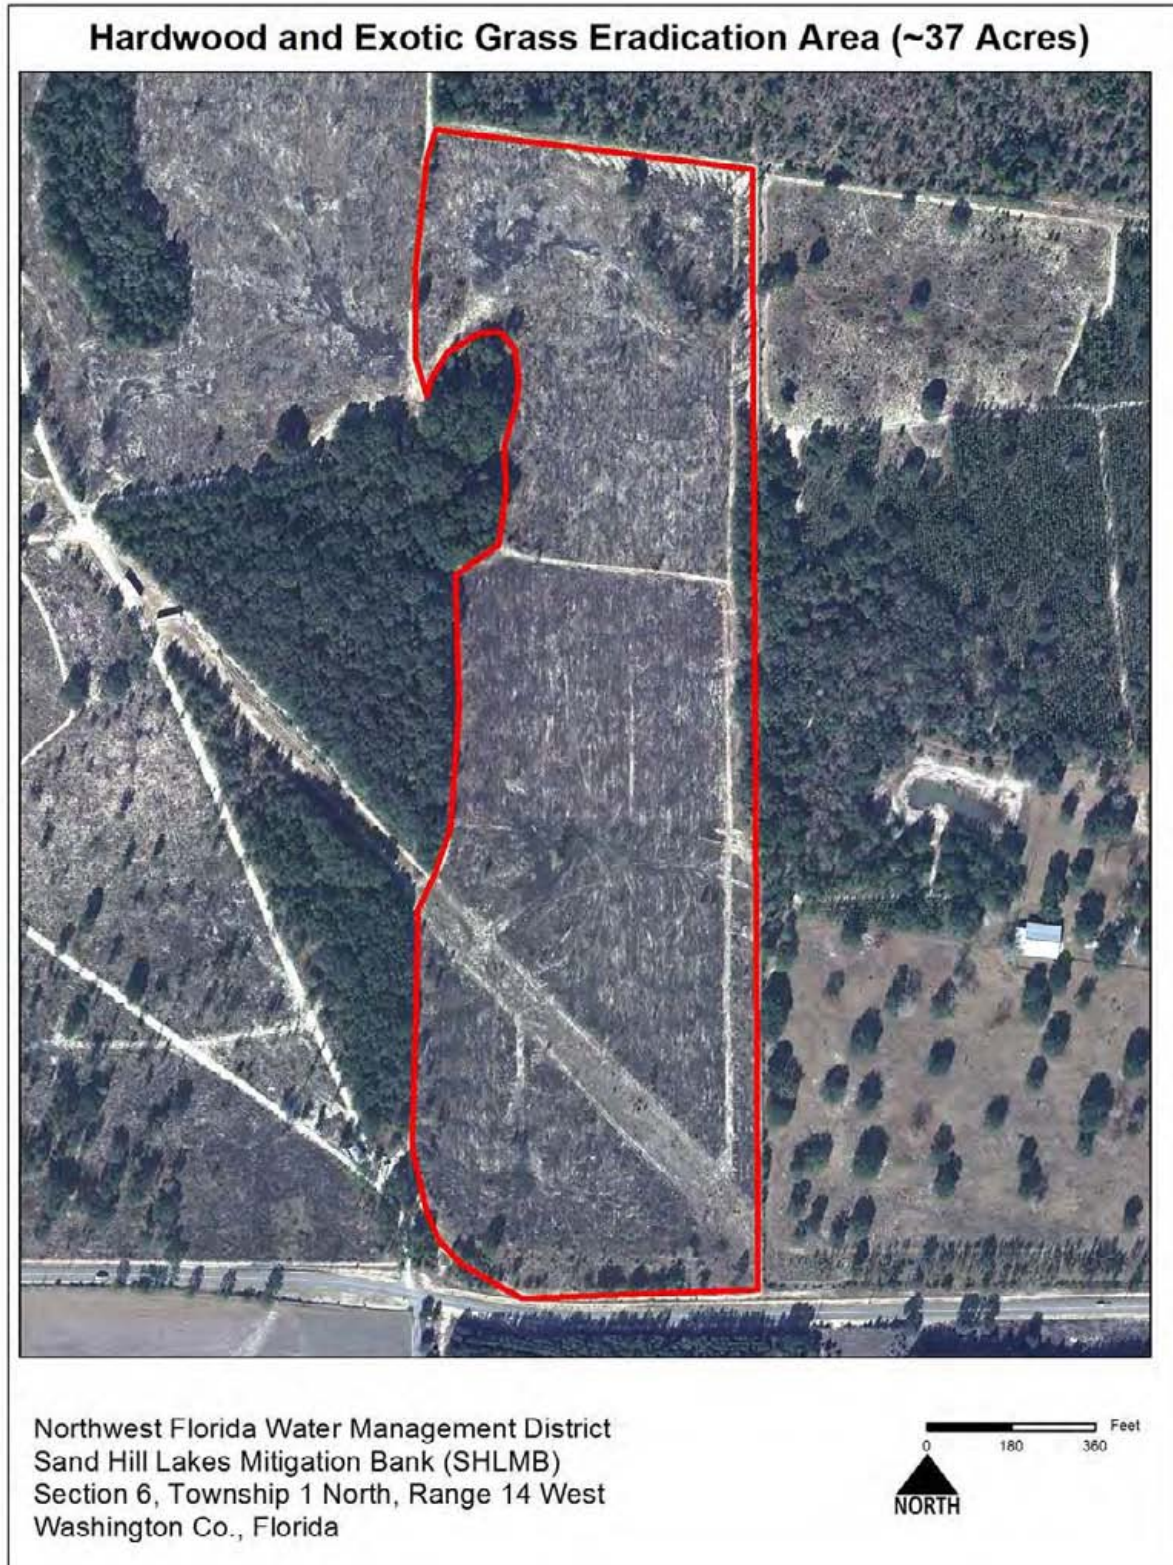
Figure 8. Nuisance native and exotic species herbicide treatment area for 2014

In 2014, shrub cover (yaupon) had increased and Bahia grass coverage exceeded 5% in a 37 acre sand hill restoration area to the east of the check station (Figure 8). The 37 acres of sand hill restoration was mowed and the yaupon and Bahia grass treated with herbicide. The area was subsequently burned in late August 2014. This area will again be treated in 2015 and planted with wire grass in the winter of 2015/16. Minor Bahia grass cover was observed in the road removal area between Little Deep Edge Pond and Green Head Branch and was treated in September (Figure 8a). In addition remnant torpedo grass cover though insignificant was again treated at the boat launches (Figure 8a). Hog damage was observed in scattered among the 168 acres of hydric pine flatwoods in 2014. FWC was notified and hog traps were placed in areas of activity. A total of 13 hogs were removed by trapping and one through hunting in 2014 (Figure 8b).

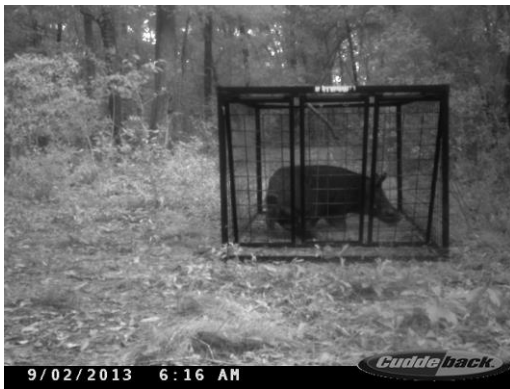
A single hog trapped in a box trap (date function not working on camera)

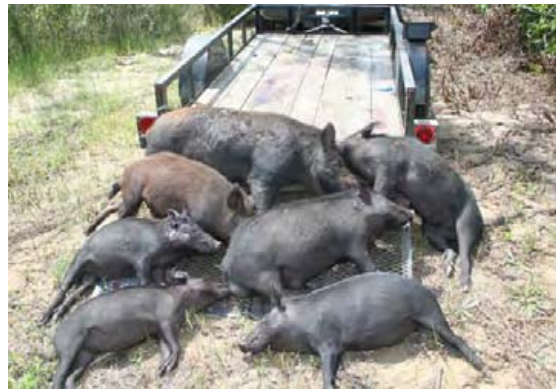
A sounder of 7 hogs captured in a corral style trap

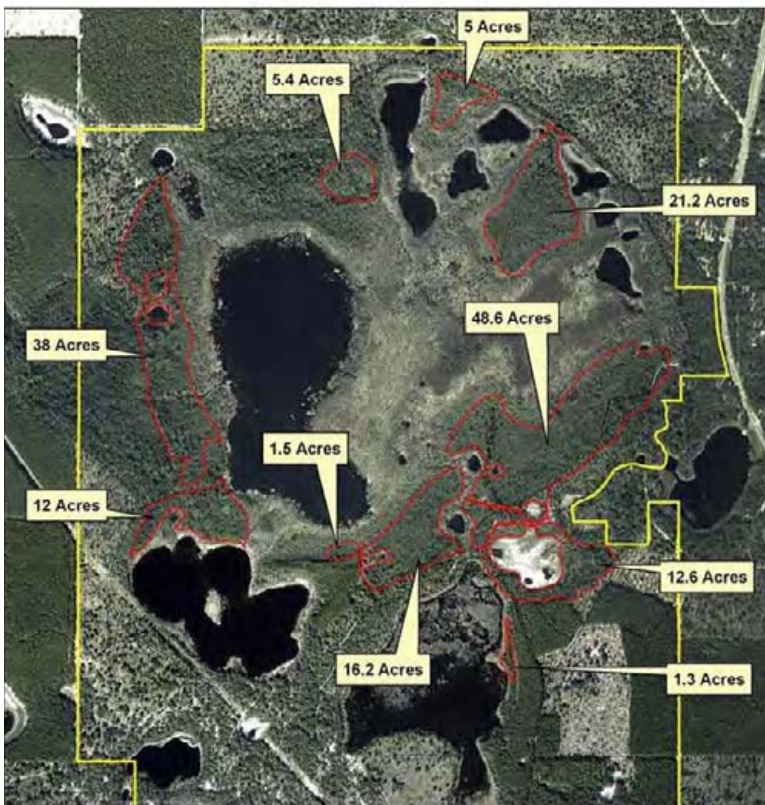
Figure 12. Hydric pine flatwoods restoration areas (165 acres)
Brush Reduction

Northwest Florida Water Management District
Sand Hill Lakes Mitigation Bank (SHLMB)
Brush Reduction (Gyro-Track Mulching) - ~165 Acres
Section 6, Township 1 North, Range 14 West
Washington Co., Florida

By March 2008, it was apparent, that while the shrub cover was greatly reduced, re-sprouting of the shrubs had occurred in all Gyro-Trac areas. Average shrub densities were determined through randomly established transects and stems per meter squared were determined. In areas with a hot fire 50-80 stems per meter squared were observed while in areas with an incomplete burn, 100 to 135 stems per meter squared were common. Based on these observations, the shrubs would return if not significantly reduced further. In an effort to determine if selected herbicides could aid in reducing shrubs numbers to an acceptable level, two polygons, the Whale, a 12 acre polygon adjacent to the Dry Pond parking, and a 16.2 acre polygon adjacent to Dry Pond and the slash pine restoration sites were chosen. These two areas were treated twice by Entrix with appropriate wetland approved herbicides, once in July and again in September. The 16.2 acre polygon was burned in the winter of 2008-2009 with a very hot fire. The 16.2 acre polygon was planted with wire grass plugs while the whale, had previously been direct seeded with wire grass seed. Preliminary results indicate that the shrub cover was greatly reduced from greater than 85% cover to less than 15% cover. Based on the positive results in these areas, herbicide was used to reduce shrub cover throughout the 165 acres of wet flatwood restoration. In 2008, 2009, and 2010 a total of 165 acres of wet pine flatwoods areas that had shrub reduction were treated with selective herbicides to further reduce shrub cover. Shrubs were hand treated two times in 2008, April and October, three times in 2009, (April, July and October) and two times in July and September of 2010. In 2007, following the Gyro-Trac treatment followed by a burn, the shrub densities were reduced from nearly 100% at the baseline to 49%. Following the burn in areas where the herbicide work was initiated going into the fall, percent cover in those areas averaged 5% shrub cover, while areas that were treated one year following average 16.2% cover in 2010. Overall the flatwood restoration sites averaged 10% shrub cover 3 years following the implementation of restoration activities.

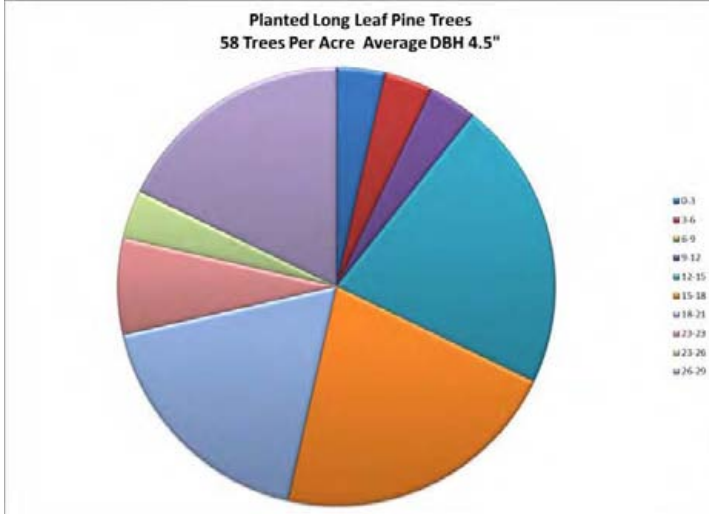
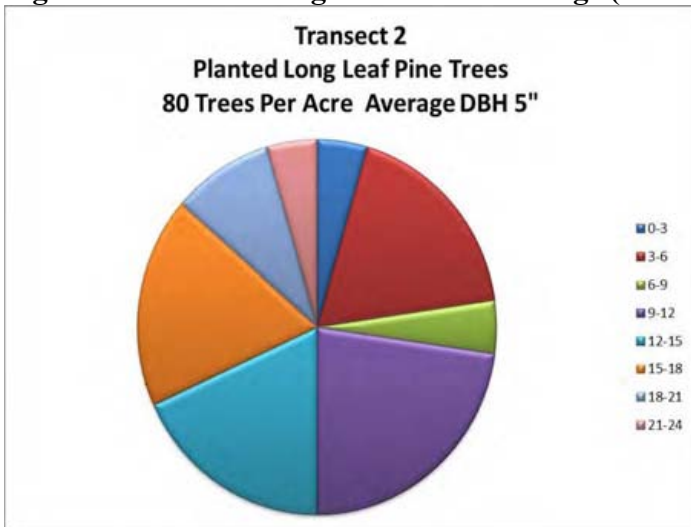
The survival of long leaf pine seedlings along each transect was observed to be within the 100-200 tree per acre requirements found in the permit. A total of 58 long leaf pine seedlings were observed along transect 1, 80 for transect 2, and 298 in transect 4 (Figure 17-19). Several warm season burns likely reduced the number of long leaf pines within transects. The significant increase along transect 4 is likely due to a survey overestimate of the plot width by an assistant. Overall health of the planted seedlings was excellent. Most of the trees are now in the 9-12 or 12-15' size class and many are over 6'. Average dbh is 4.5".

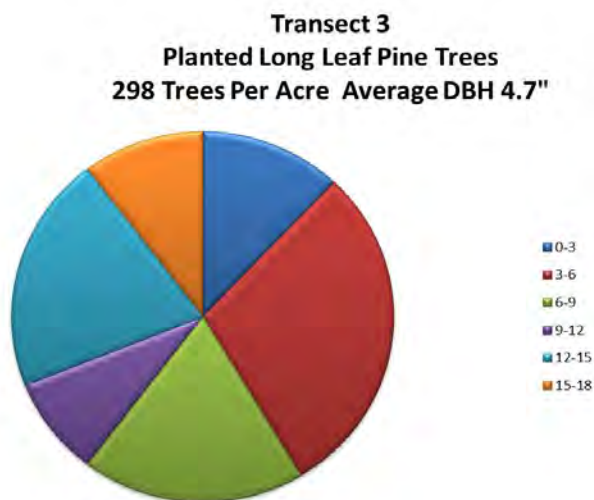
In 2014, the survival of long leaf pine seedlings was 298 per acre in Transect 3 and 163 in Transect 5. The increase in observed trees in Transect 3 and 5 was due to planting additional trees in 2012 due to poor survival. Overall health of the planted seedlings was excellent. Many of the trees are near 6' in height and the average DBH was 4.7" (Figure 22 and 23).
